HAZARDOUS MATERIALS ASSESSMENT REPORT

Job details: Owner/s: Mr. R. & Mrs. H. Dyson
Location: 118 Mill Hill Road, Bondi Junction

Date of assessment: 19th April 2016

Our reference: HM04780416

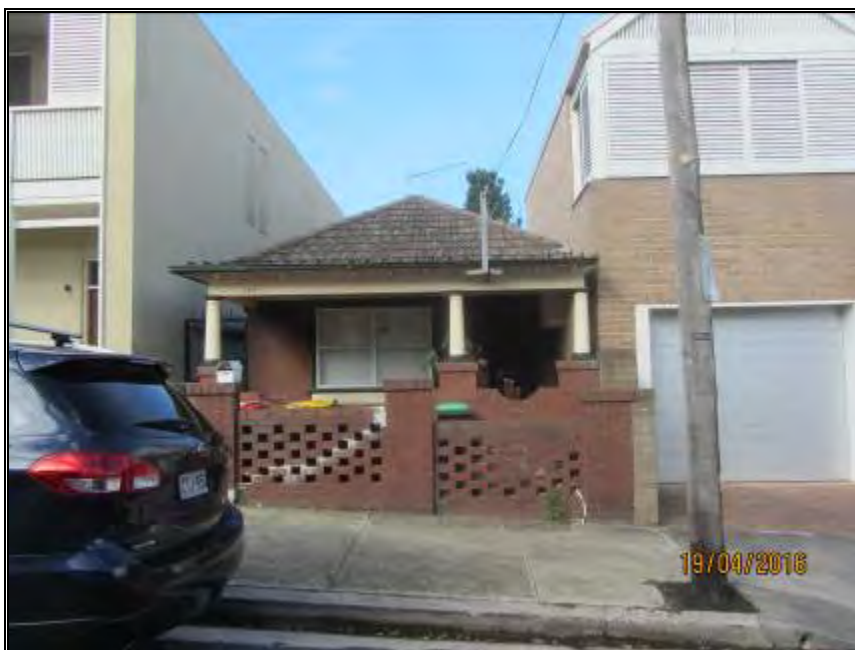
Front western elevation of the residence
