## Dilapidation Assessment Report

Prepared for: Cape Cod Australia Pty. Limited  
Job address: No. 39 Varna Street, Clovelly.  
Property Owner/s: Mr. S. Paddam & Mrs. K Mammen.  
Report reference: **RANDWICK COUNCIL**  
Development Application No: not available  
Date of assessment: 4<sup>th</sup> July 2017

**Re: Dilapidation Report – No. 39 Varna Street, Clovelly.**

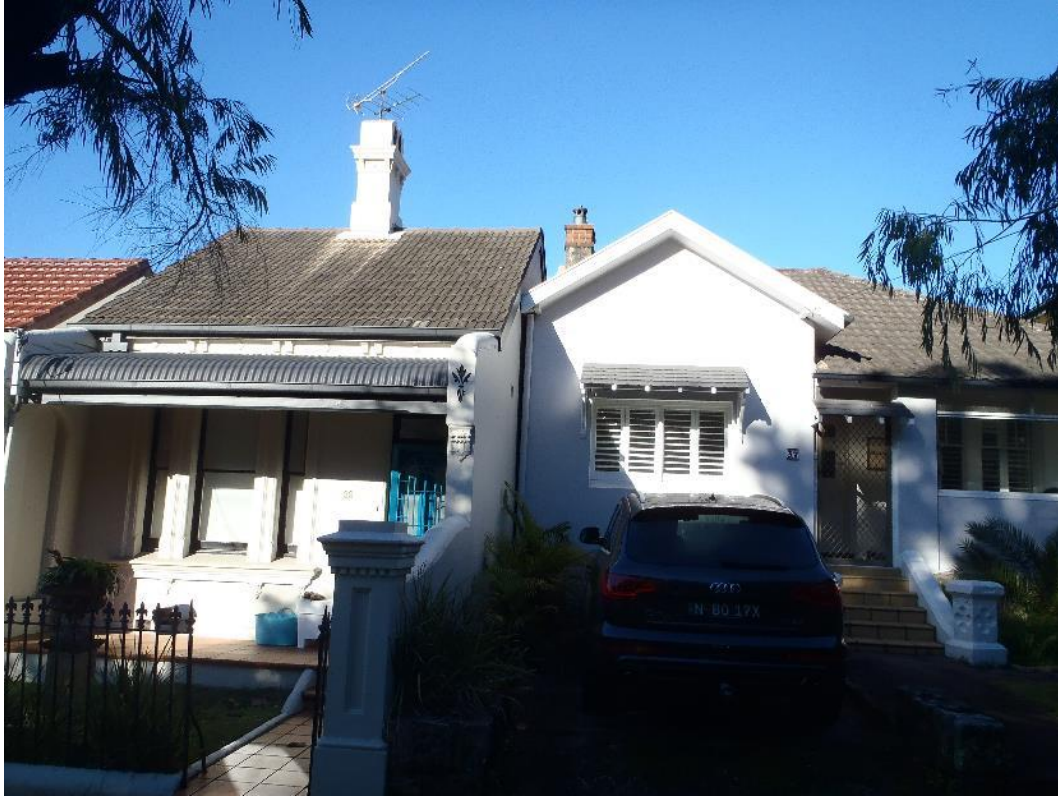
We observed that the concrete roof tiles to the original roof surfaces are generally interlinked and securely bedded, in our opinion forming a weather resistant cover to the residence. **[Photograph 1]**

**Photograph 1** shows the general condition of the tiled roof surface.

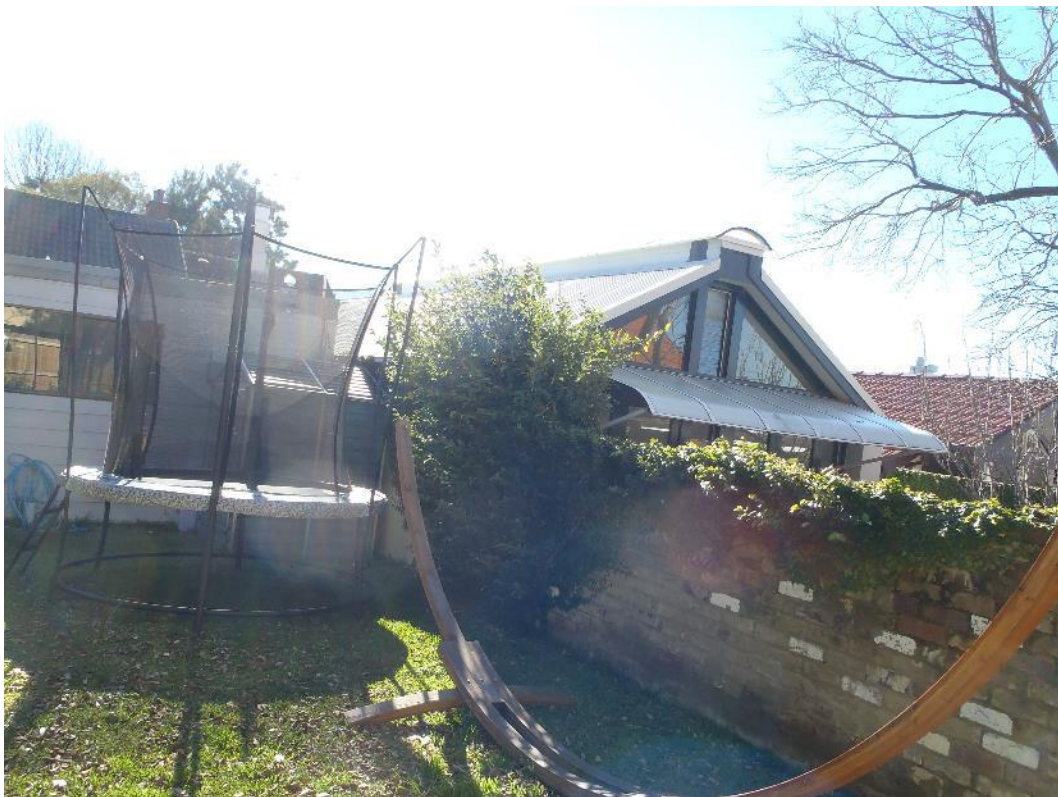
We noted that the corrugated profile sheet metal roofing to the rear addition roof surfaces is in good condition and is securely fixed, in our opinion forming a weather resistant cover to the rear addition. **[Photograph 2]**

**Photograph 2** shows the general condition of the corrugated roof surface.

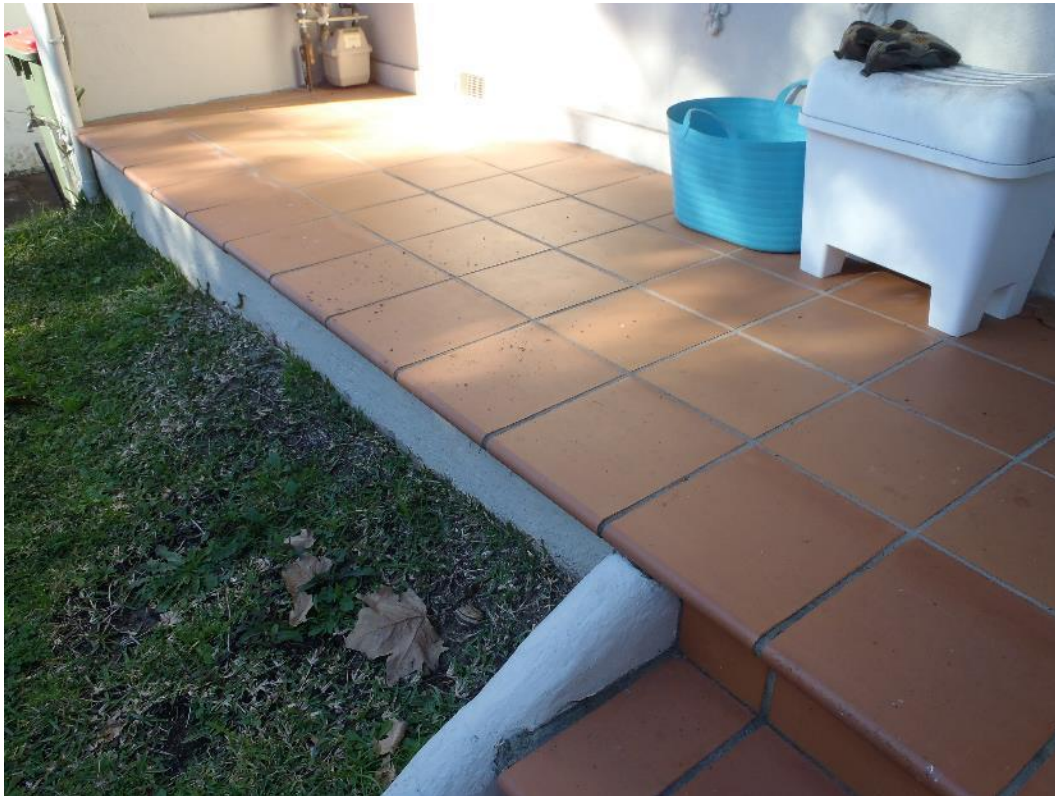
We noted that the terracotta tiles to the front verandah were generally sound with the grout complete. **[Photograph 3]**

**Photograph 3** shows the general condition of the terracotta tiles to the front verandah.

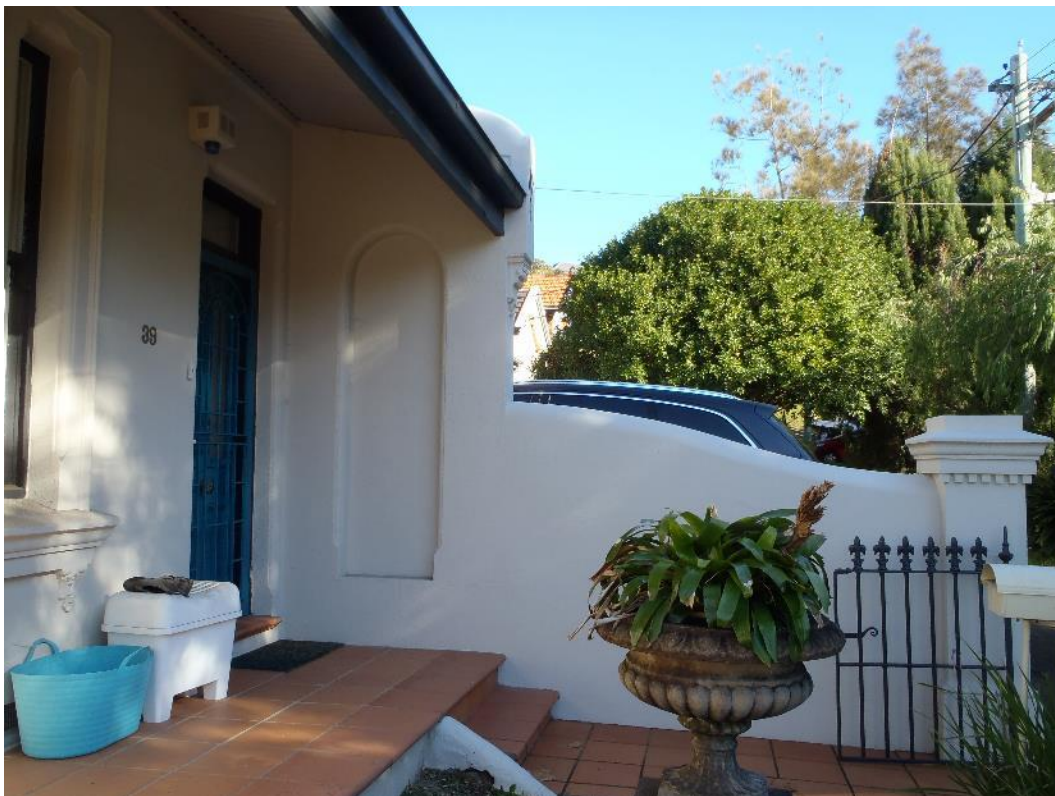
We noted that the front *common* boundary fence and privacy wall is surface coated clay masonry brick. **[Photograph 4]**

**Photograph 4** shows the general condition of the *common* boundary fence and privacy wall.

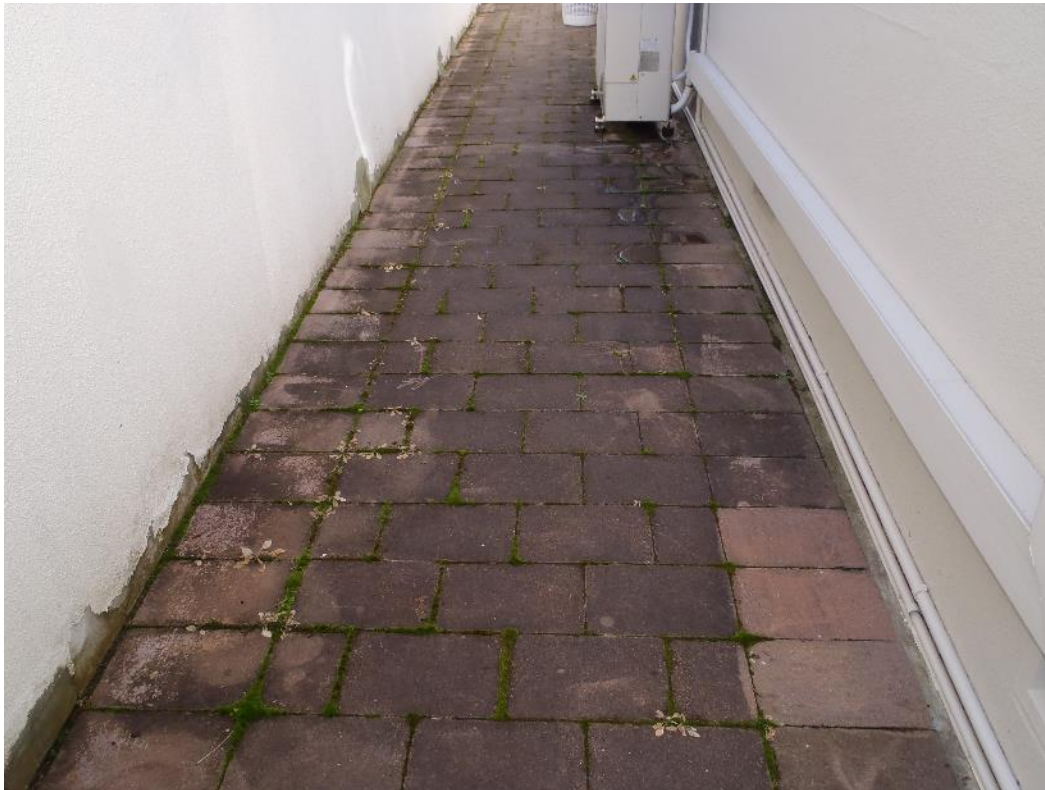
We noted that the side elevation was finished with clay pavers. **[Photograph 5]**

**Photograph 5** shows the general condition of the eastern elevation paved pathway.

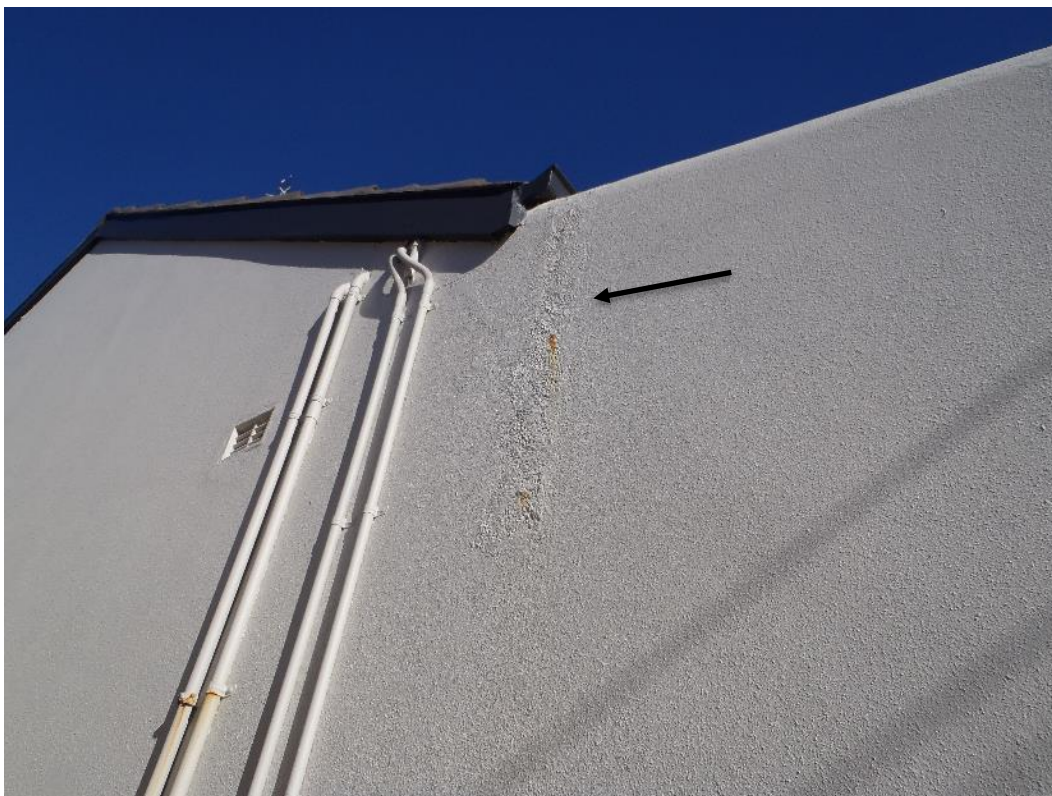
We noted evidence of previous repairs to the external wall of the front porch privacy wall.  
**[Photograph 6]**

**Photograph 6** shows evidence of previous repairs to the external wall of the eastern side of the front porch privacy wall.

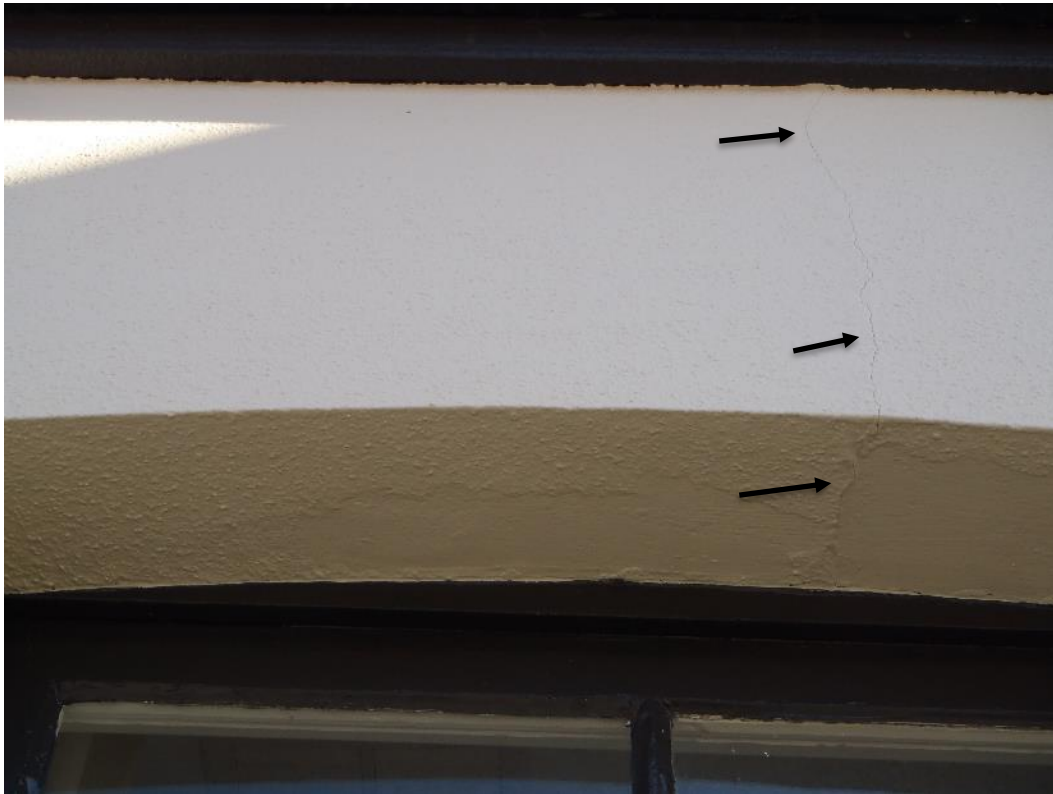
We noted vertical cracking extending upward from the Bedroom 2 window head. **[Photograph 7]**

**Photograph 7** shows vertical cracking extending upward from the Bedroom 2 window head.

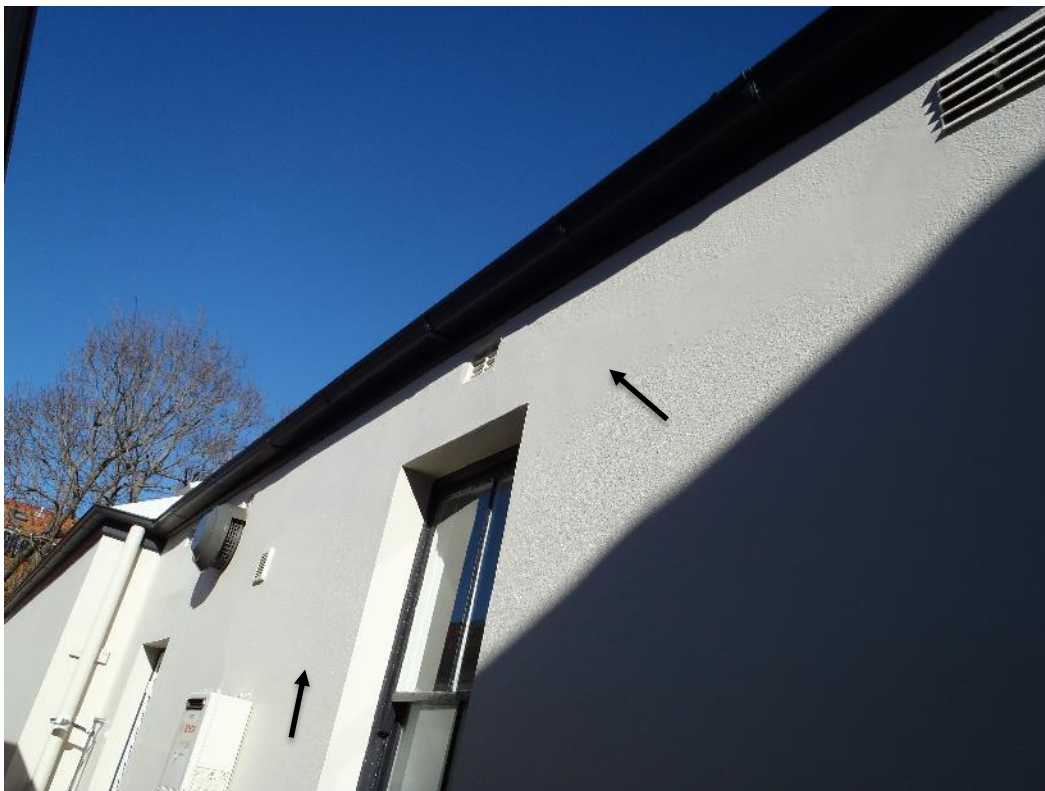
We noted evidence of previous repairs (difference in surface texture) around the Bedroom 3 window.  
**[Photograph 8]**

**Photograph 8** shows evidence of previous repairs (difference in surface texture) around the Bedroom 3 window.

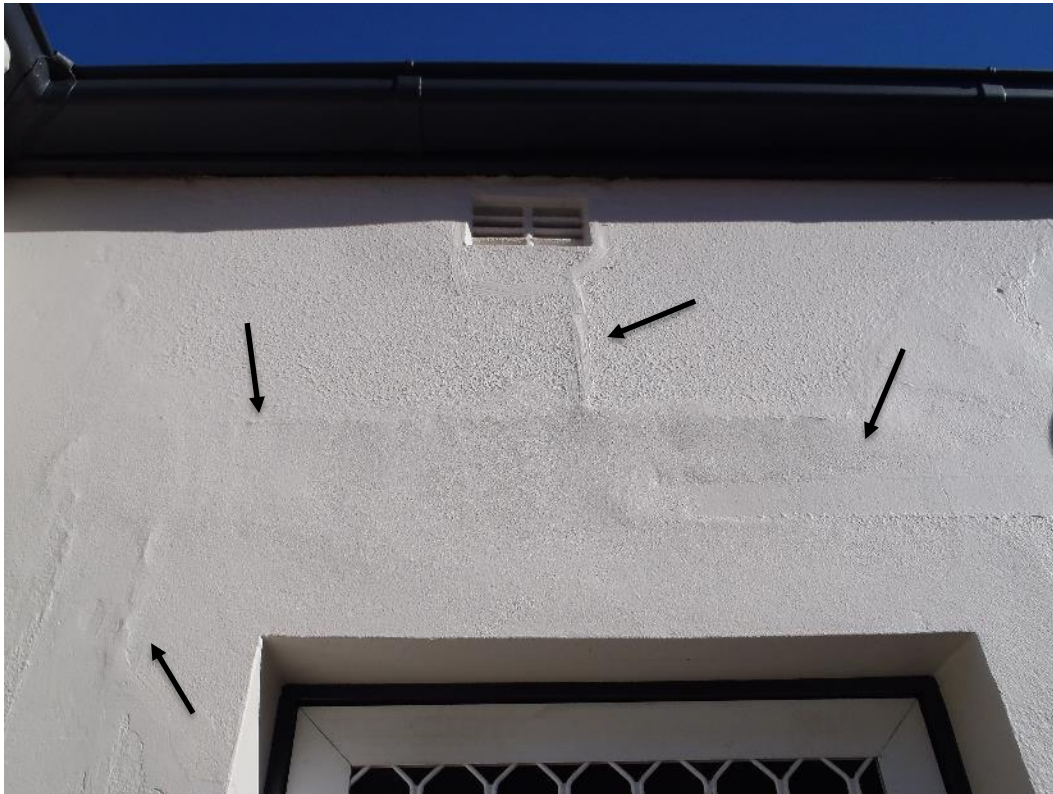
We noted evidence of previous repairs and radial cracking around the Kitchen door. **[Photograph 9]**

**Photograph 9** shows evidence of previous repairs and radial cracking around the Kitchen door.

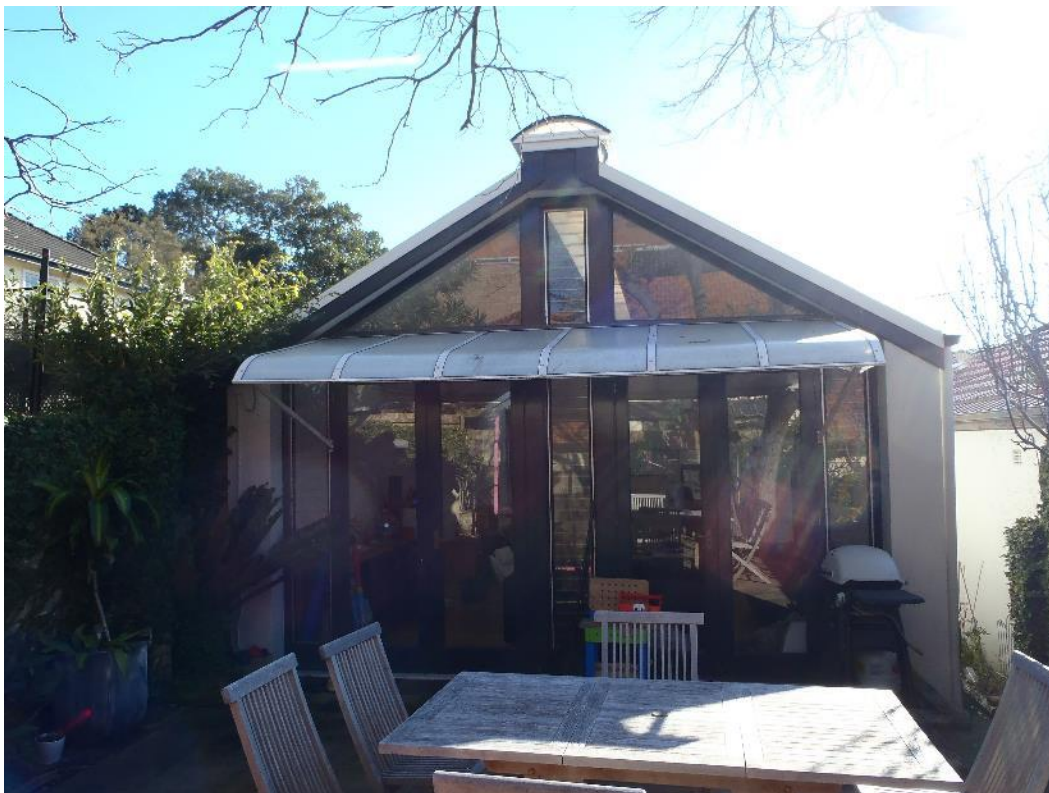
We noted that the rear elevation was gable ended with glass infill panels and an acrylic bull-nosed awning. **[Photograph 10]**

**Photograph 10** shows the general condition of the rear elevation.

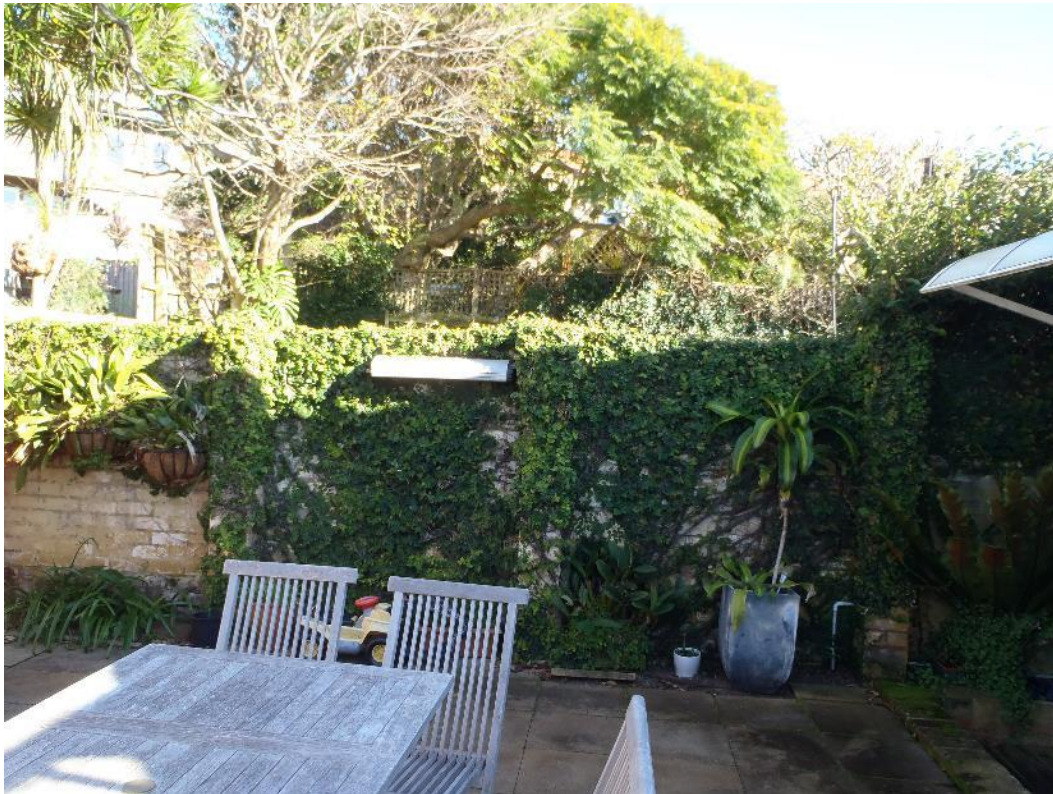
We noted that the rear *common* boundary fence with the adjoining property, No. 37 Varna Street, Clovelly was rendered brick with vegetation growth along the wall. **[Photograph 11]**

**Photograph 11** shows the rear common boundary fence with the adjoining property, No. 37 Varna Street, Clovelly.

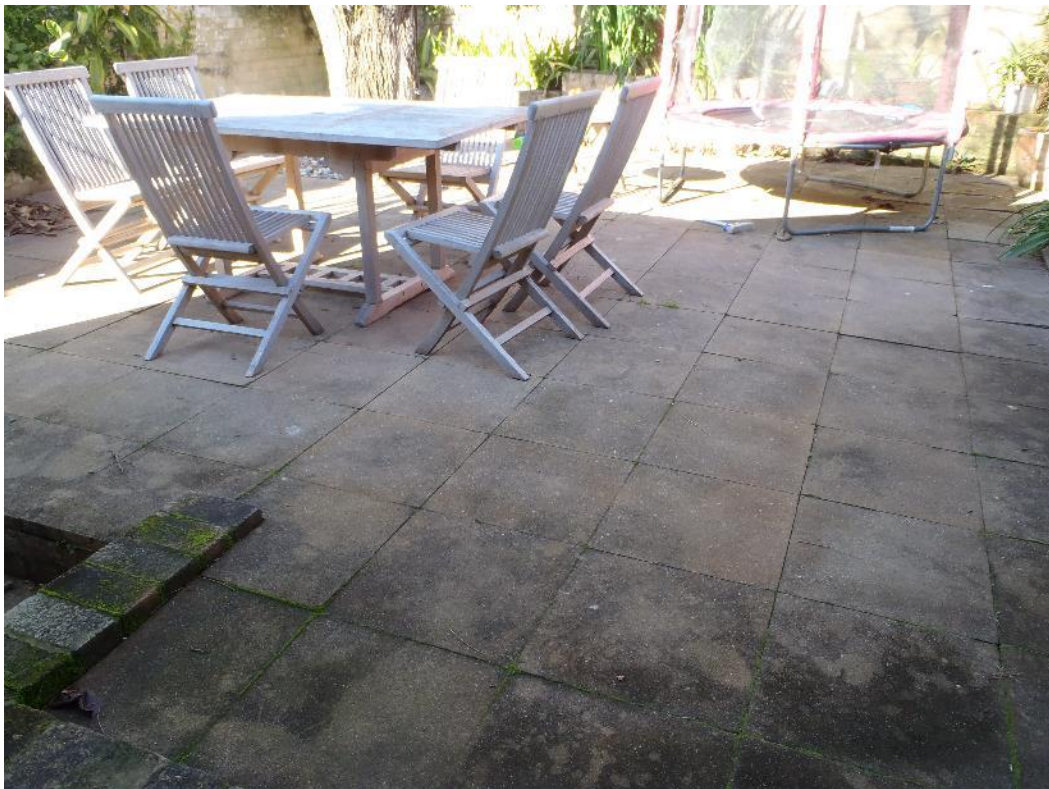
We noted some displacement and lichen growth to the paved surface of the rear courtyard.  
**[Photograph 12]**

**Photograph 12** shows general condition of the paved surface of the rear courtyard.

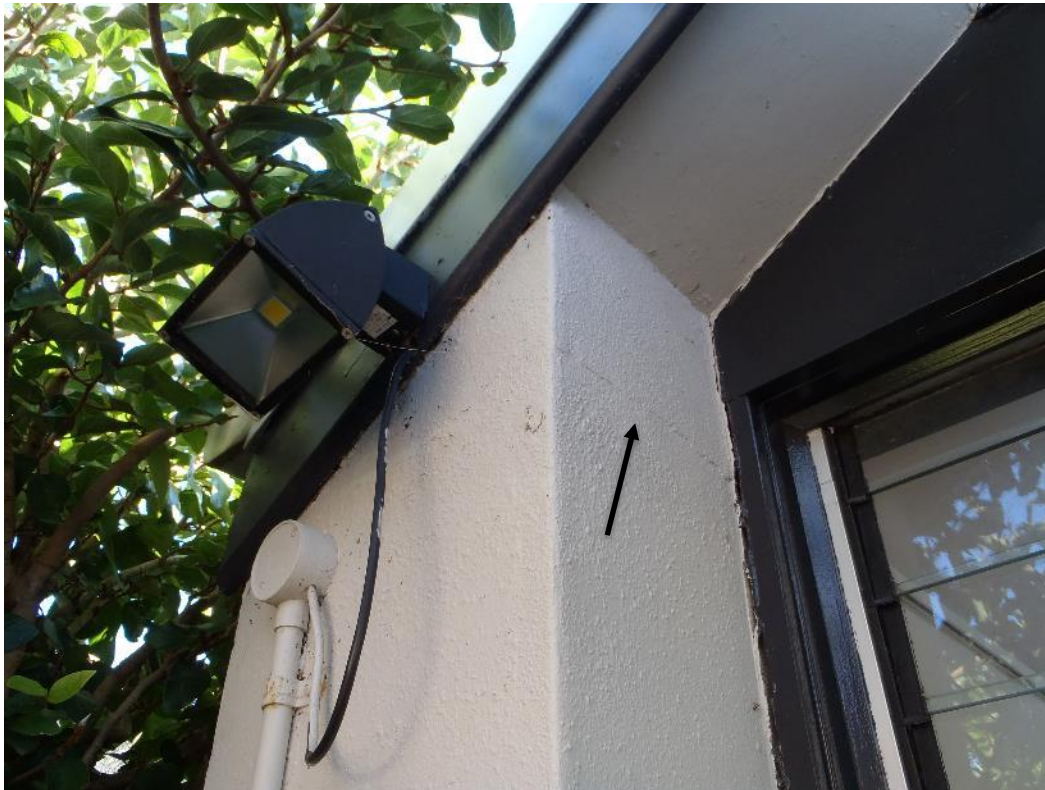
We noted radial cracking [ $< 1$  mm] to the cement rendered window reveal extending toward the barge board light fitting. **[Photograph 13]**

**Photograph 13** shows radial cracking to the cement rendered window reveal extending toward the barge board light fitting.

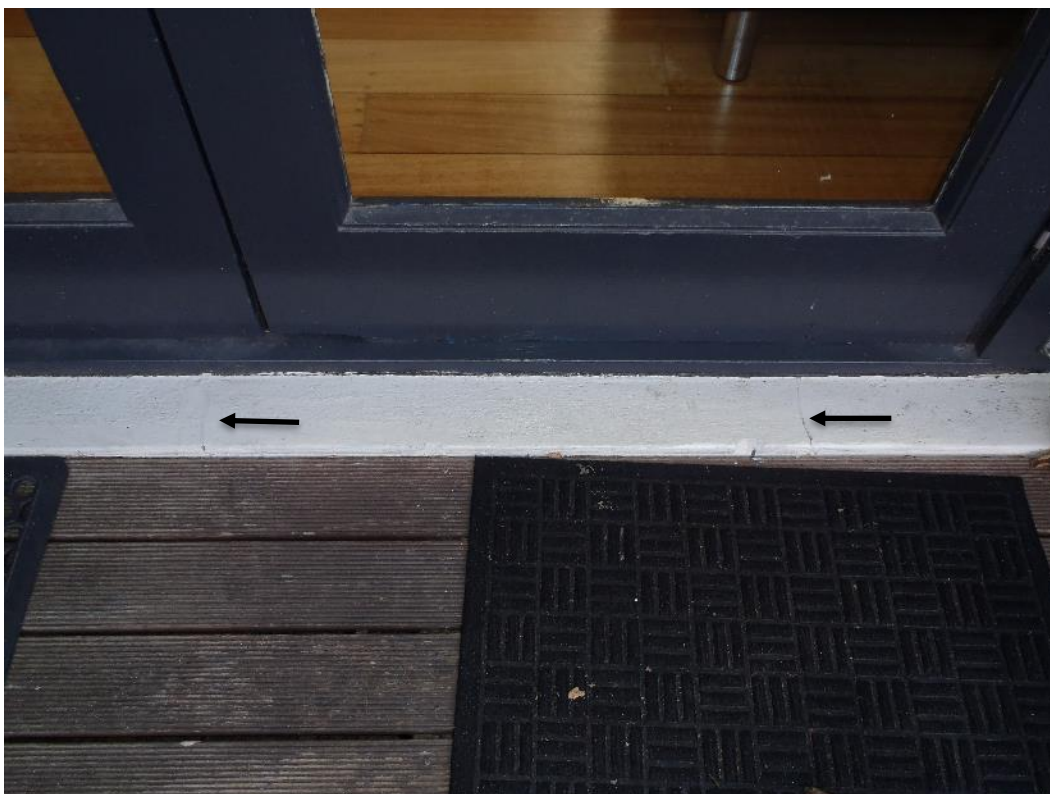
We noted hairline cracking [ $< 1$  mm] to the rear door threshold step. **[Photograph 14]**

**Photograph 14** shows hairline cracking to the rear door threshold step.

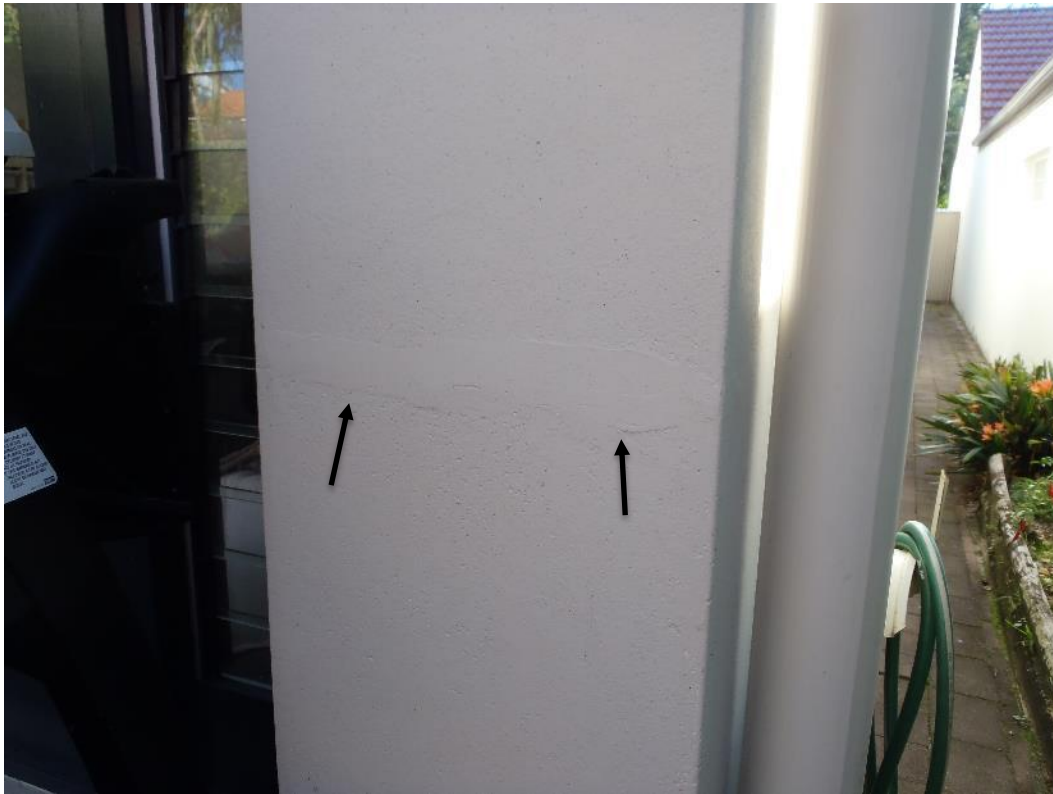
We noted evidence of horizontal previous repairs to the south-eastern external corner.  
**[Photograph 15]**

**Photograph 15** shows evidence of horizontal previous repairs to the south-eastern external corner.

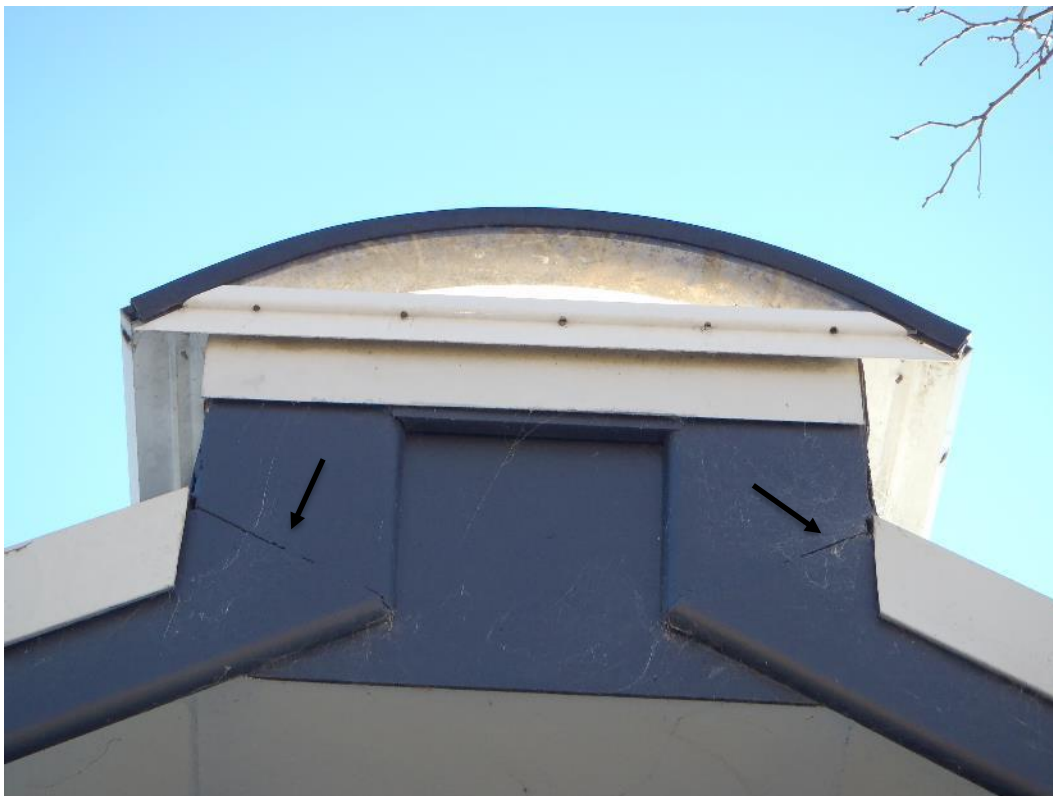
We noted separation cracking to the mitre joints in the barge board on the gable end peak.  
**[Photograph 16]**

**Photograph 16** shows separation cracking to the mitre joints in the barge board on the gable end peak.

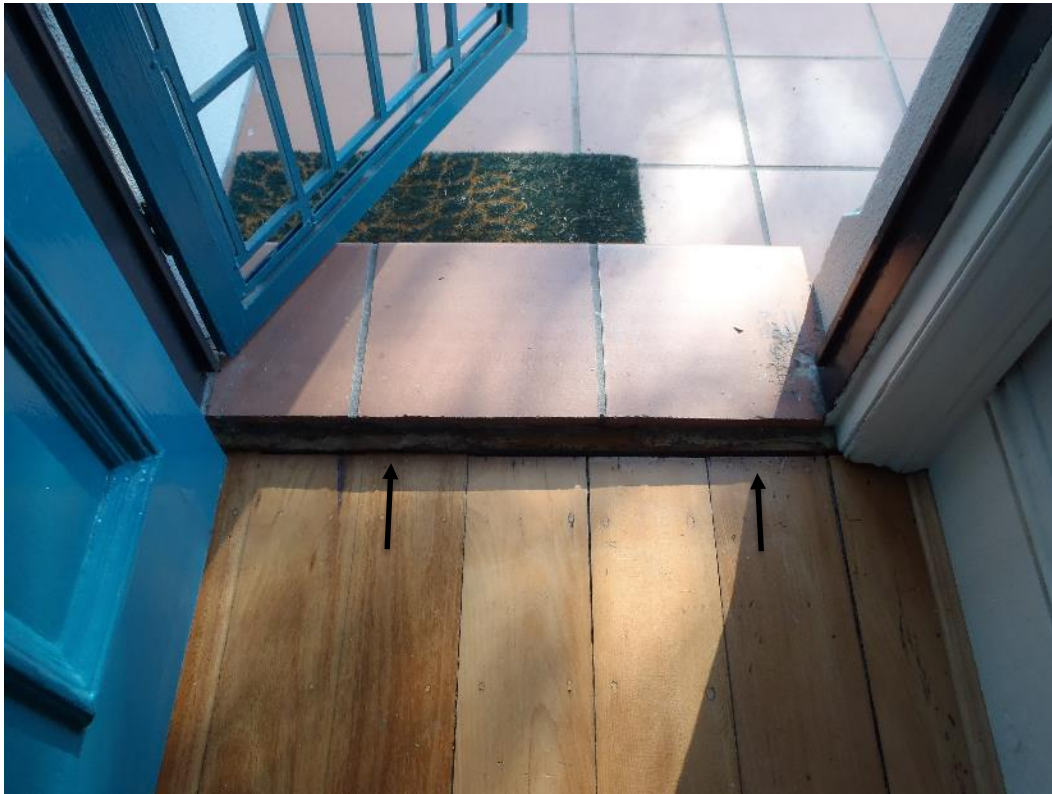
We noted gaps between the tiled entry threshold step and the strip timber flooring. We further noted damage to the threshold step tiles. **[Photograph 17]**

**Photograph 17** shows gaps to the strip timber flooring and damage to the threshold step tiles.

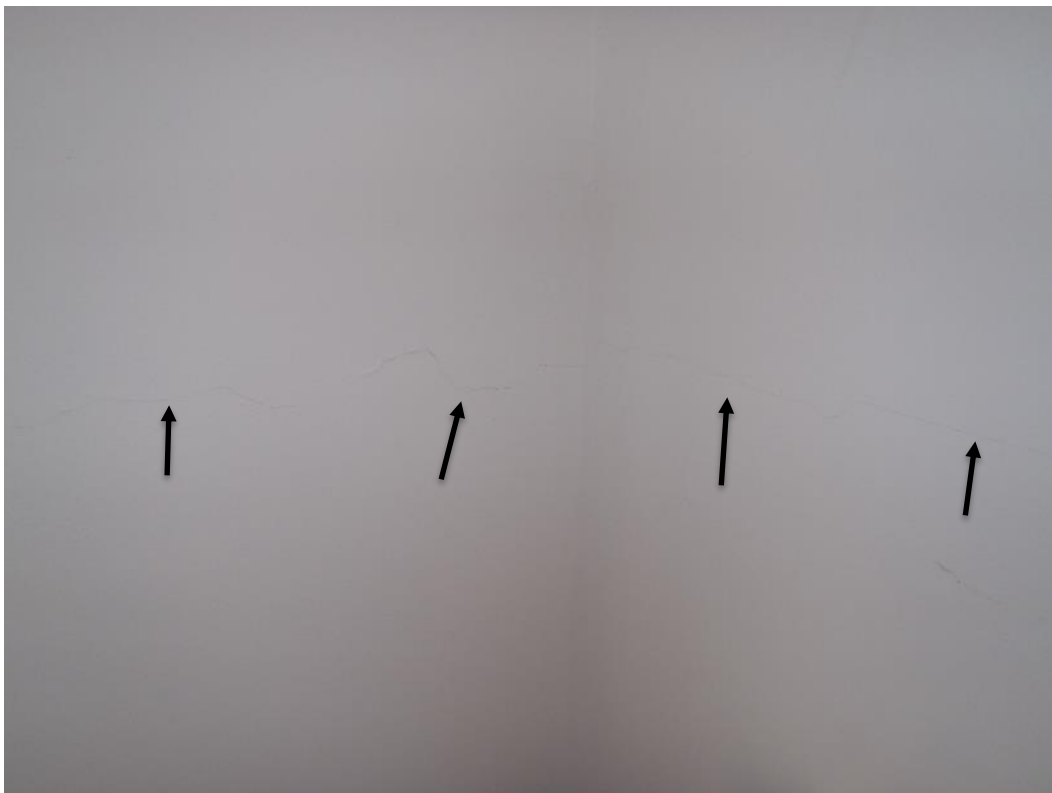
We noted horizontal cracking [ $< 1$  mm] in the north-eastern corner. **[Photograph 18]**

**Photograph 18** shows horizontal cracking in the north-eastern corner of Bedroom 1.

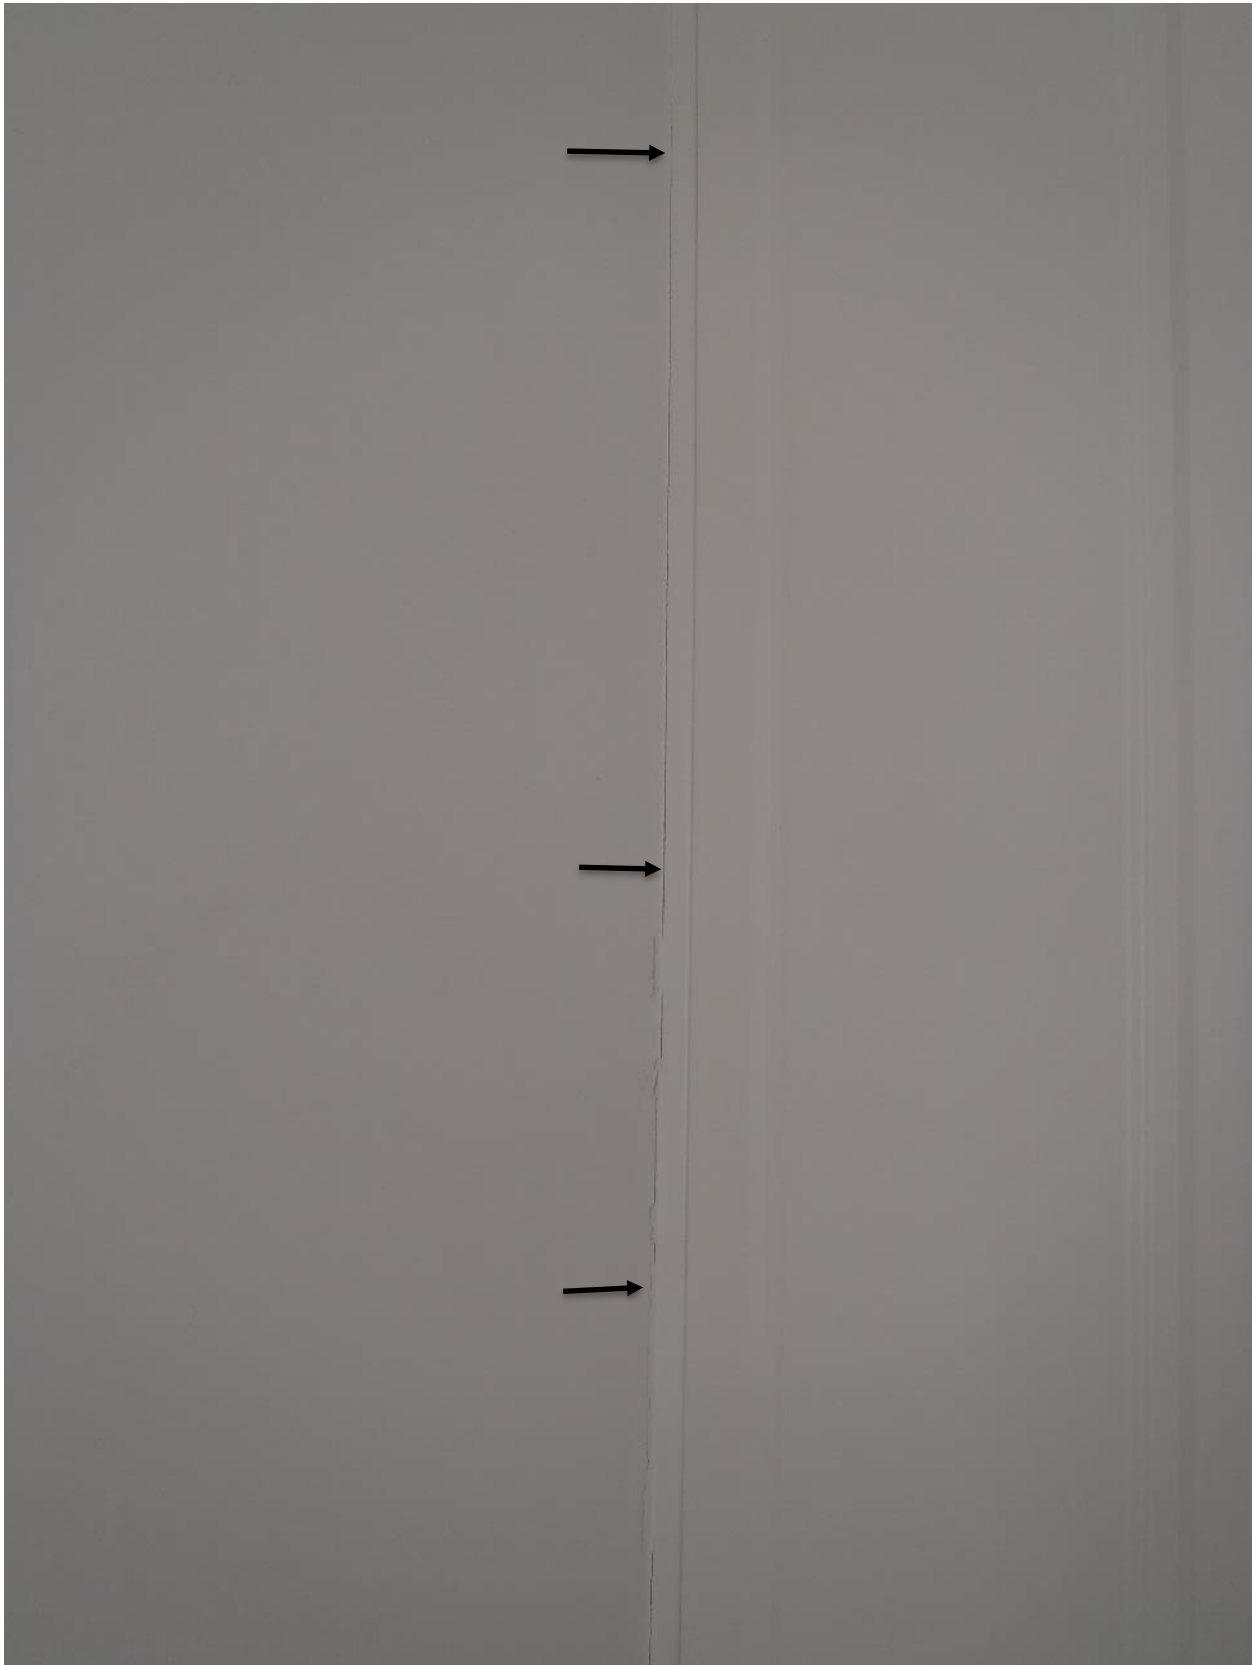
We noted vertical separation cracking [ $< 1$  mm] adjacent to the wardrobe cupboard in the south-eastern corner. **[Photograph 19]**

**Photograph 19** shows vertical separation cracking adjacent to the wardrobe cupboard in the south-eastern corner of Bedroom 1.

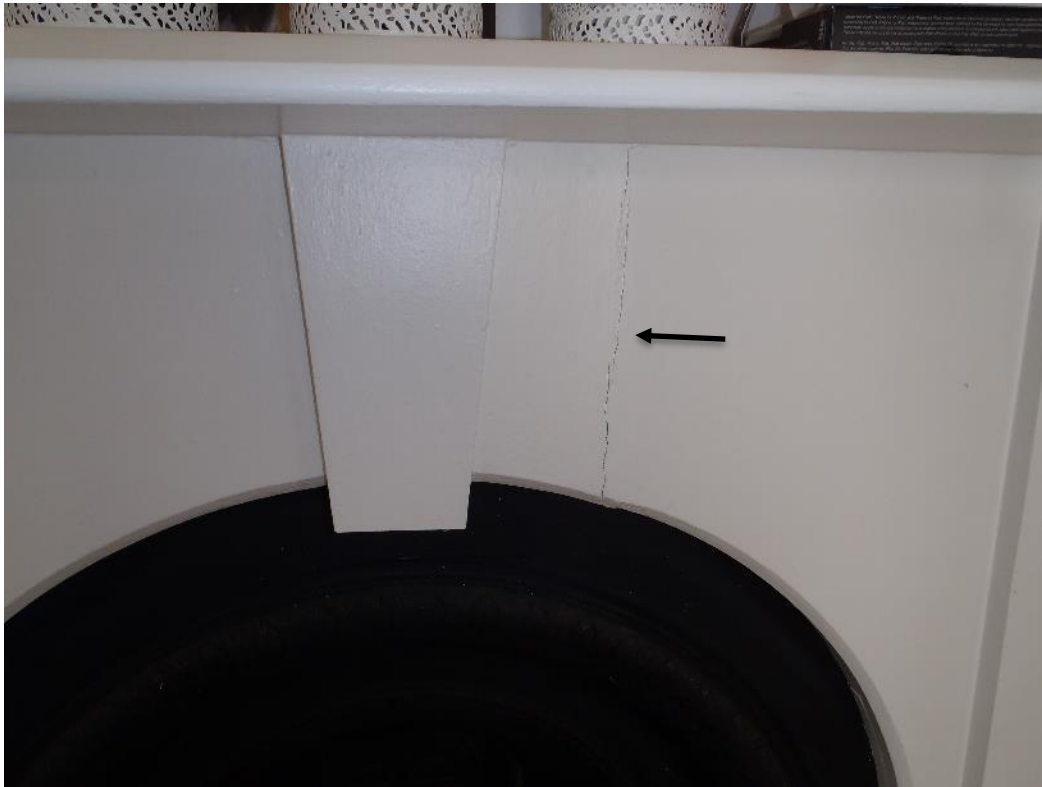
We noted vertical cracking [ $< 1$  mm] to the fireplace mantle. **[Photograph 20]**

**Photograph 20** shows vertical cracking to the fireplace mantle in Bedroom 1.

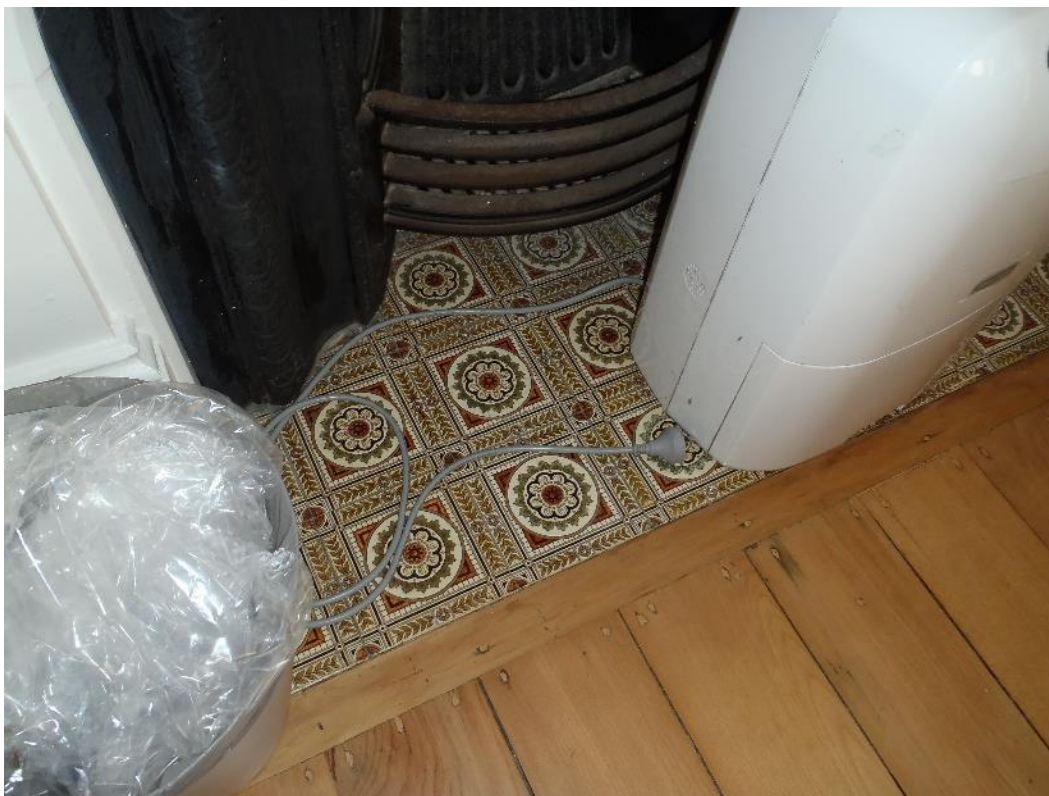
We noted that the grout to the fireplace hearth tiles is complete and that when randomly “tap” tested appeared to be sound. We did not observe any recent cracking to the hearth tiles. **[Photograph 21]**

**Photograph 21** shows the general condition of the fireplace hearth tiles in Bedroom 1.

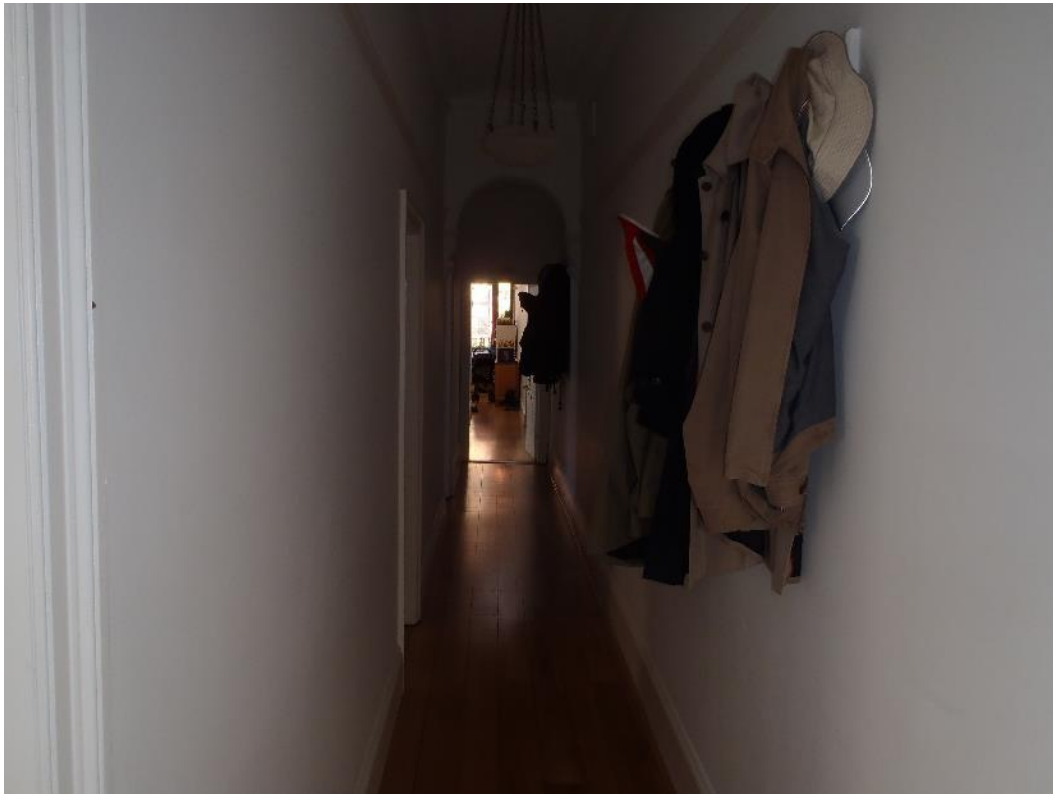
We noted that the western wall is the *common party / separation* wall with the adjoining property, No. 37 Varna Street, Clovelly. **[Photograph 22]**

**Photograph 22** shows the general condition of the hallway.

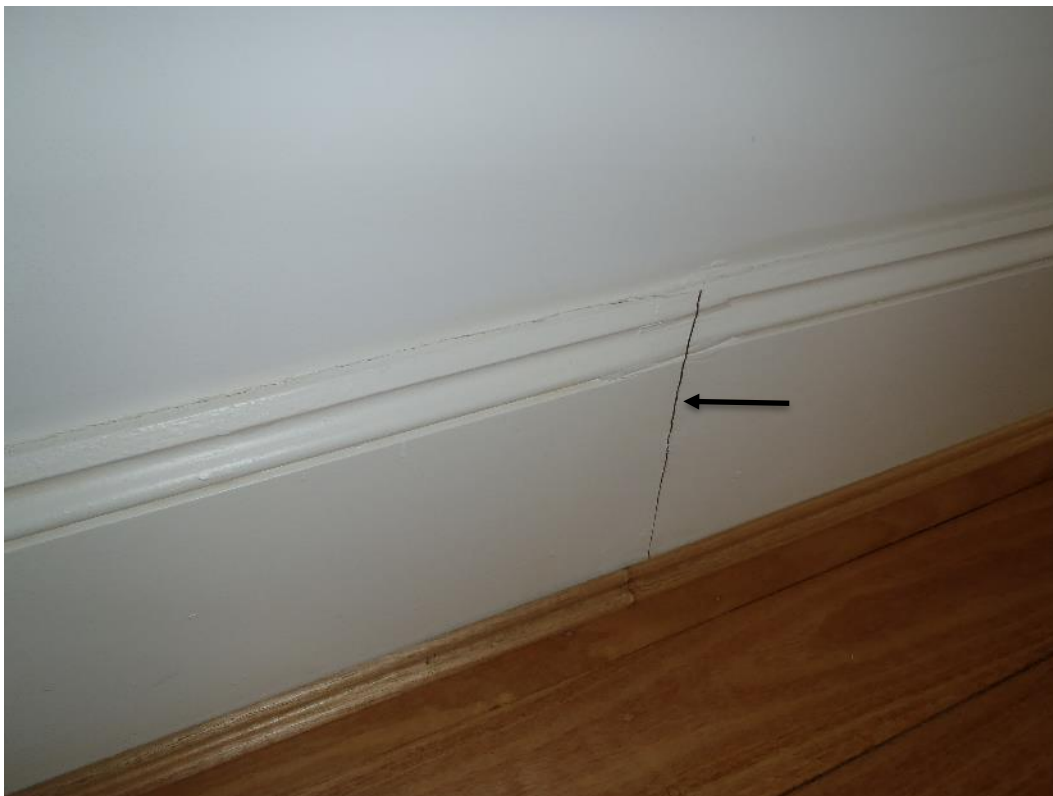
We note separation cracking [1 – 3 mm] to the mitre joint in the skirting outside Bedroom 2 along the *common party / separation* wall with the adjoining property, No. 37 Varna Street, Clovelly. **[Photograph 23]**

**Photograph 23** shows separation cracking to the mitre joint in the skirting outside Bedroom 2 along the *common party / separation* wall with the adjoining property, No. 37 Varna Street, Clovelly.

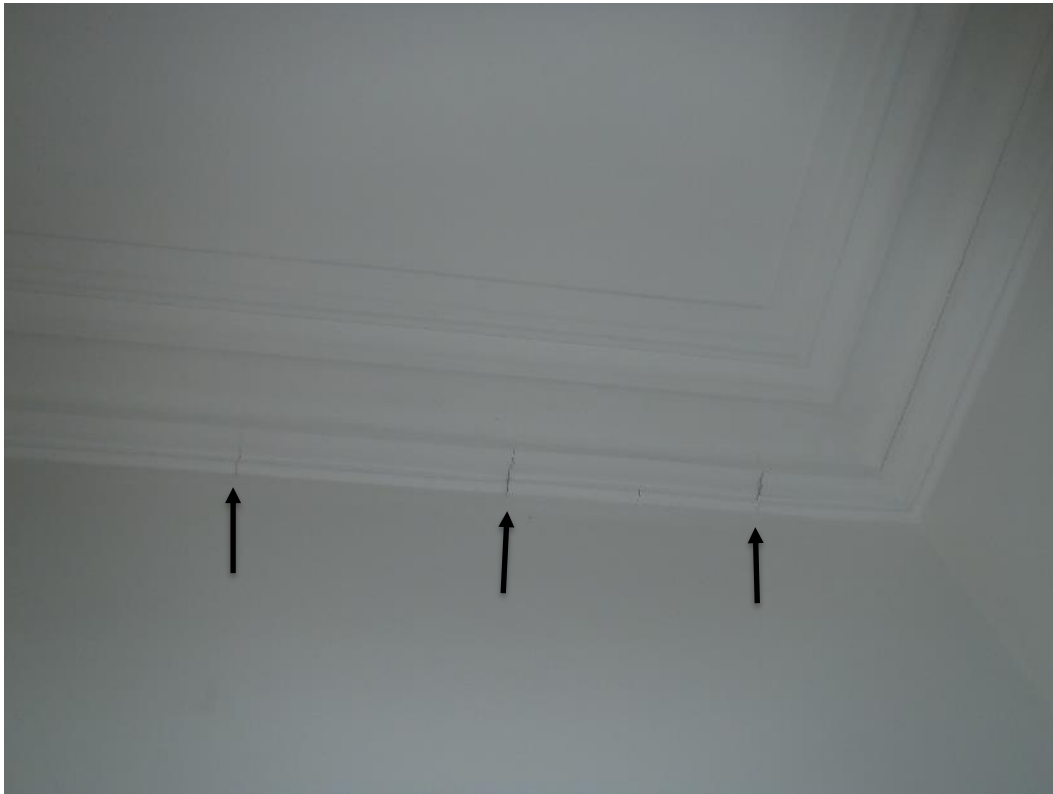
We noted deterioration / flaking paint to the decorative profile plaster cornice outside Bedroom 2. **[Photograph 24]**

**Photograph 24** shows deterioration / flaking paint to the decorative profile plaster cornice outside Bedroom 2.
