## Dilapidation Assessment Report

Prepared for: Cape Cod Australia Pty. Limited  
Job address: No. 39 Varna Street, Clovelly.  
Property Owner/s: Mr. S. Paddam & Mrs. K Mammen.  
Report reference: **RANDWICK COUNCIL**  
Development Application No: not available  
Date of assessment: 4<sup>th</sup> July 2017

**Re: Dilapidation Report – No. 39 Varna Street, Clovelly.**

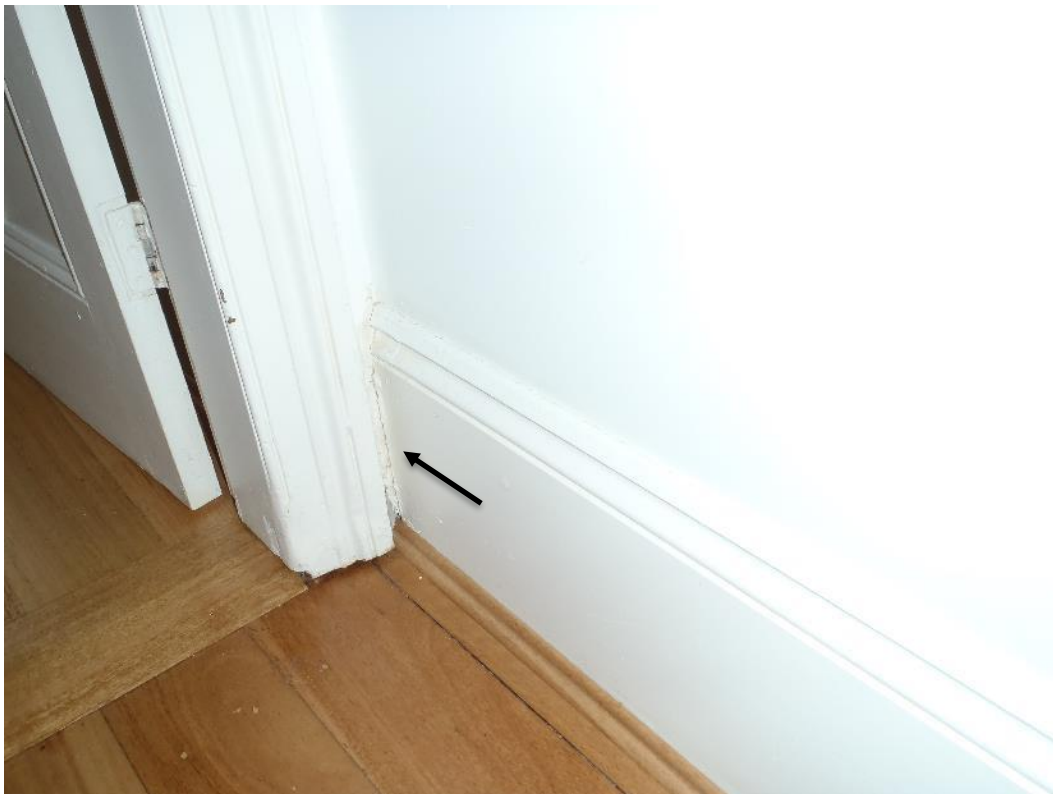
We note separation cracking [1 – 3 mm] to the mitre joint in the skirting adjacent to the hallway door opening along the *common party / separation* wall with the adjoining property, No. 37 Varna Street, Clovelly. **[Photograph 25]**

**Photograph 25** shows separation cracking to the mitre joint in the skirting adjacent to the hallway door opening along the *common party / separation* wall with the adjoining property, No. 37 Varna Street, Clovelly.

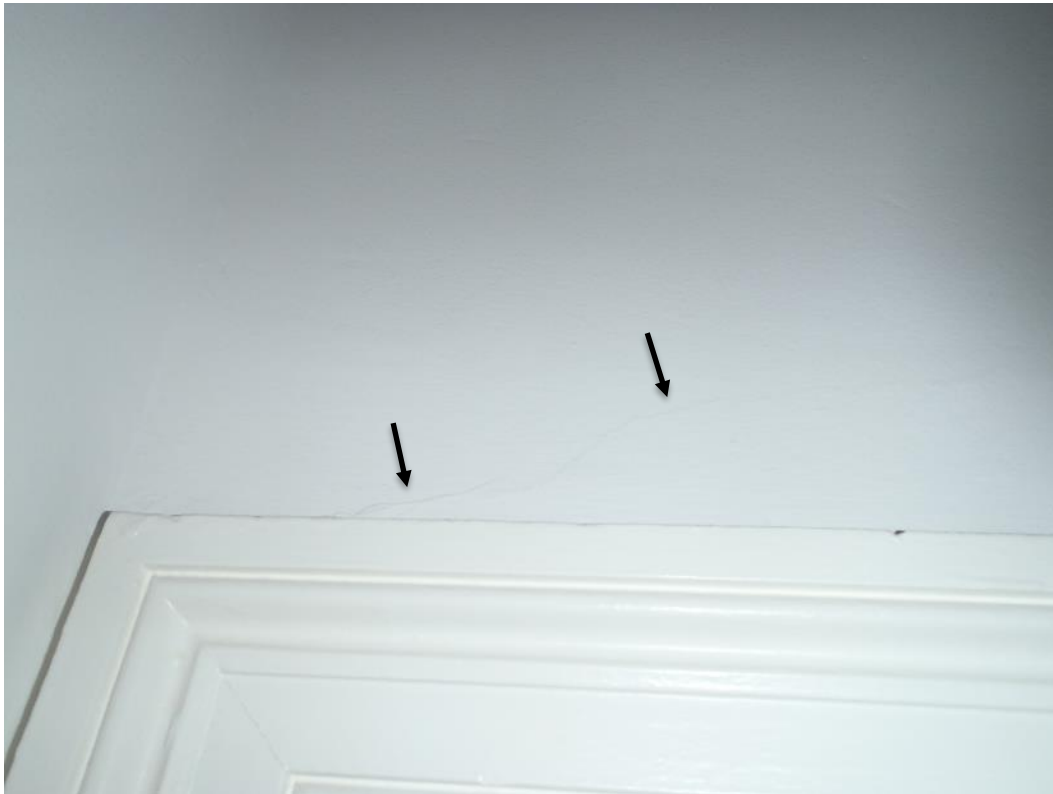
We noted hairline radial cracking [ $< 1$  mm] above the hallway door head. **[Photograph 26]**

**Photograph 26** shows hairline radial cracking above the hallway door head.

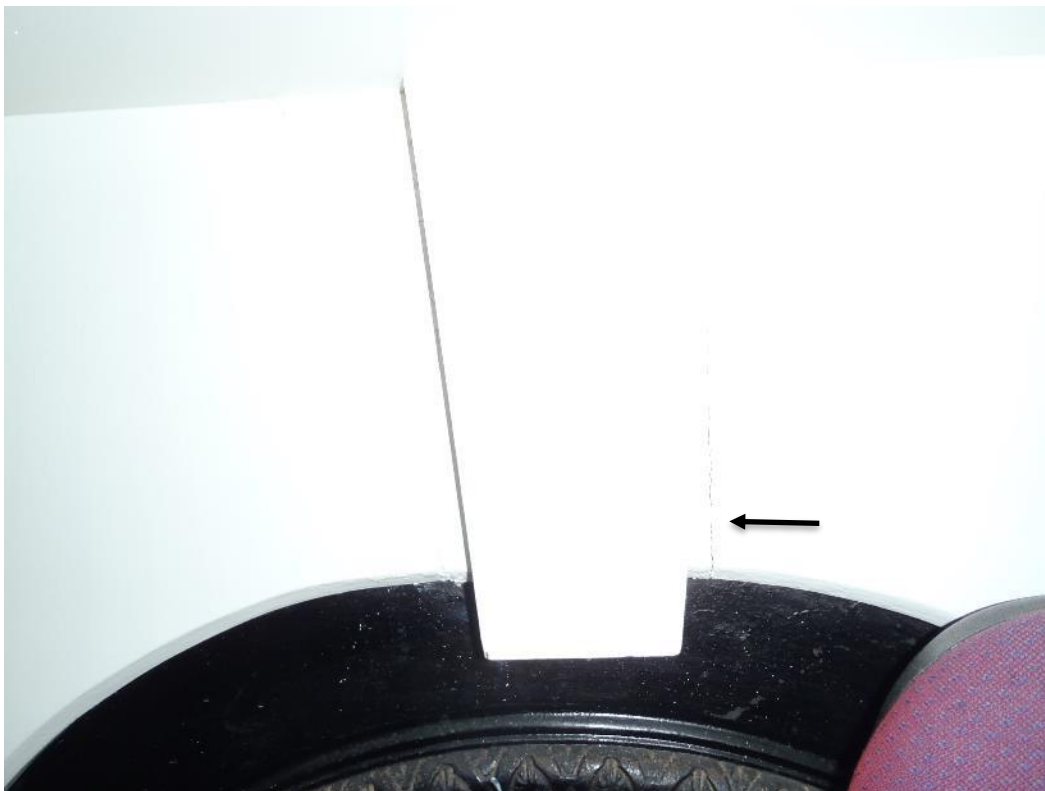
We noted vertical cracking [ $< 1$  mm] to the fireplace mantle. **[Photograph 27]**

**Photograph 27** shows vertical cracking to the fireplace mantle in Bedroom 2.

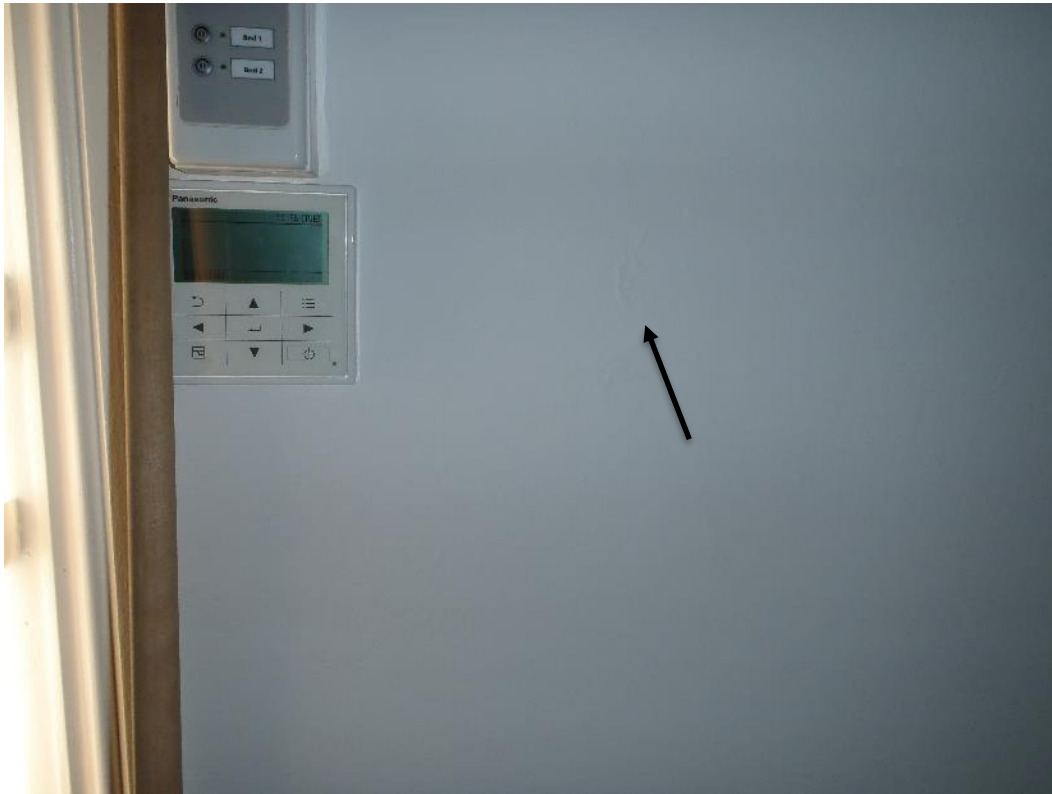
We noted evidence of previous repairs to the surface coated rendered wall adjacent to the window. **[Photograph 28]**

**Photograph 28** shows evidence of previous repairs to the surface coated rendered wall adjacent to the window in Bedroom 2.

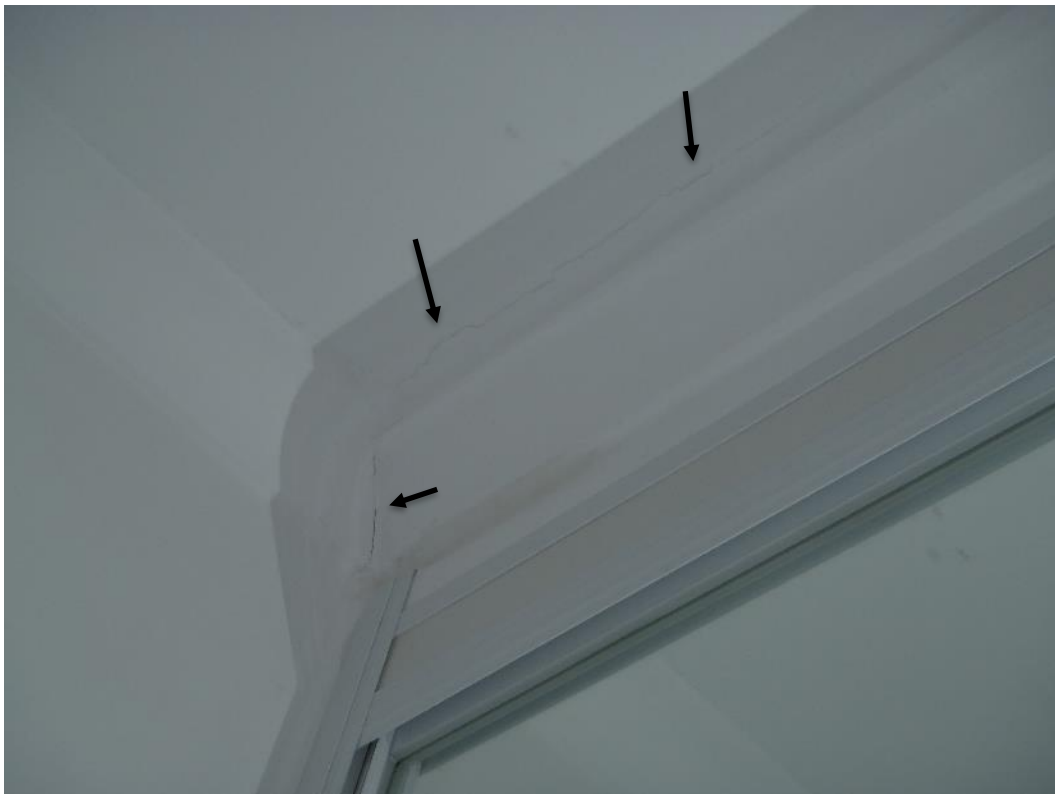
We noted separation cracking [ $< 1$  mm] to the plasterboard ceiling lining and to the mitre joint in the cove profiled plaster cornice in the south-eastern corner. **[Photograph 29]**

**Photograph 29** shows separation cracking to the plasterboard ceiling lining and to the mitre joint in the cove profiled plaster cornice in the south-eastern corner of Bedroom 3.

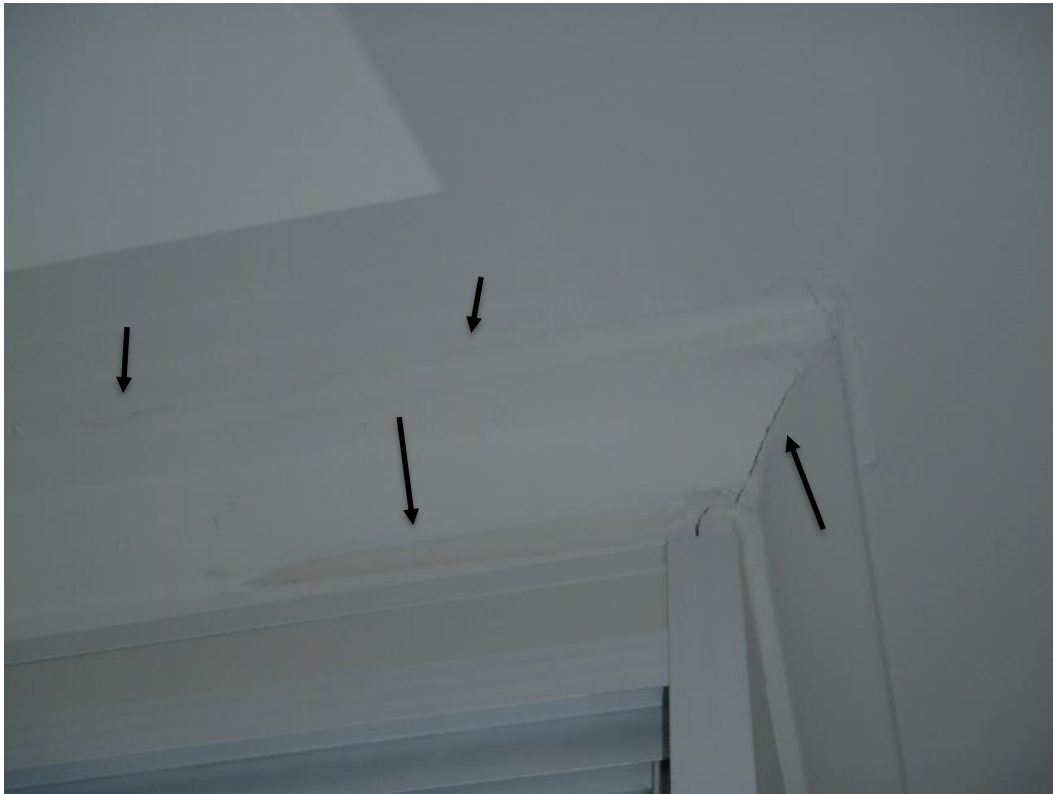
We noted separation cracking [ $< 1$  mm] to the plasterboard ceiling lining and to the mitre joint in the cove profiled plaster cornice adjacent to the wardrobe cupboard. We further noted evidence of previous repairs to the cove profiled plaster cornice. **[Photograph 30]**

**Photograph 30** shows separation cracking to the ceiling lining and to the mitre joint in the cornice adjacent to the wardrobe cupboard in Bedroom 3. **Note:** evidence of previous repairs to the plaster cornice.

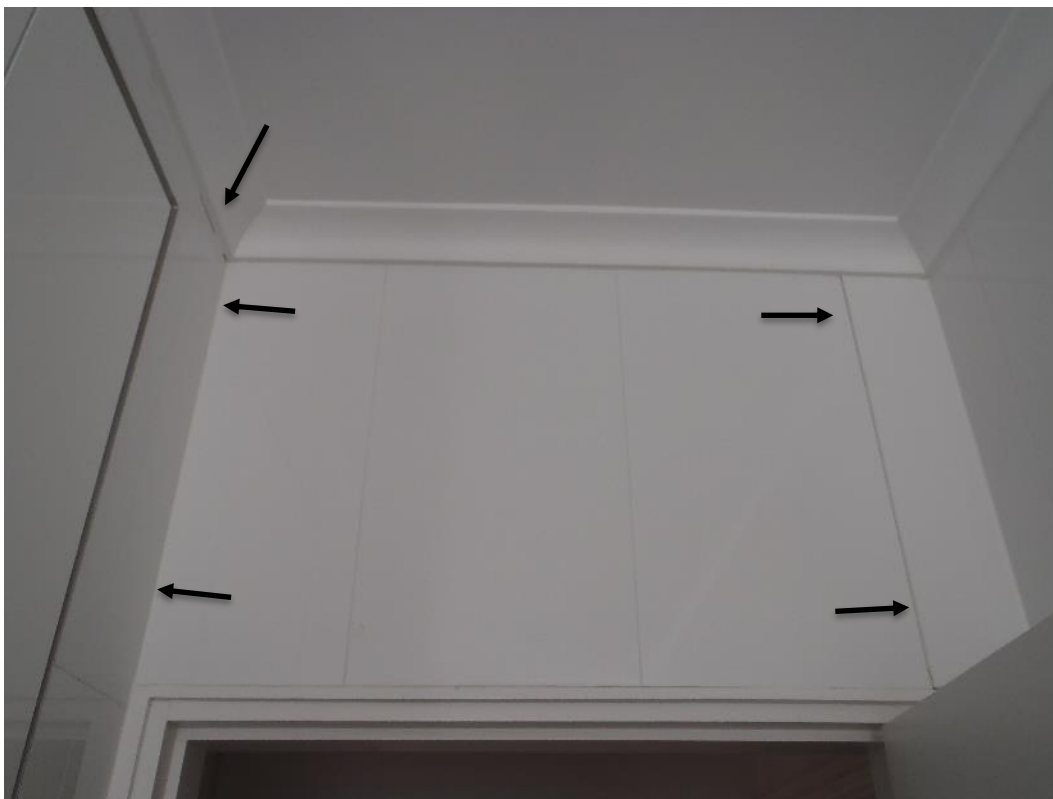
We noted vertical cracking to the tile grout on both sides above the door head. We further noted separation cracking [ $< 1$  mm] between the tiled wall surface and the cove profiled plaster cornice. **[Photograph 31]**

**Photograph 31** shows vertical cracking to the tile grout on both sides above the door head in the Bathroom.

**Note:** separation cracking between the tiled wall surface and the cornice.

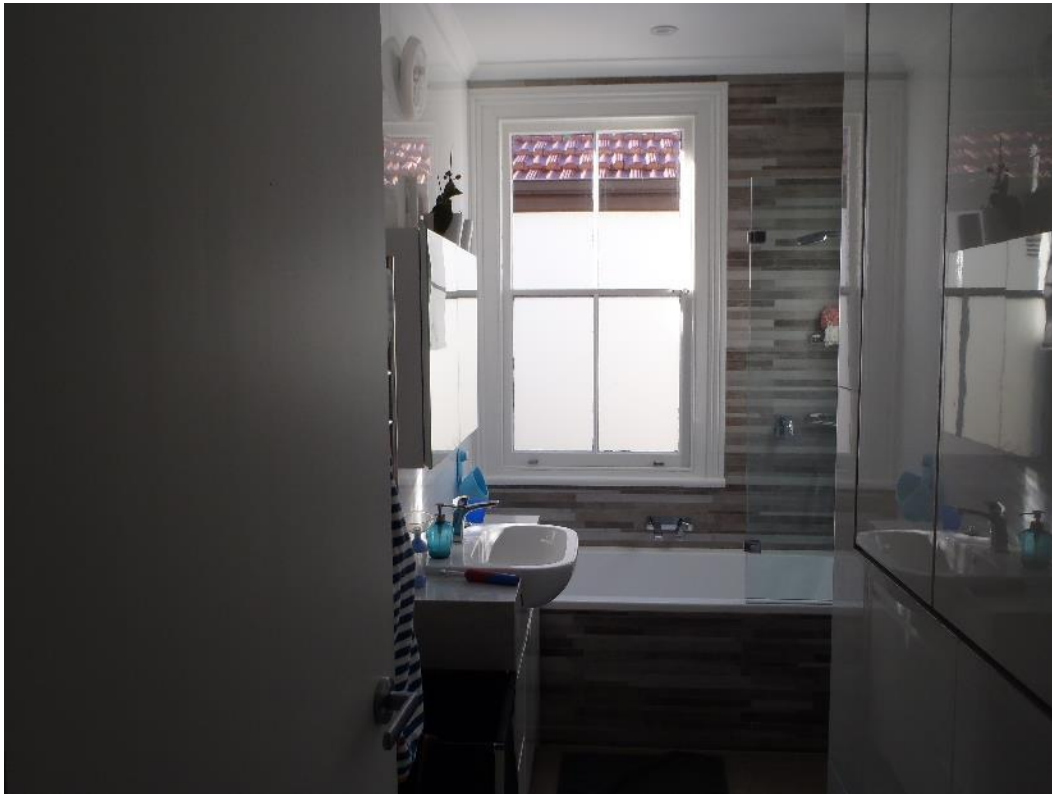
We did not observe any cracking to the ceramic wall tiles and noted that the wall and floor tiles when randomly “tap” tested appeared to be sound. **[Photograph 32]**

**Photograph 32** shows the general layout of the Bathroom.

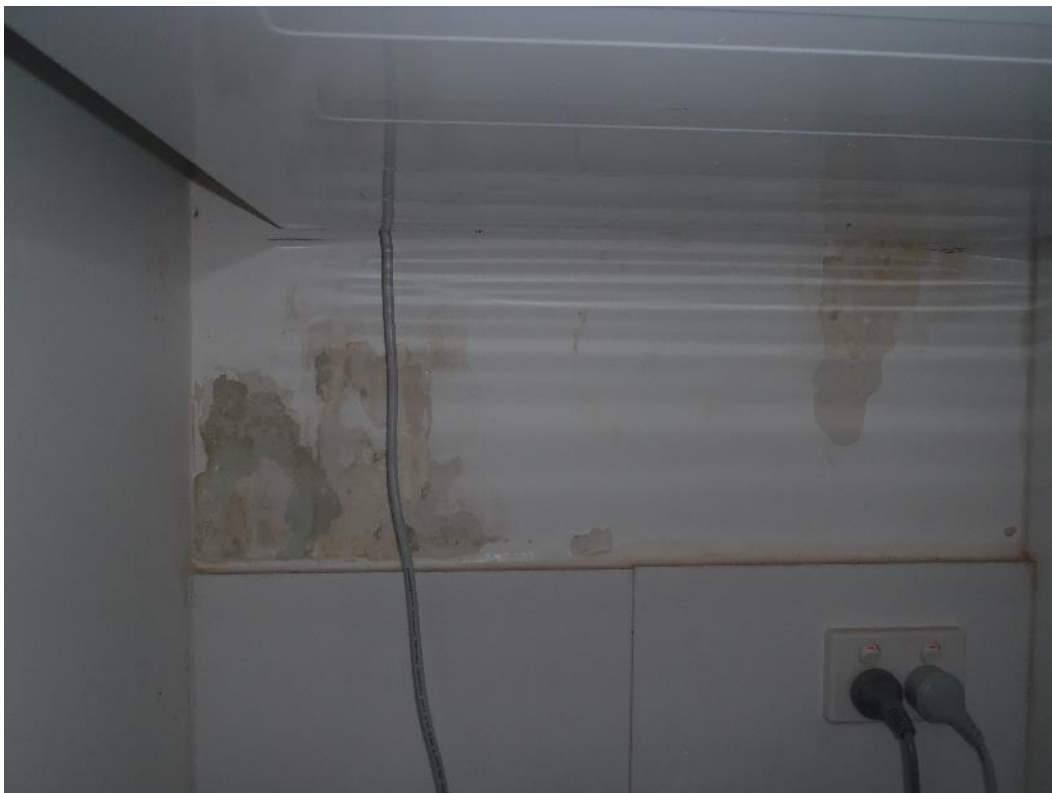
We noted deterioration / flaking paint to the surface coated cement rendered wall surface above the splashback tiles under the wall mounted clothes dryer. **[Photograph 33]**

**Photograph 33** shows deterioration / flaking paint to the surface coated cement rendered wall surface above the splashback tiles under the wall mounted clothes dryer in the Laundry.

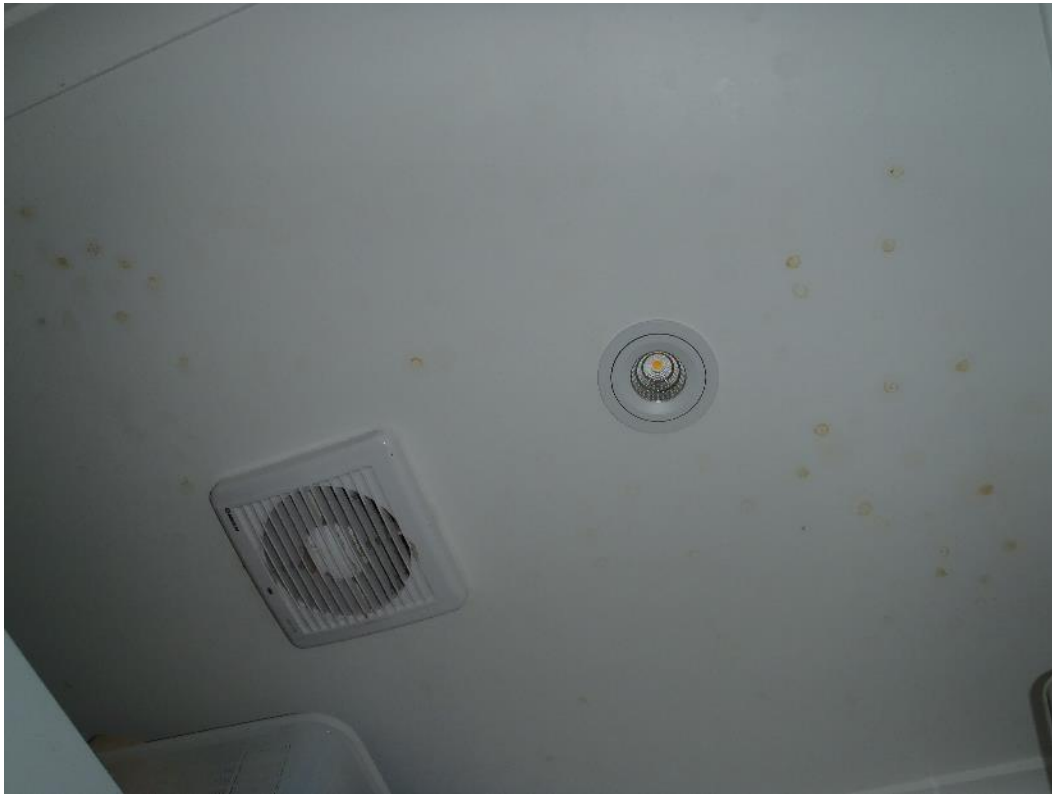
We noted general staining to the ceiling lining. **[Photograph 34]**

**Photograph 34** shows staining to the ceiling lining in the Laundry.

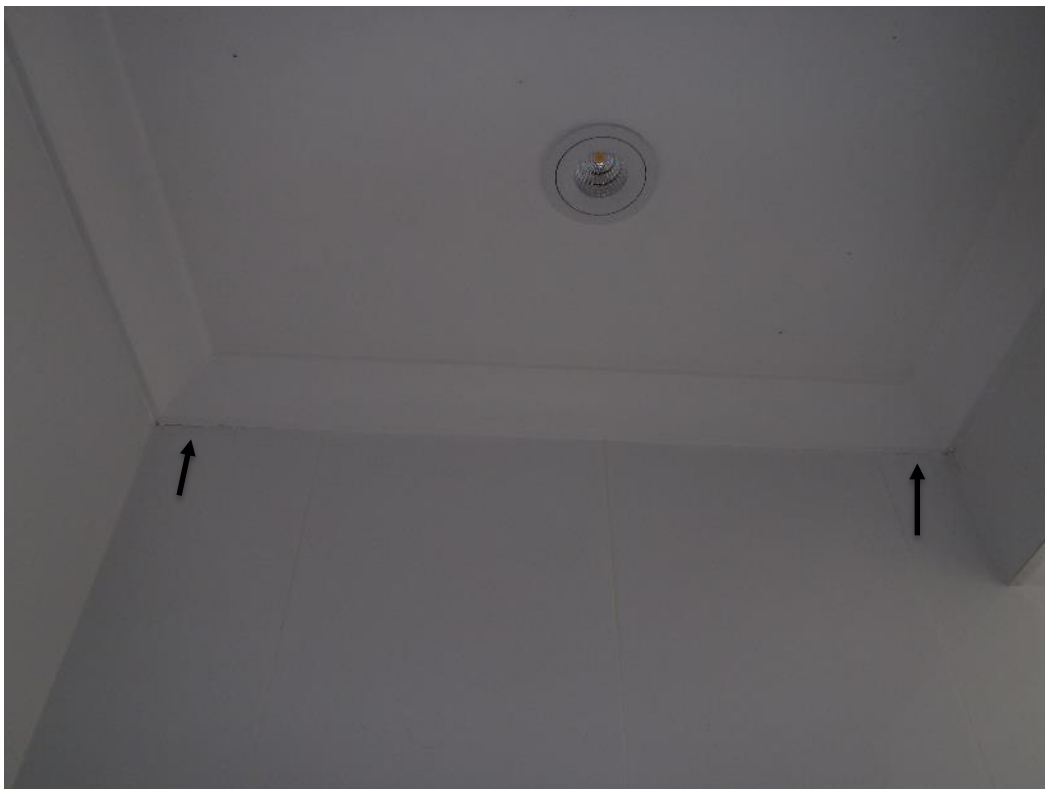
We noted separation cracking [ $< 1$  mm] between the tiled wall surface and the cove profiled plaster cornice along the northern wall. **[Photograph 35]**

**Photograph 35** shows separation cracking between the tiled wall surface and the cove profiled plaster cornice along the northern wall in the Shower Room.

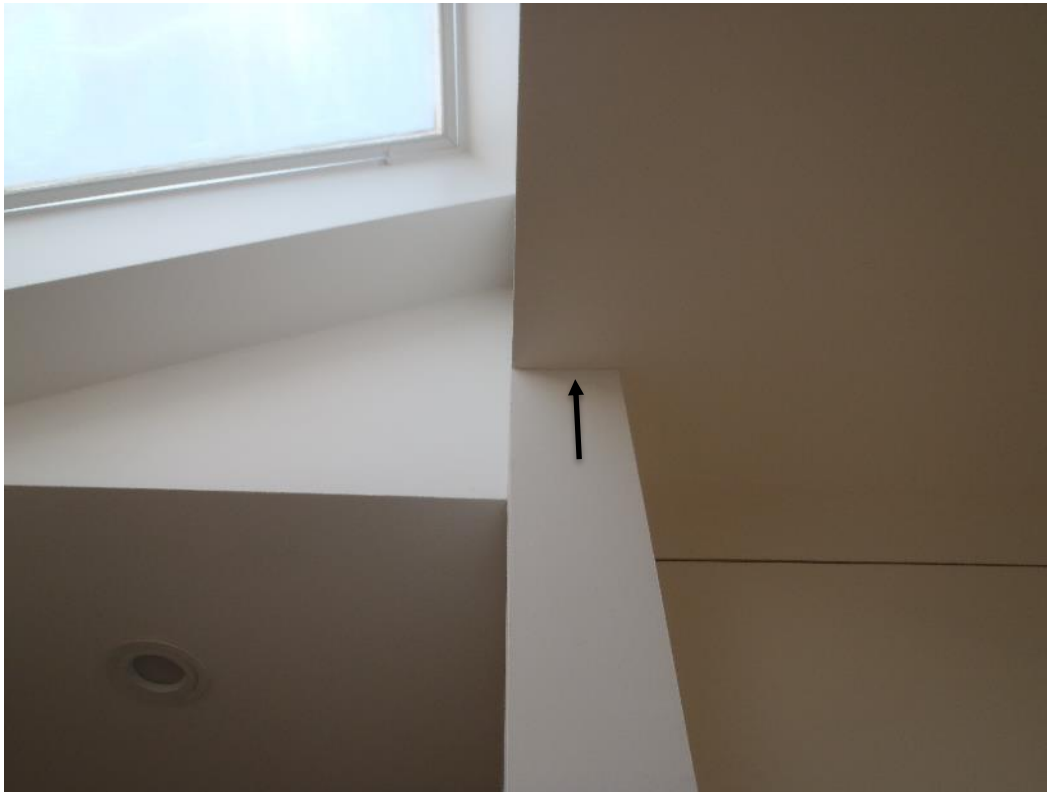
We noted separation cracking [ $< 1$  mm] to the square set wall / ceiling junction at the entry bulkhead. **[Photograph 36]**

**Photograph 36** shows separation cracking to the square set wall / ceiling junction at the entry bulkhead in the Kitchen.

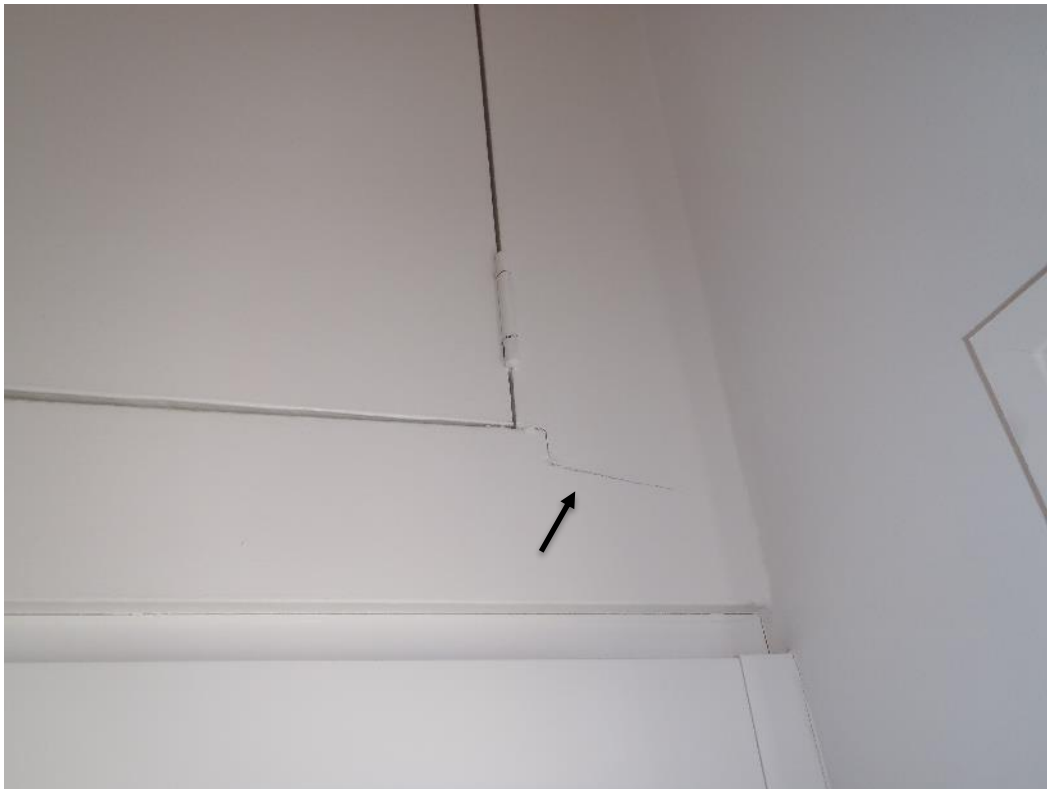
We noted step cracking extending from the bottom of the cupboard toward the external wall. **[Photograph 37]**

**Photograph 37** shows step cracking extending from the bottom of the cupboard toward the external wall in the Kitchen.

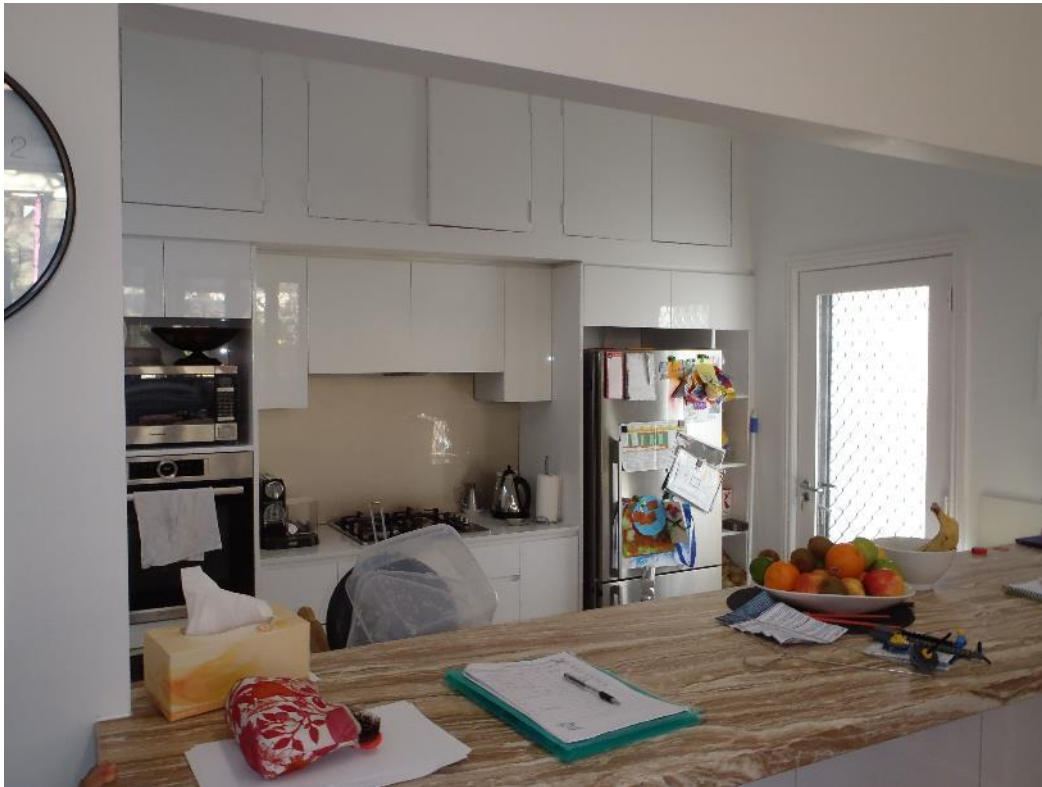
We noted that the grout to the tiles is complete and that the tiles when randomly “tap” tested appeared to be sound. **[Photograph 38]**

**Photograph 38** shows the general condition of the Kitchen.

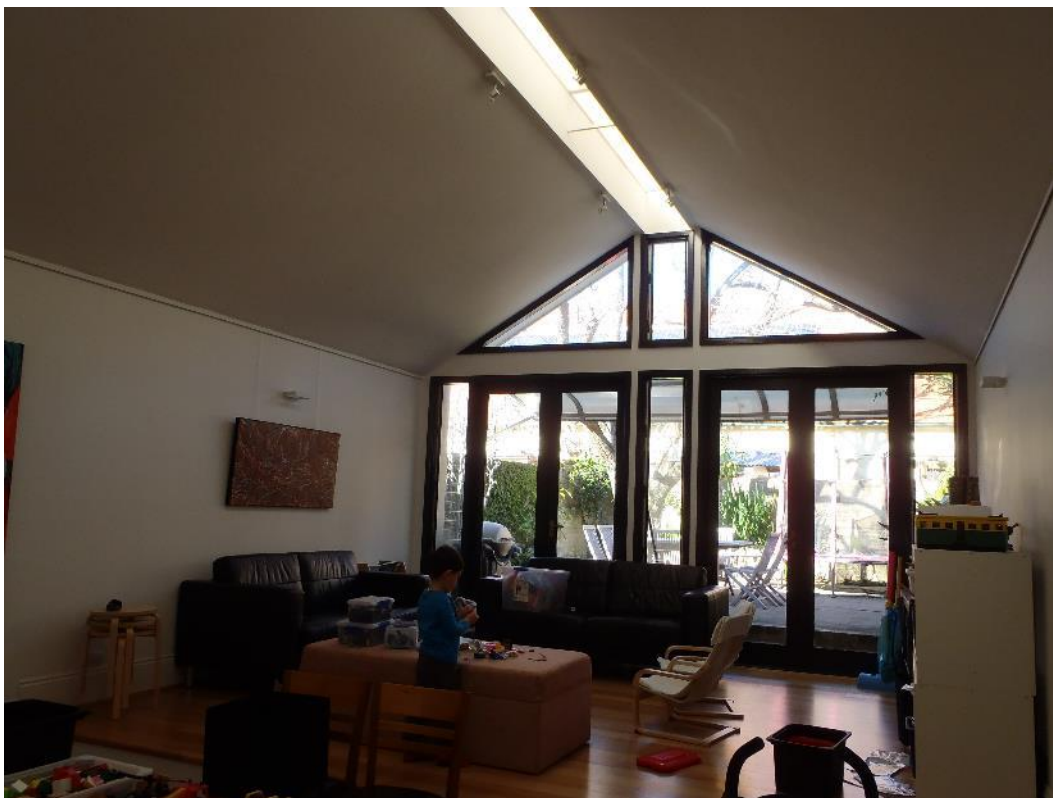
We observed that the cathedral ceiling had a domed skylight along the roof pitch. **[Photograph 39]**

**Photograph 39** shows the general condition of the Lounge Room.

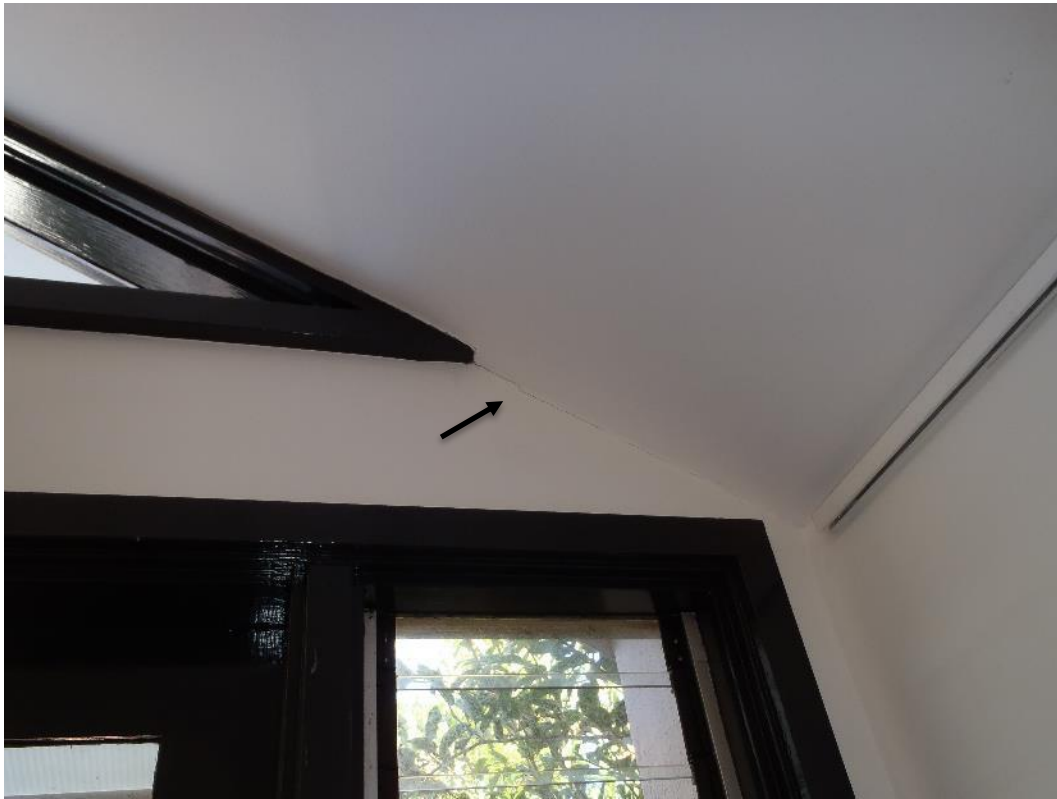
We noted separation cracking [ $< 1$  mm] to the square set wall / ceiling junction extending from the gable end window in the south-western corner. **[Photograph 40]**

**Photograph 40** shows separation cracking to the square set wall / ceiling junction extending from the gable end window in the south-western corner of the Lounge Room.

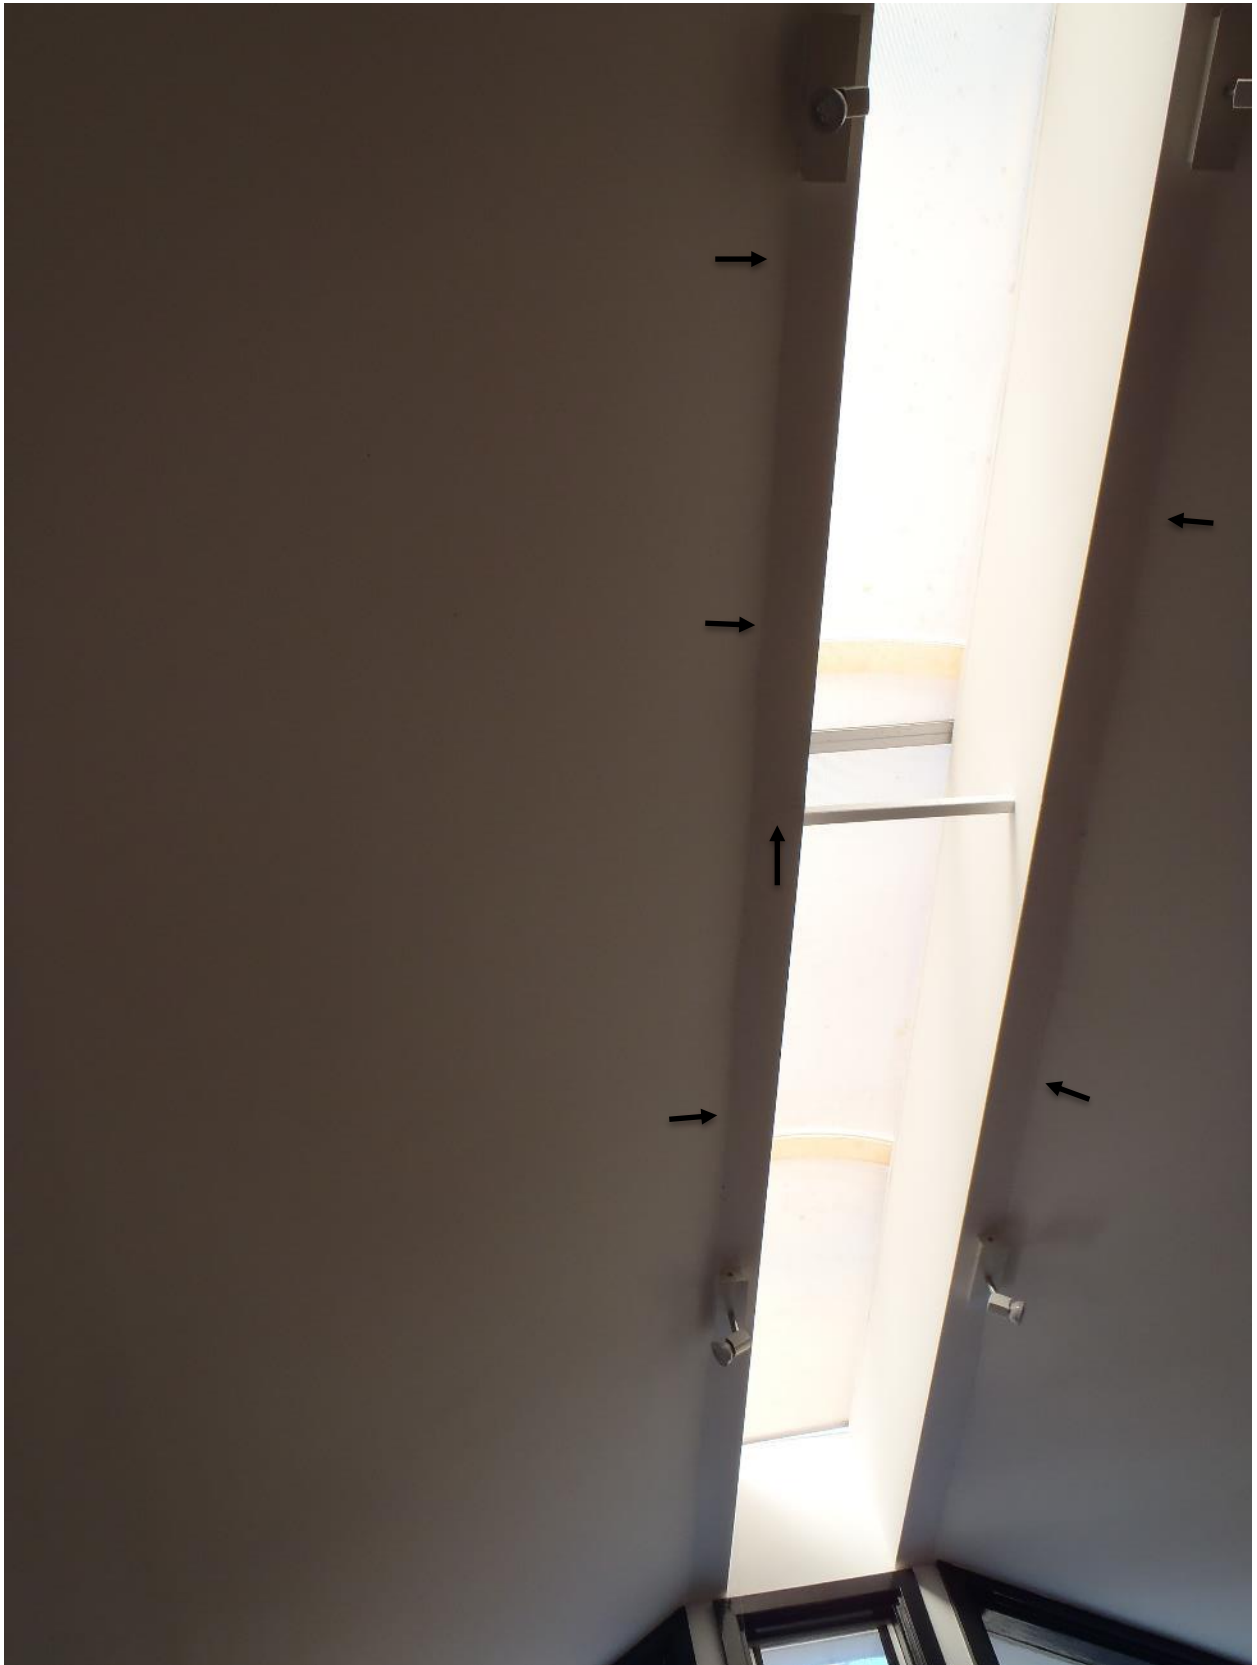
We noted hairline separation cracking [ $< 1$  mm] to the square set ceiling junction adjacent to the skylight. **[Photograph 41]**

**Photograph 41** shows hairline separation cracking to the square set ceiling junction adjacent to the skylight in the Lounge Room.

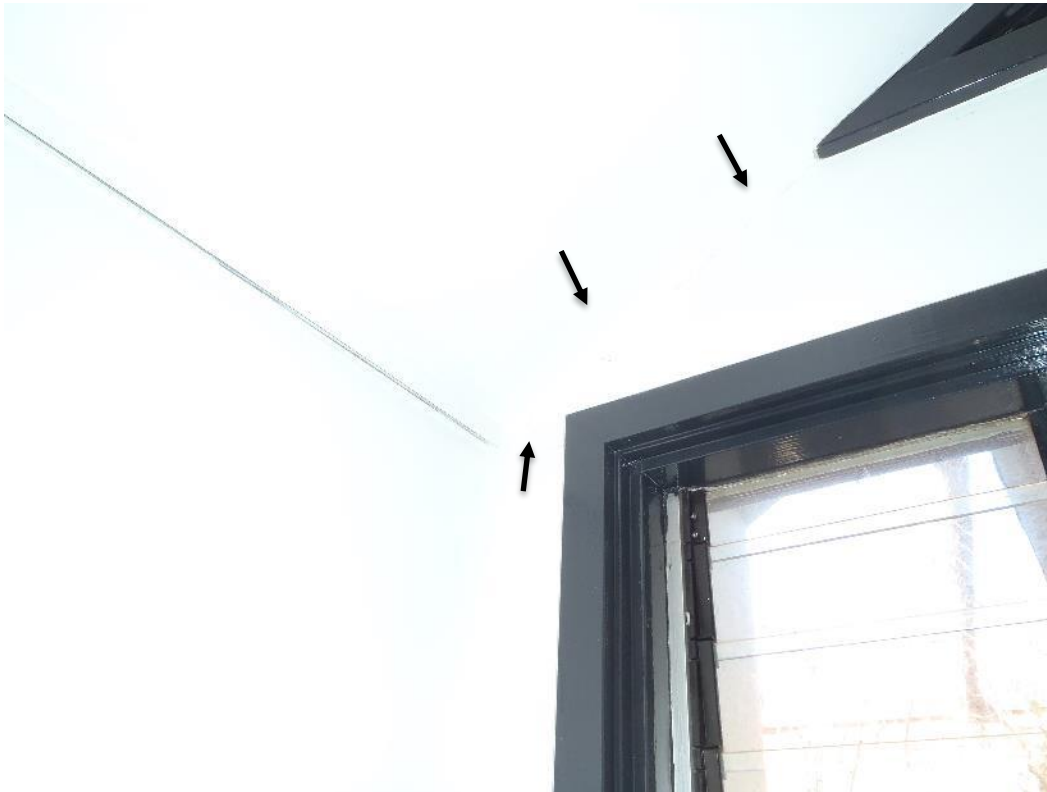
We noted separation cracking [ $< 1$  mm] to the square set wall / ceiling junction extending from the gable end window in the south-eastern corner. We further noted horizontal cracking [ $< 1$  mm] extending from the window head. **[Photograph 42]**

**Photograph 42** shows separation cracking to the square set wall / ceiling junction extending from the gable end window in the south-eastern corner in the Lounge Room.

**Note:** We further noted horizontal cracking extending from the window head.
