Dilapidation Assessment Report

Prepared for: Cape Cod Australia Pty. Limited
Job address: 51 Young Street, Cremorne.
Property Owner/s: Mrs Mary Mann.
Report reference: **NORTH SYDNEY COUNCIL**
Development Application No: not available
Date of assessment: 11th October 2016

Re: Dilapidation Report

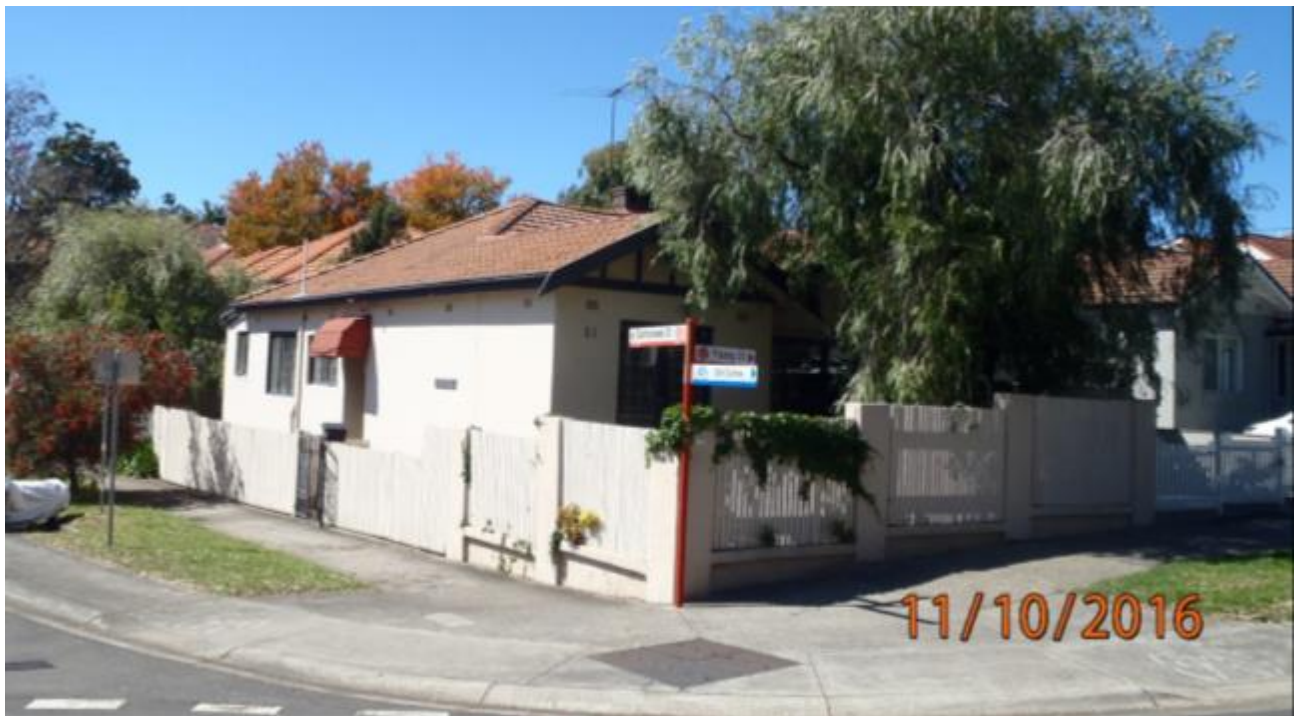
Shows the front north westerly elevation of the property:
No. 51 Young Street, Cremorne.

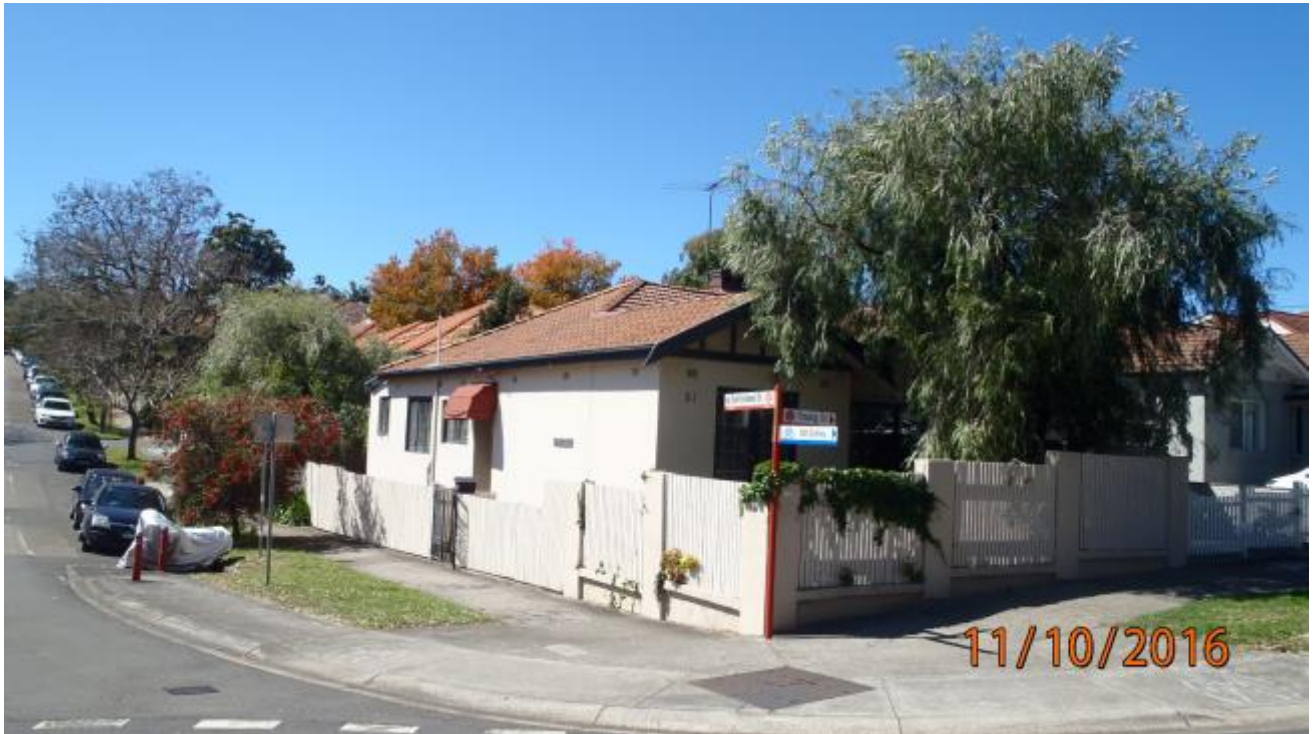
We observed that the terracotta roof tiles to the *common* roof surfaces are generally interlinked and securely bedded, in our opinion forming a weather resistant cover to the residence. **[Photographs 1 and 2]**

Photograph 1 shows the condition of the tiled roof surface from the front and side elevation.

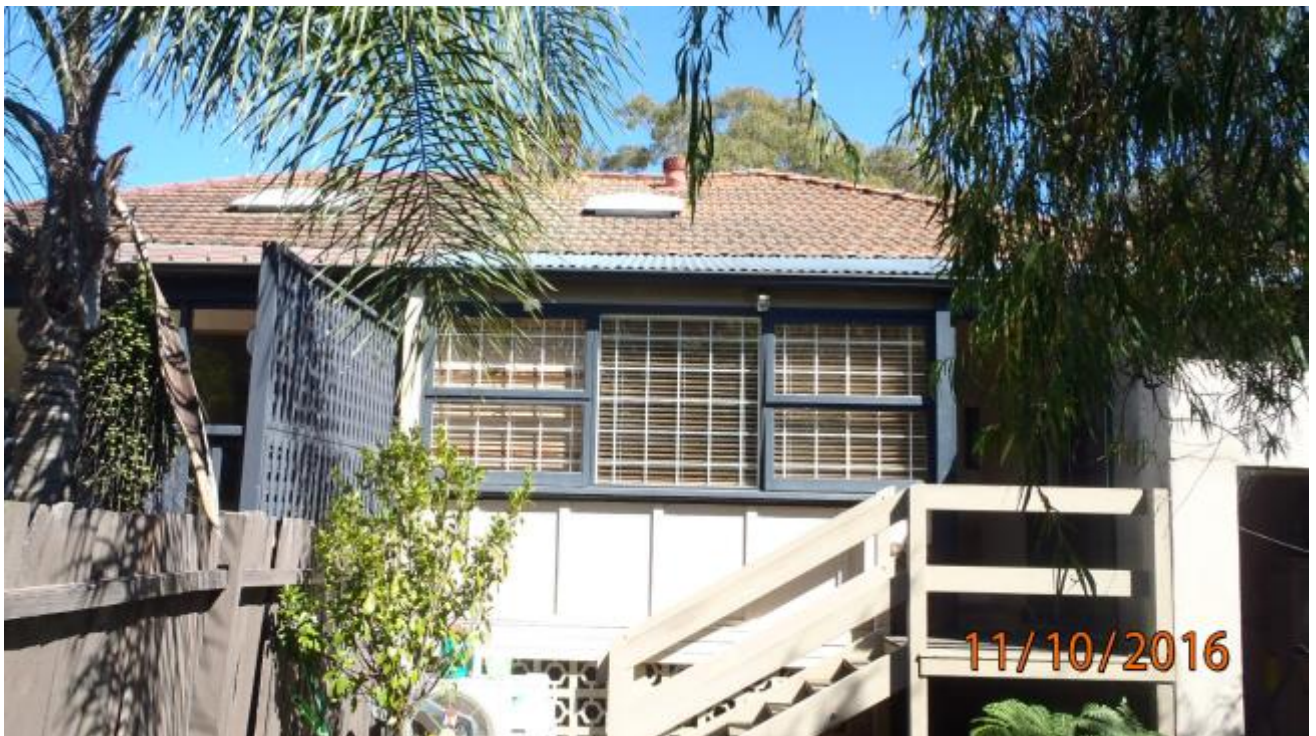
We observed that the rear skillion roof is pre-finished corrugated profile sheet metal roofing. **[Photograph 2]**

We noted that there is a timber landing and stair structure leading to the rear doorway. **[Photograph 2]**

Photograph 2 shows the rear elevation of the residence, the condition of the tiled roof surface from the rear elevation and the skillion roof sheet metal roofing surface.

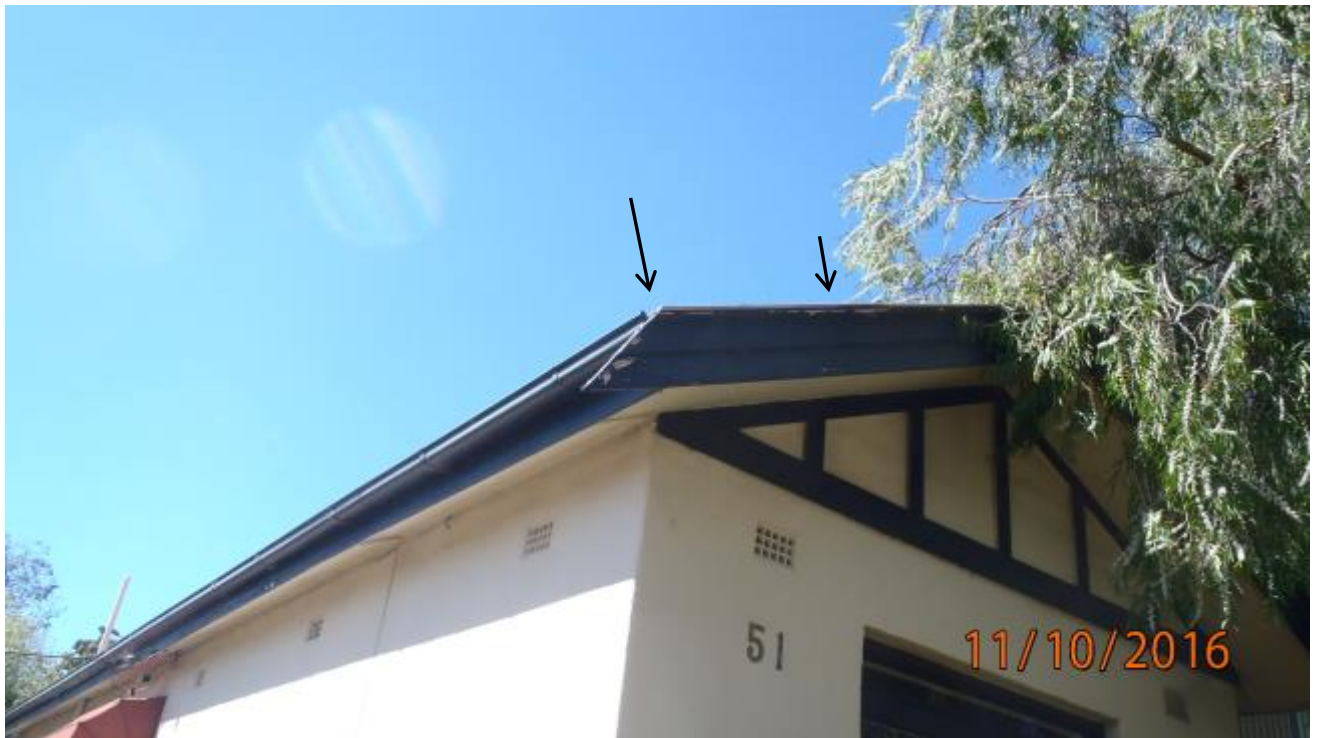
We noted flaking and deterioration of the surface coating to the timber barge board **[Photograph 3]**

We also noted that the large tree in the front yard had overgrown the terracotta tiled roof surface and was touching the timber barge board. **[Photograph 3]**

Photograph 3 shows deterioration of the surface coating to the front barge board and the tree adjacent to the front of the property.

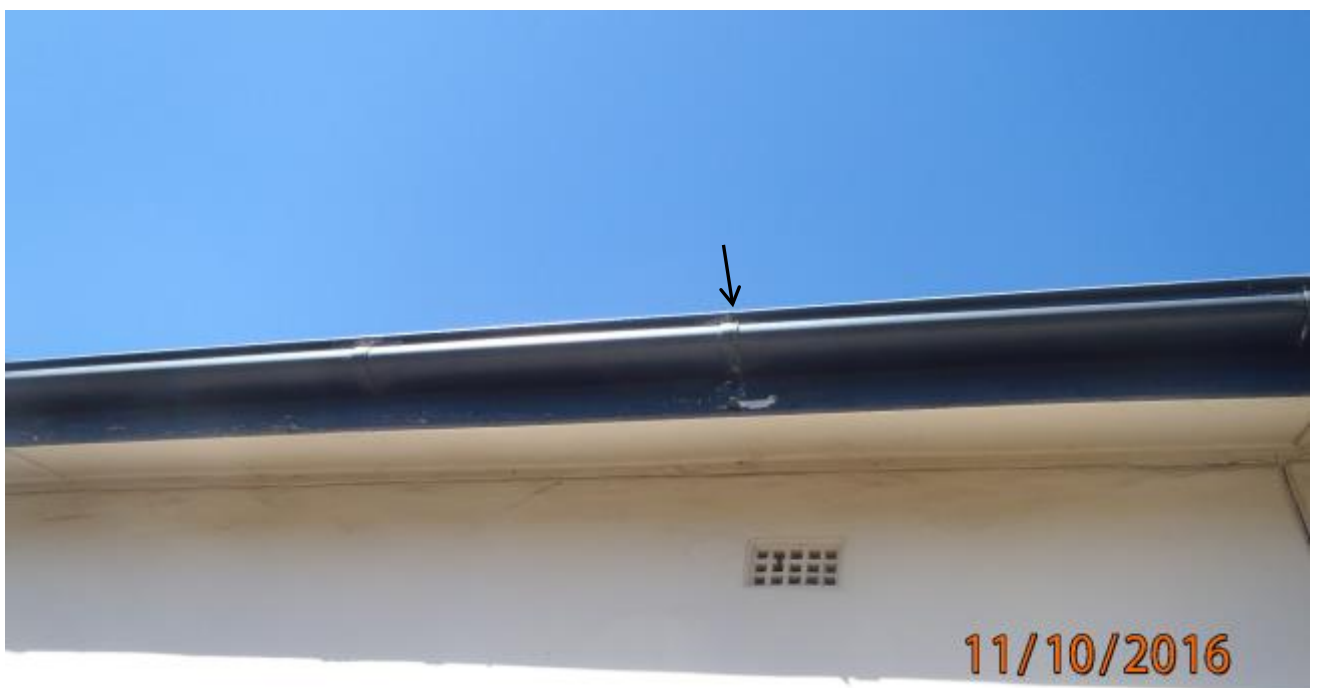
We noted flaking and deterioration of the surface coating on the timber fascia board outside Bedroom 1. **[Photograph 4]**

Photograph 4 shows deterioration of the surface coating to the side fascia board.

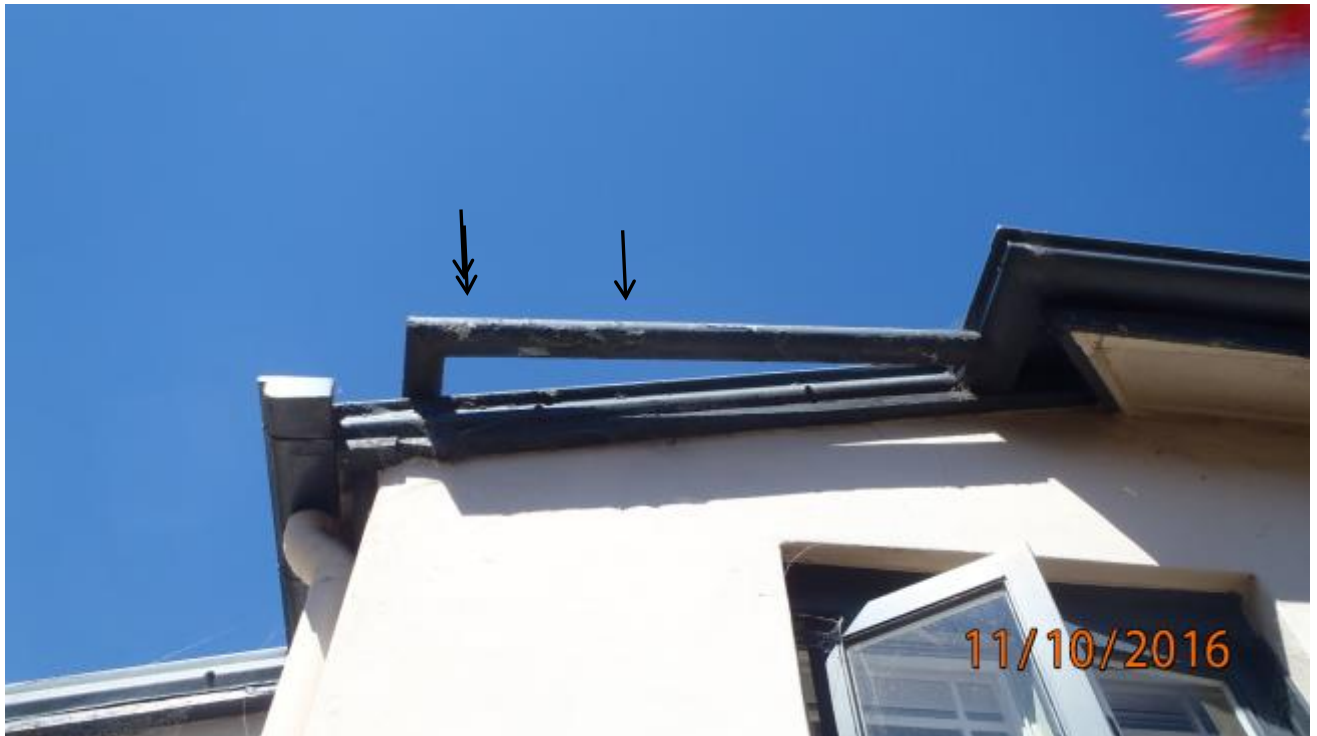
We noted flaking and deterioration of the surface coating to the gutter extension pipe to the rear section over the Kitchen. **[Photograph 5]**

Photograph 5 shows deterioration of the surface coating to the rear gutter extension.

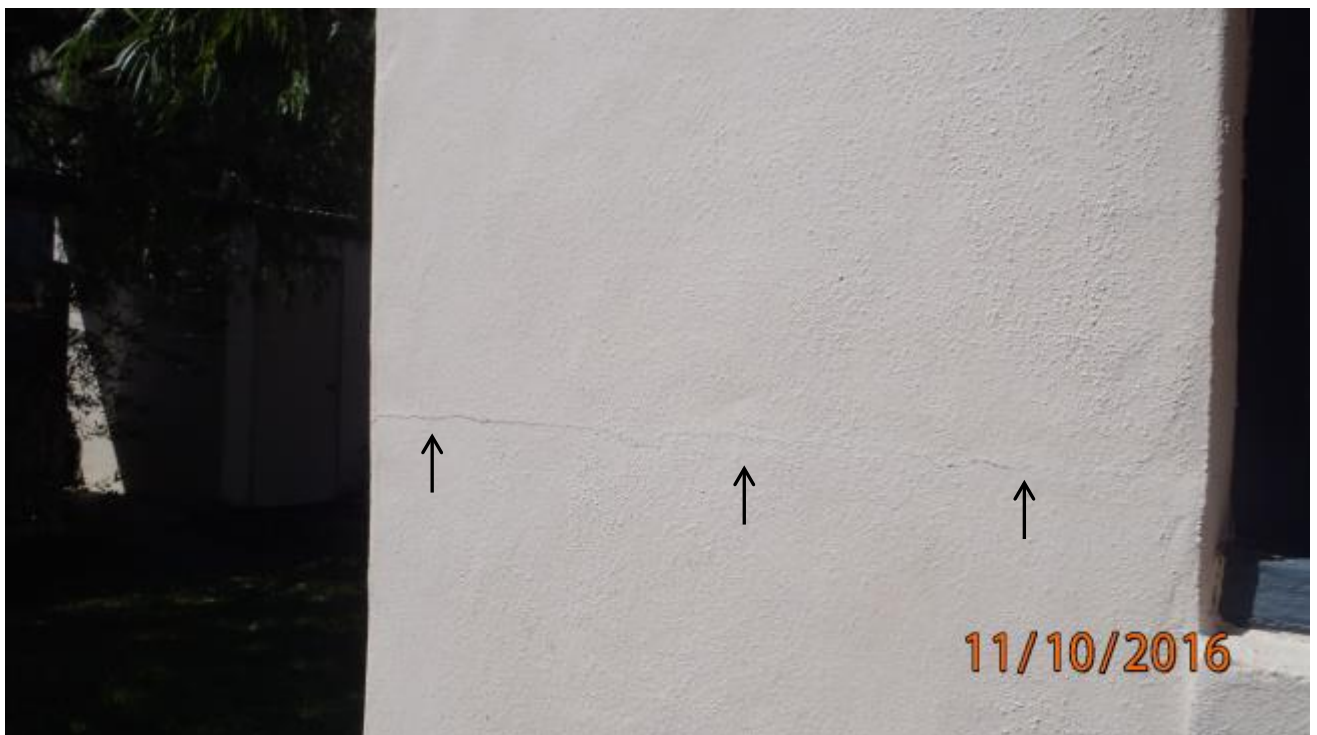
We noted a horizontal crack extending from the rear of the residence toward the Laundry window. **[Photograph 6]**

Photograph 6 shows a horizontal crack extending from the rear of the residence toward the Laundry window.

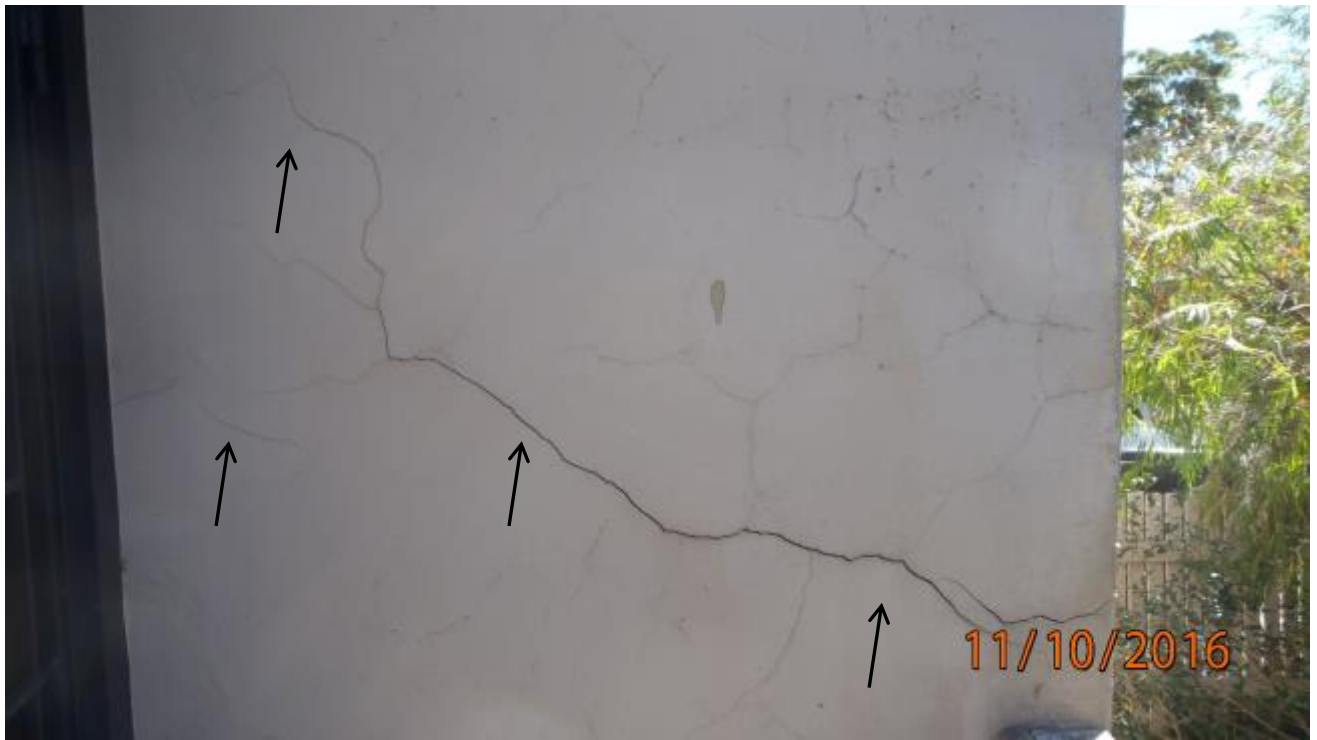
We noted radial cracking [1mm – 3mm] to the cement rendered clay masonry brickwork to the Kitchen wall above the rear stair landing. **[Photograph 7]**

Photograph 7 shows radial cracking to the cement rendered clay masonry brickwork to the Kitchen wall above the rear stair landing.

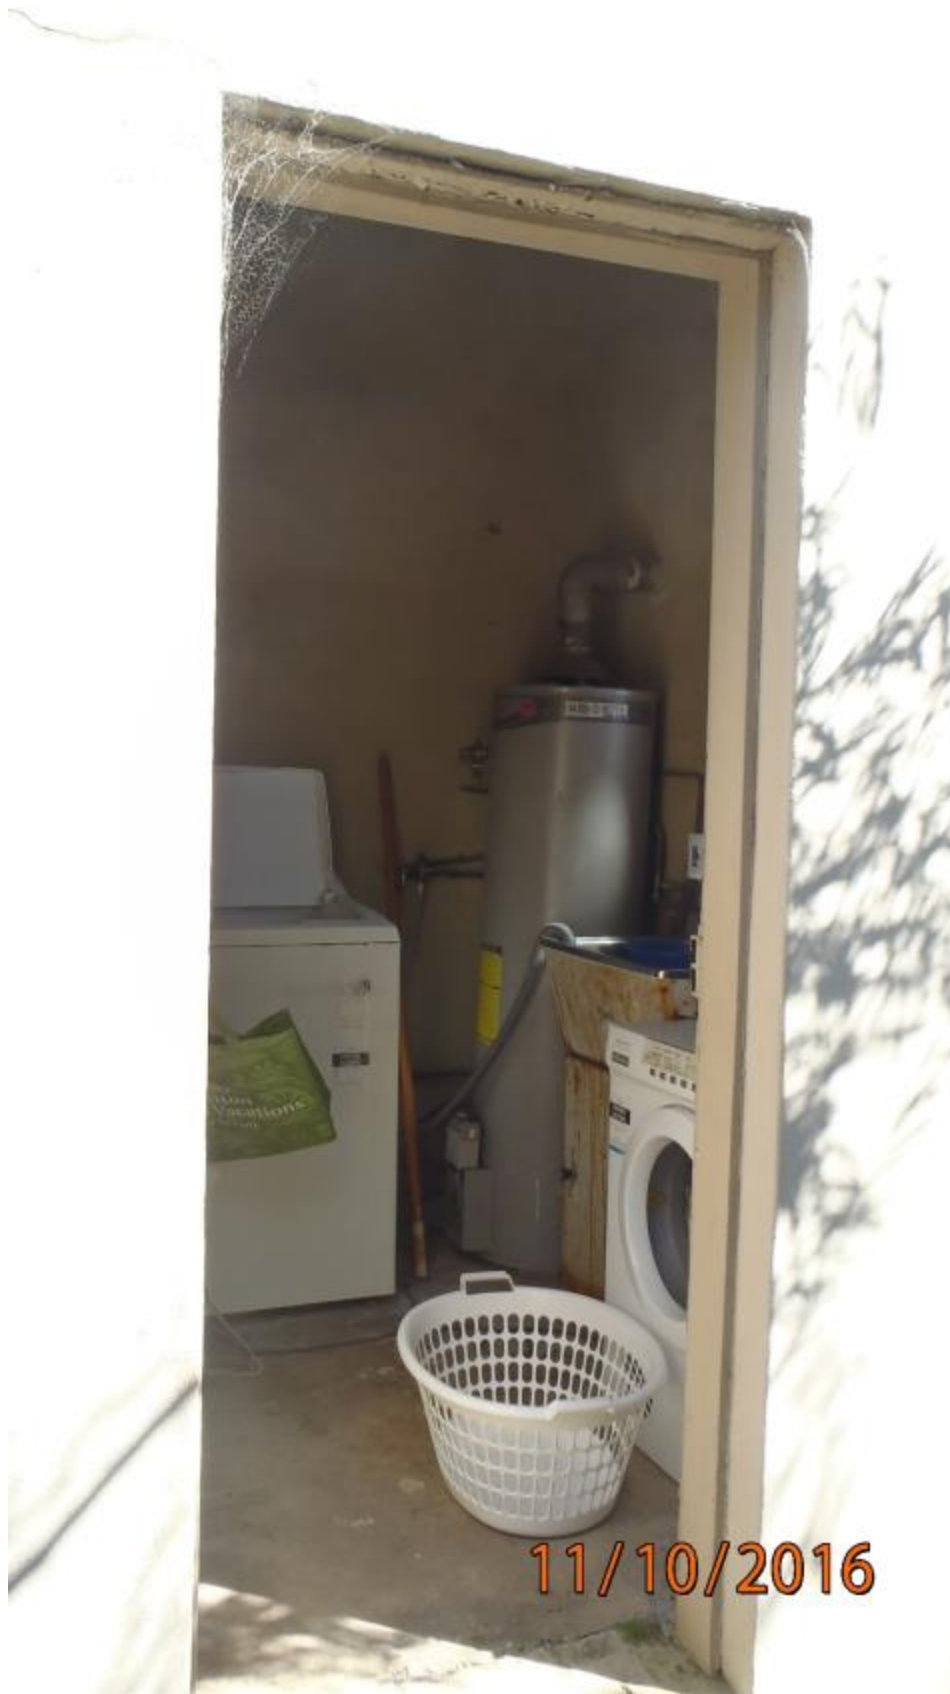
We noted that there is an external Laundry at the rear of the property. **[Photograph 8]**

Photograph 8 shows the external Laundry to the rear of the residence.

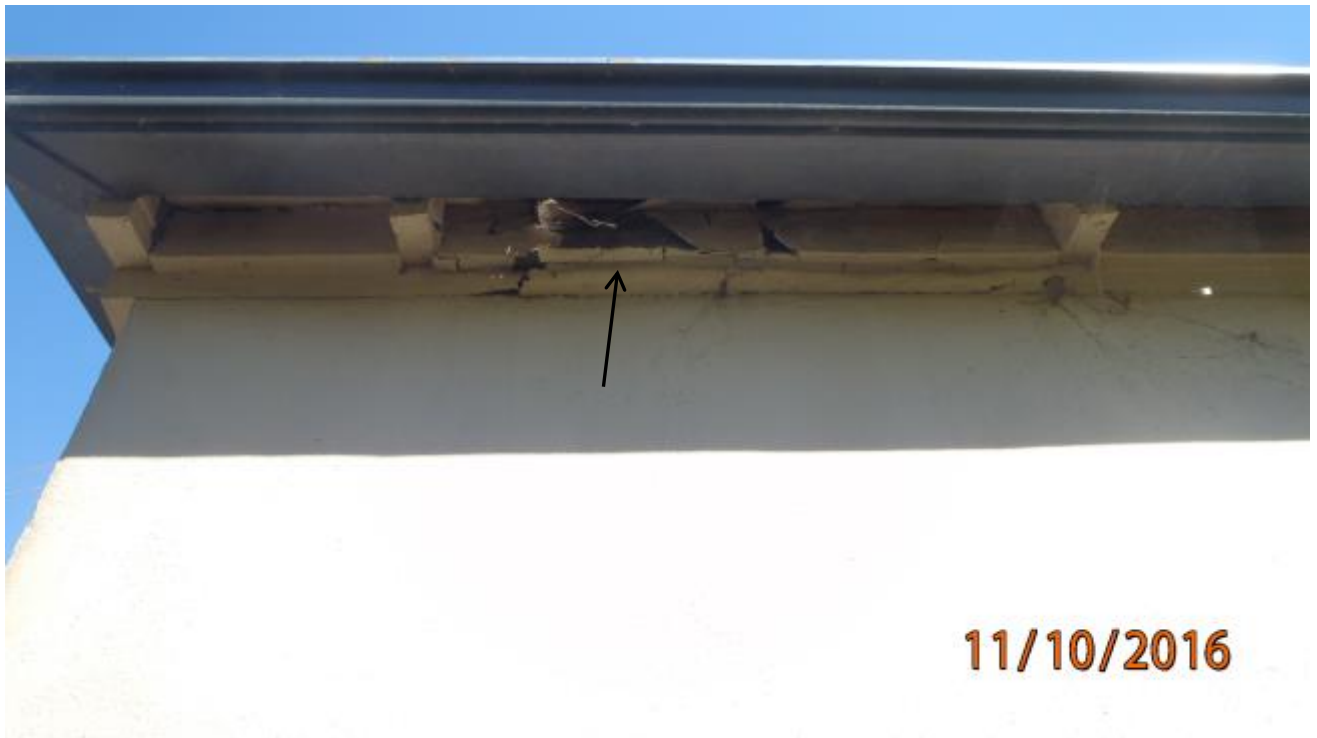
We noted flaking and deterioration to the surface coating of the eave structure above the Laundry door **[Photograph 9]**

Photograph 9 shows flaking and deterioration to the surface coating of the eave structure above the Laundry door.

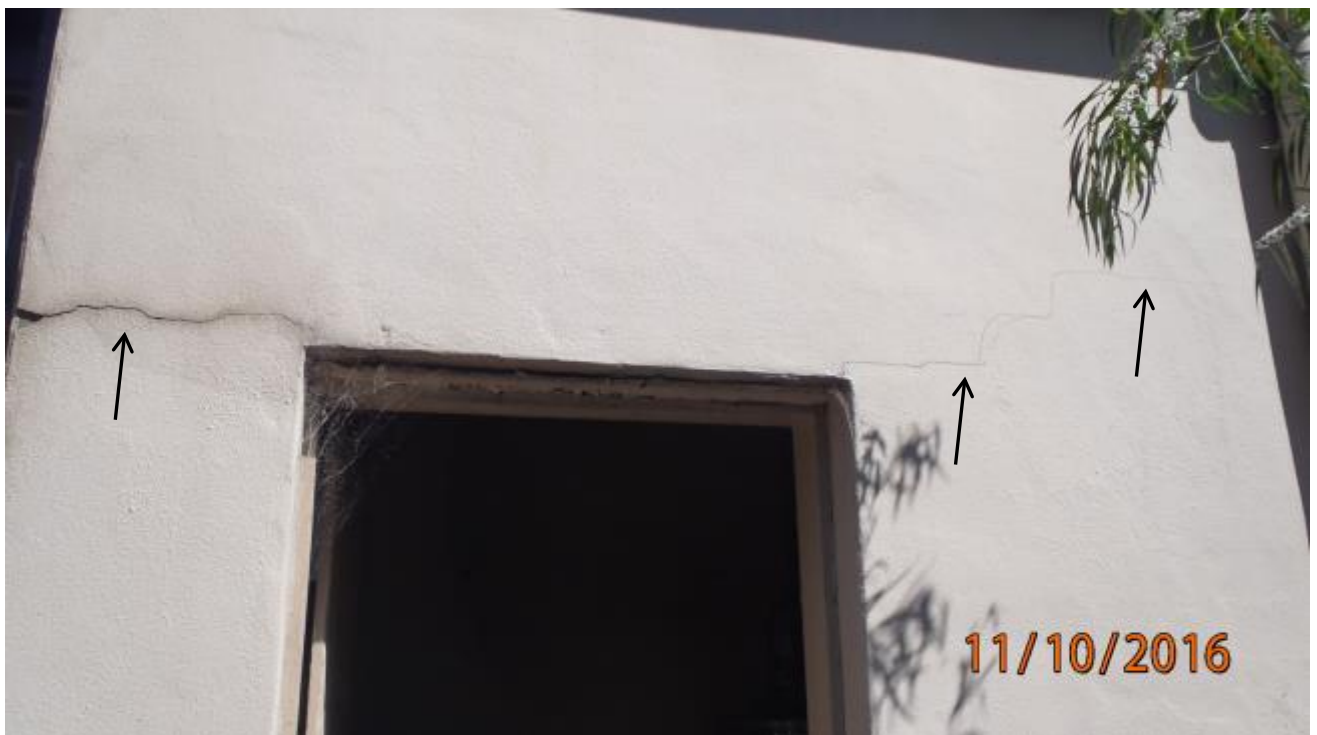
We noted horizontal cracking [1mm – 3mm] to the cement rendered clay masonry brickwork adjacent to the Laundry door head. **[Photograph 10]**

Photograph 10 shows horizontal and step cracking to the cement rendered clay masonry brickwork adjacent to the Laundry door head.

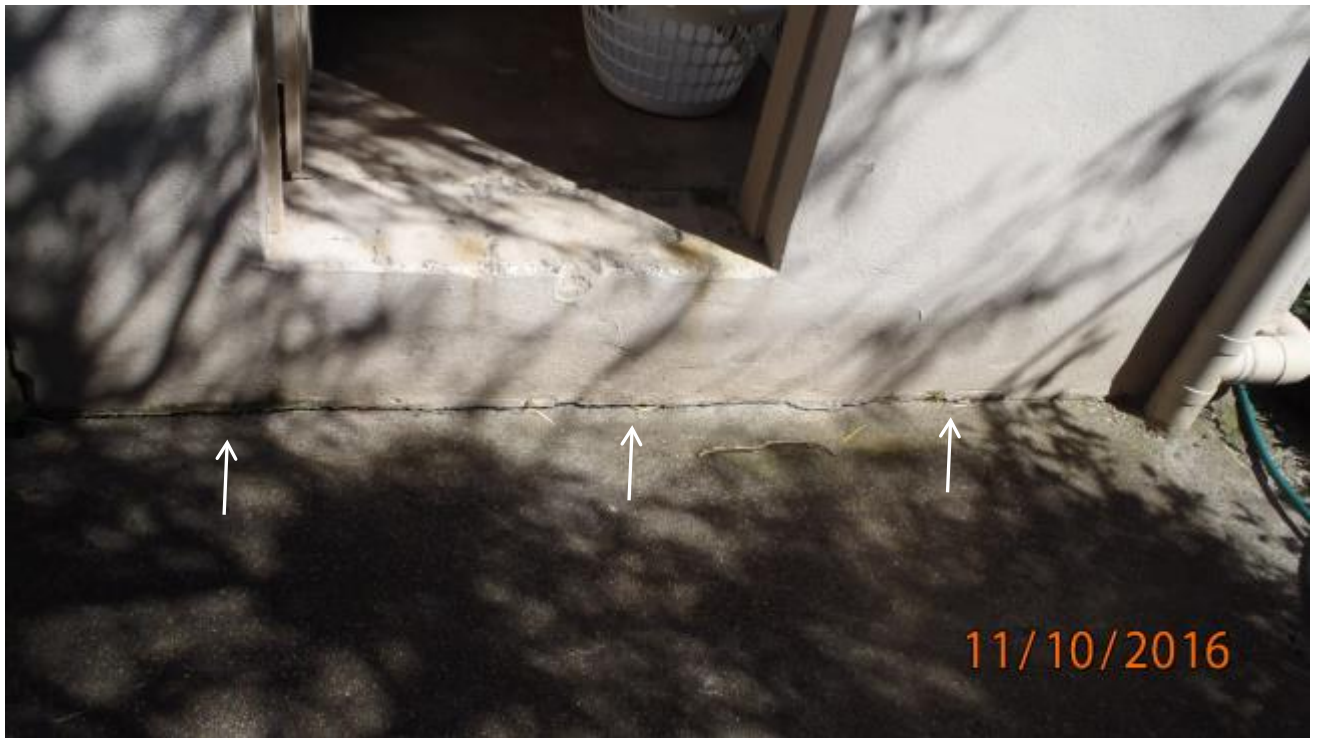
We noted separation cracking [1mm – 3mm] between the cement rendered clay masonry brickwork and the concrete pathway below the Laundry door step. **[Photograph 11]**

Photograph 11 shows separation cracking between the cement rendered clay masonry brickwork and the concrete pathway below the Laundry door step.

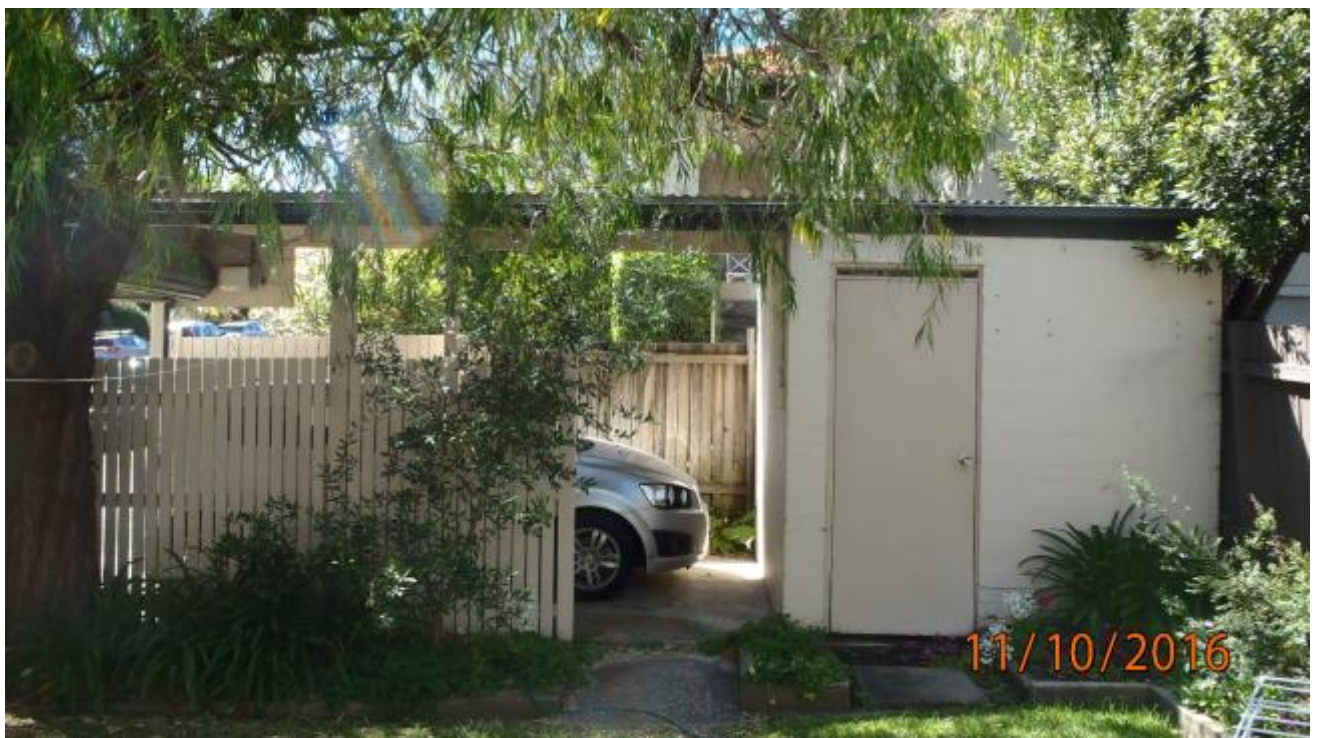
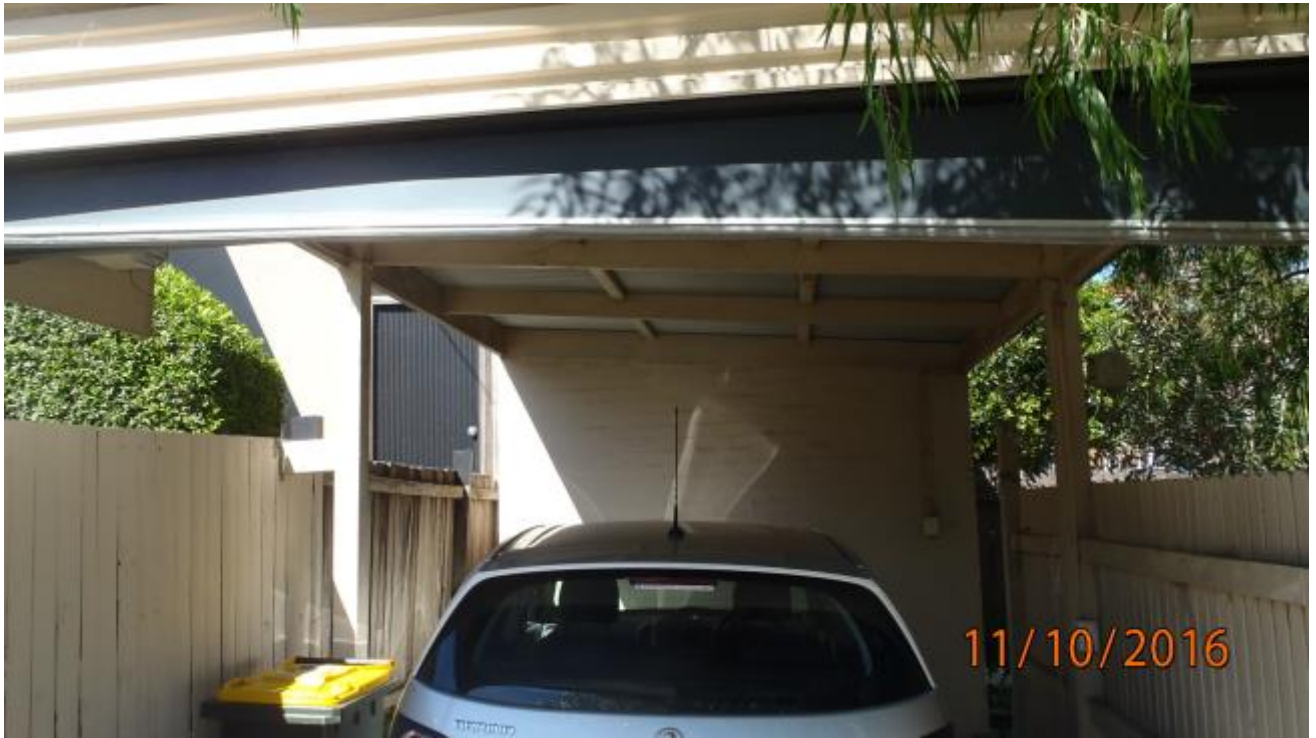
We noted a timber framed carport with pre-finished corrugated profile sheet metal roofing attached to a surface coated brick shed structure under a common roofline. **[Photograph 12 & 13]**

Photograph 12 shows the carport and shed structure to the rear of the residence.

Photograph 13 shows the internal view of the carport structure

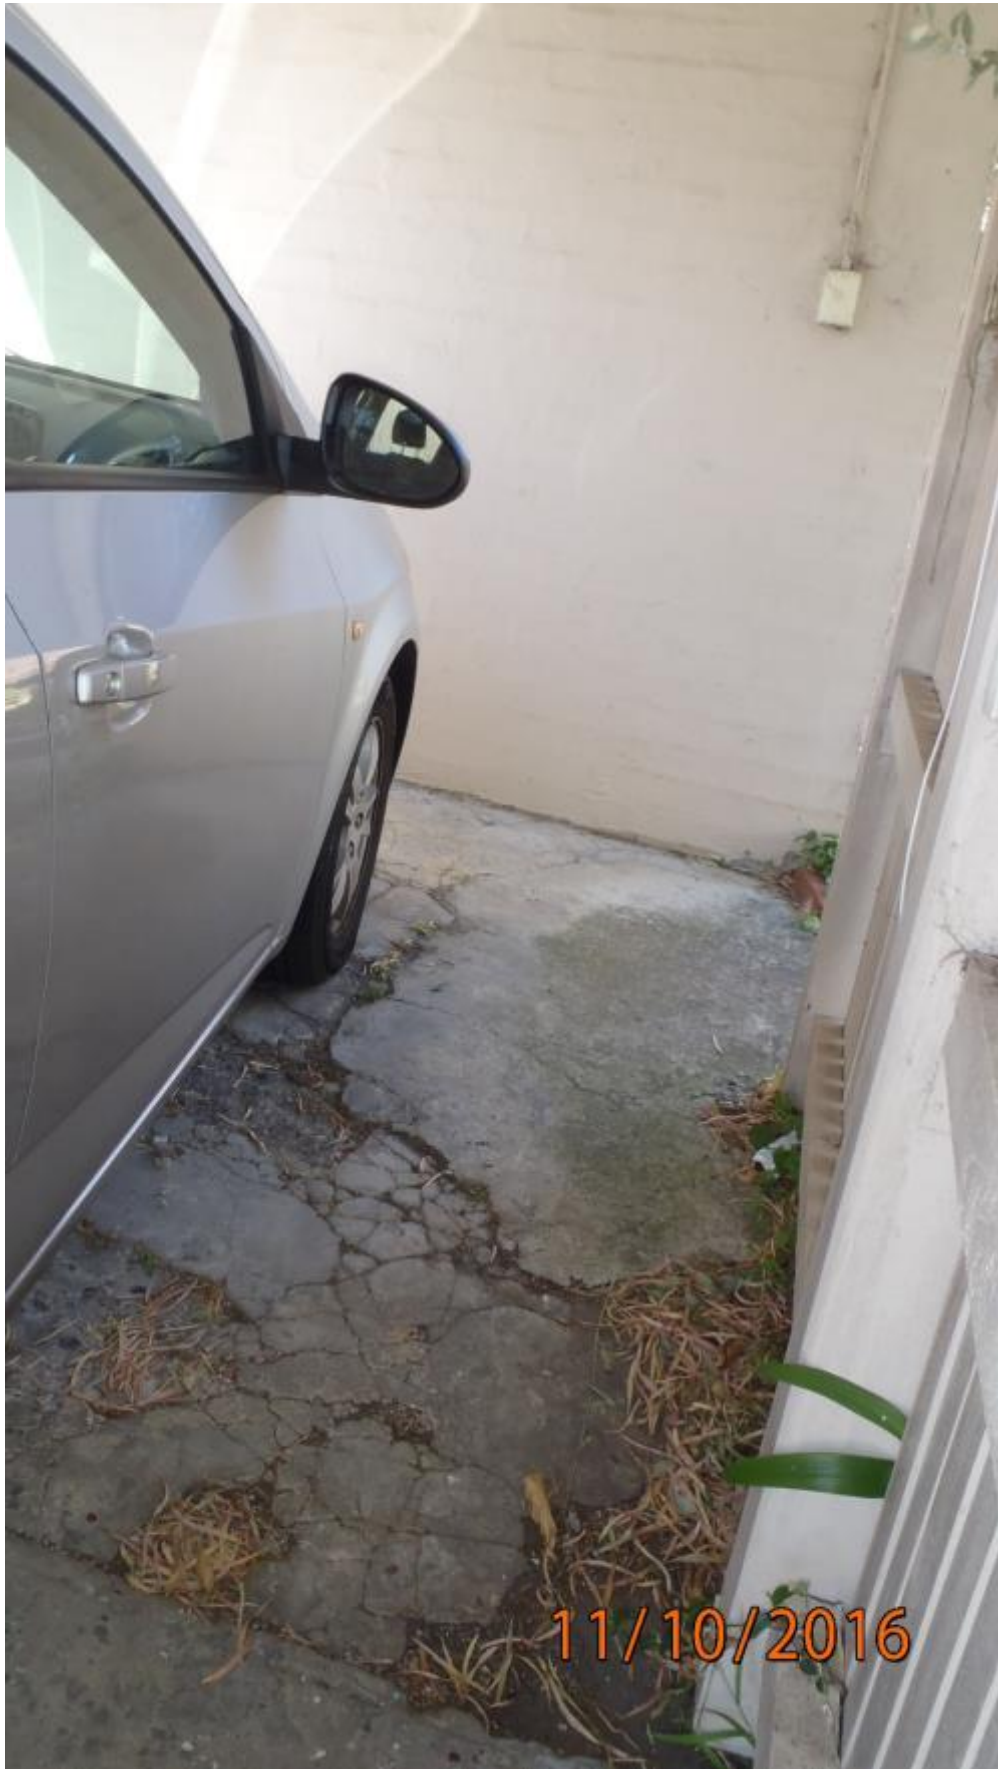
We further noted that the concrete slab floor of the carport showed significant cracking. **[Photograph 14]**

Photograph 14 shows cracking to the concrete slab floor in the carport.

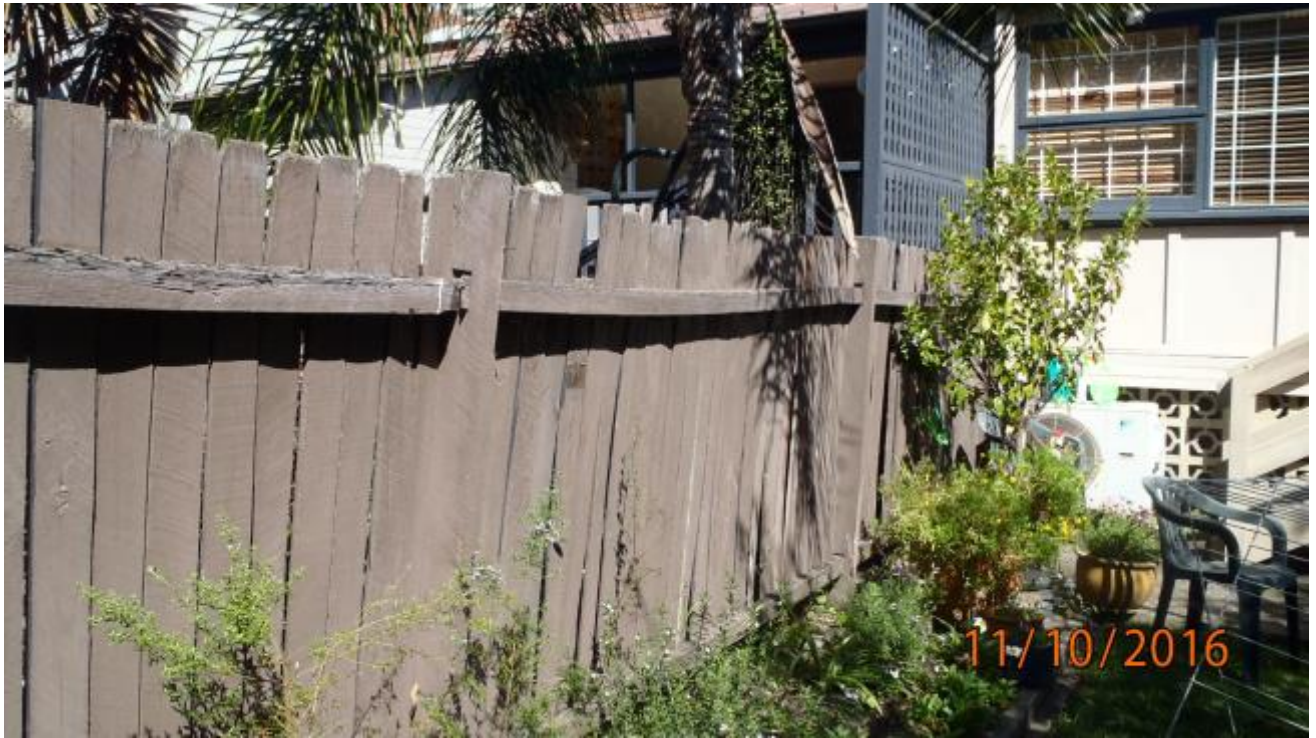
We noted that the *common* rear boundary fence between the adjoining property No. 49 Young Street, Cremorne is a timber post and rail structure. **[Photograph 15]**

Photograph 15 shows the *common* rear boundary fence between the adjoining property No. 49 Young Street, Cremorne.

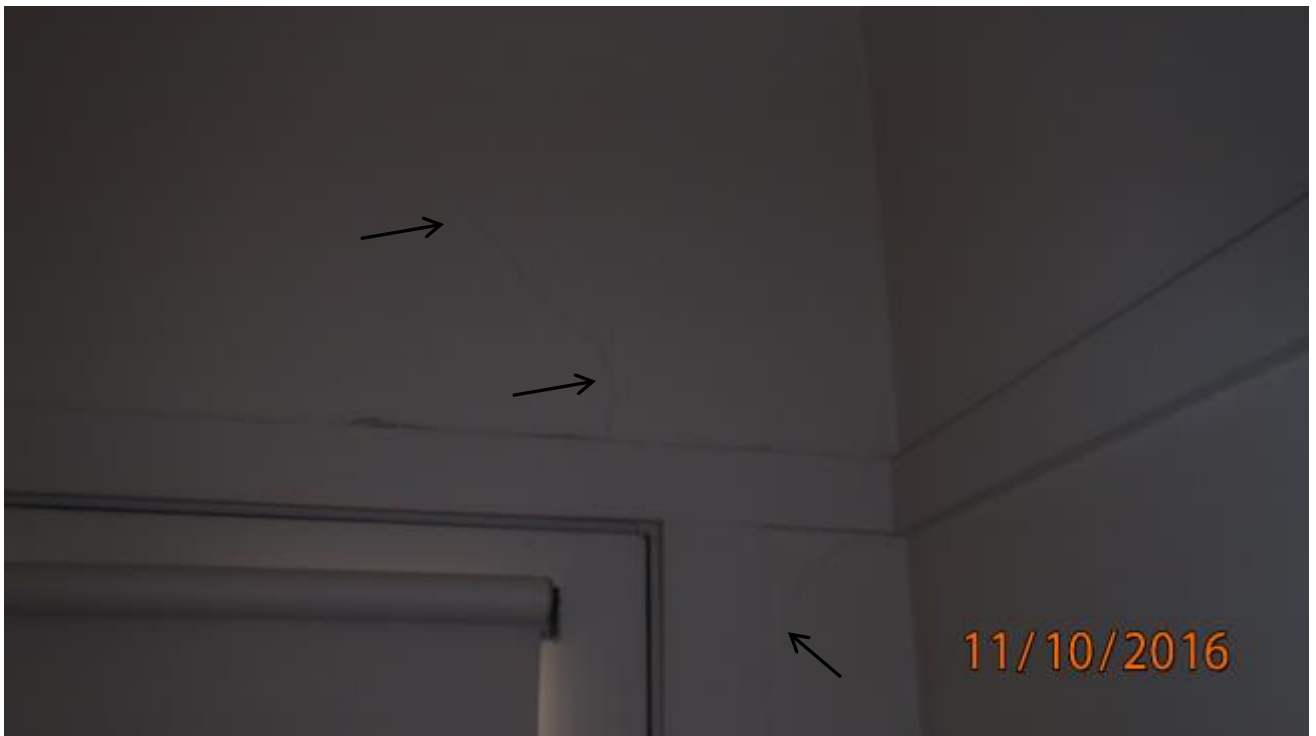
We noted radial cracking [$<1\text{mm}$] extending above and beside the entry door. **[Photograph 16]**

Photograph 16 shows radial cracking extending above and beside the entry door.

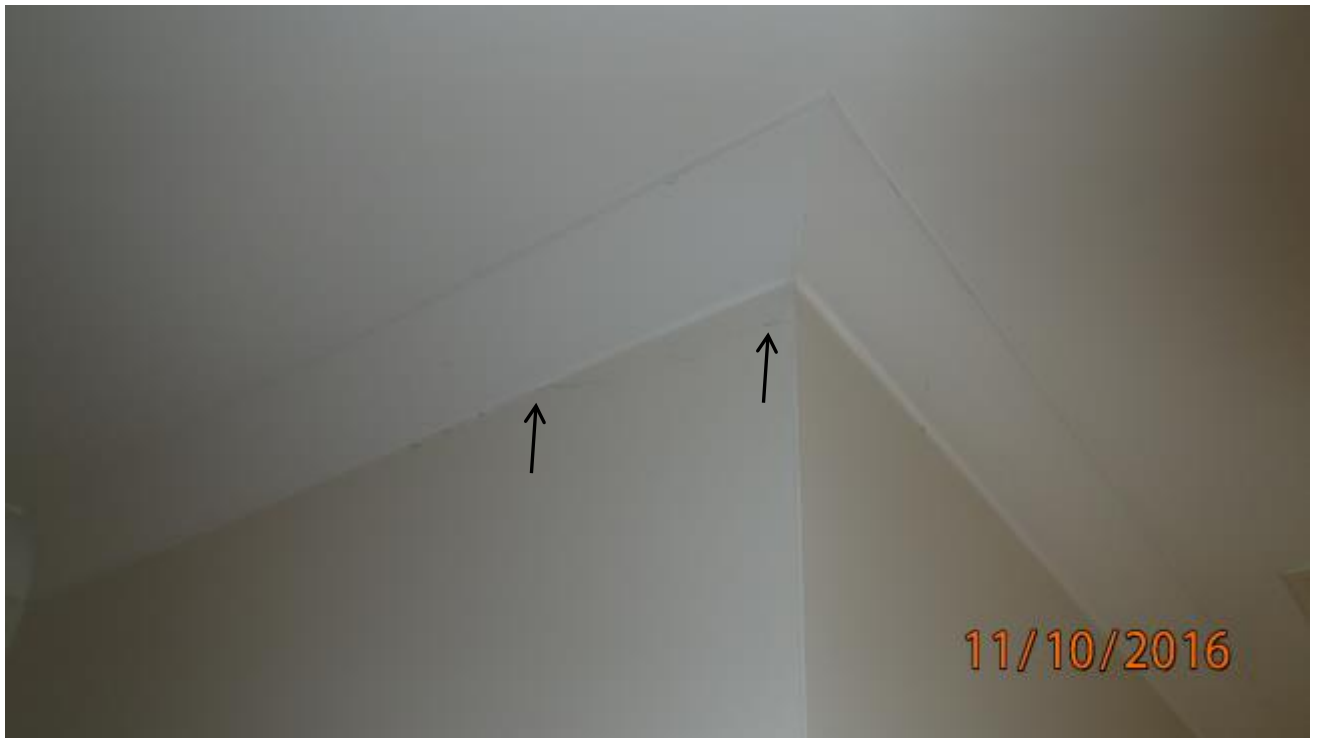
We noted hairline radial cracks [$<1\text{mm}$] extending underneath the plaster cornice on the eastern wall. **[Photograph 17]**

Photograph 17 shows radial cracks extending underneath the plaster cornice on the eastern wall of the Entry.

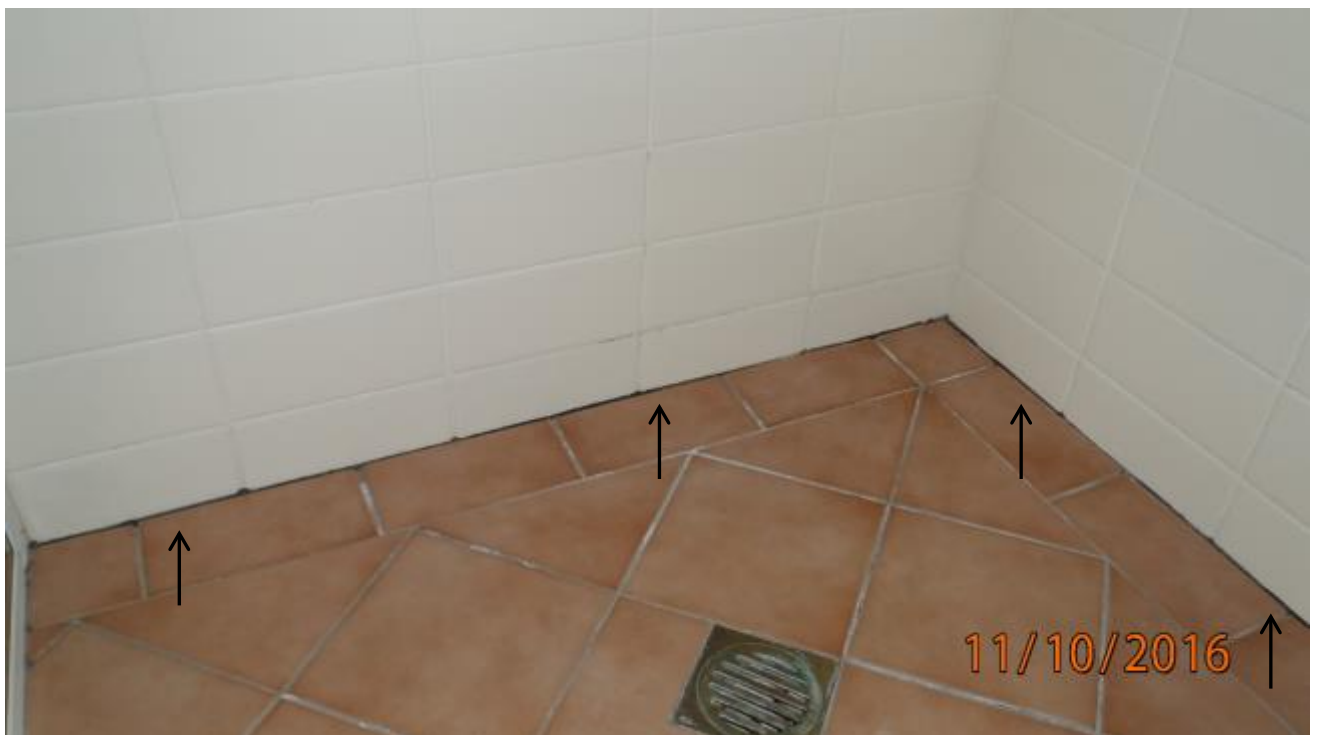
We noted mould / mildew growth around the wall to floor junction in the shower. **[Photograph 18]**

Photograph 18 shows mould / mildew growth around the wall to floor junction in the shower of the Ensuite.

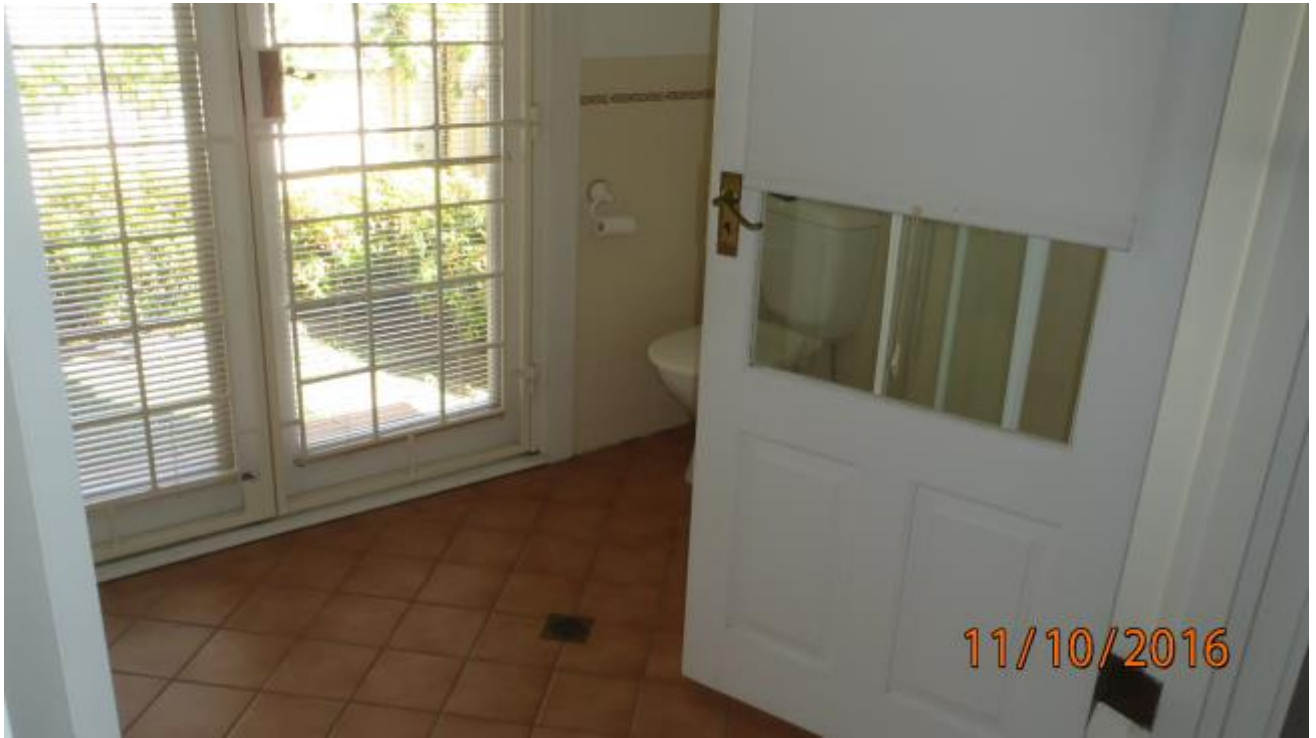
We noted that the grout to the wall and floor tiles is complete and that the wall and floor tiles when randomly “tap” tested appeared to be sound. We did not observe any recent cracking to the tile grout at the wall / wall, wall / floor junctions. **[Photograph 19]**

Photograph 19 shows the general layout of the Ensuite.

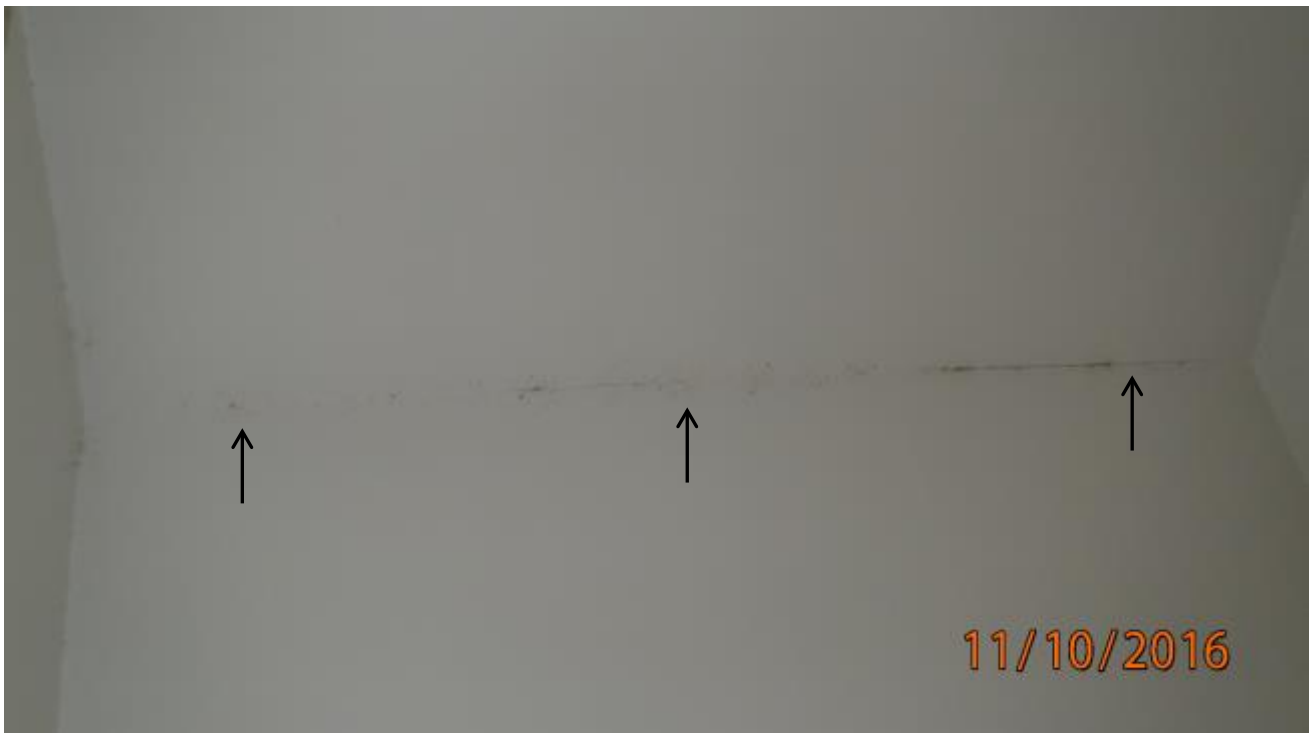
We noted hairline cracking [$<1\text{mm}$] extending along the square set pitched ceiling joint. **[Photograph 20]**

Photograph 20 shows hairline cracking extending along the square set pitched ceiling joint in the Ensuite.
