Dilapidation Assessment Report

Prepared for: Cape Cod Australia Pty. Limited
Job address: 51 Young Street, Cremorne.
Property Owner/s: Mrs Mary Mann.
Report reference: **NORTH SYDNEY COUNCIL**
Development Application No: not available
Date of assessment: 11th October 2016

Re: Dilapidation Report

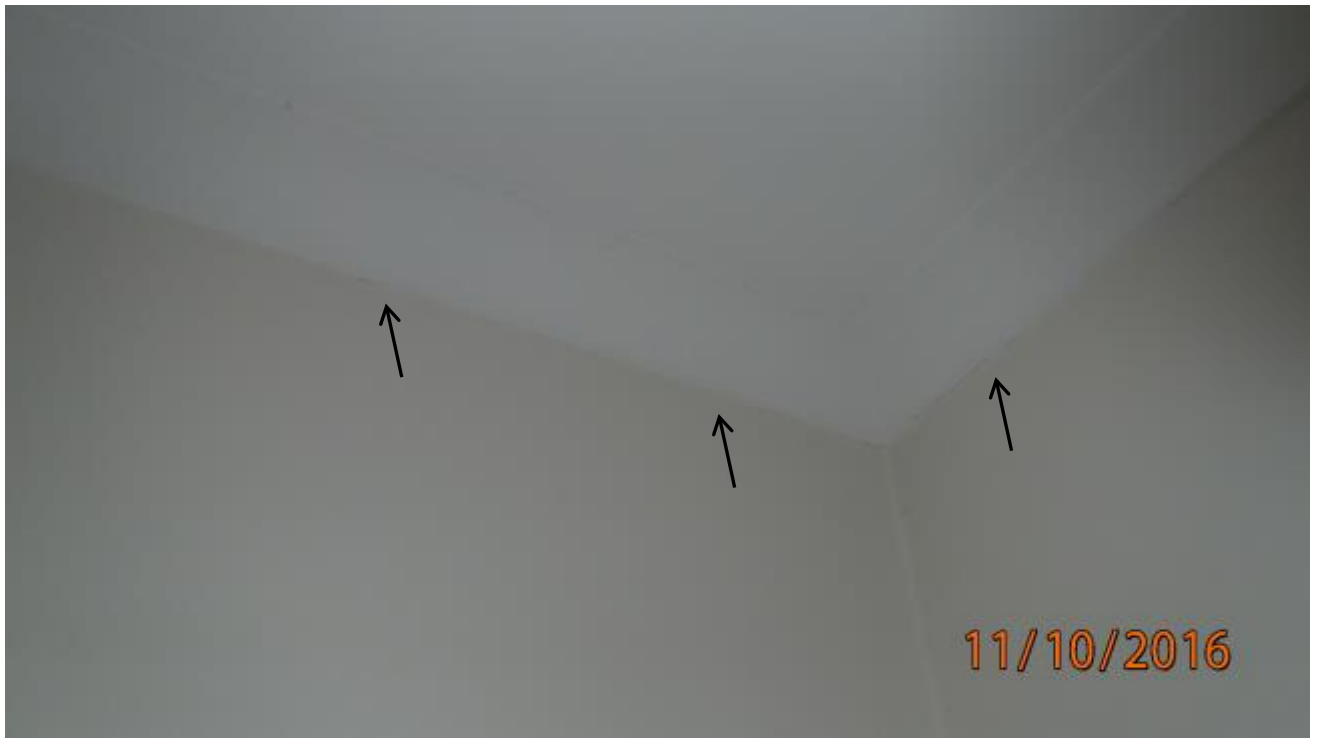
We noted separation cracking [$<1\text{mm}$] to the wall / cornice junction in the south western corner. **[Photograph 21]**

Photograph 21 shows separation cracking to the wall / cornice junction in the south western corner of Bedroom 1.

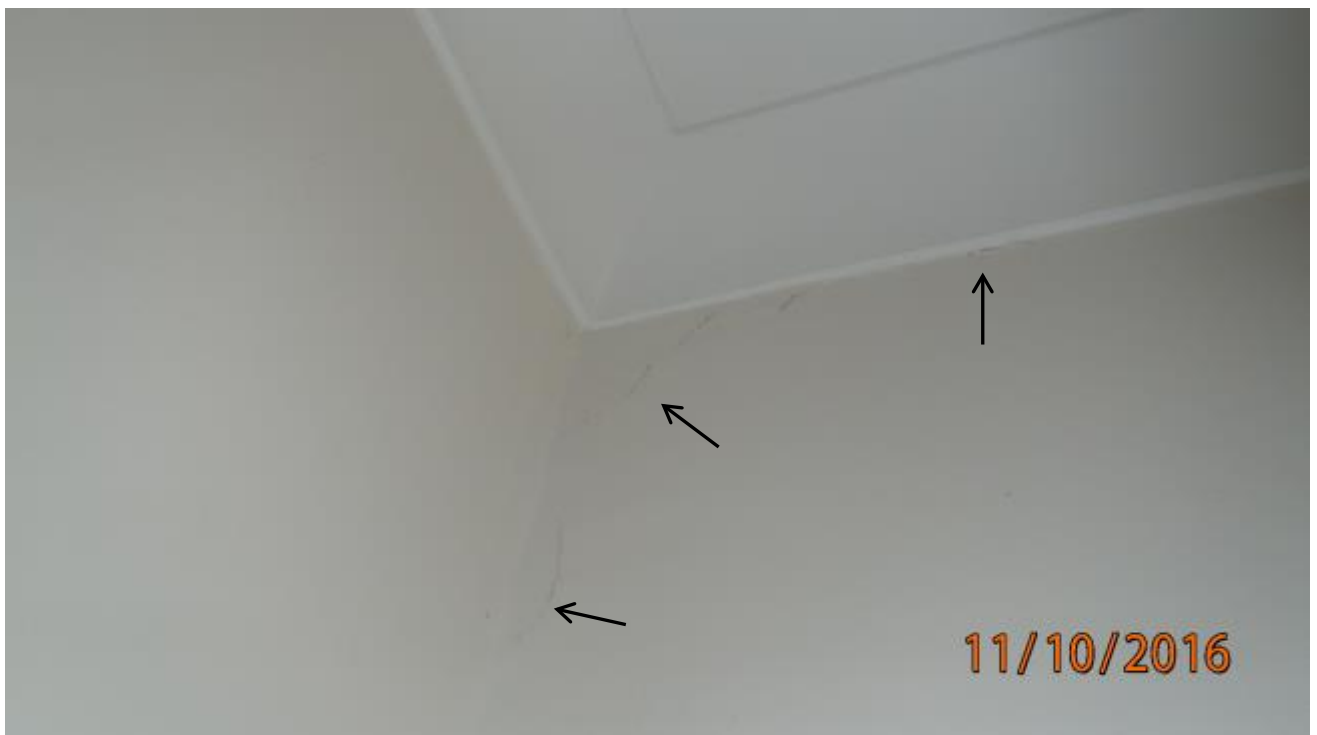
We noted radial, vertical and separation cracking [$<1\text{mm}$] in the south eastern corner adjacent to the door opening. **[Photograph 22]**

Photograph 22 shows radial, vertical and separation cracking in the south eastern corner adjacent to the door opening in Bedroom 1.

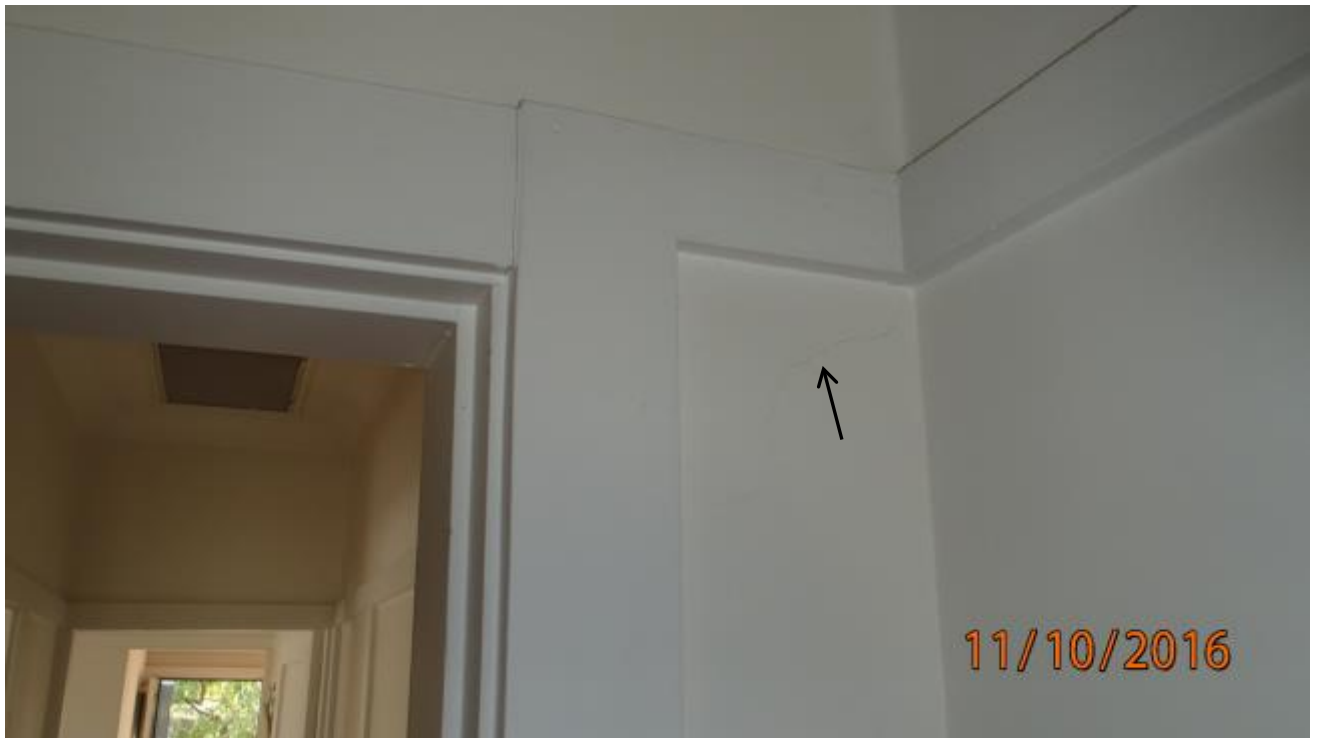
We noted hairline radial cracking [$<1\text{mm}$] extending from the door architrave to the southern wall. **[Photograph 23]**

Photograph 23 shows radial cracking extending from the door architrave to the southern wall in Bedroom 1.

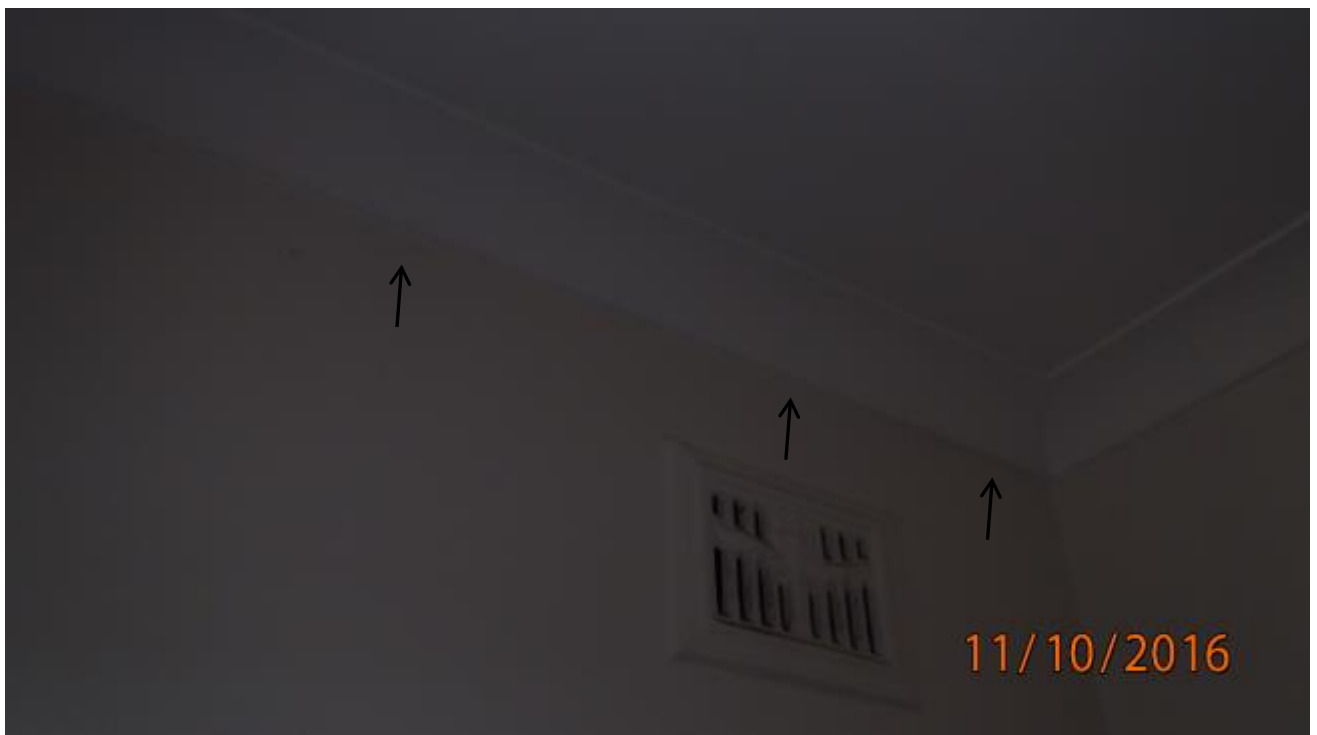
We noted separation cracking [$<1\text{mm}$] to the wall / cornice junction and the wall above the wall vent in the north eastern corner. **[Photograph 24]**

Photograph 24 shows separation cracking to the wall / cornice junction and the wall above the wall vent in the north eastern corner in Bedroom 1.

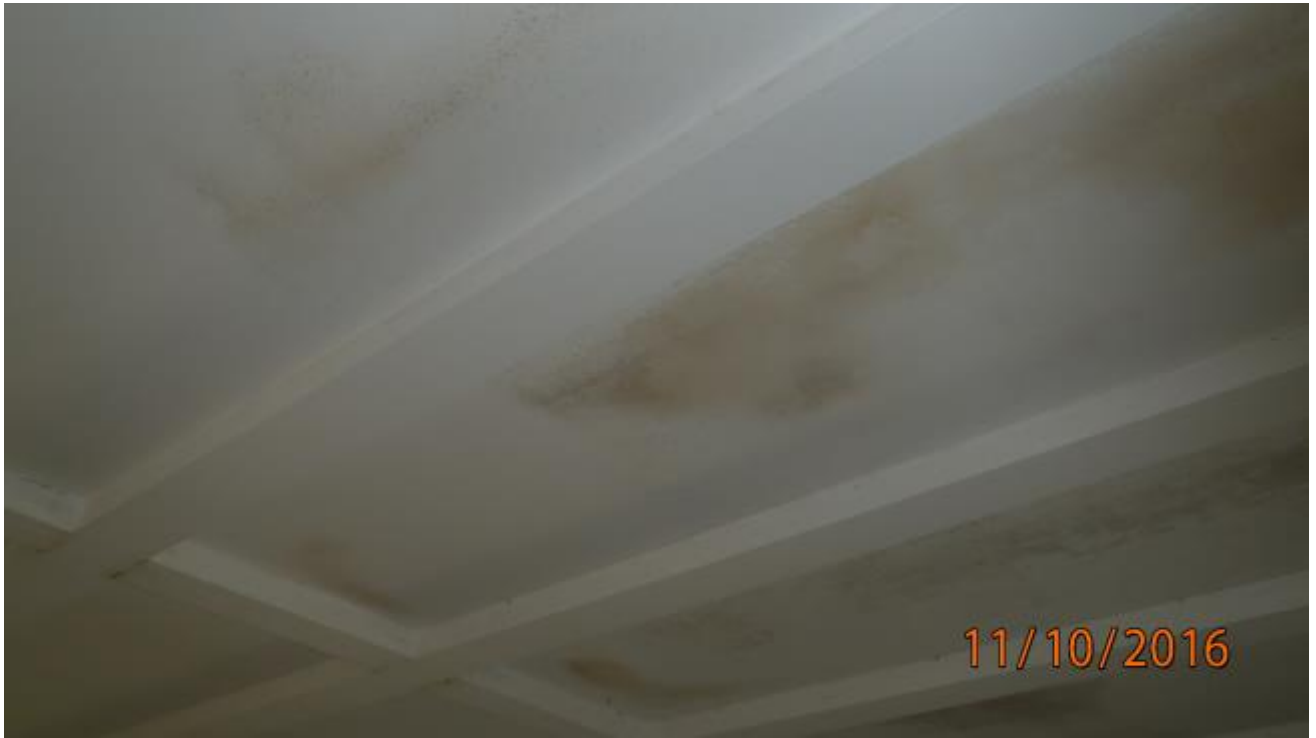
We noted mould growth and staining to the ceiling lining. **[Photograph 25]**

Photograph 25 shows mould growth and staining to the ceiling lining in the Sunroom.

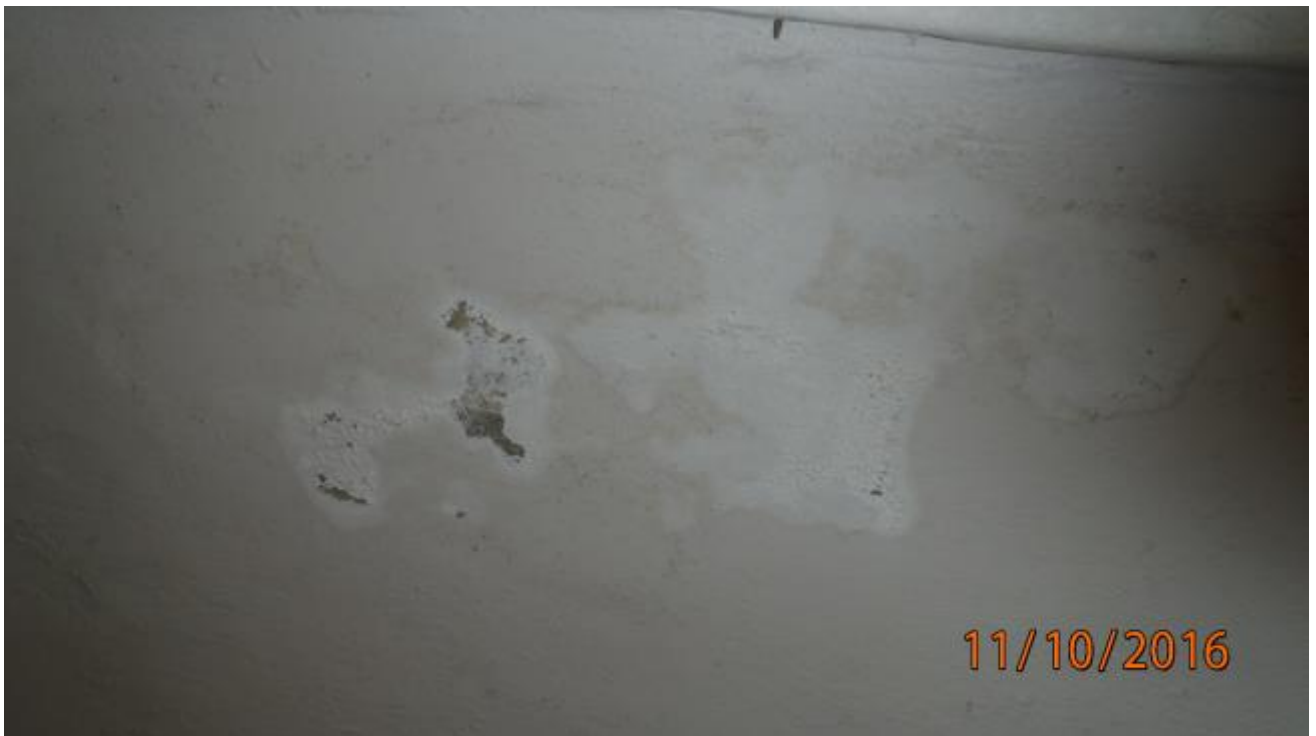
We noted evidence of previous repairs and staining to the surface coated cement rendered walls underneath the window. **[Photograph 26]**

Photograph 26 shows evidence of previous repairs and staining to the surface coated cement rendered walls underneath the window in the Sunroom.

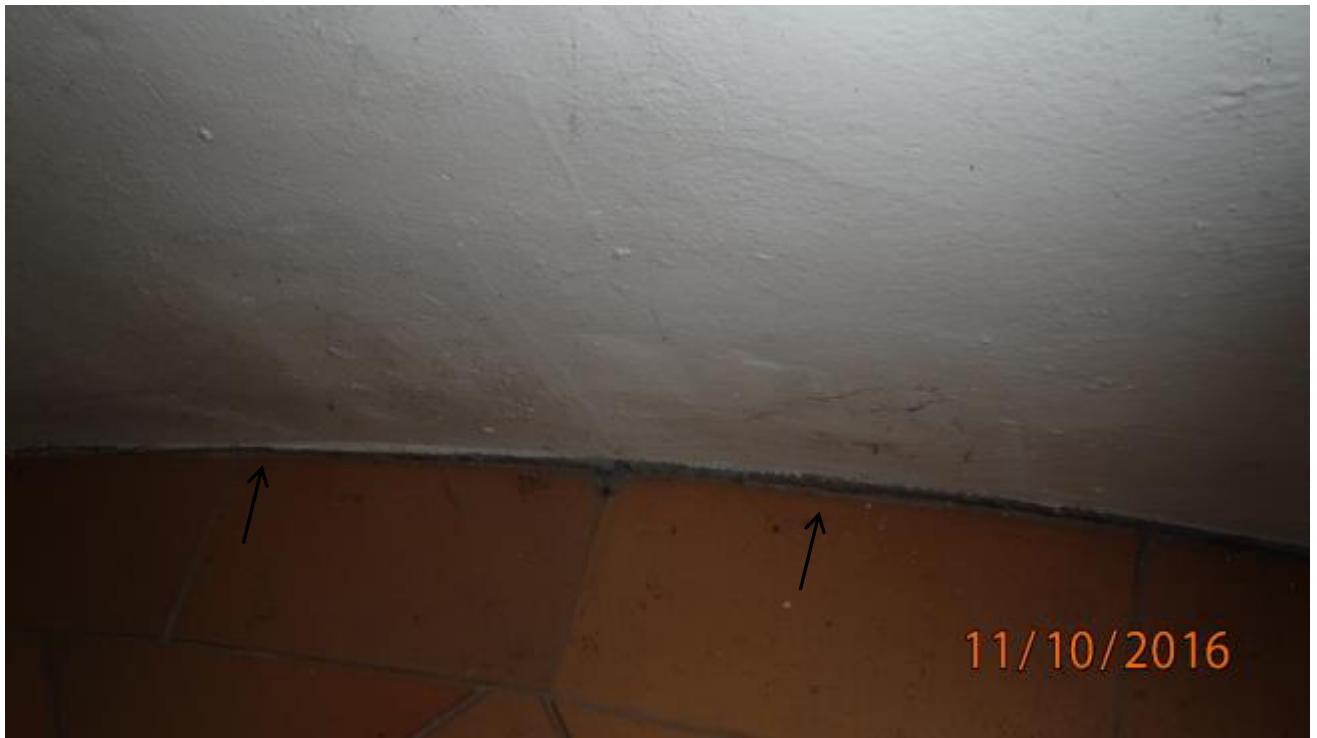
We noted separation cracking [$<1\text{mm}$] to the wall / floor junction underneath the window. **[Photograph 27]**

Photograph 27 shows separation cracking to the wall / floor junction underneath the window in the Sunroom.

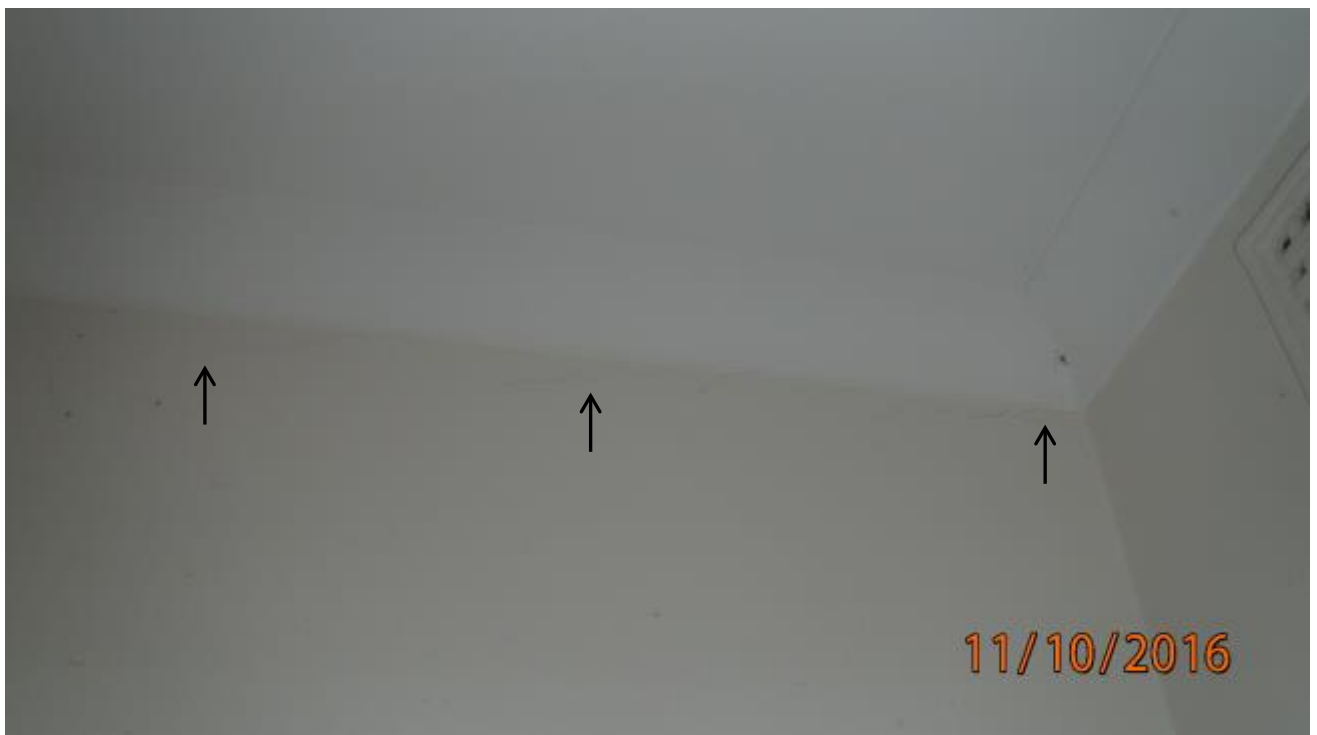
We noted hairline radial cracking [$<1\text{mm}$] extending underneath the cove profiled cornice along the *common party / separation* wall with the adjoining property No. 49 Young Street, Cremorne in the south western corner. **[Photograph 28]**

Photograph 28 shows radial cracking extending underneath the cove profiled cornice along the *common party / separation* wall with the adjoining property No. 49 Young Street, Cremorne in the south western corner of Bedroom 2.

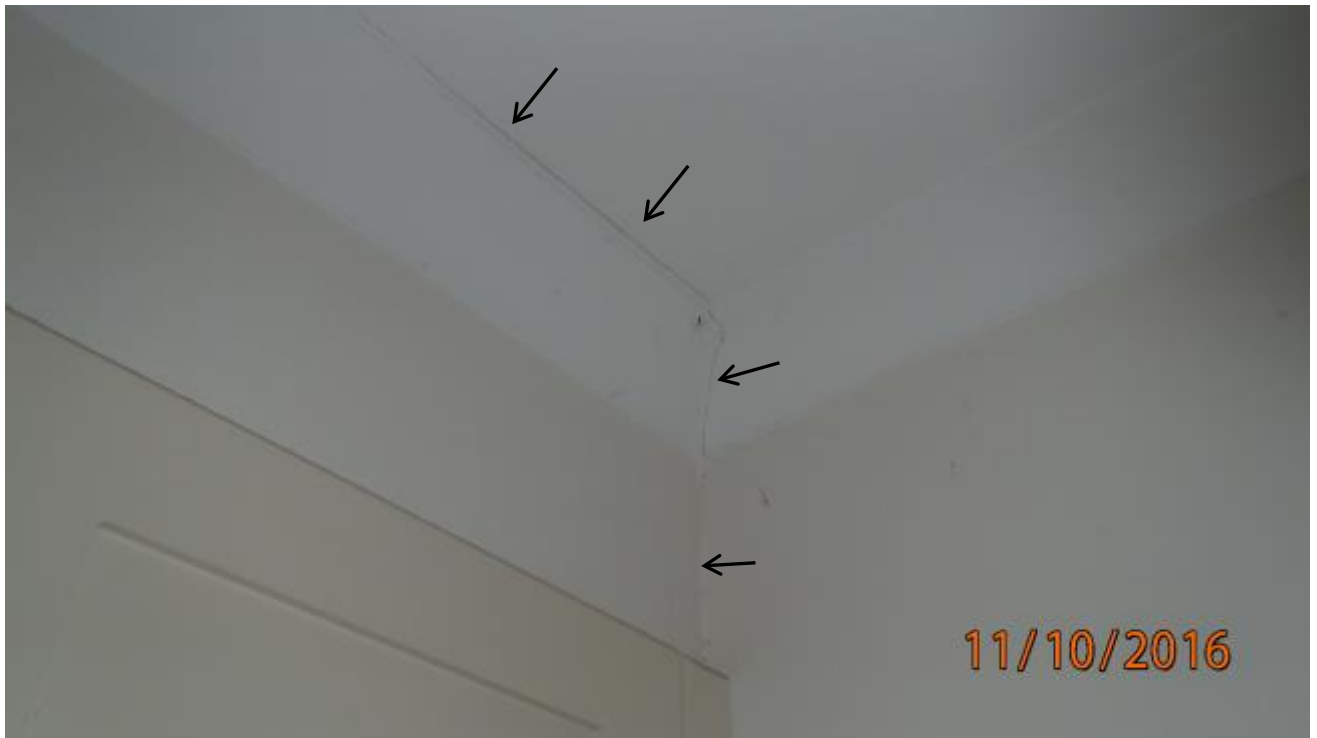
We noted hairline cracking [$<1\text{mm}$] to the mitre joint in the cove profiled cornice, vertical cracking [$<1\text{mm}$] to the wall / wall junction and separation cracking [$<1\text{mm}$] to the ceiling / cornice junction adjacent to the *common party / separation* wall with the adjoining property No. 49 Young Street, Cremorne in the south eastern corner. **[Photograph 29]**

Photograph 29 shows hairline cracking to the mitre joint in the cove profiled cornice, vertical cracking to the wall / wall junction and separation cracking to the ceiling / cornice junction adjacent to the *common party / separation* wall with the adjoining property No. 49 Young Street, Cremorne in the south eastern corner of Bedroom 2.

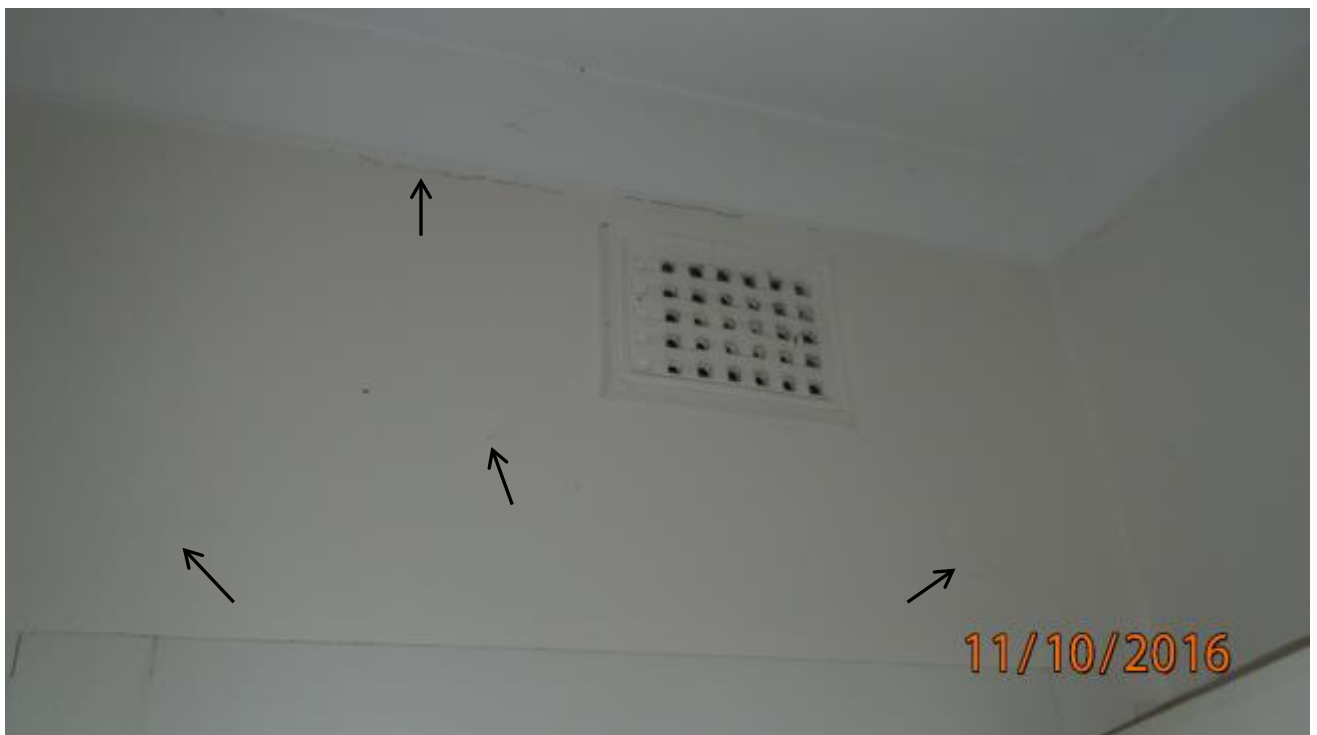
We noted radial cracking [$<1\text{mm}$] around the wall vent in the north western corner. **[Photograph 30]**

Photograph 30 shows radial cracking around the wall vent in the north western corner of Bedroom 2.

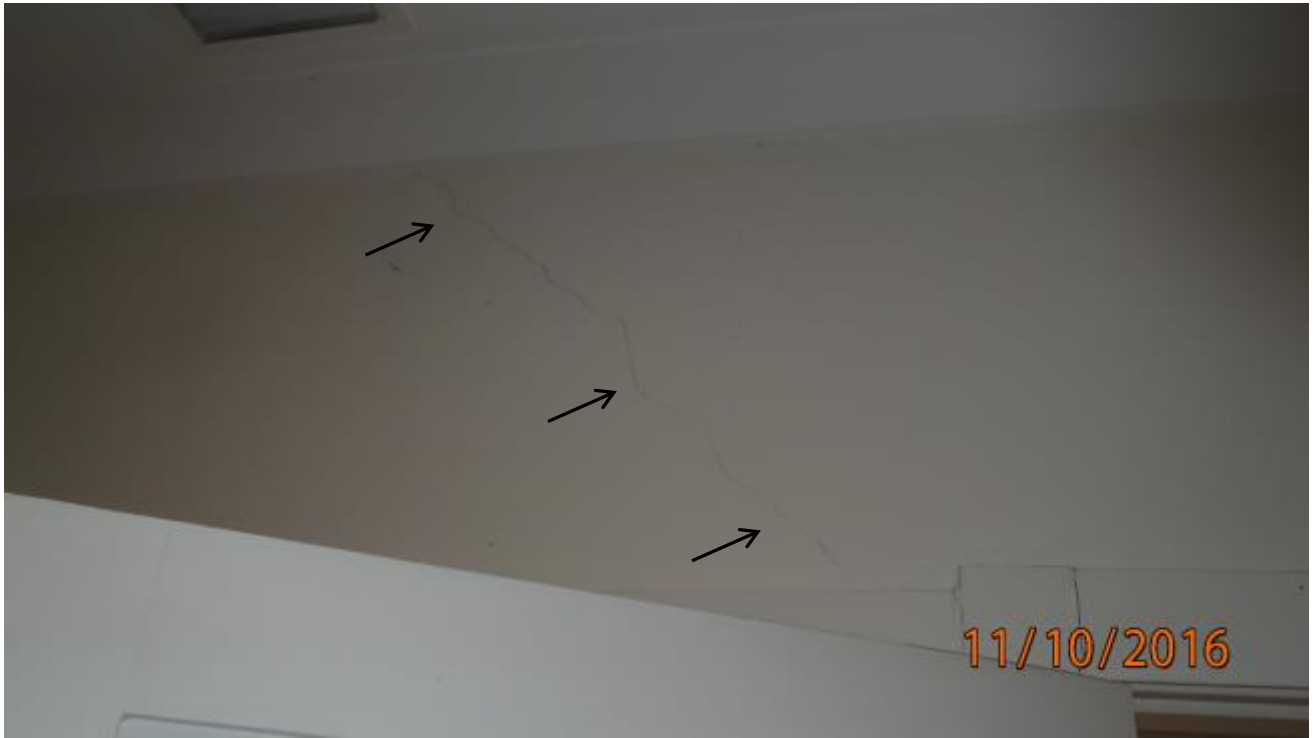
We noted radial cracking [$<1\text{mm}$] extending above the door head toward the ceiling on the northern wall. **[Photograph 31]**

Photograph 31 shows radial cracking extending above the door head toward the ceiling on the northern wall in Bedroom 2.

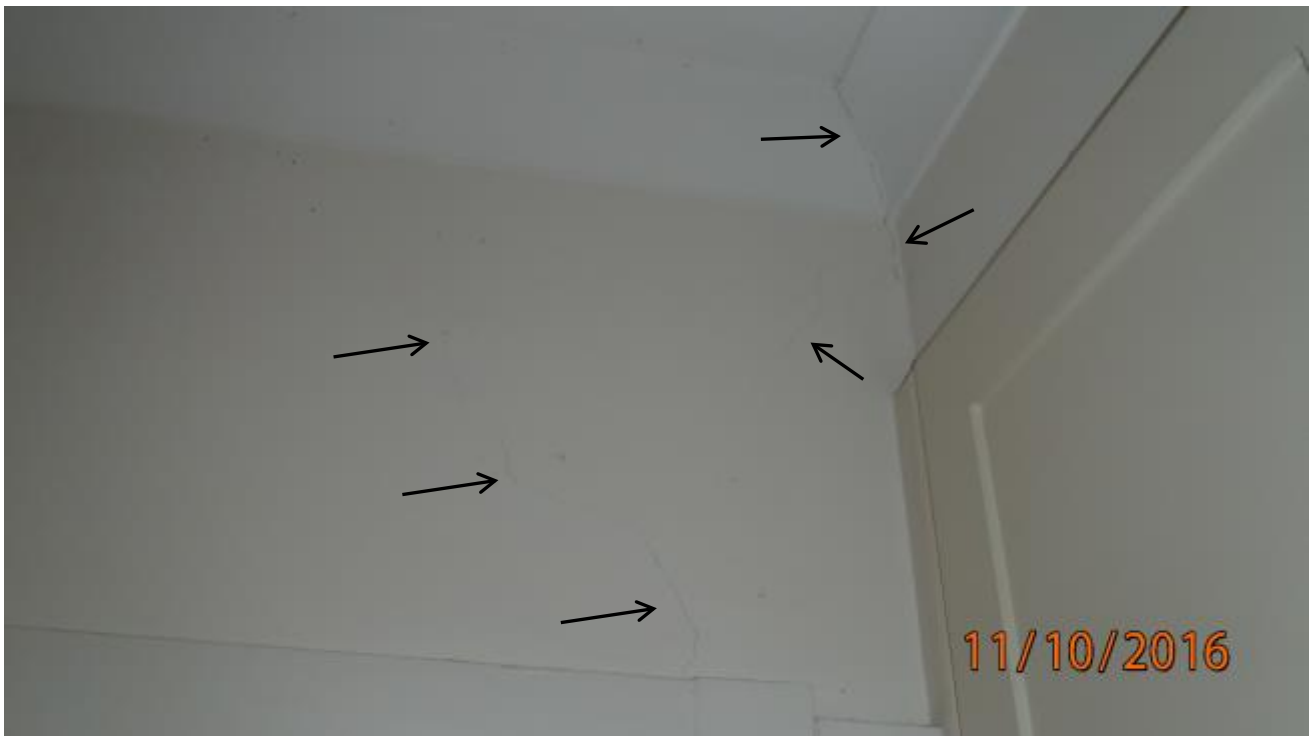
We noted radial cracking [$<1\text{mm}$] extending above the door head toward the ceiling on the northern wall and to the mitre joint in the cove profiled cornice in the north eastern corner. **[Photograph 32]**

Photograph 32 shows radial cracking extending above the door head toward the ceiling on the northern wall and to the mitre joint in the cove profiled cornice in the north eastern corner in Bedroom 2.

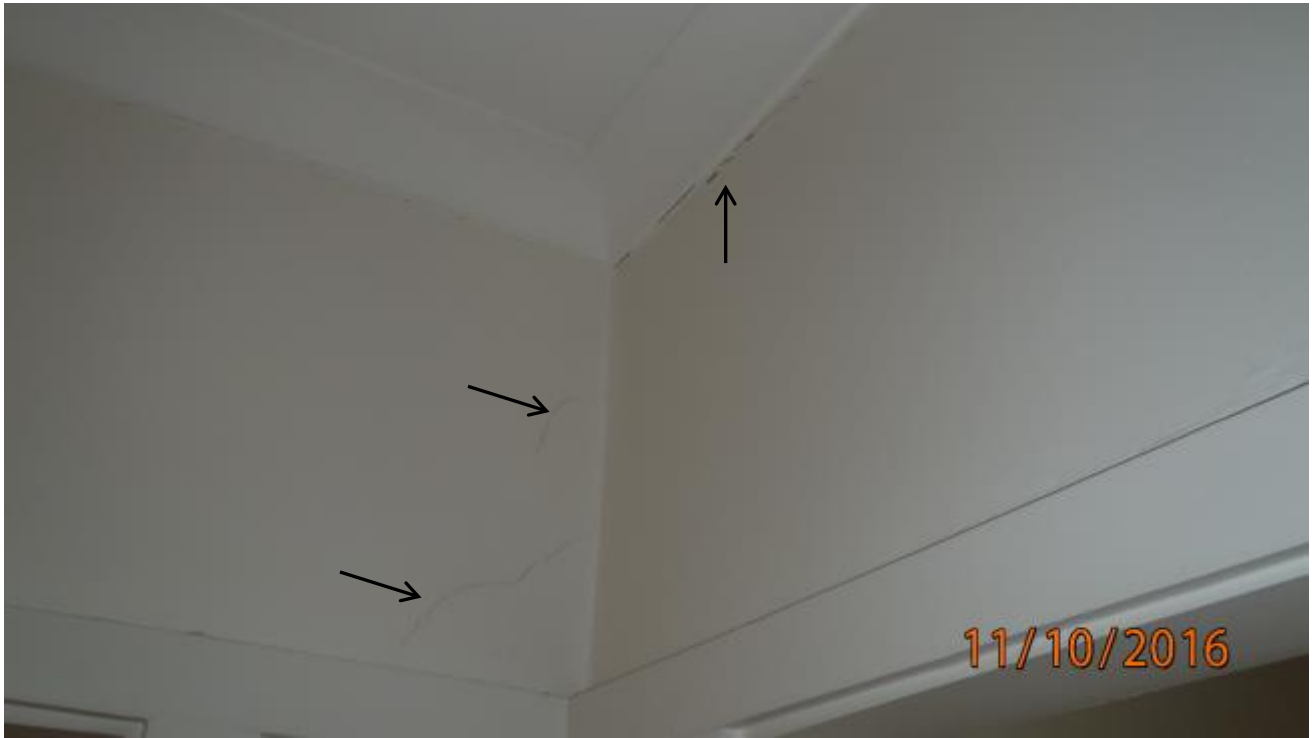
We noted hairline radial cracking [$<1\text{mm}$] and separation cracking [$<1\text{mm}$] to the wall / cornice junction in the south western corner. **[Photograph 33]**

Photograph 33 shows radial cracking and separation cracking to the wall / cornice junction in the south western corner of the Hallway.

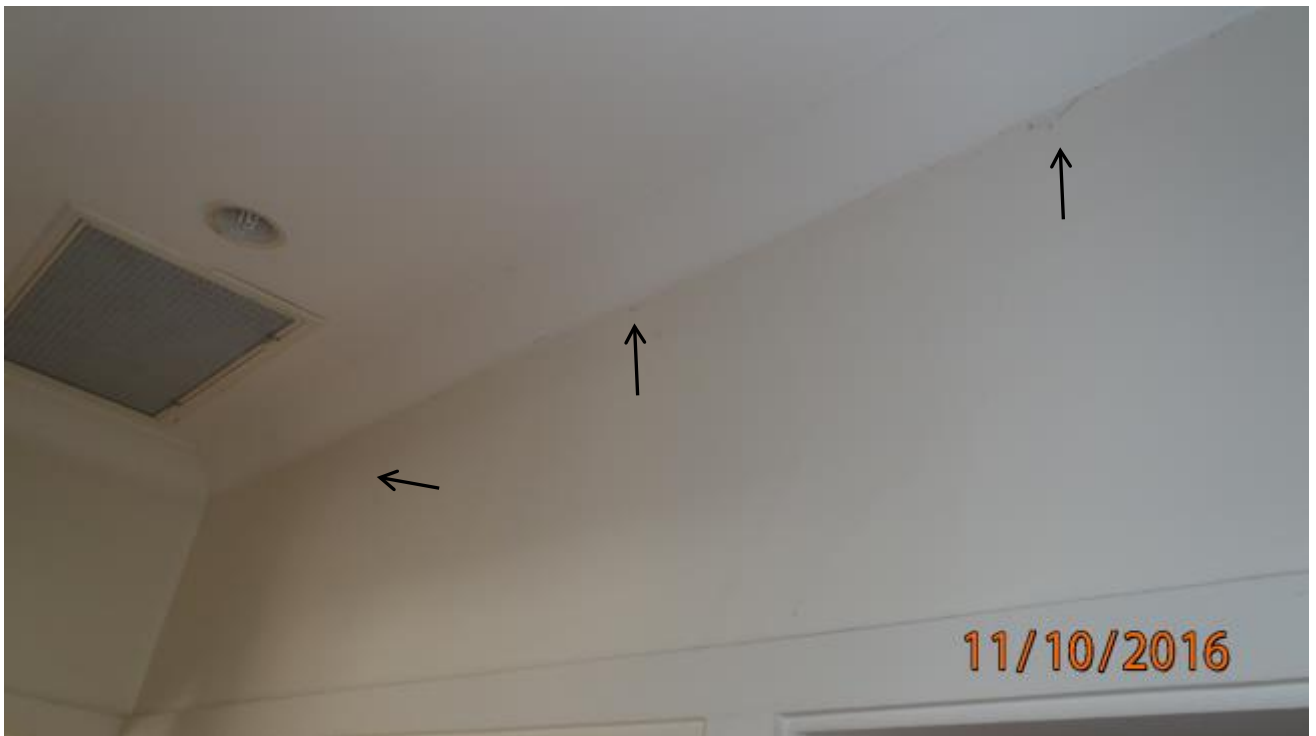
We noted hairline radial cracking [$<1\text{mm}$] and separation cracking [$<1\text{mm}$] to the wall / cornice junction on the southern wall. **[Photograph 34]**

Photograph 34 shows radial cracking and separation cracking to the wall / cornice junction on the southern wall of the Hallway.

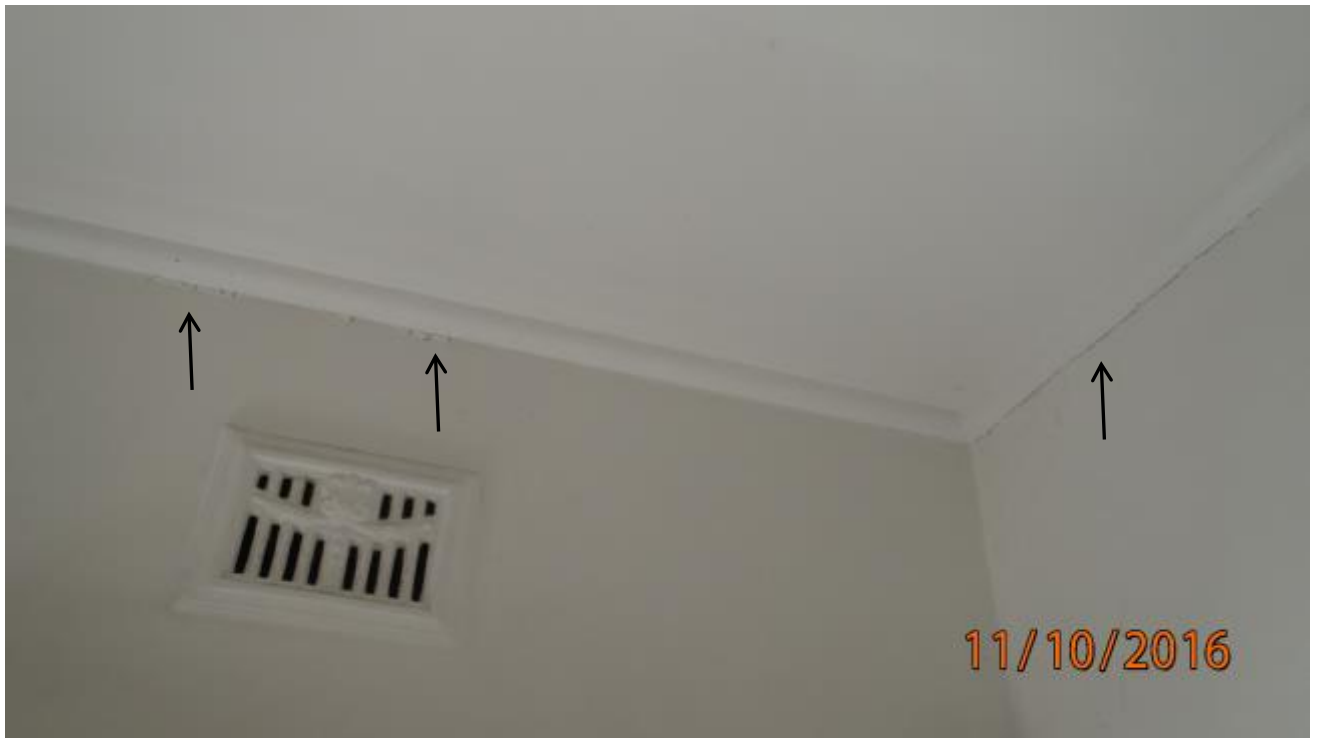
We noted flaking paint and separation cracking [$<1\text{mm}$] to the wall / cornice junction in the north eastern corner. **[Photograph 35]**

Photograph 35 shows flaking paint and separation cracking [$<1\text{mm}$] to the wall / cornice junction in the north eastern corner of the Bathroom.

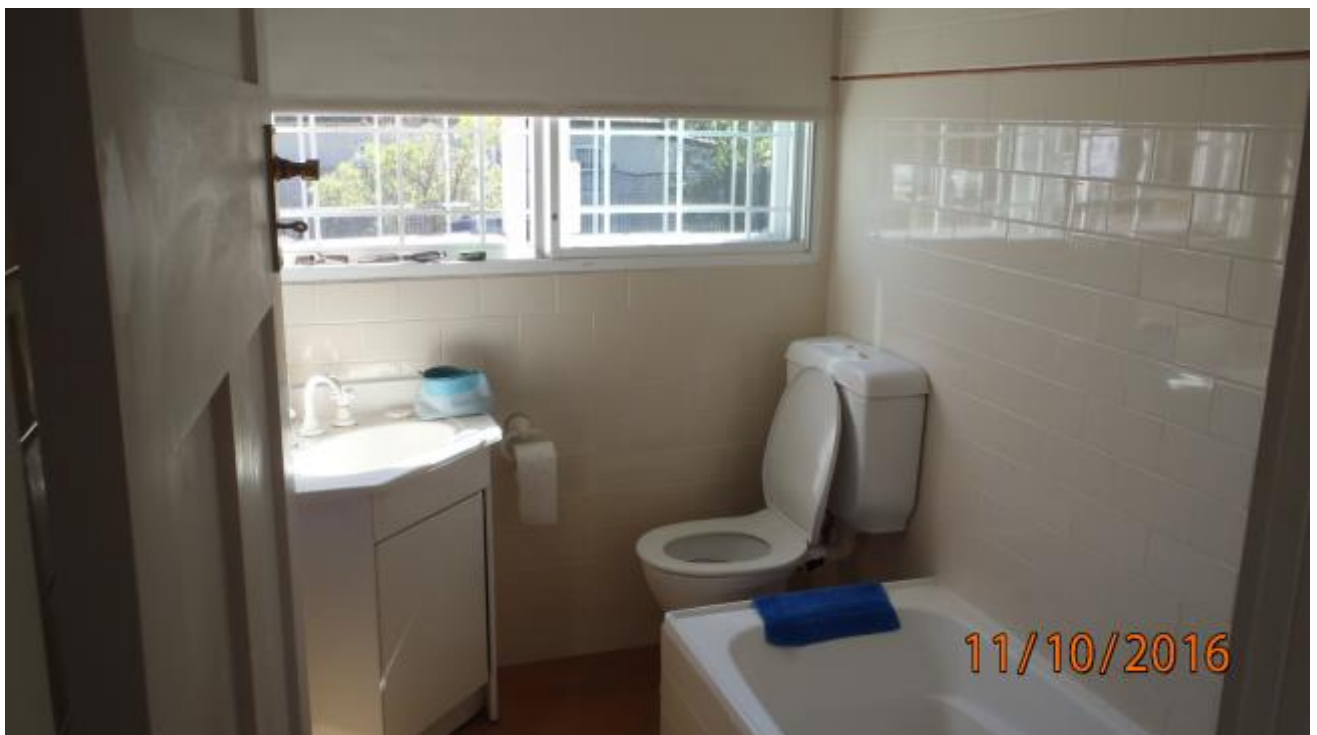
We noted that the grout to the wall and floor tiles is complete and that the wall and floor tiles when randomly “tap” tested appeared to be sound. We did not observe any recent cracking to the tile grout at the wall / wall, wall / floor junctions. **[Photograph 36]**

Photograph 36 shows the general layout of the Bathroom.

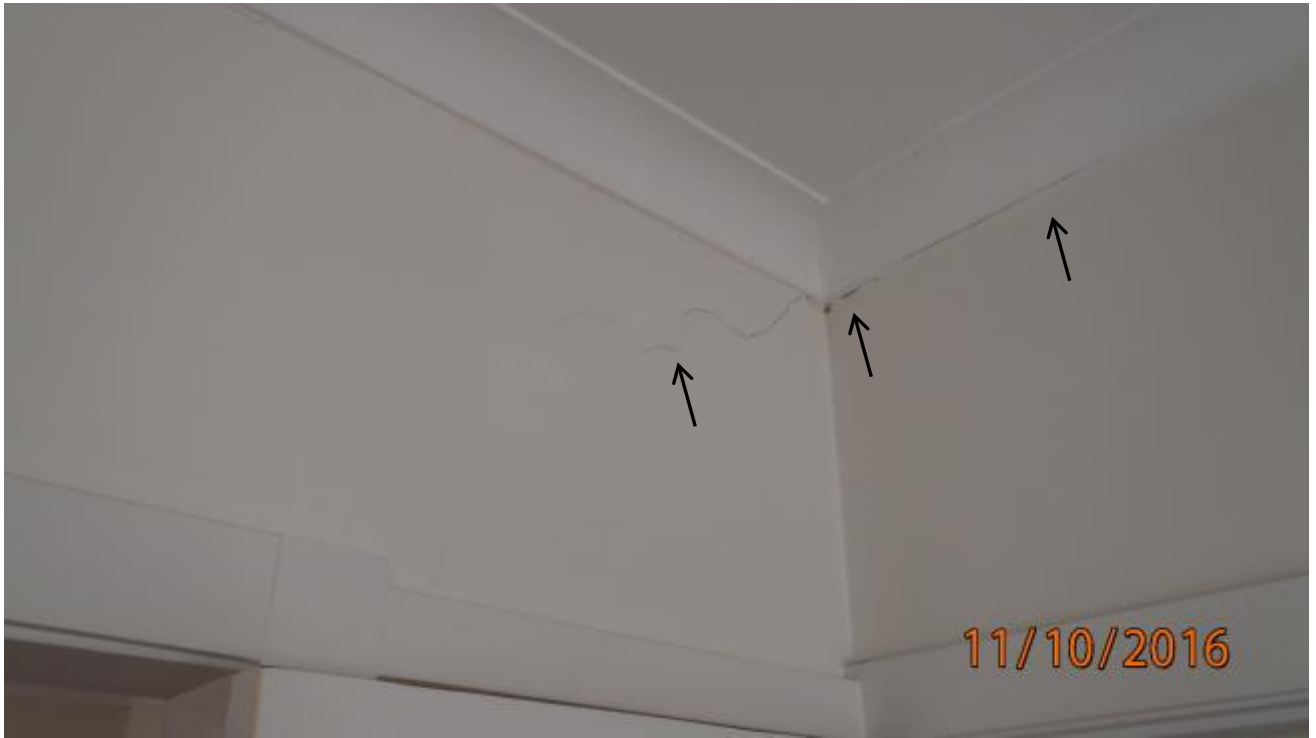
We noted radial cracking [$<1\text{mm}$] and separation cracking [$<1\text{mm}$] to the wall / cornice junction on the south western corner. **[Photograph 37]**

Photograph 37 shows radial cracking and separation cracking to the wall / cornice junction on the south western corner of the Dining room.

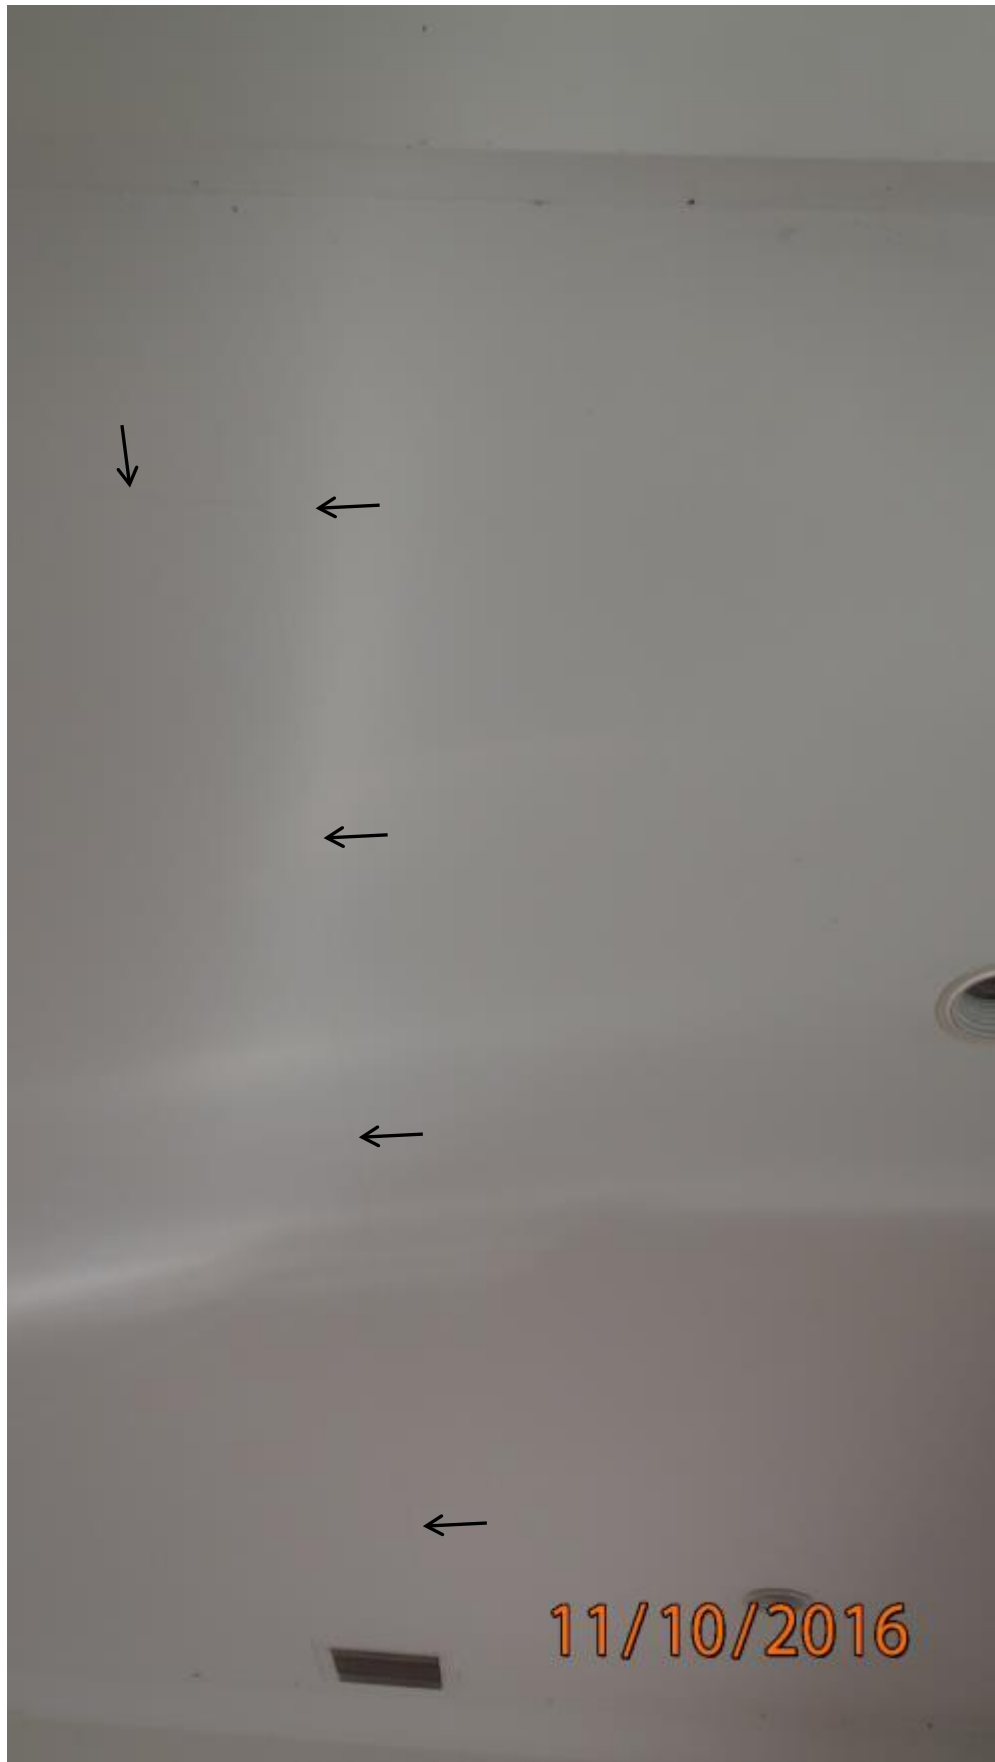
We noted separation cracking [$<1\text{mm}$] to the ceiling lining. **[Photograph 38]**

Photograph 38 shows separation cracking to the ceiling lining in the Dining Room / Kitchen area.

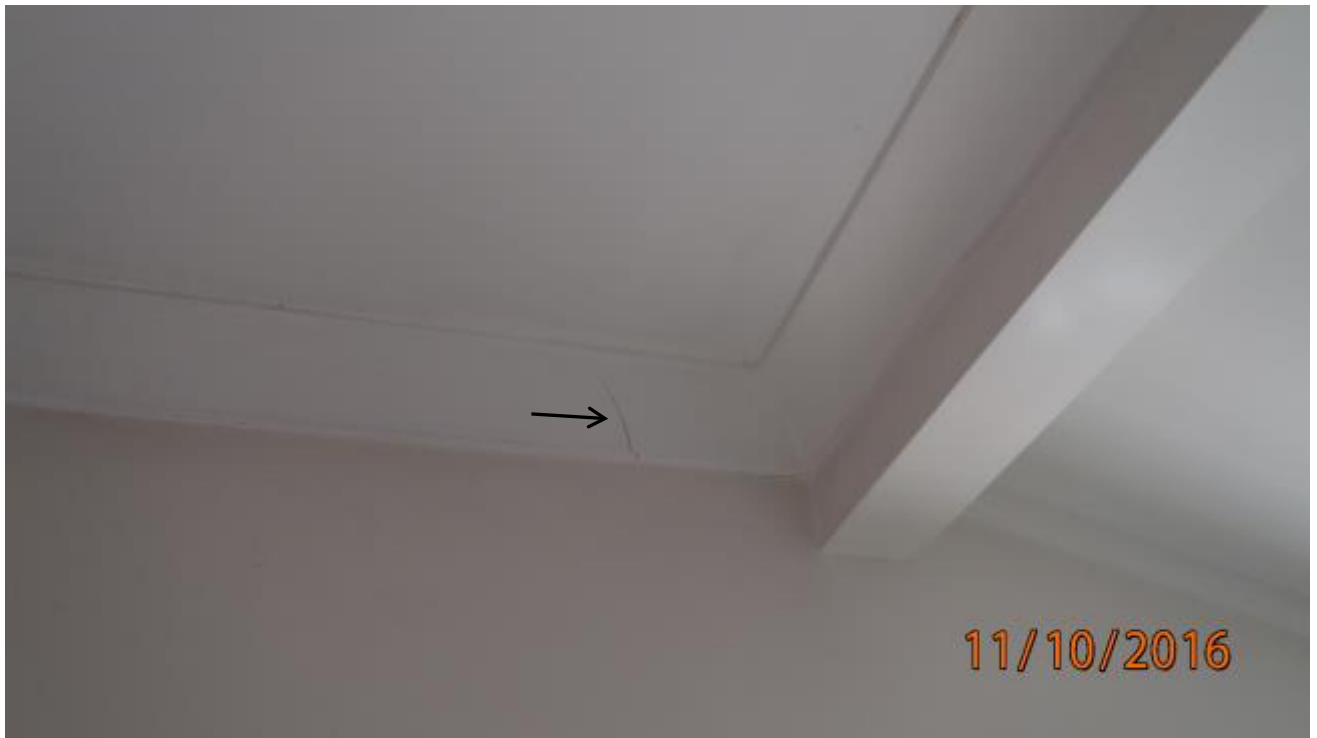
We noted separation cracking [$<1\text{mm}$] to the mitre joint of the cove profiled plaster cornice in the north eastern corner **[Photograph 39]**

Photograph 39 shows separation cracking to the mitre joint of the cove profiled plaster cornice in the north eastern corner of the Dining Room.

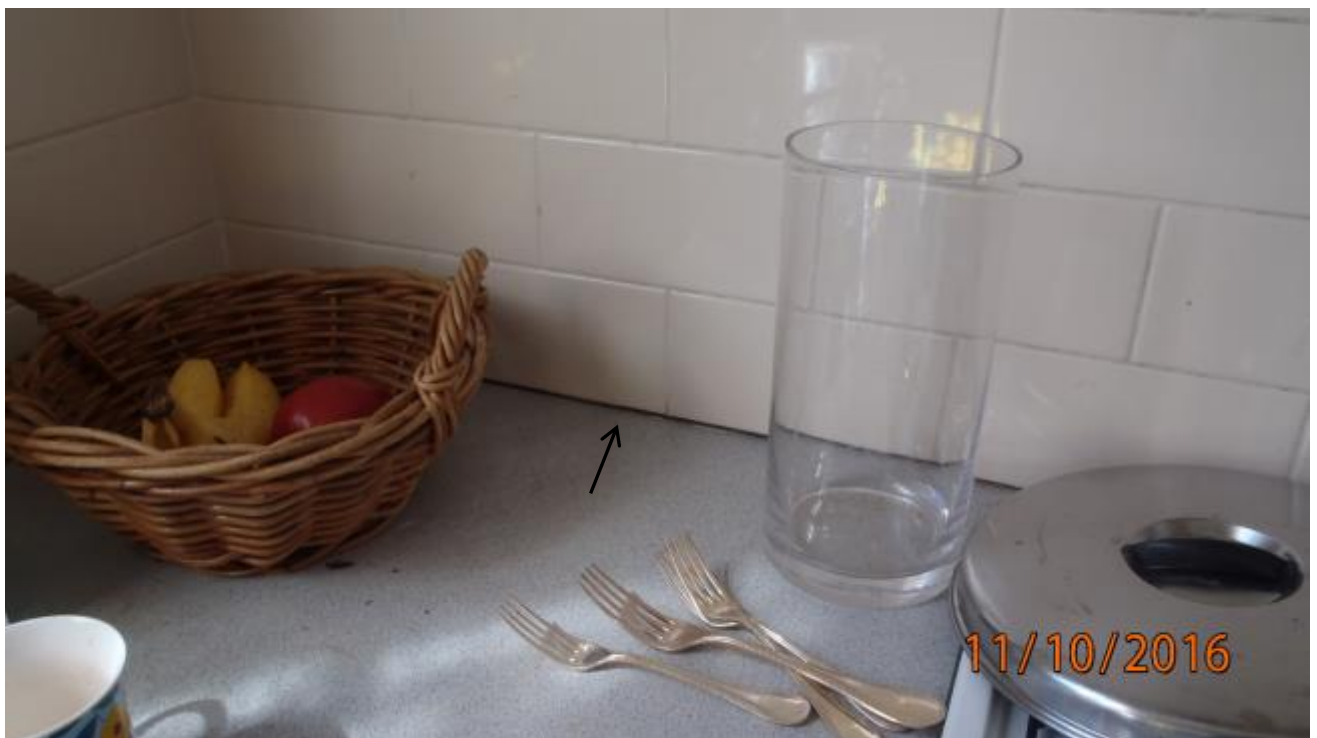
We noted separation cracking [$<1\text{mm}$] between the benchtop and the ceramic splashback tiles. **[Photograph 40]**

Photograph 40 shows separation cracking between the benchtop and the ceramic splashback tiles in the Kitchen.

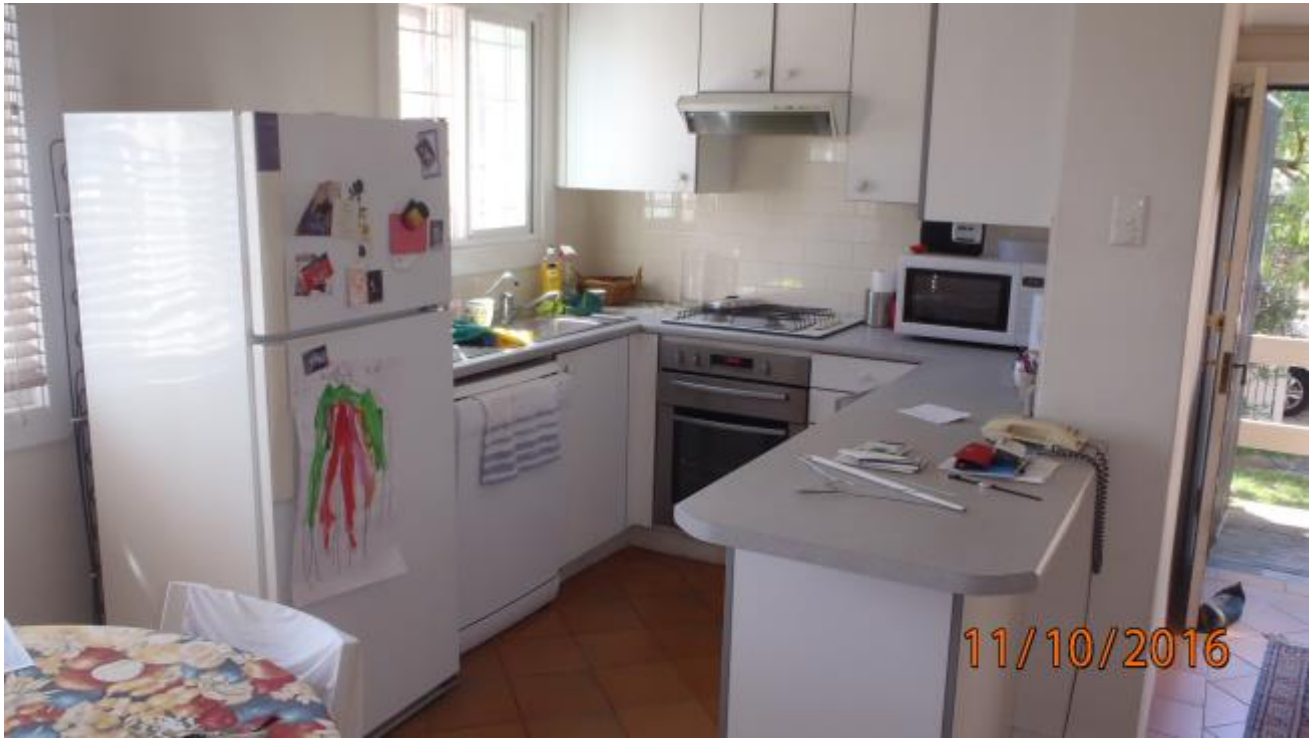
We noted that the grout to the wall and floor tiles is complete and that the wall and floor tiles when randomly “tap” tested appeared to be sound. **[Photograph 41]**

Photograph 41 shows the general layout of the Kitchen.
