Dilapidation Assessment Report

Prepared for: Cape Cod Australia Pty. Limited
Job address: 51 Young Street, Cremorne.
Property Owner/s: Mrs Mary Mann.
Report reference: **NORTH SYDNEY COUNCIL**
Development Application No: not available
Date of assessment: 11th October 2016

Re: Dilapidation Report

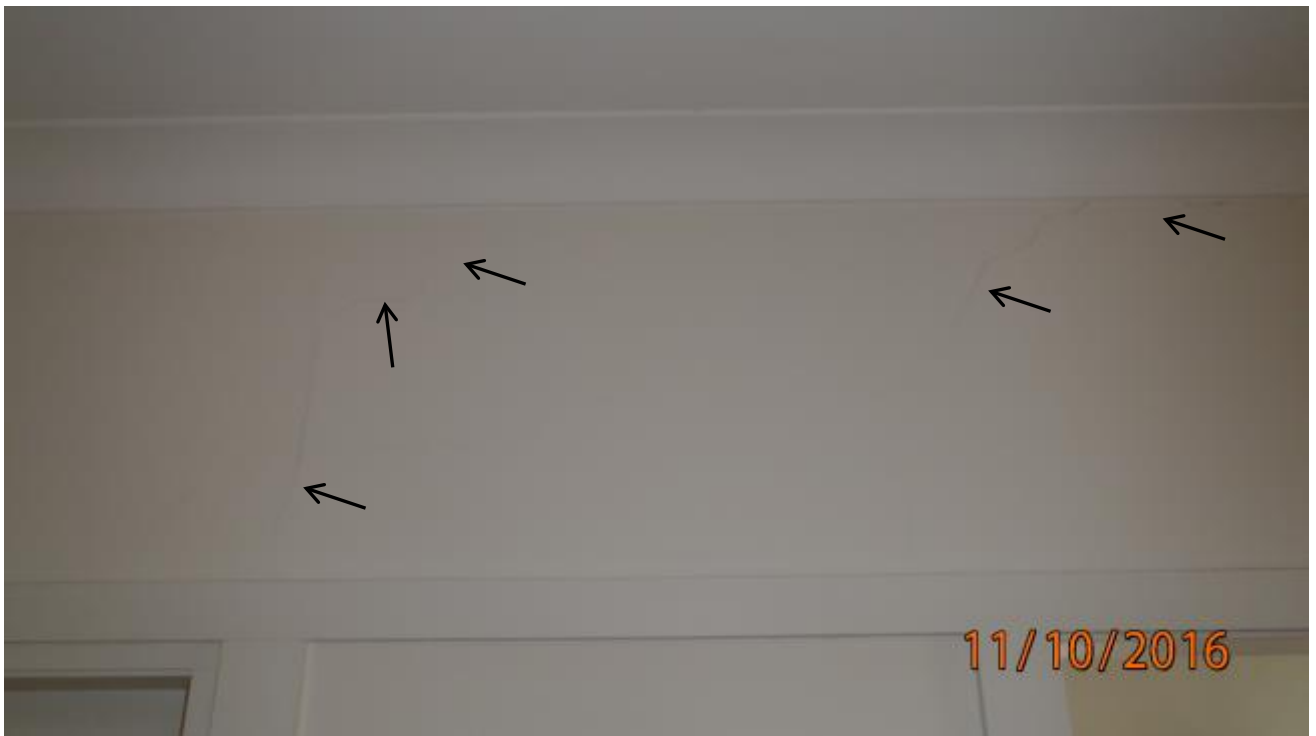
We noted radial cracking [$<1\text{mm}$] and separation cracking [$<1\text{mm}$] to the wall / cornice junction on the northern wall. **[Photograph 42]**

Photograph 42 shows radial cracking and separation cracking to the wall / cornice junction on the northern wall of the Lounge Room.

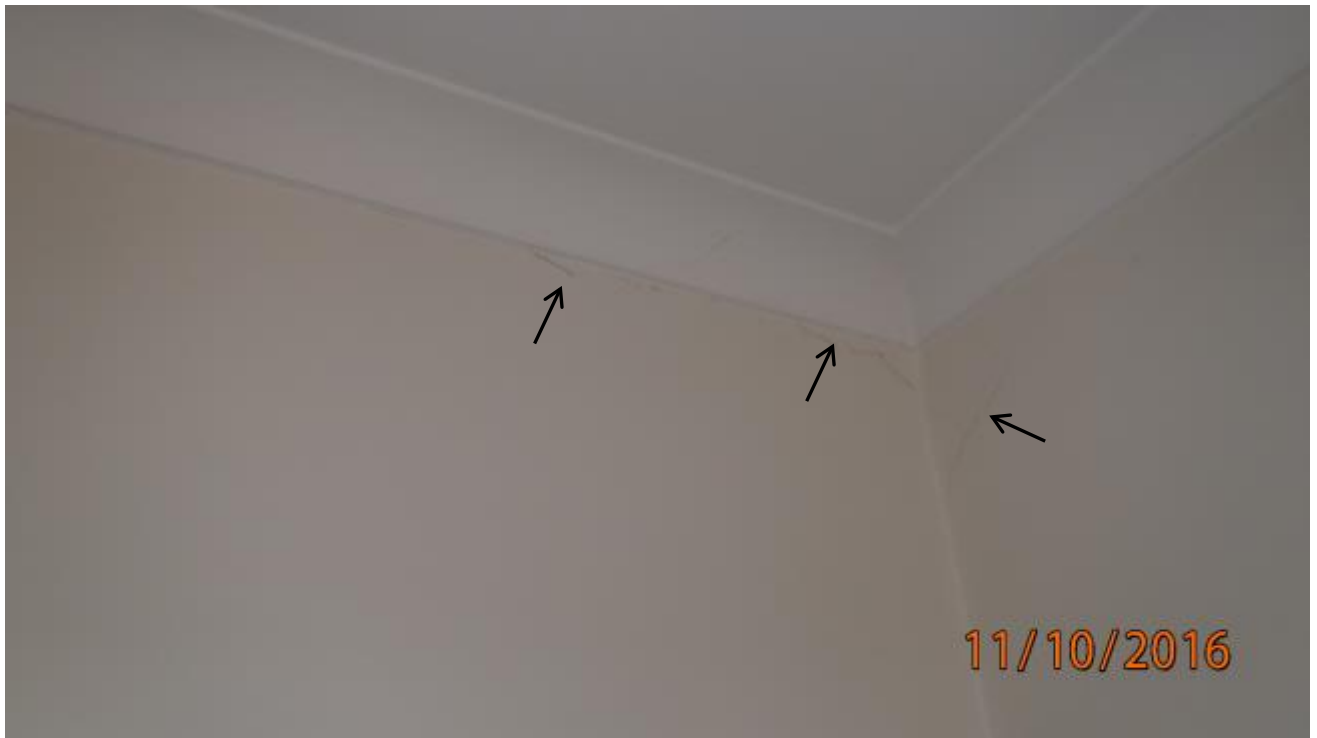
We noted vertical, radial and separation cracking [$<1\text{mm}$] to the cement rendered wall lining in the north western corner. **[Photograph 43]**

Photograph 43 shows vertical, radial and separation cracking to the cement rendered wall lining in the north western corner of the Lounge room.

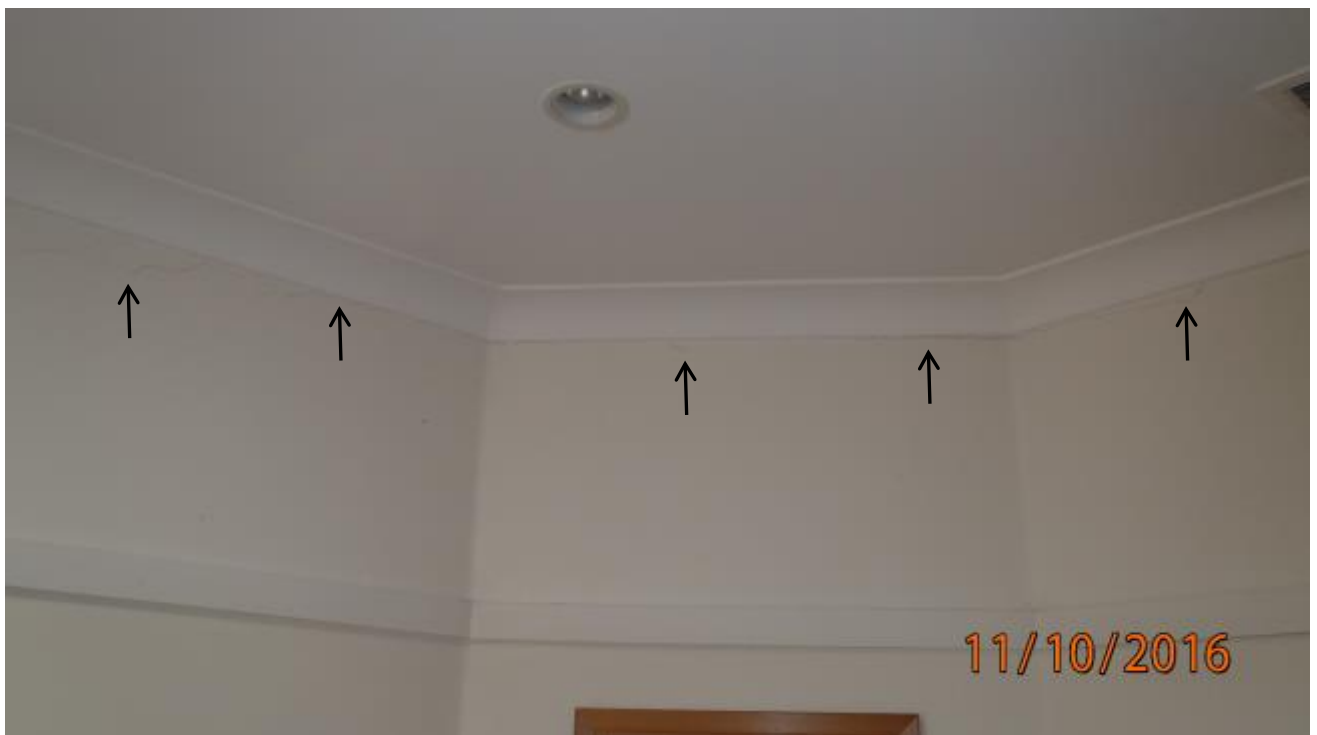
We noted radial and separation cracking [$<1\text{mm}$] to the cement rendered wall above the fireplace in the south western corner. **[Photograph 44]**

Photograph 44 shows radial and separation cracking to the cement rendered wall above the fireplace in the south western corner of the Lounge Room.

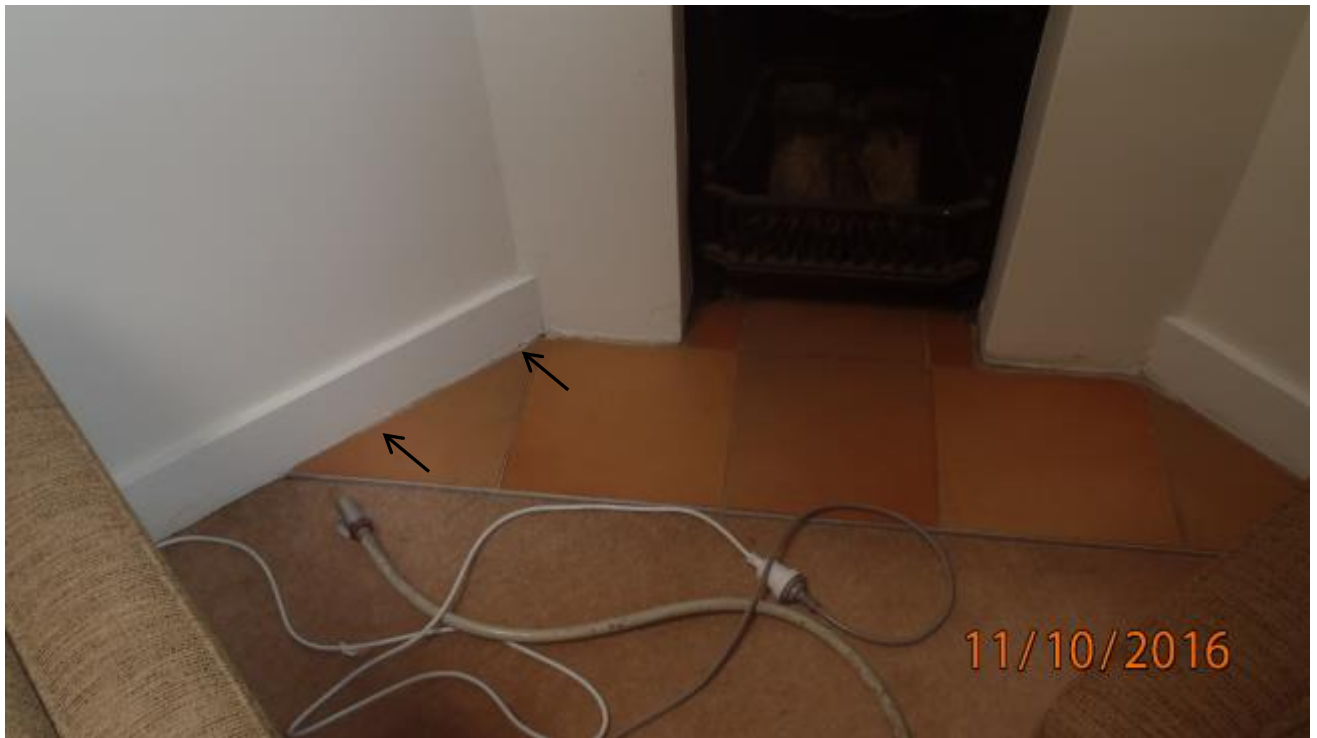
We noted separation cracking [$<1\text{mm}$] between the fireplace hearth tiles and the timber skirting. **[Photograph 45]**

Photograph 45 shows separation cracking between the fireplace hearth tiles and the timber skirting in the Lounge Room.

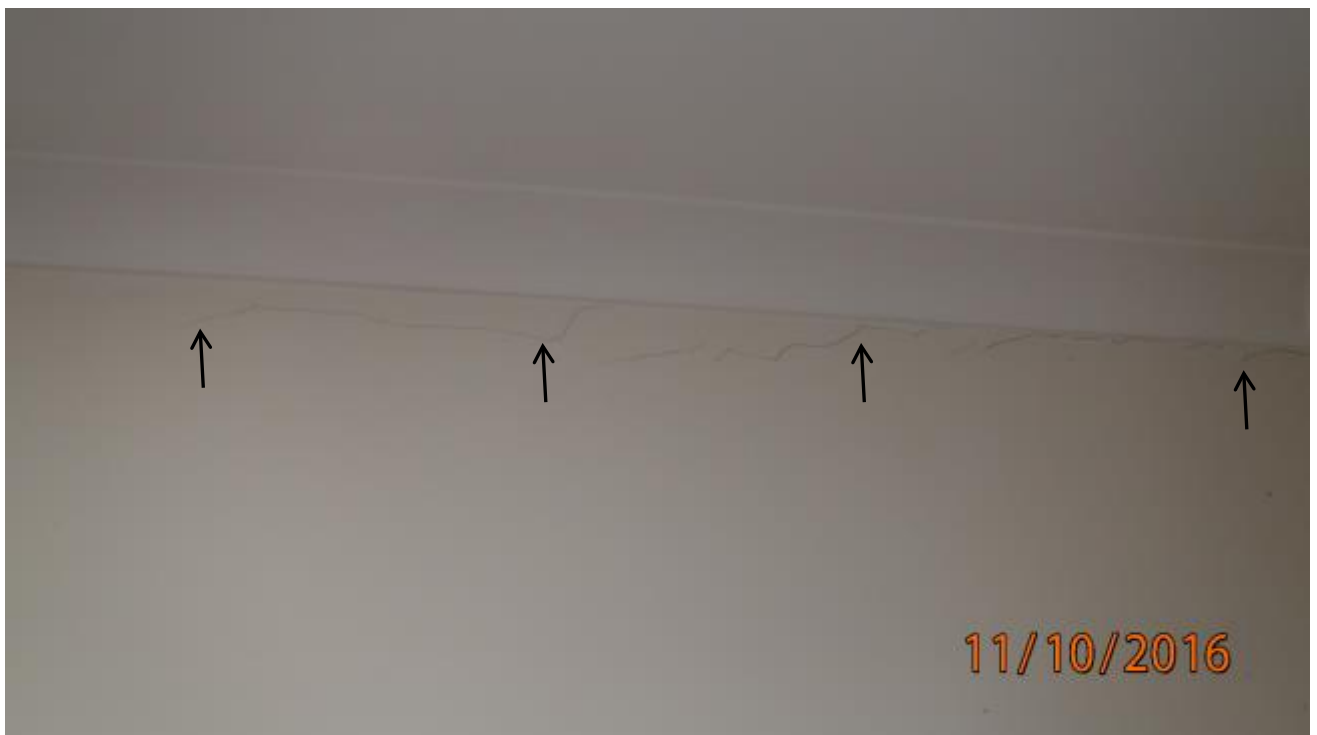
We noted radial and separation cracking [$<1\text{mm}$] to the cement rendered wall just under the cove profiled cornice along the *common party / separation* wall with the adjoining property No. 49 Young Street, Cremorne in the south eastern corner. **[Photograph 46]**

Photograph 46 shows radial and separation cracking to the cement rendered wall just under the cove profiled cornice along the *common party / separation* wall with the adjoining property No. 49 Young Street, Cremorne in the south eastern corner of the Lounge Room.

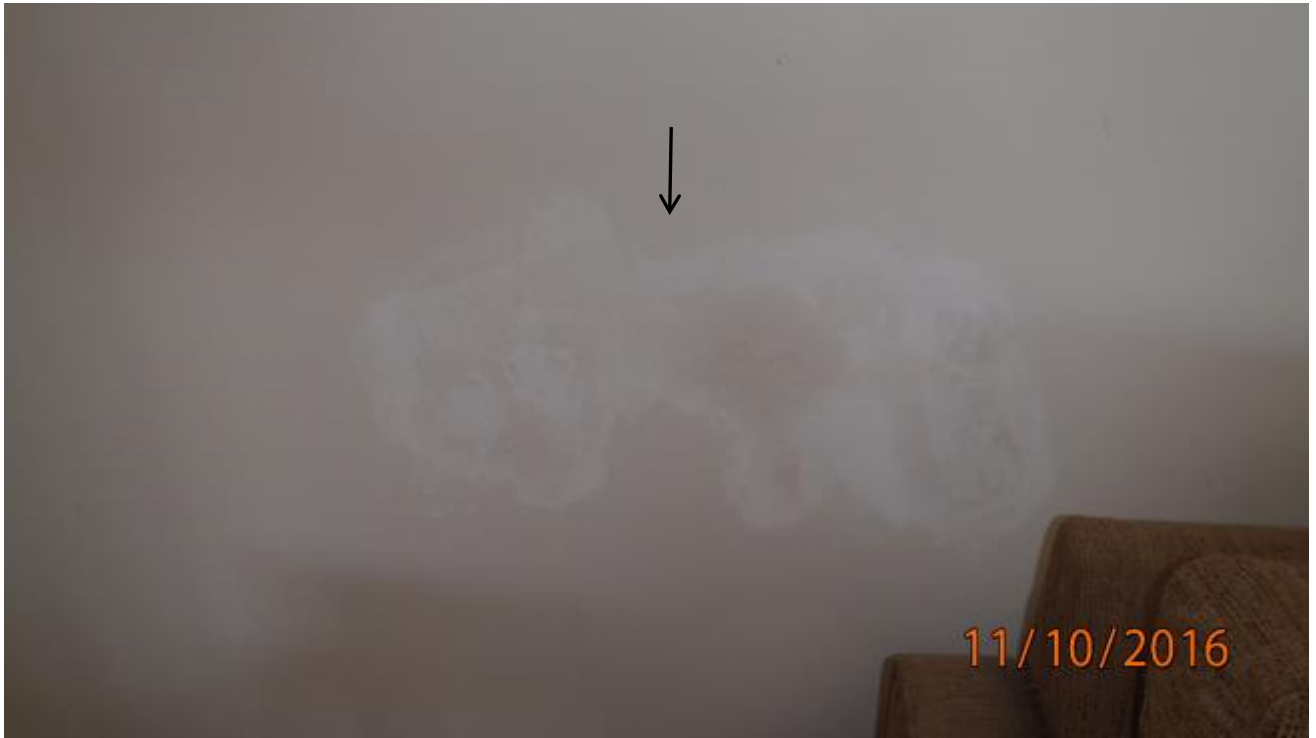
We noted evidence of a previous repair on the common party / separation wall with the adjoining property No. 49 Young Street, Cremorne in the south eastern corner. **[Photograph 47]**

Photograph 47 shows evidence of a previous repair on the *common party / separation* wall with the adjoining property No. 49 Young Street, Cremorne in the south eastern corner of the Lounge Room.

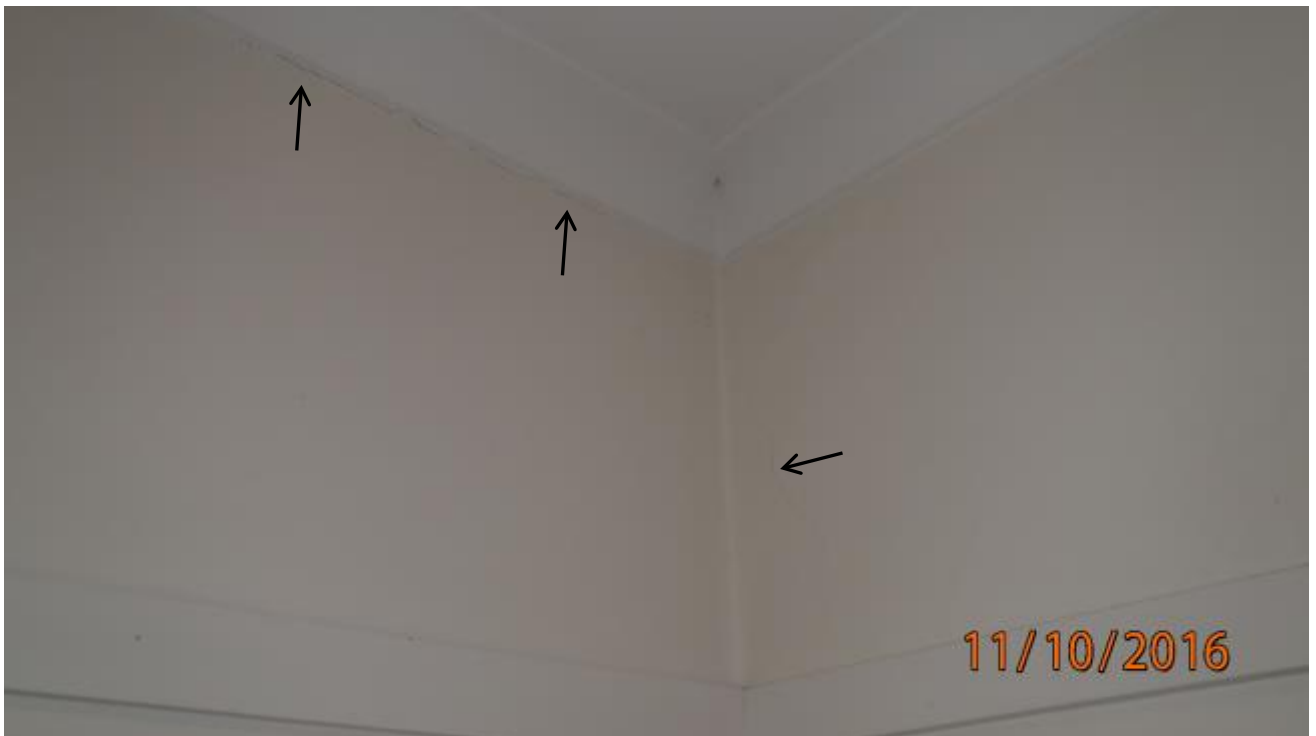
We noted radial and separation cracking [$<1\text{mm}$] to the cement rendered wall in the south eastern corner. **[Photograph 48]**

Photograph 48 shows radial and separation cracking to the cement rendered wall in the south eastern corner of the Lounge Room.

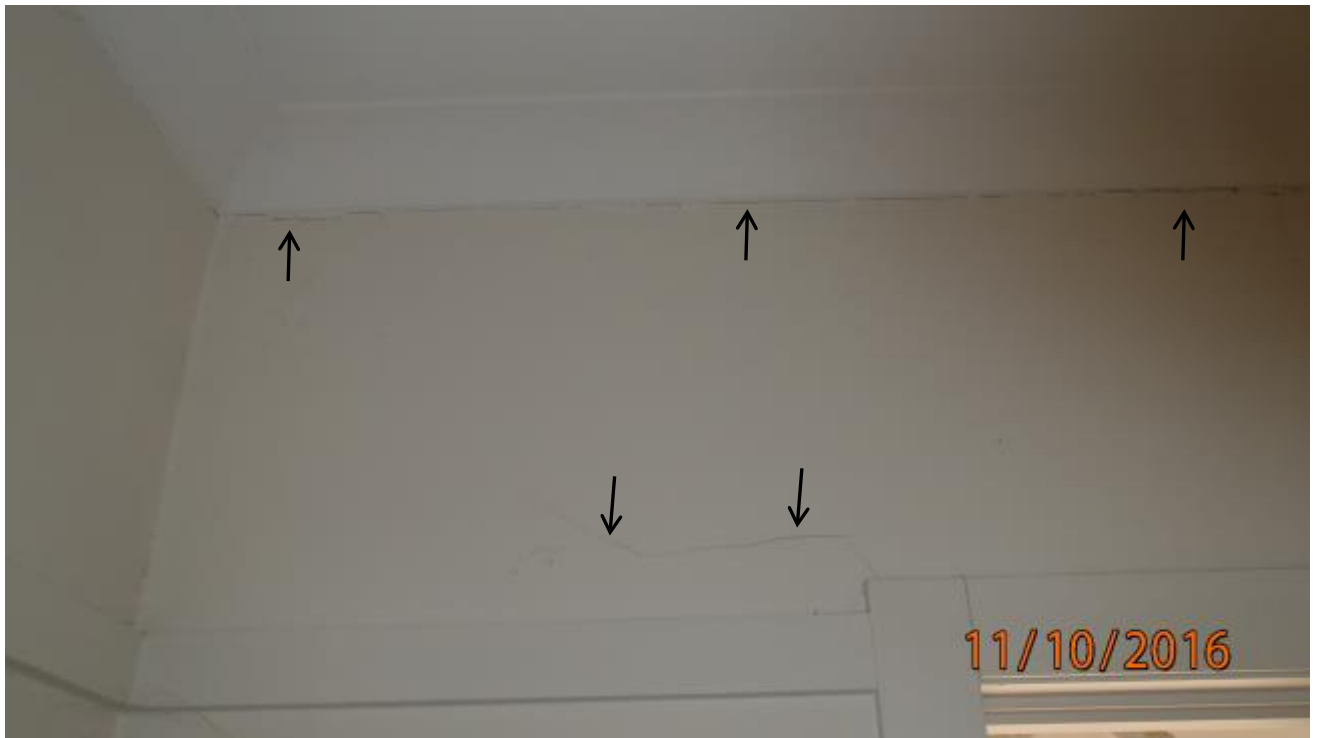
We noted radial and separation cracking [$<1\text{mm}$] to the cement rendered wall in the north eastern corner. **[Photograph 49]**

Photograph 49 shows radial and separation cracking to the cement rendered wall in the north eastern corner of the Lounge Room.

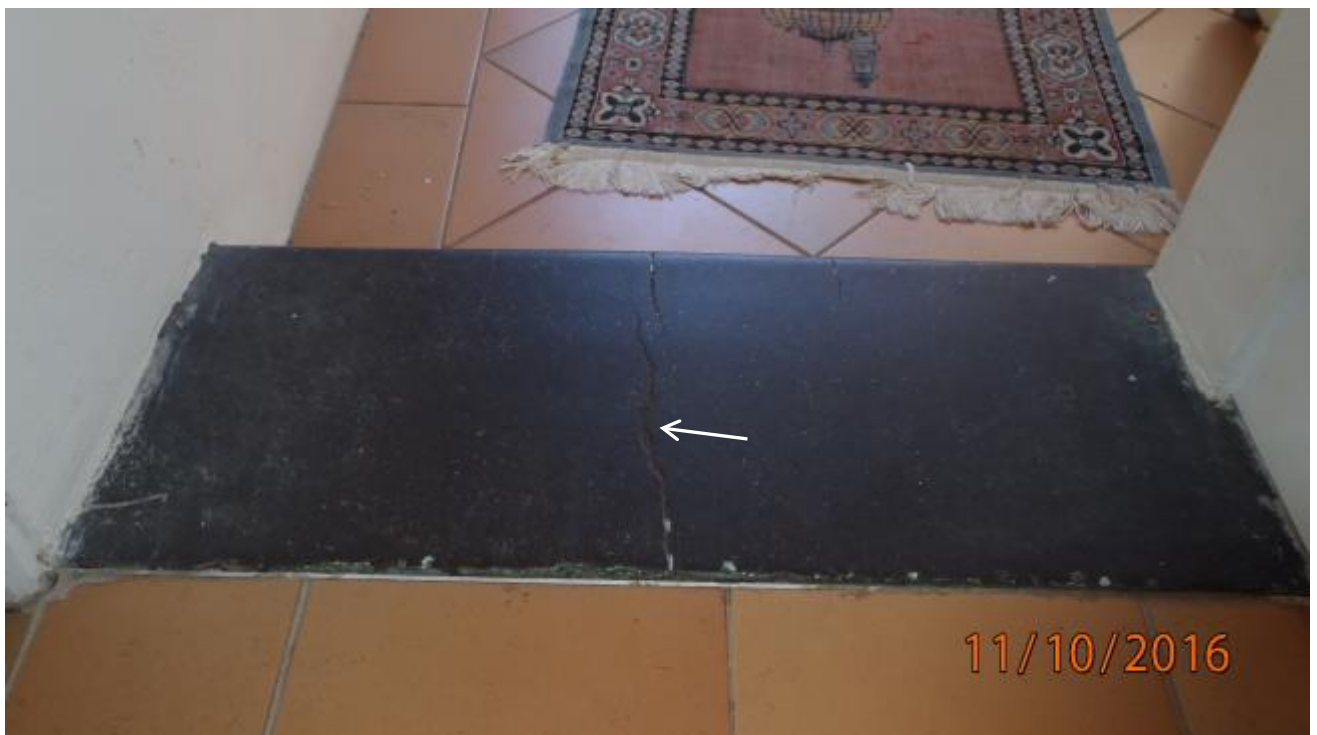
We noted cracking to the surface coated concrete threshold step to the Dining room. **[Photograph 50]**

Photograph 50 shows cracking to the surface coated concrete threshold step to the Rear Sunroom from the Dining Room.

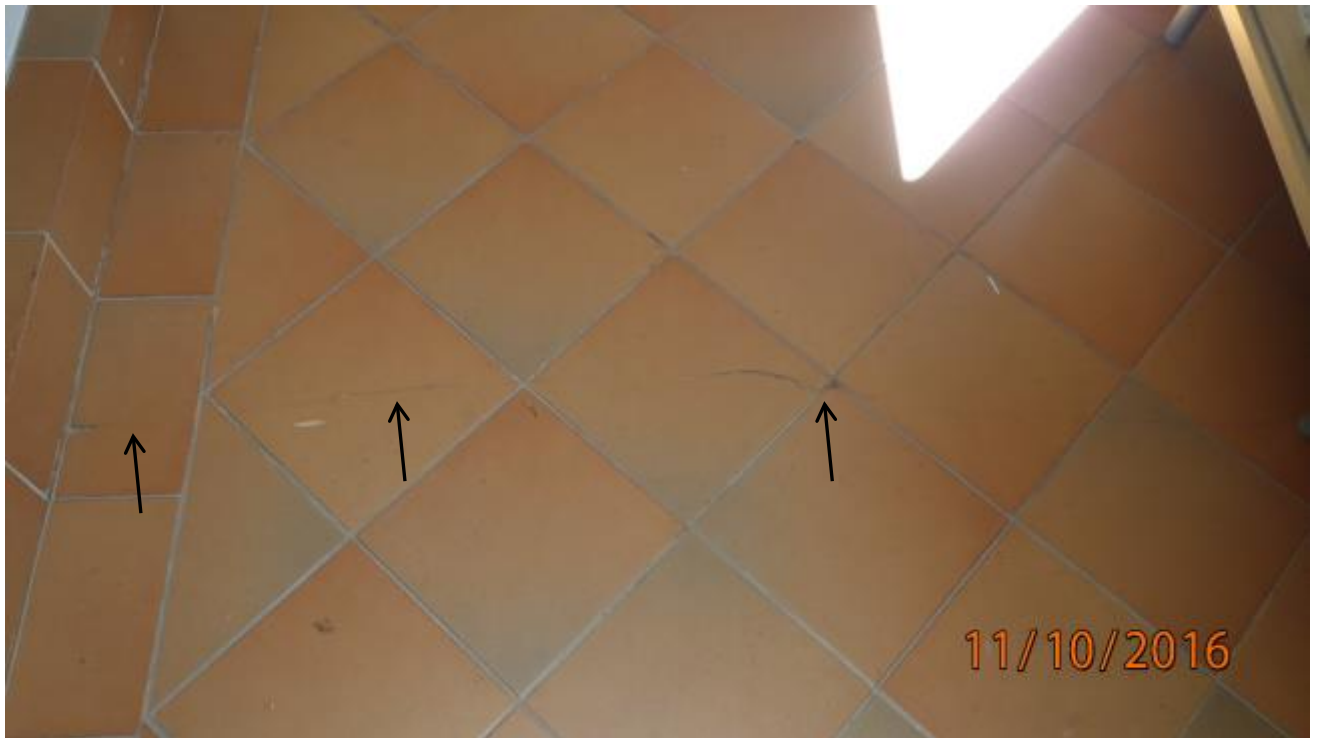
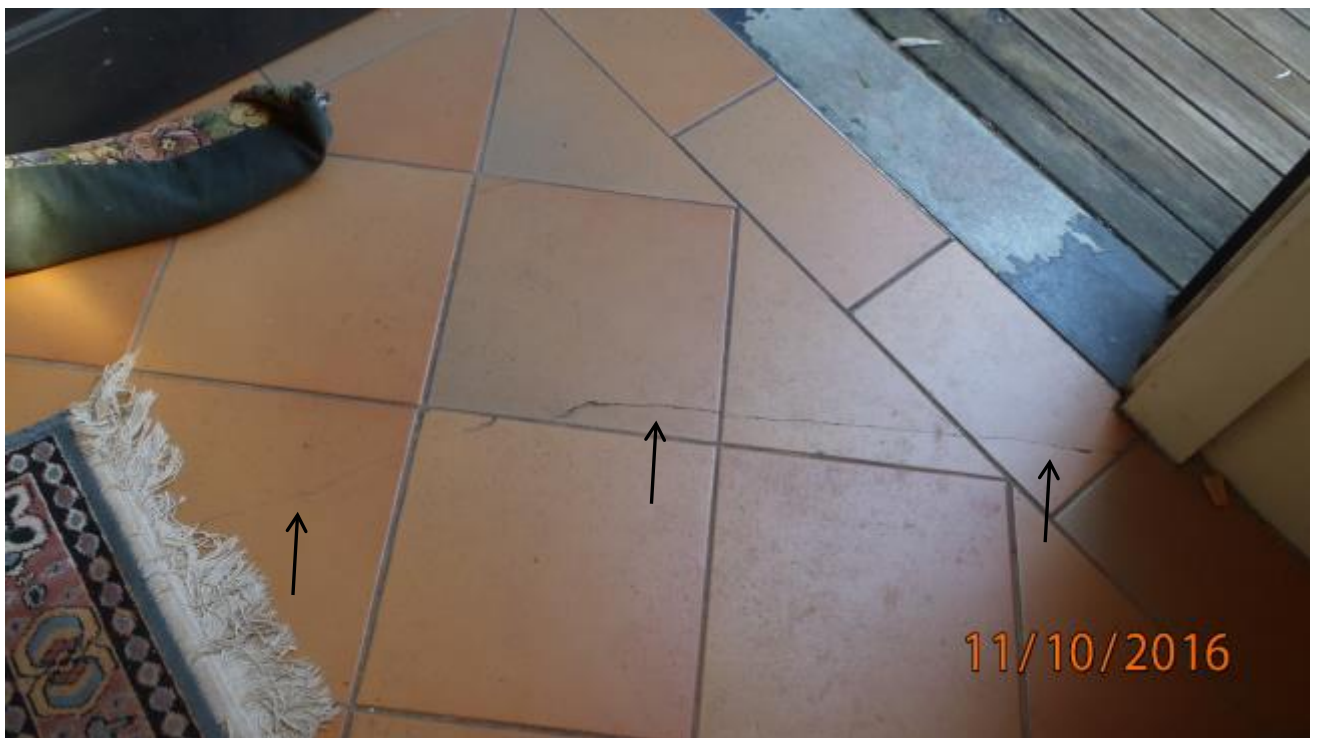
We noted cracking to the ceramic floor tiles through the centre of the room and adjacent to the back door. **[Photographs 51 & 52]**

Photograph 51 shows cracking to the ceramic floor tiles through the centre of the Sunroom.

Photograph 52 shows cracking to the ceramic floor tiles adjacent to the back door.

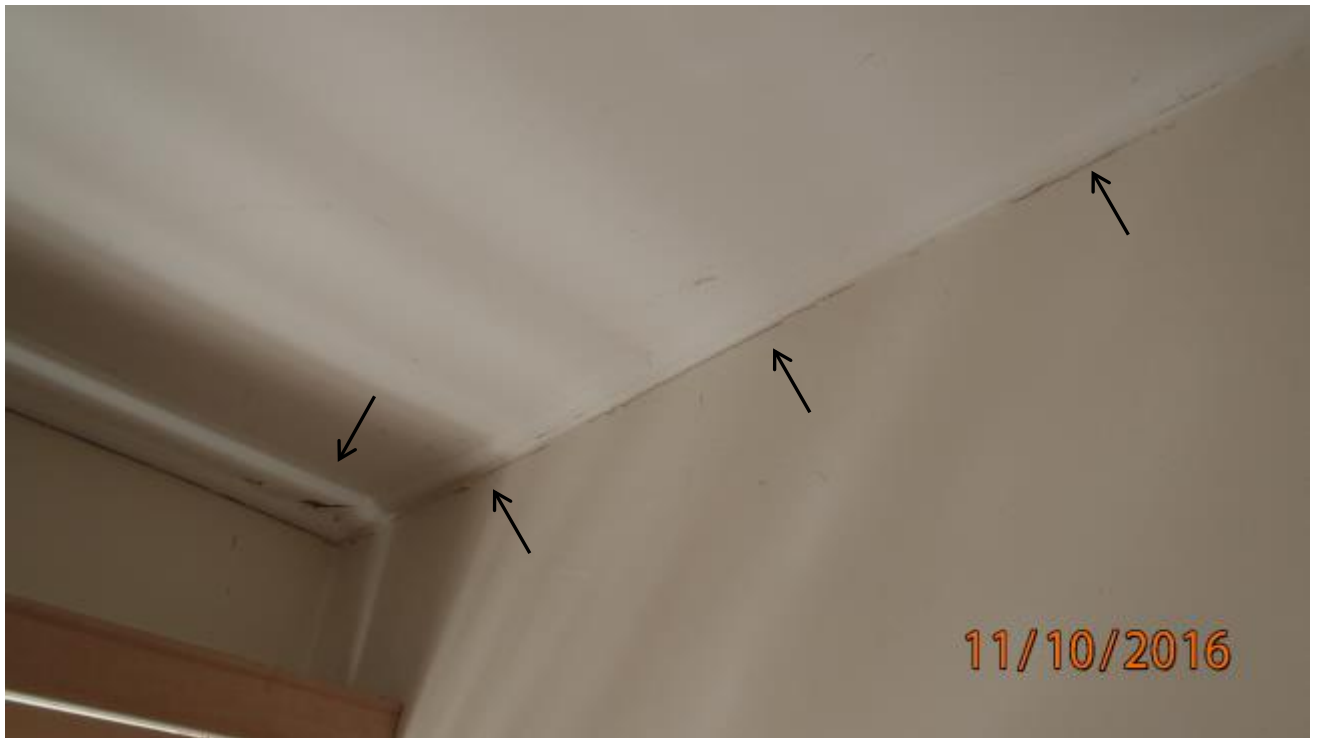
We noted flaking paint and hairline separation cracking [$<1\text{mm}$] around the quad moulded cornice in the south eastern corner. **[Photograph 53]**

Photograph 53 shows flaking paint and hairline separation cracking [$<1\text{mm}$] around the quad moulded cornice in the south eastern corner of the Sunroom.

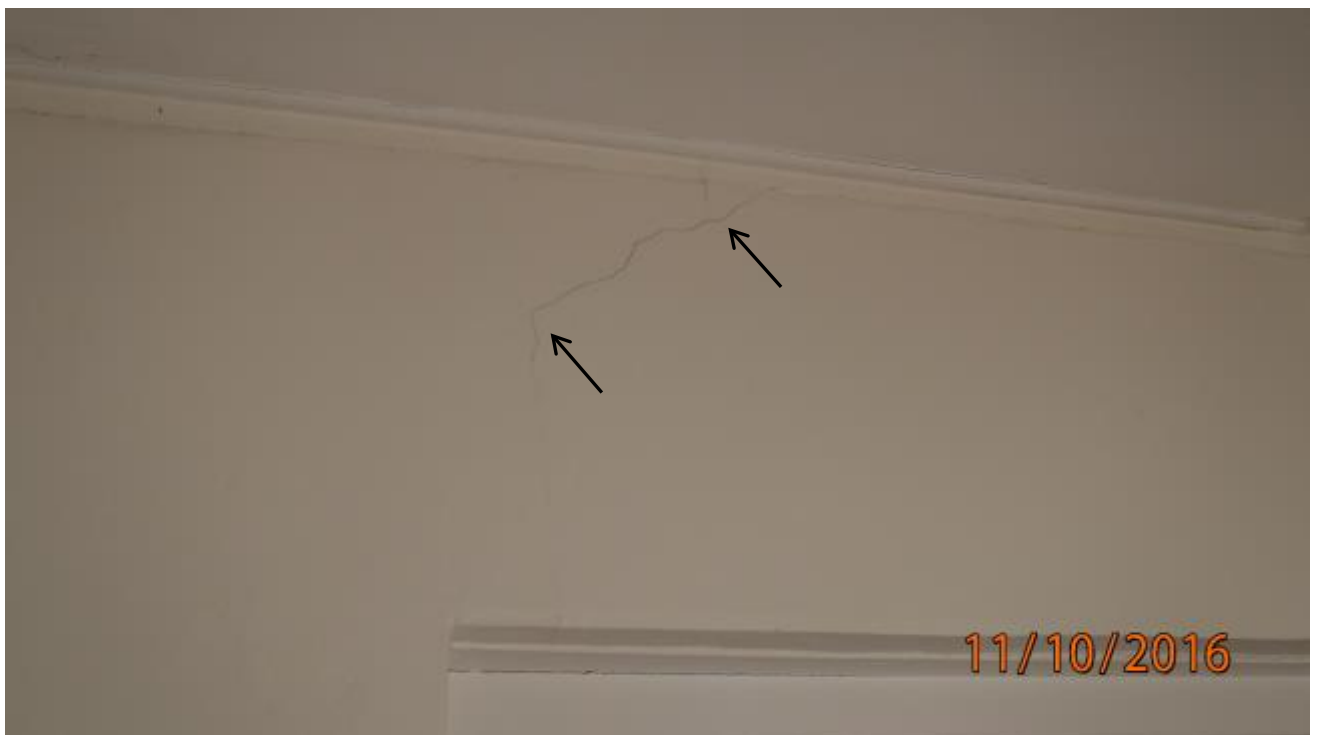
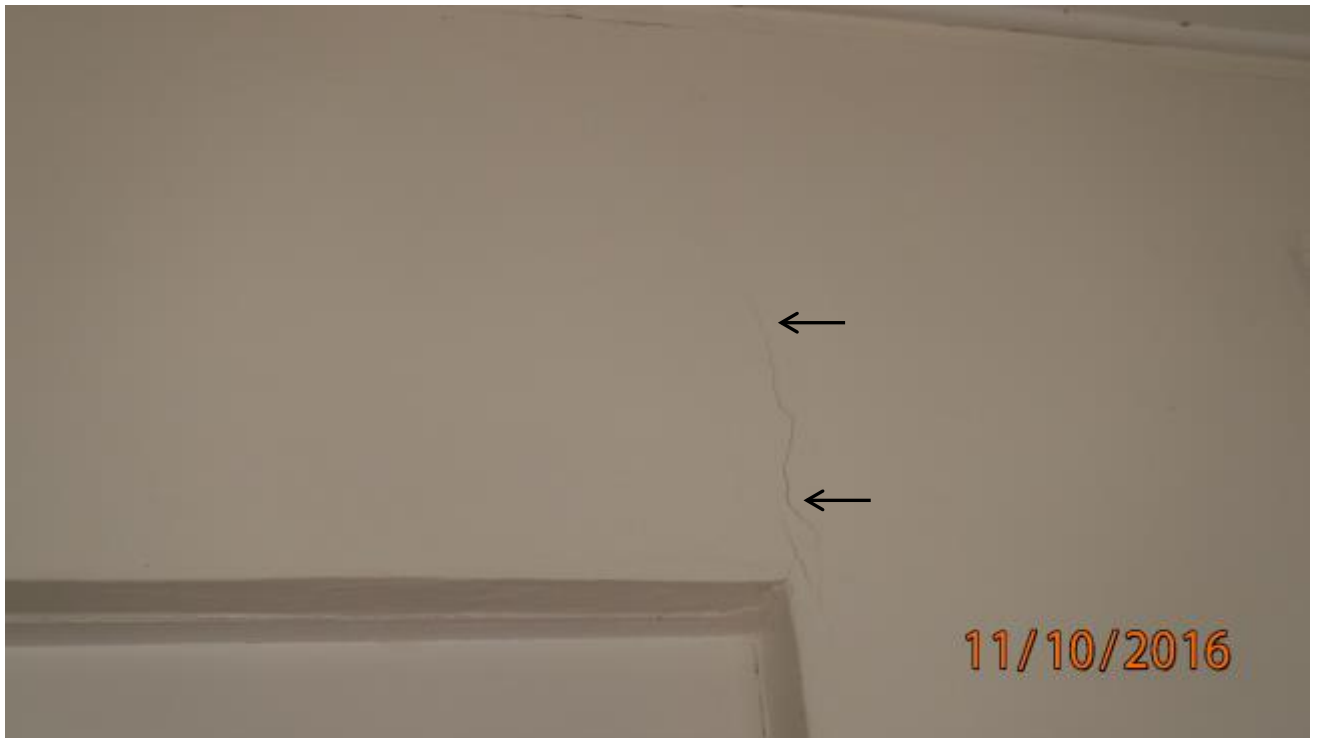
We noted radial cracking [$<1\text{mm}$] to the cement rendered wall above the doorway common with the Lounge Room. **[Photographs 54 & 55]**

Photograph 54 shows radial cracking to the cement rendered wall above the doorway common with the Lounge Room in the Sunroom.

Photograph 55 shows radial cracking to the cement rendered wall above the doorway common with the Lounge Room in the Sunroom.

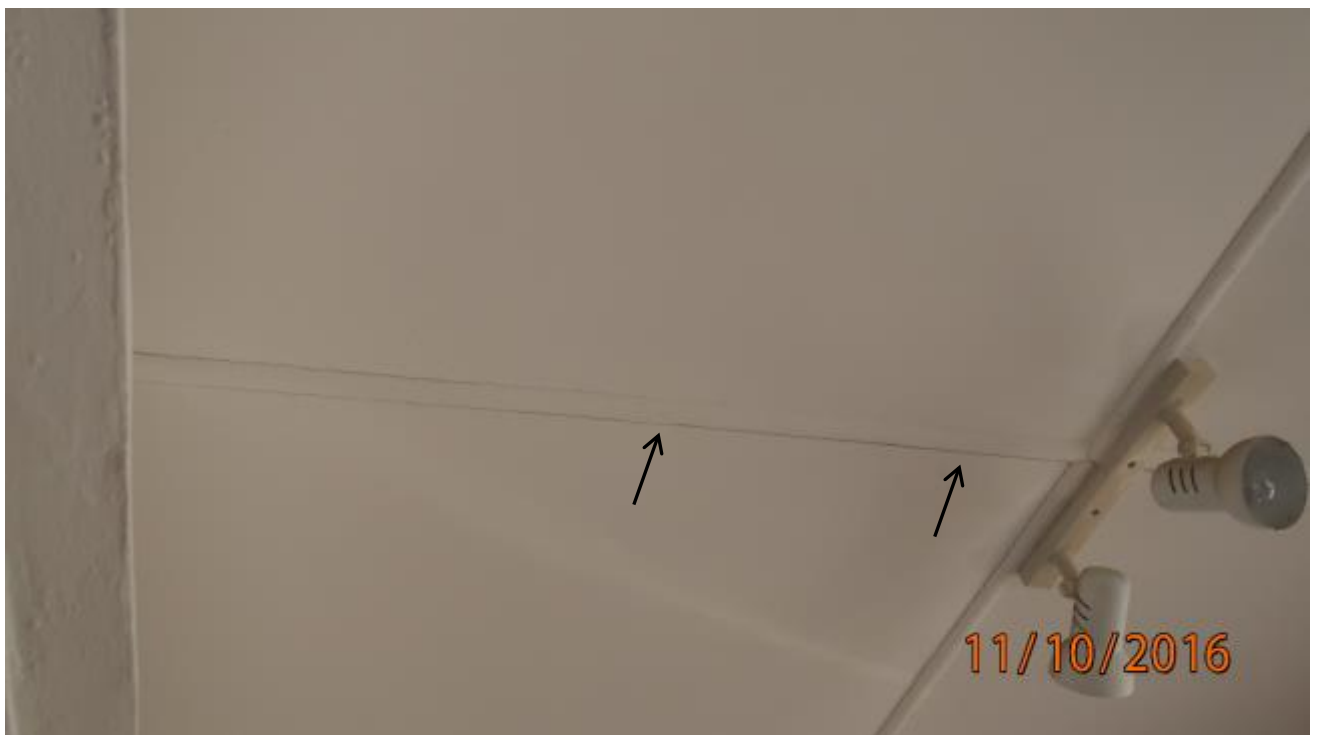
We noted separation cracking [$<1\text{mm}$] to the ceiling lining adjacent to the cover battens. **[Photograph 56]**

Photograph 56 shows separation cracking to the ceiling lining adjacent to the cover battens in the Sunroom.

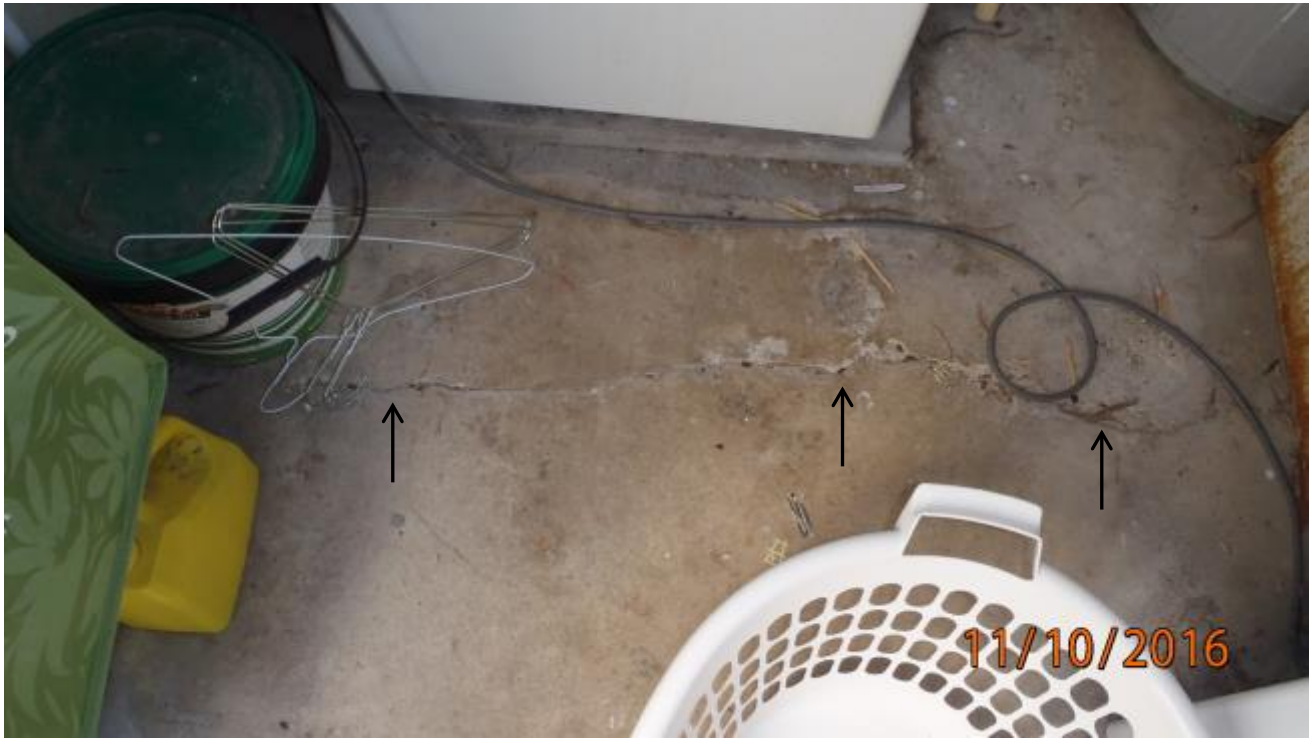
We noted cracking to the concrete slab floor. **[Photograph 57]**

Photograph 57 shows cracking to the concrete slab floor in the external Laundry.
