HAZARDOUS MATERIALS ASSESSMENT REPORT

Job details: Owner: Mr. F. & Mrs. S. Bastian.
Location: 19 Redman Street, Seaforth.

Our reference: HM05510117

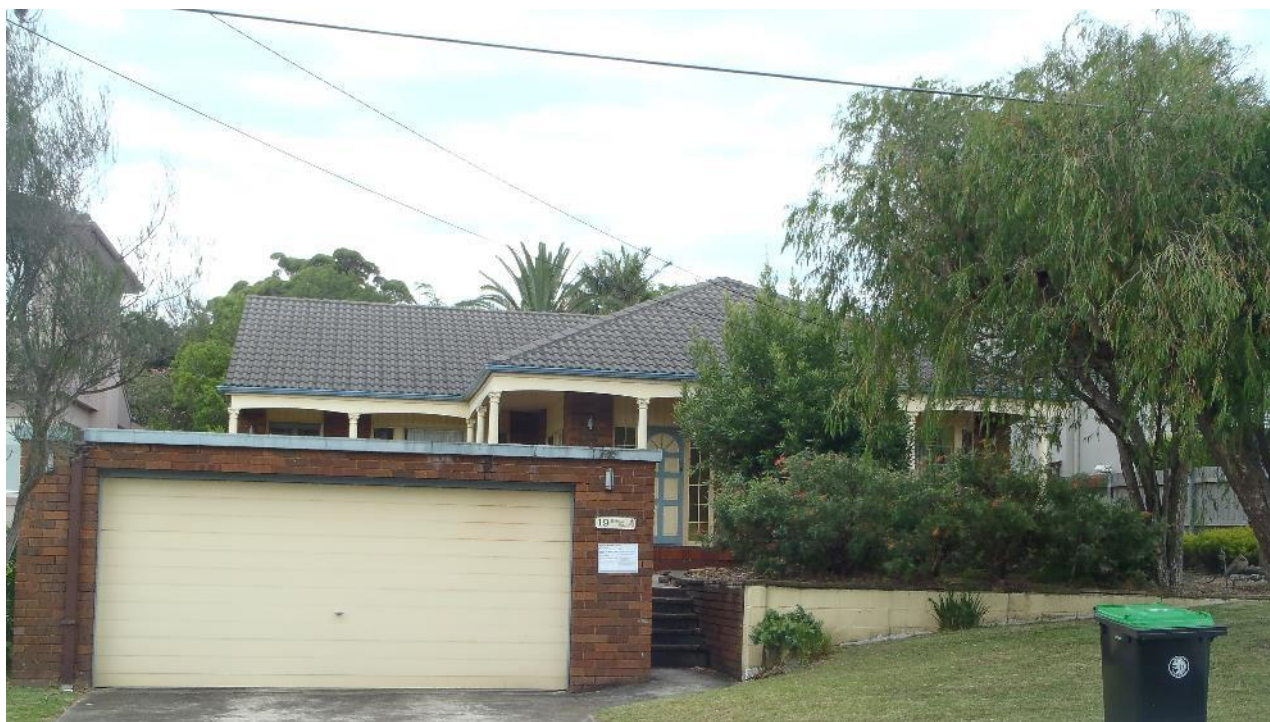
Front eastern elevation of the residence
