Dilapidation Assessment Report

Prepared for: Cape Cod Australia Pty. Limited
Job address: 2 Crabbes Avenue, North Willoughby.
Property Owner/s: Mr. James & Mrs. Allison Campbell.
Report reference: **WILLOUGHBY CITY COUNCIL**
Development Application No: not available
Date of assessment: 3rd August 2016

Re: Dilapidation Report

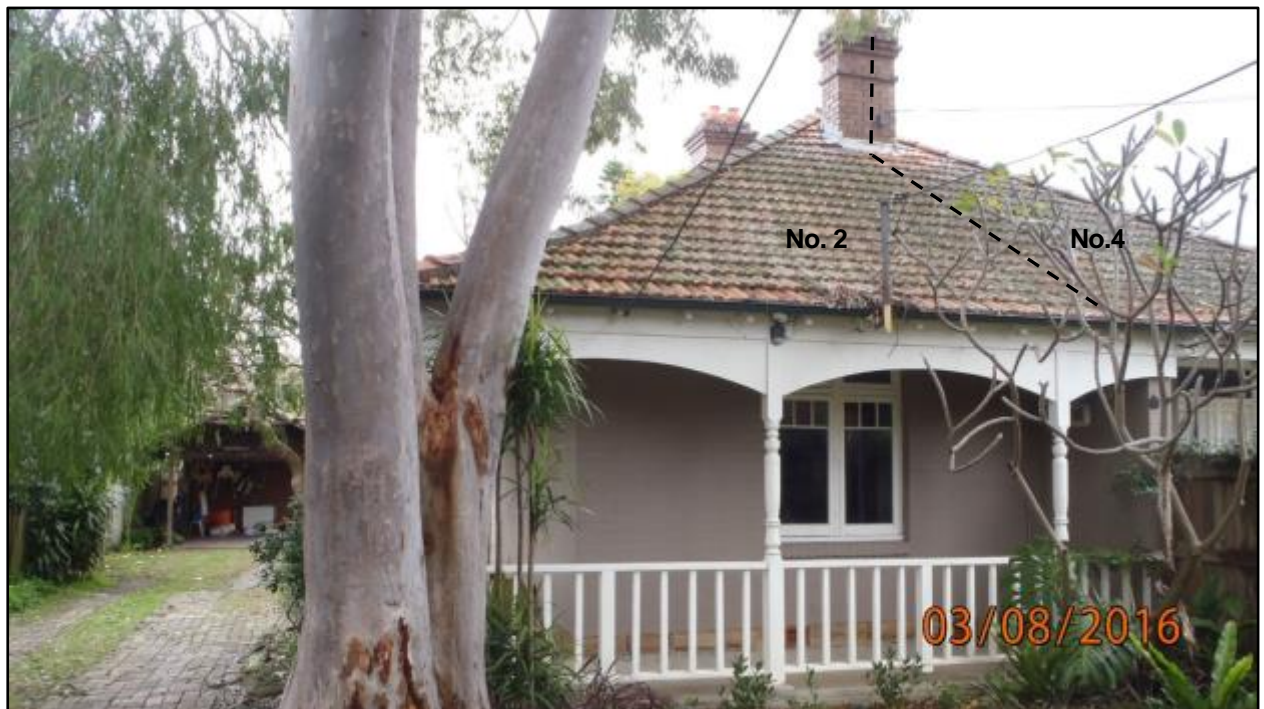
Shows the front northern elevation of the adjoining properties:
No.2 and No.4 Crabbes Avenue, North Willoughby.

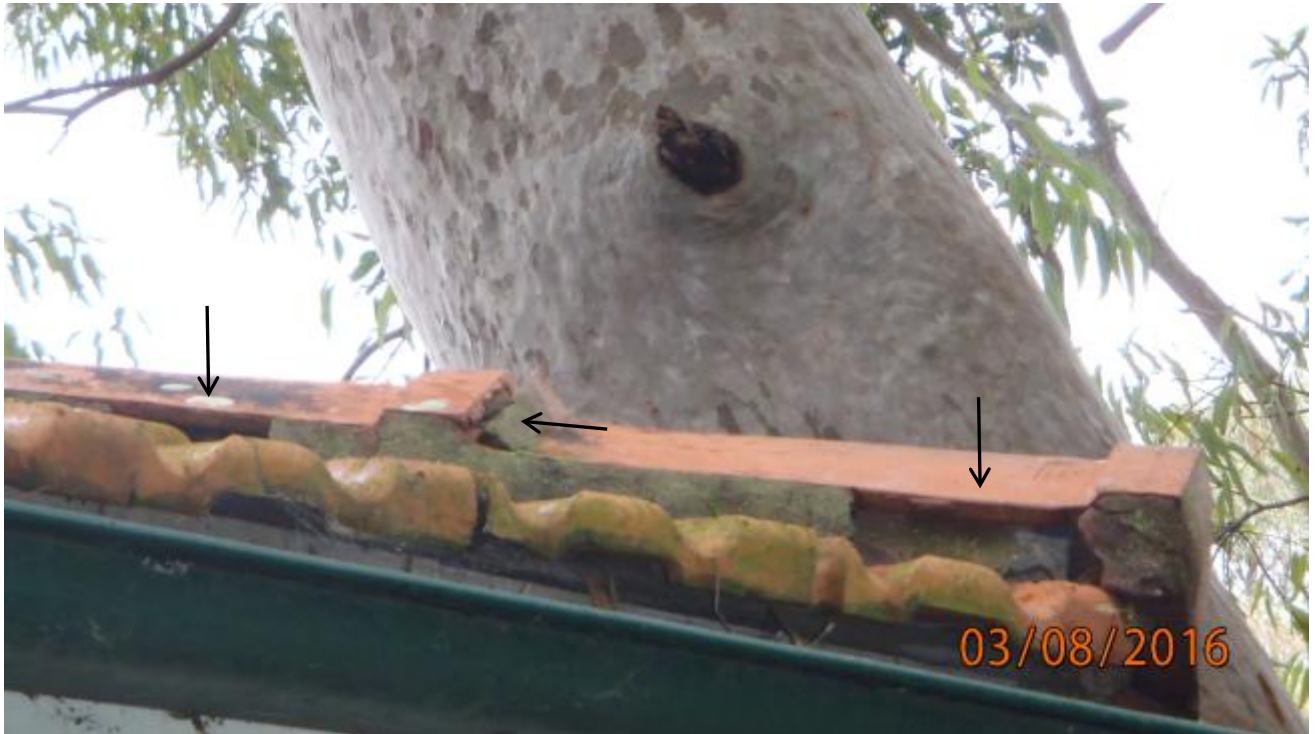
We observed that the terra cotta roof tiles to the roof surface are generally interlinked but show signs of deterioration. **[Photograph 1]**

Photograph 1 shows deterioration to the pointing on the tiled roof surface.

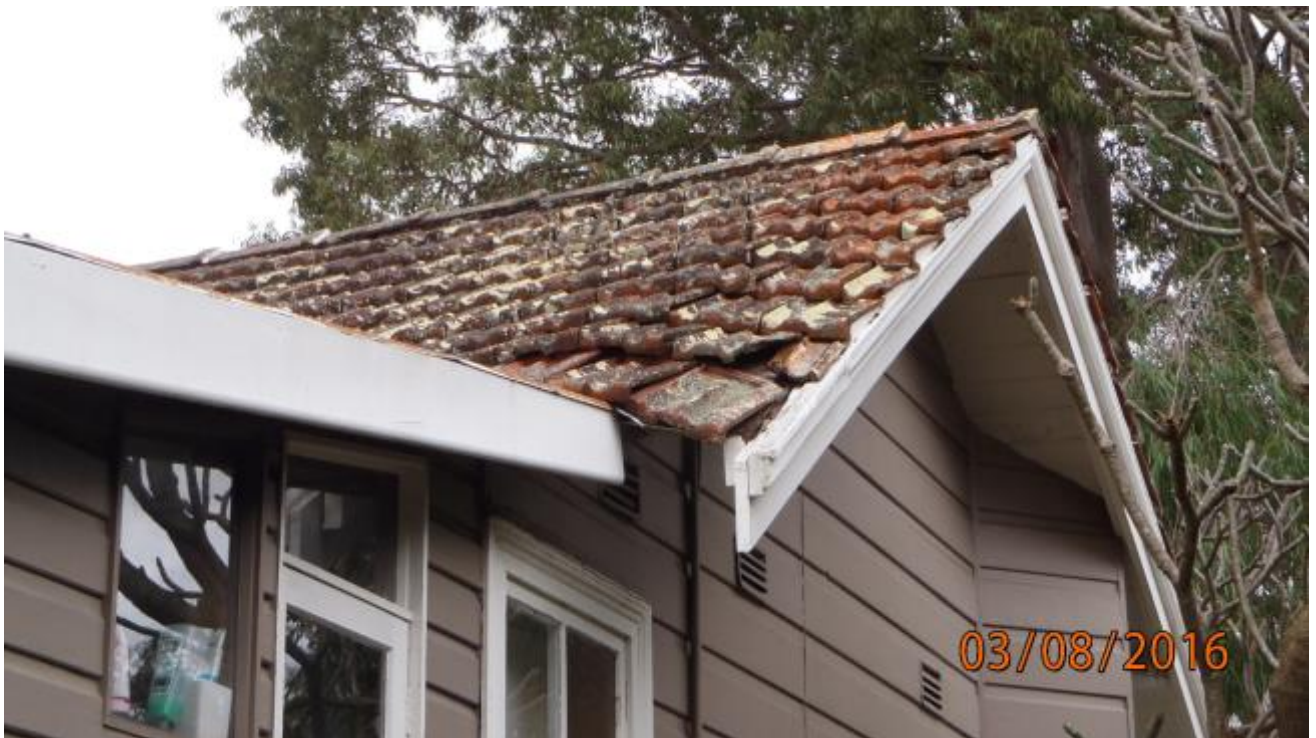
We noted the roof, eave and barge board have collapsed on the eastern elevation gable. **[Photograph 2]**

We noted that the side and rear section external walls are constructed of timber weatherboard cladding. **[Photograph 2 and 4]**

Photograph 2 shows the roof, eave and barge board have collapsed and the displaced tiles.

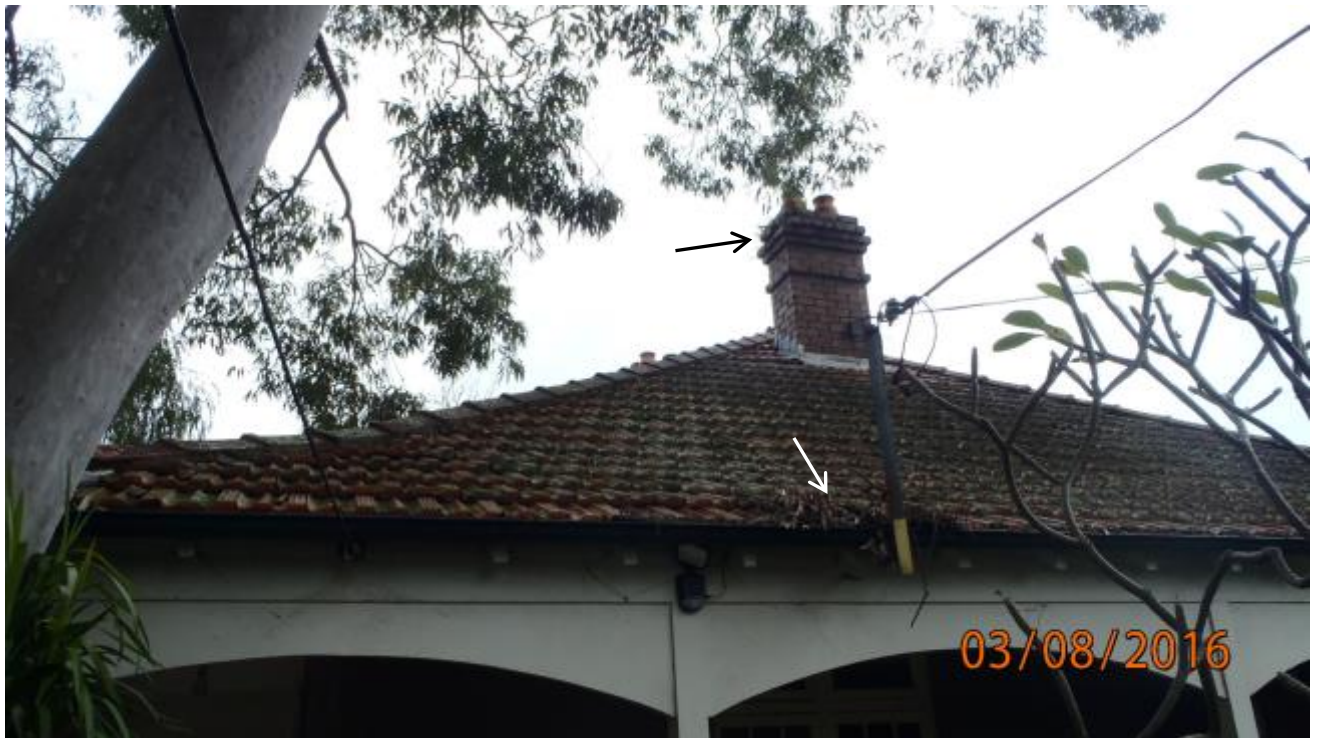
We noted that there was leaf litter build up to the front section gutter and plant growth to the chimney. **[Photograph 3]**

Photograph 3 shows leaf litter in the gutter and plant growth on the chimney.

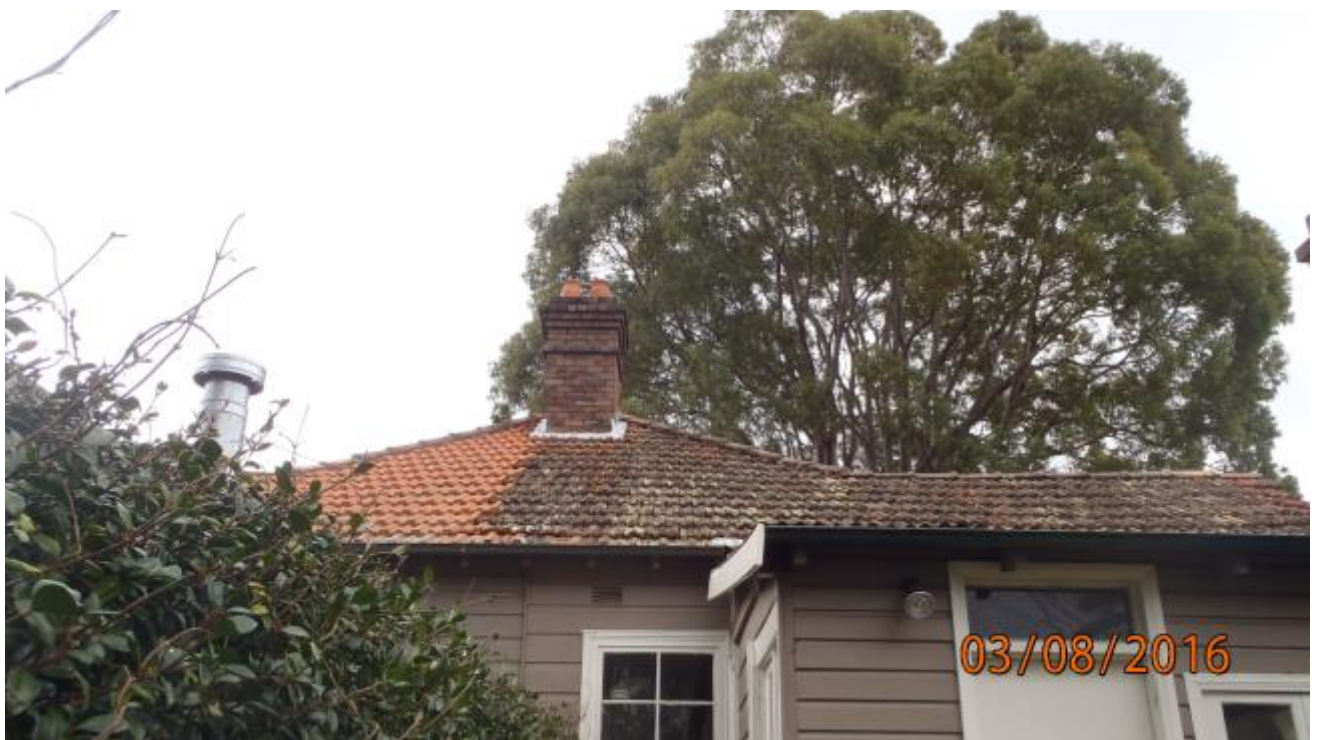
We noted that there was a difference in tiles to the rear of adjoining properties **[Photograph 4]**

Photograph 4 shows the difference in tiles between the adjoining properties.

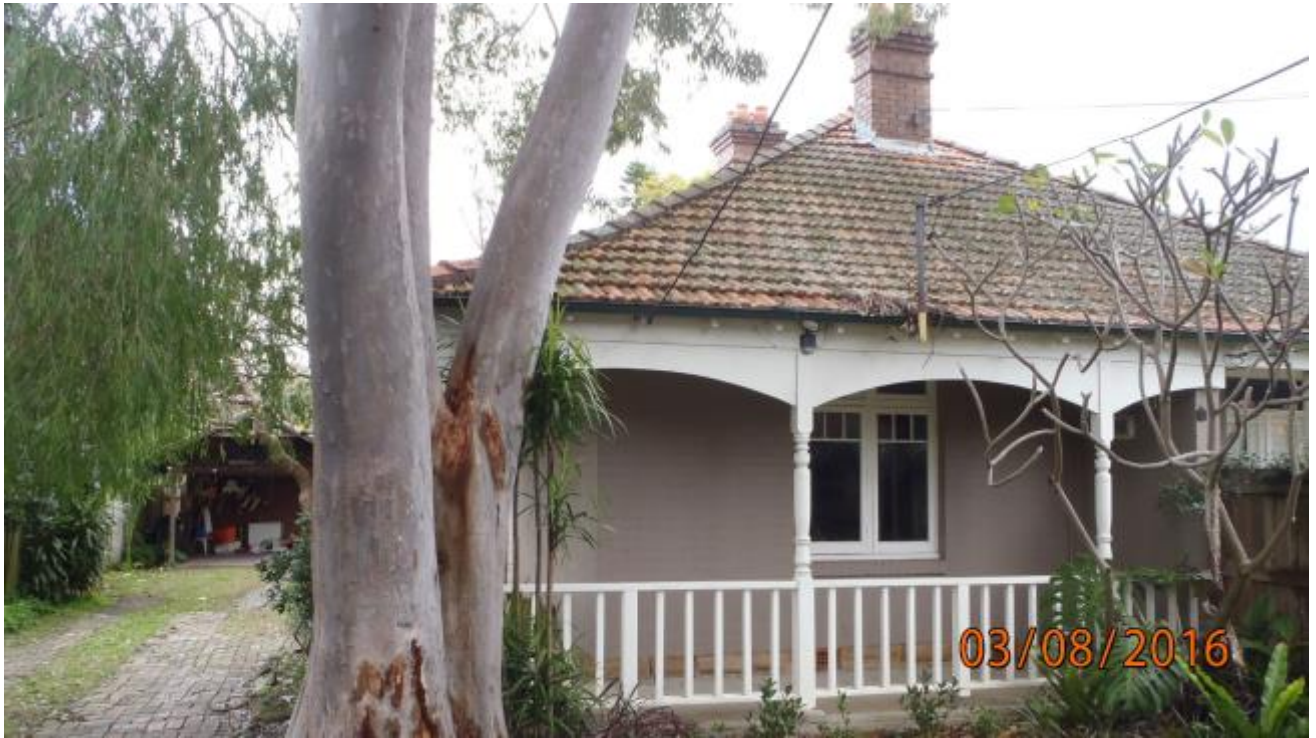
We noted that the frontal section external walls are constructed of clay masonry brickwork. We also noted that the external brick work is surface coated. **[Photograph 5]**

Photograph 5 shows the general front section is surface coated brickwork.

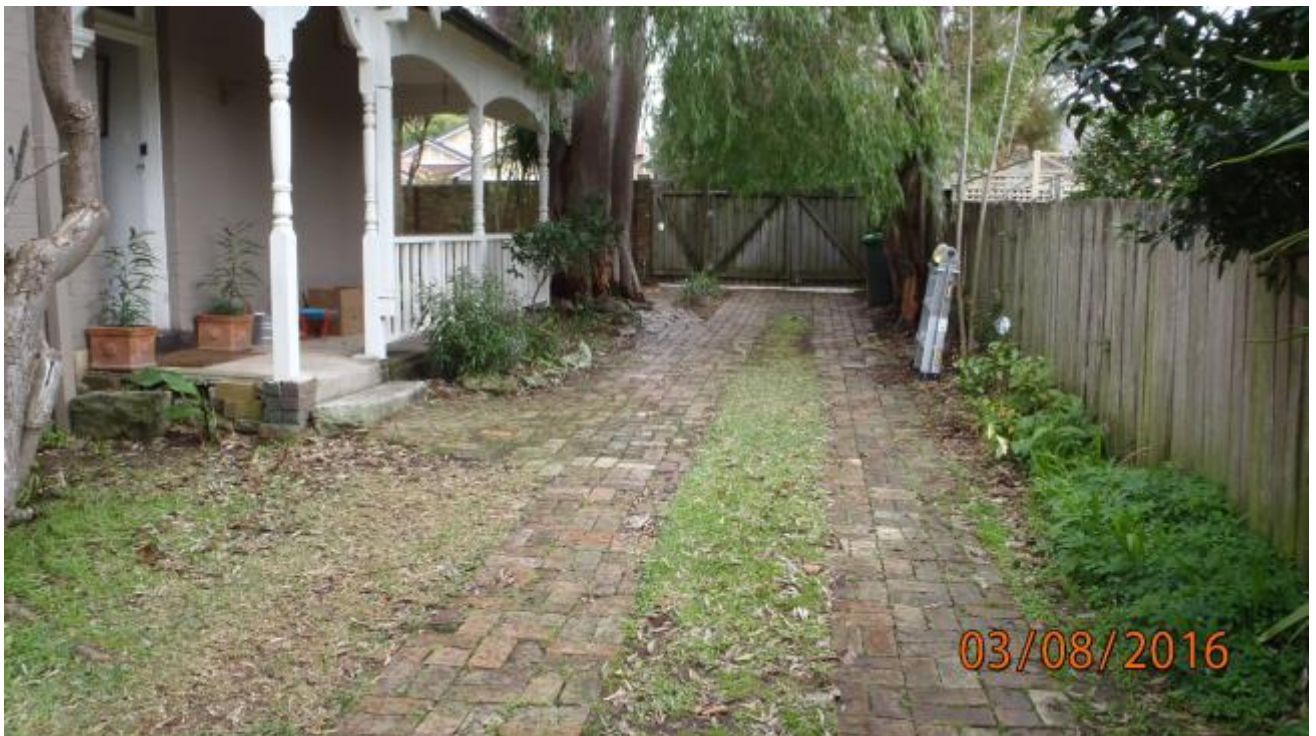
We noted that the front northern aspect has a paved driveway and path. **[Photograph 6]** and also noted lifting of the front pathway adjacent to the large tree. **[Photograph 7]**

Photograph 6 shows the driveway as viewed from the southern aspect.

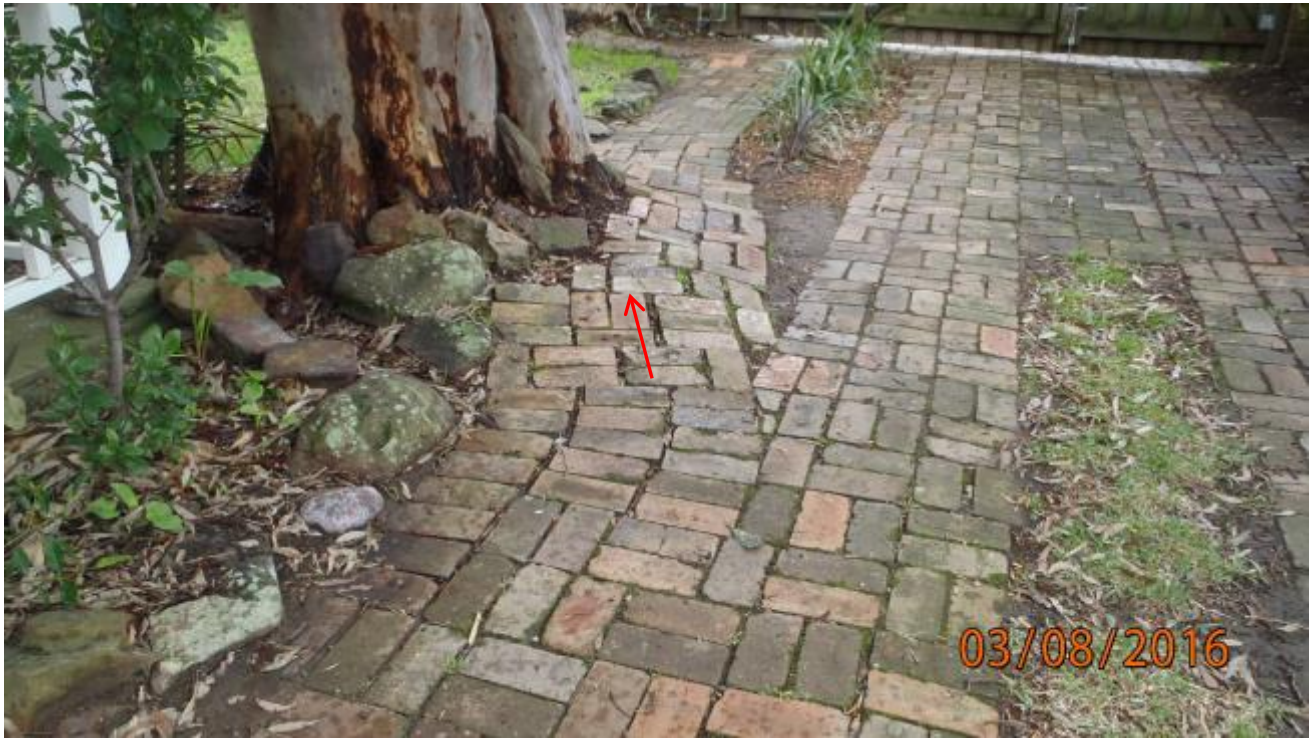
Photograph 7 shows displaced paving to the pathway at the front of the property

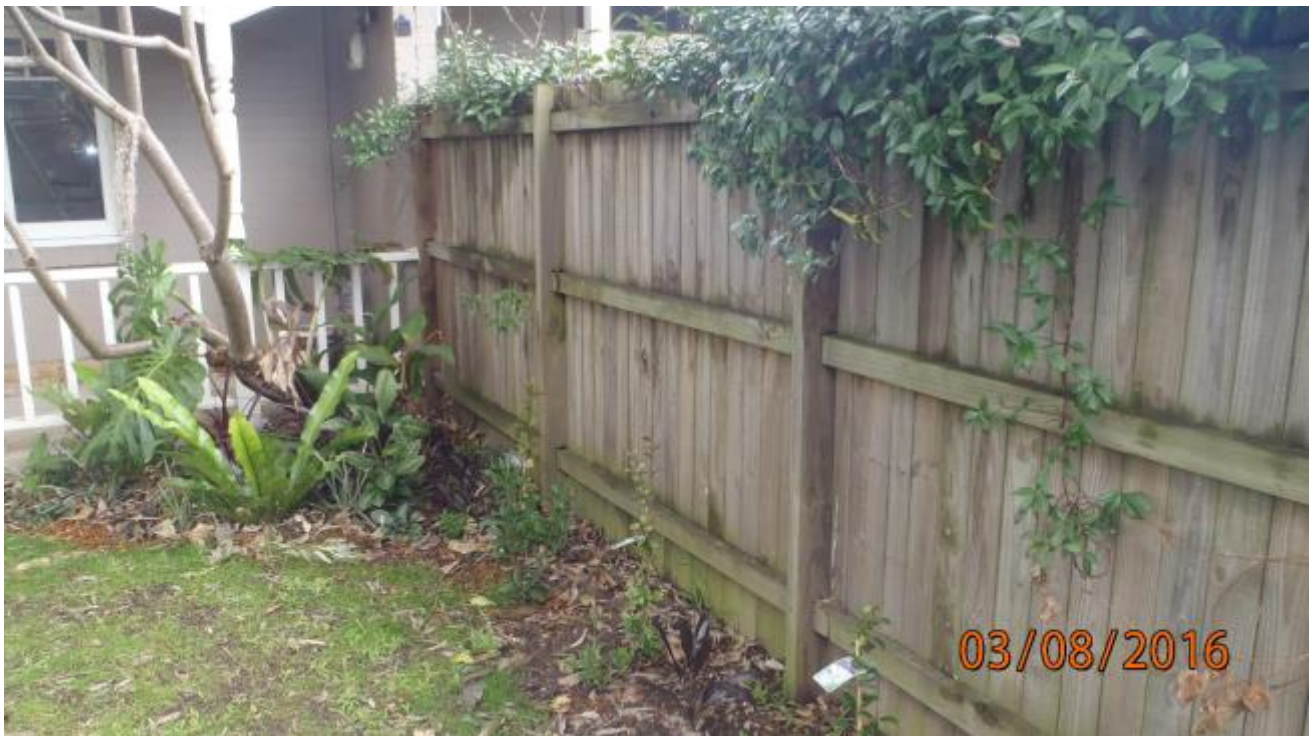
We noted that the common boundary fence with No.4 Crabbes Avenue is of treated timber, post and rail construction. **[Photograph 8]**

Photograph 8 shows the general condition of the front common boundary fence.

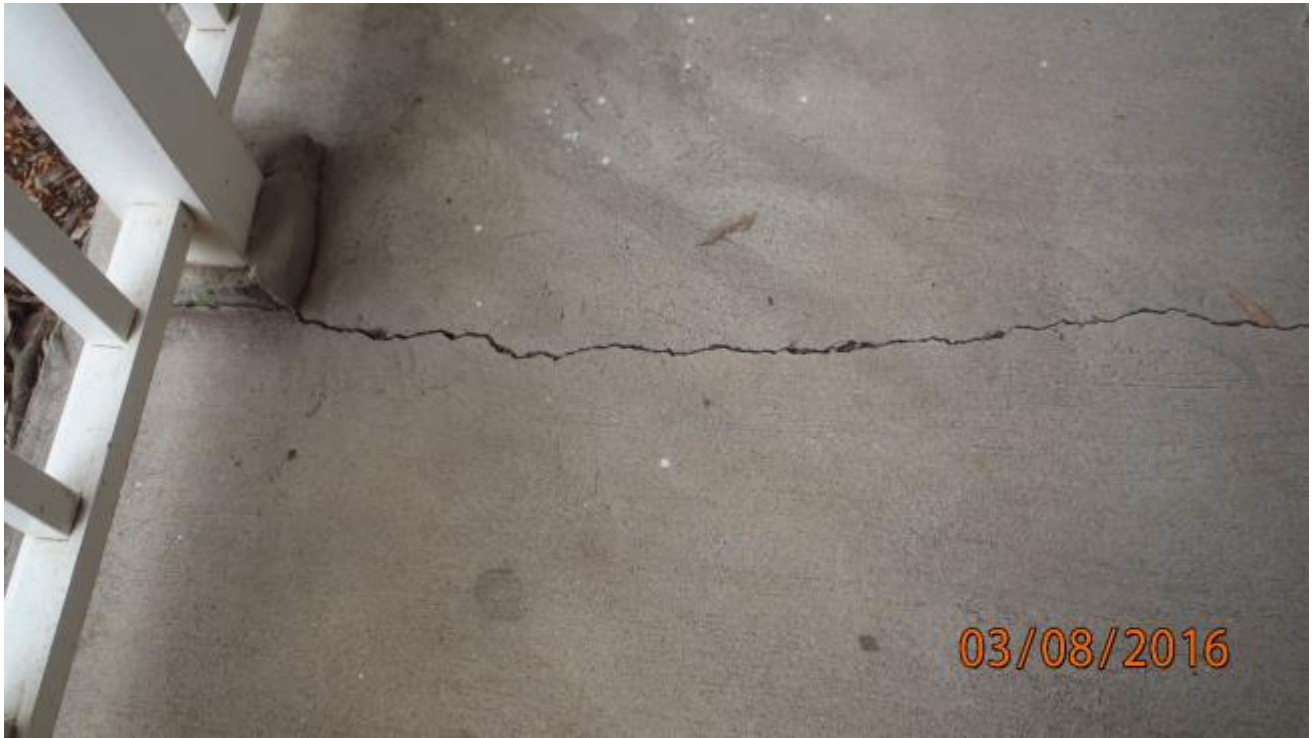
We noted cracking to the concrete slab floor of the front verandah outside the Bedroom 1 window **[Photograph 9]**

Photograph 9 shows a crack to the front verandah slab floor.

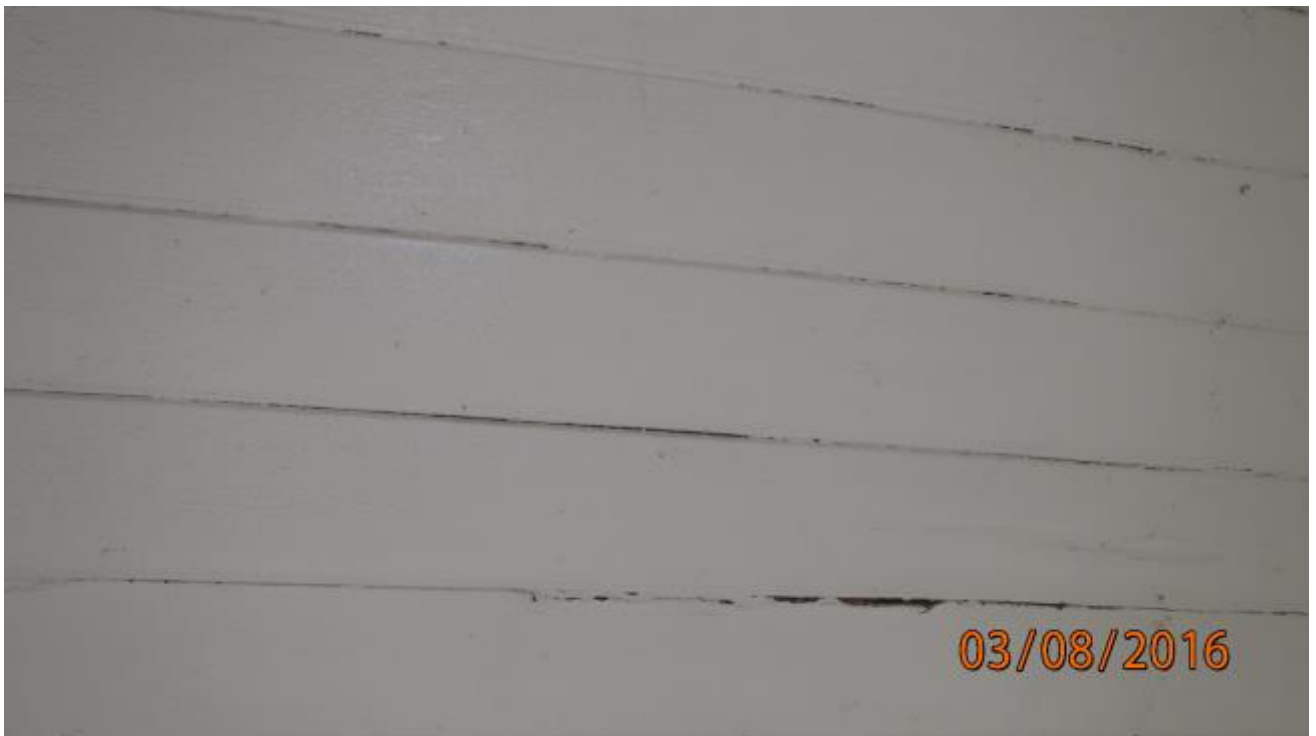
We noted general separation cracking to the surface coated timber lining boards to the porch soffit. **[Photograph 10]**

Photograph 10 shows cracking between the lining boards to the verandah soffit lining

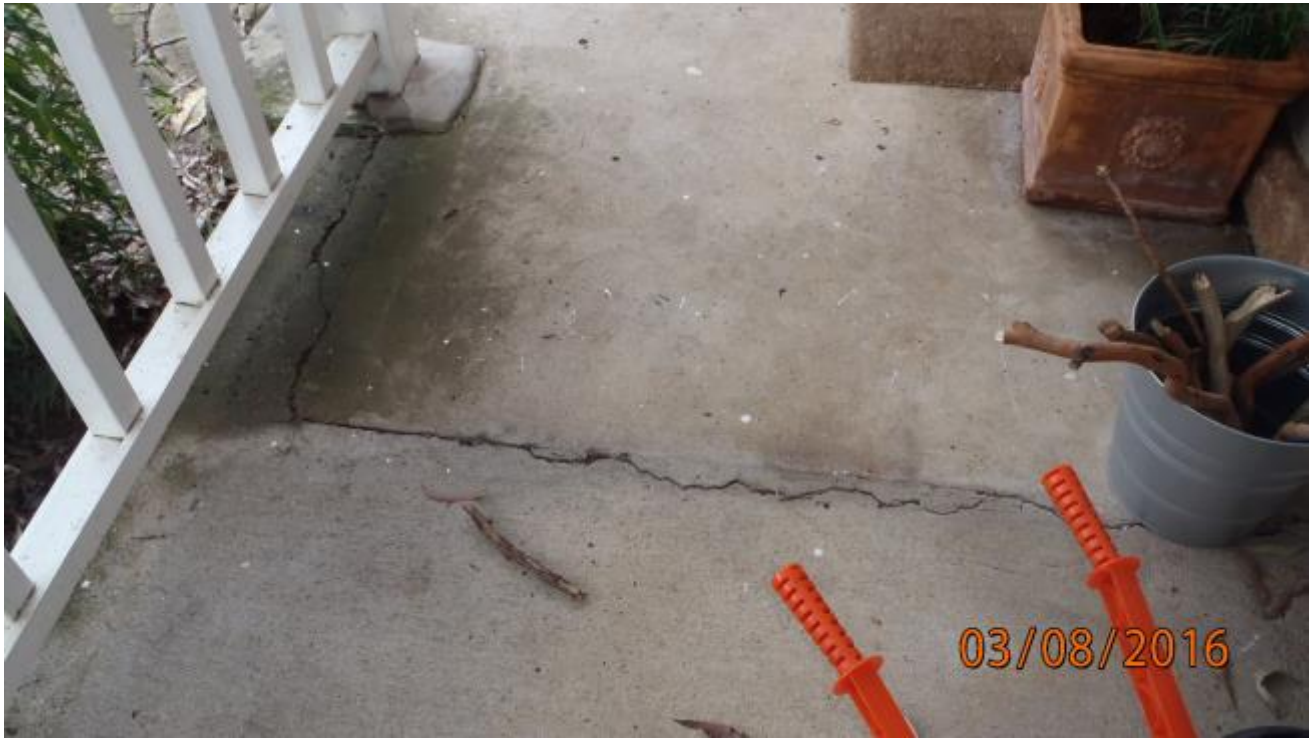
We noted cracking to the concrete slab floor and mildew growth to the front verandah adjacent to the entry and the difference in surface texture in this area. **[Photograph 11]**

Photograph 11 shows cracking to the concrete slab floor and mildew growth to the front verandah adjacent to the entry and the difference in surface texture in this area.

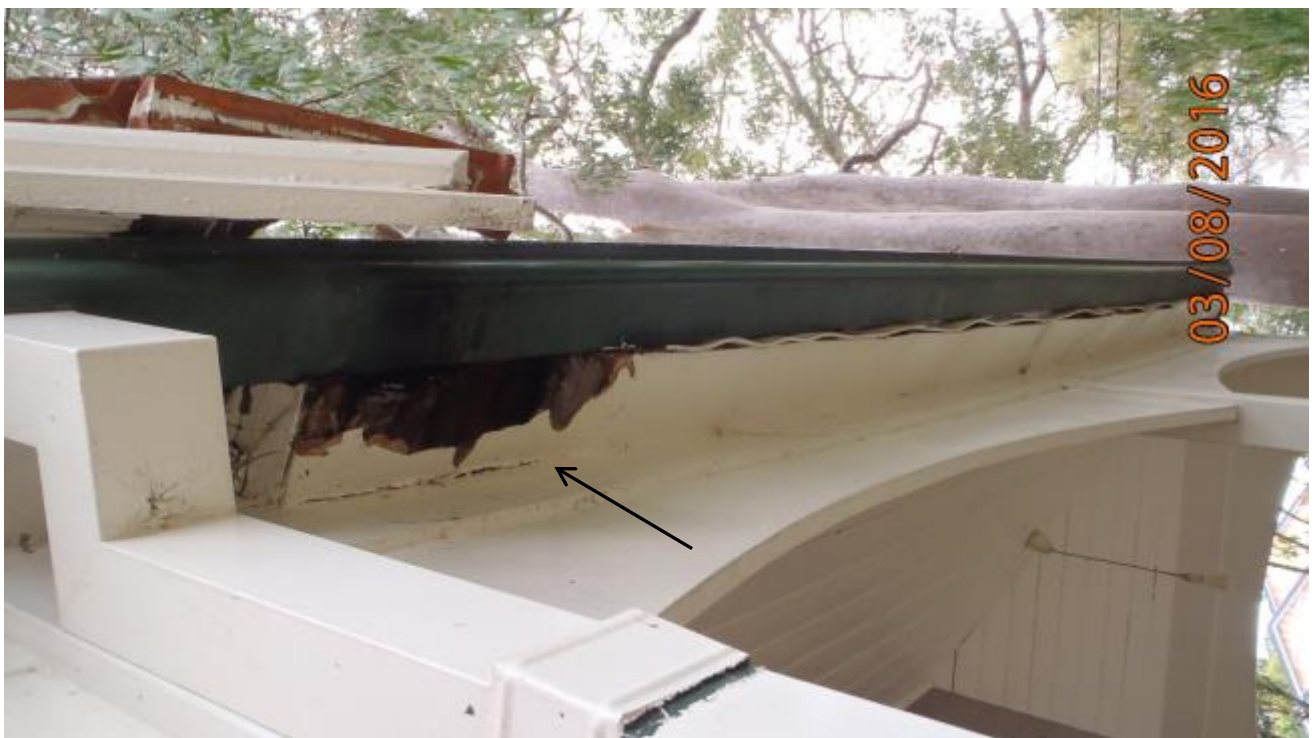
We noted damage to the soffit lining adjacent to the front entry **[Photograph 12]**

Photograph 12 shows damage to the soffit lining.

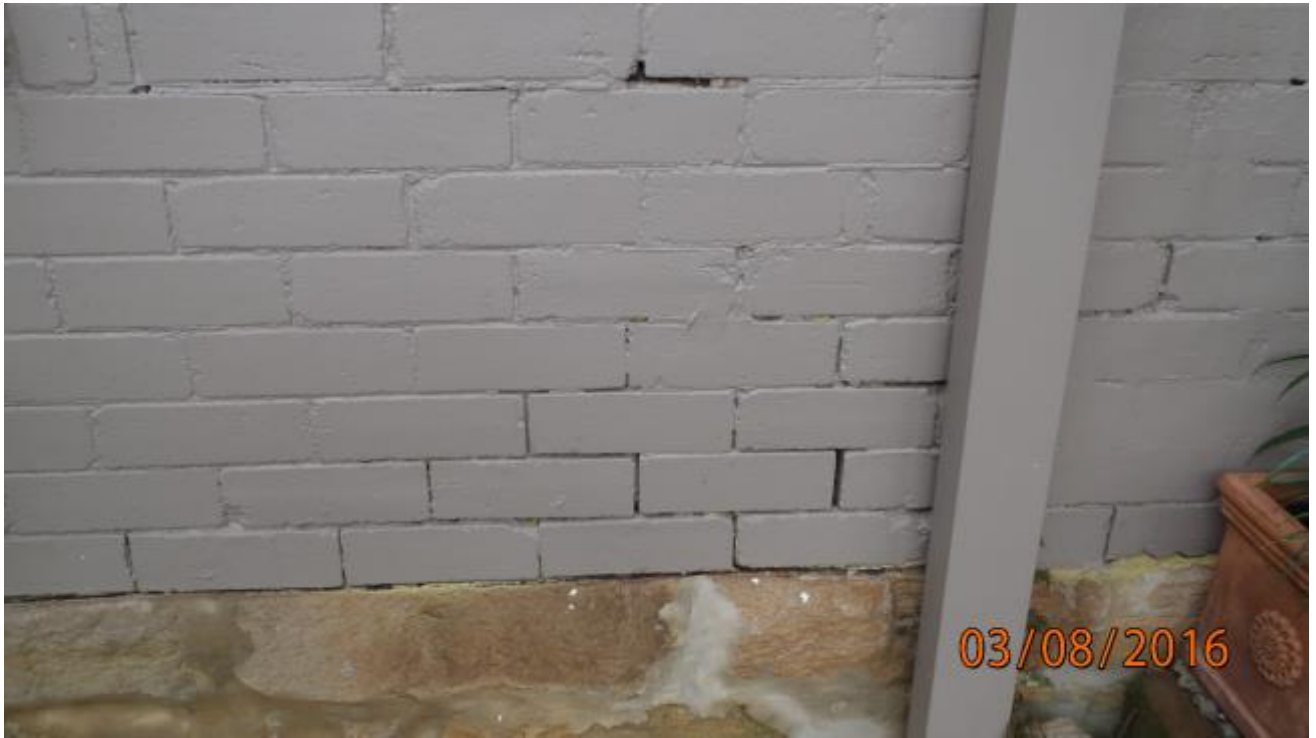
We noted displaced mortar between the entry and the Lounge room window. **[Photograph 13]**

Photograph 13 shows displaced mortar outside the Lounge Room.

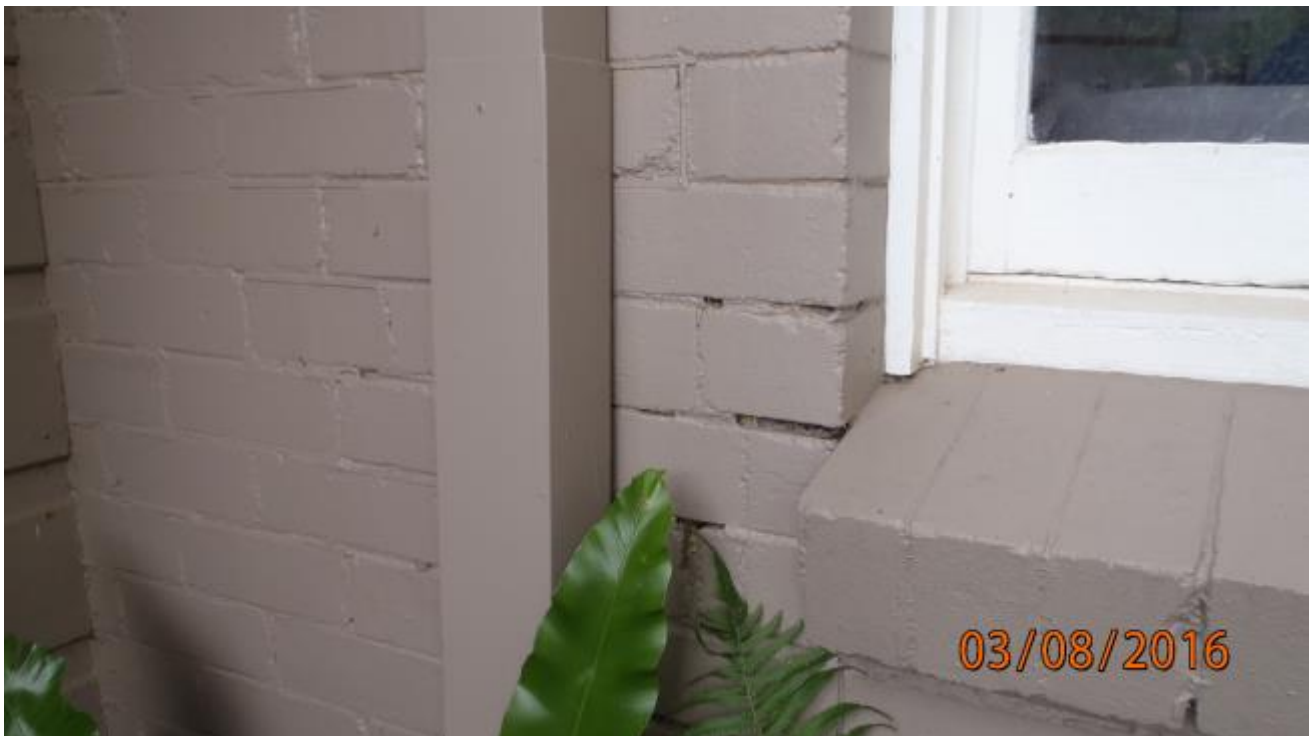
We noted displaced mortar outside the Lounge room window. **[Photograph 14]**

Photograph 14 shows displaced mortar outside the Lounge Room window.

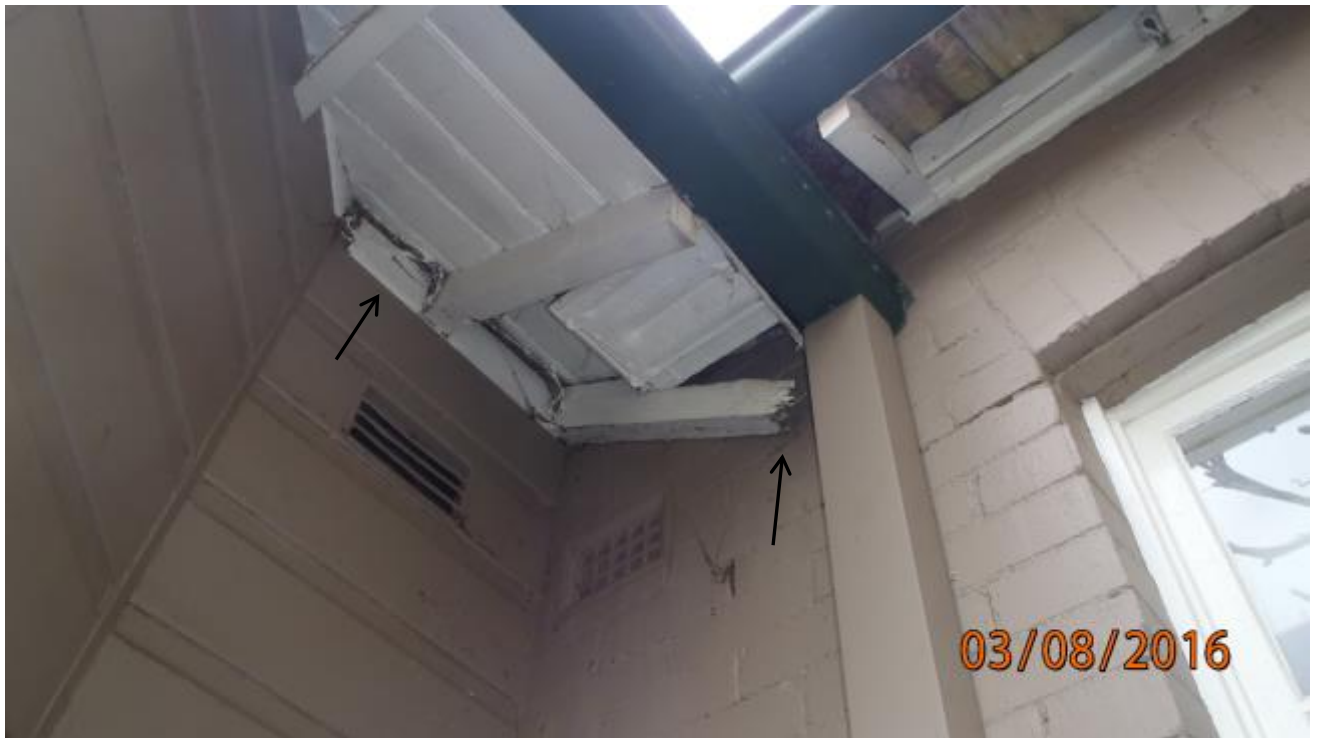
We noted general deterioration and rotted timber to the eave soffit lining and rafter ends between the Lounge and the Bedroom 2 window. **[Photograph 15]**

Photograph 15 shows general deterioration and rotted timber to the eave soffit lining and rafter ends.

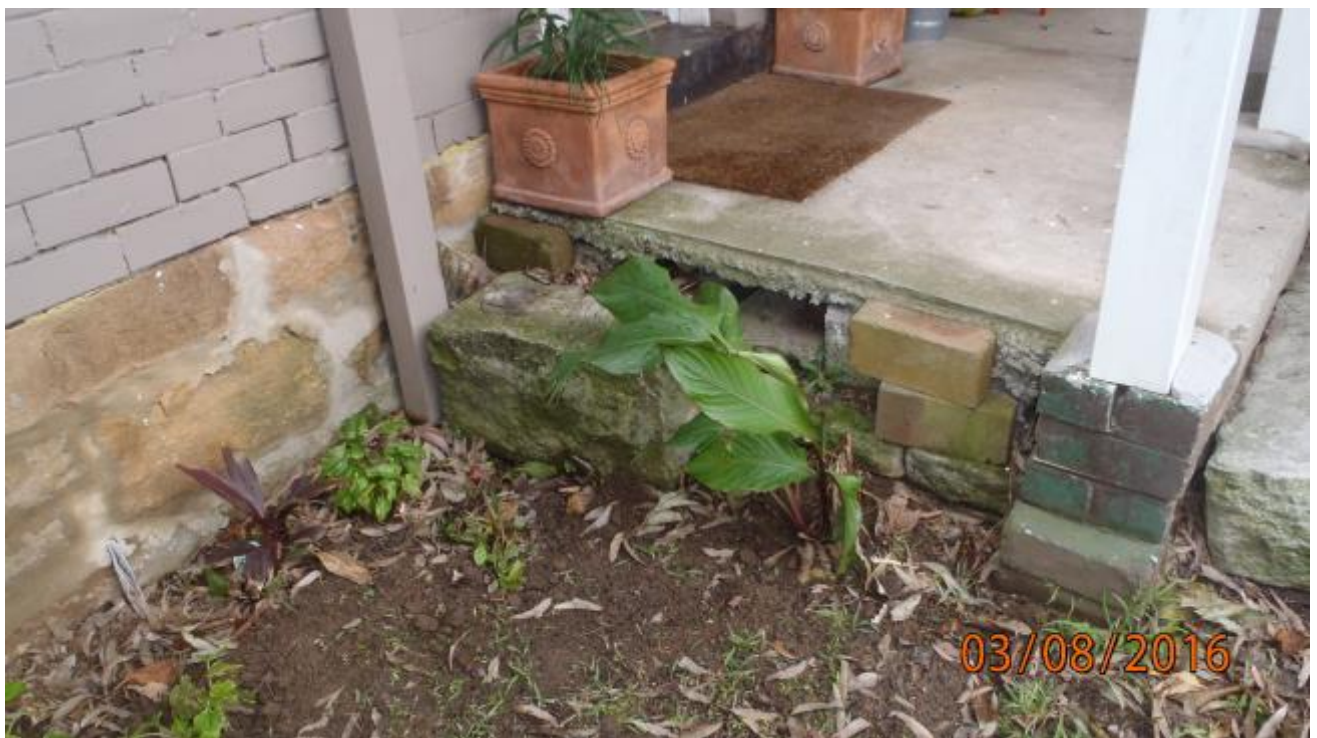
We noted that the construction of the suspended slab verandah floor is a combination of masonry bricks and sandstone blocks **[Photograph 16]**

Photograph 16 shows the construction of the front porch footings.

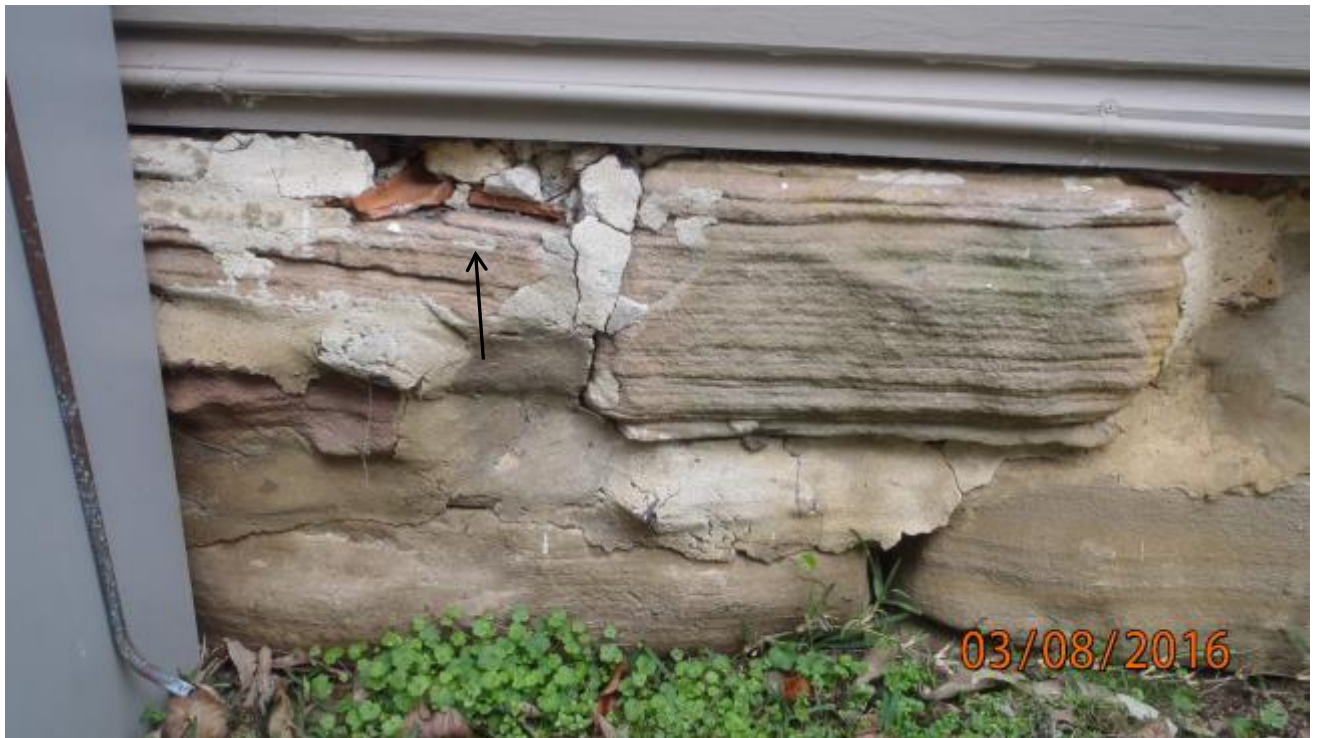
We noted evidence of a previous repair to the sandstone block footings adjacent to the Hot Water Unit **[Photograph 17]**

Photograph 17 shows a previous repair and step cracking to the sandstone block footings adjacent to the Hot Water Unit.

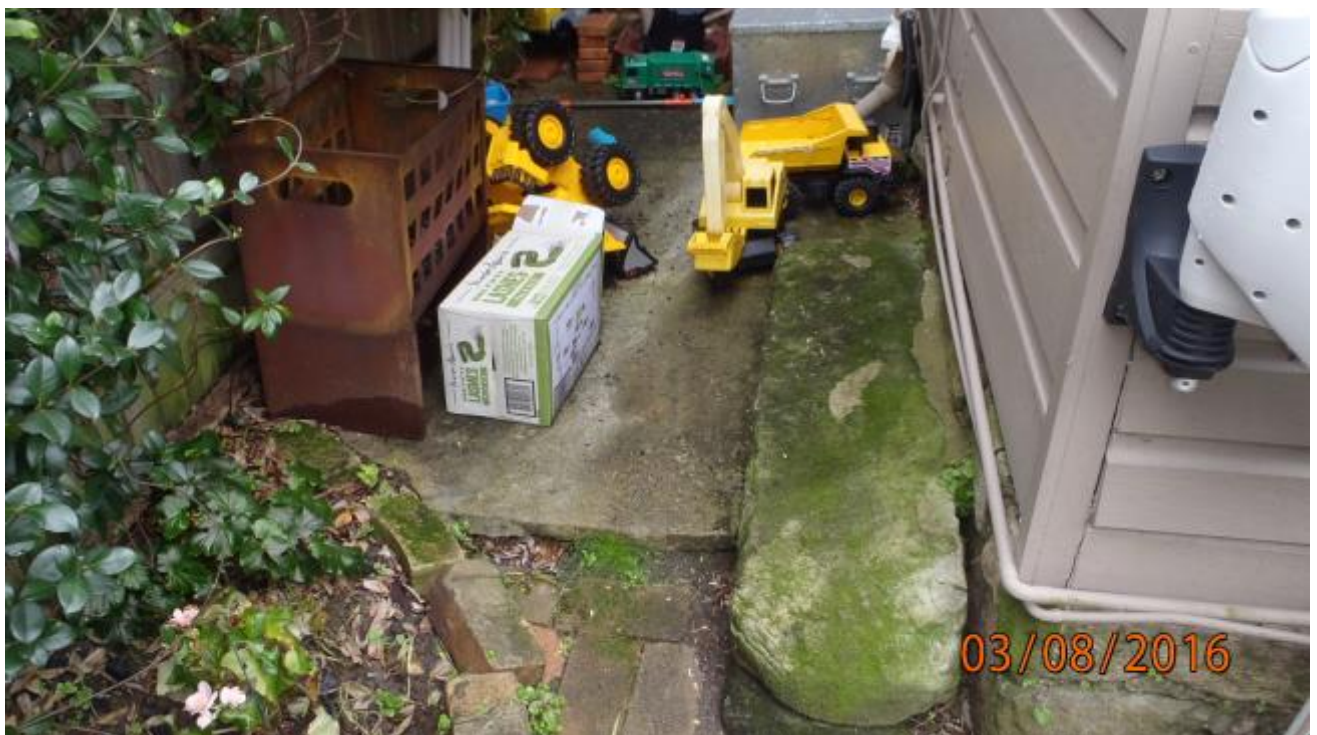
We noted mildew growth to the rear south western corner footings and sandstone blockwork outside the Laundry **[Photograph 18]**

Photograph 18 shows mildew / mould growth outside the Laundry.

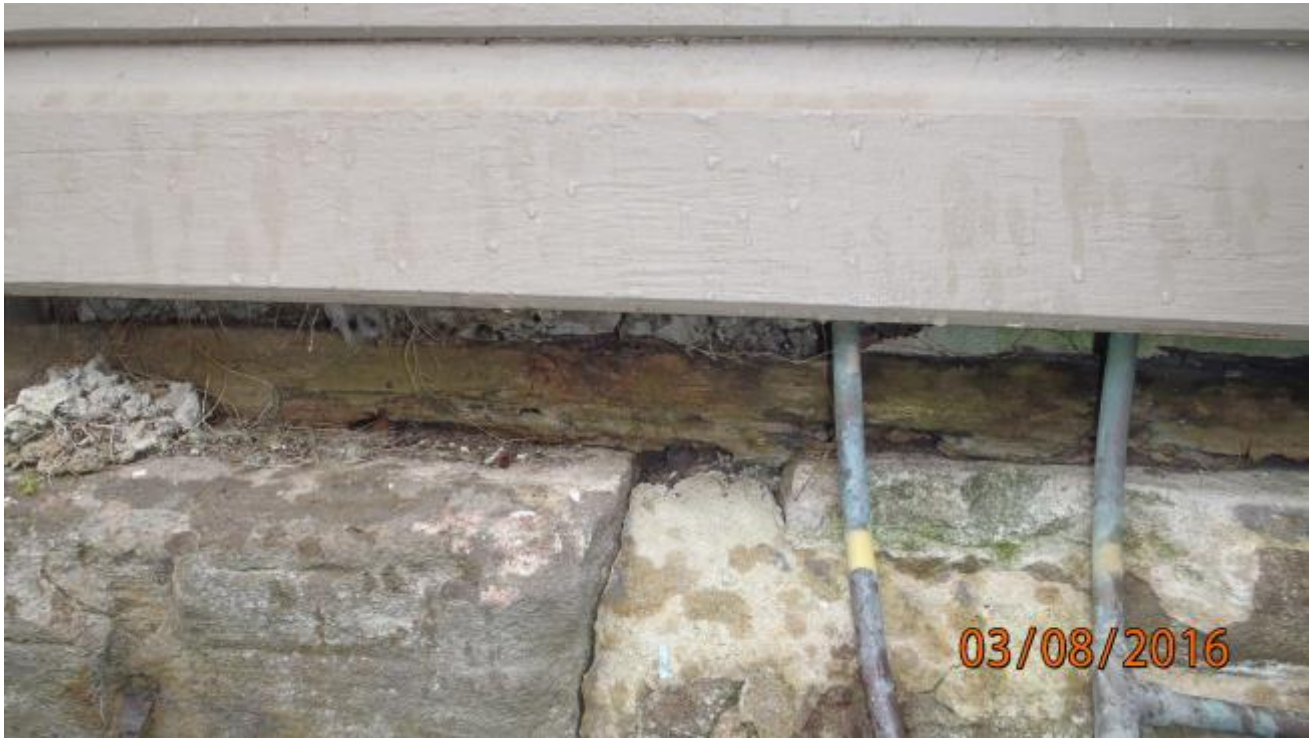
We noted rotting and general deterioration to the timber bearers on top of the sandstone block footings outside the Bathroom. **[Photograph 19]**

Photograph 19 shows rotting and general deterioration to the timber bearers.

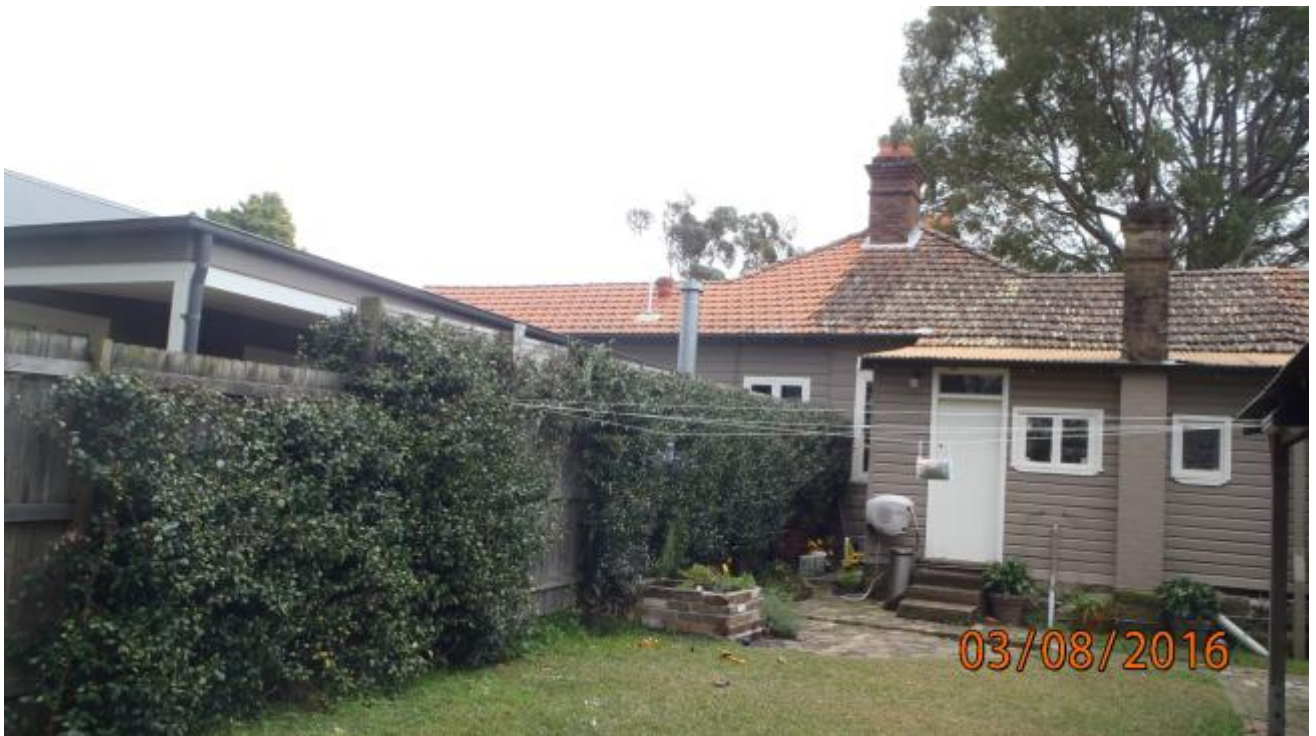
We noted that the common boundary fence between No. 4 Crabbes Avenue is of treated timber, post and rail construction, and has climbing plants growing along it. **[Photograph 20]**

Photograph 20 shows the rear common boundary fence between No. 4 Crabbes Avenue.

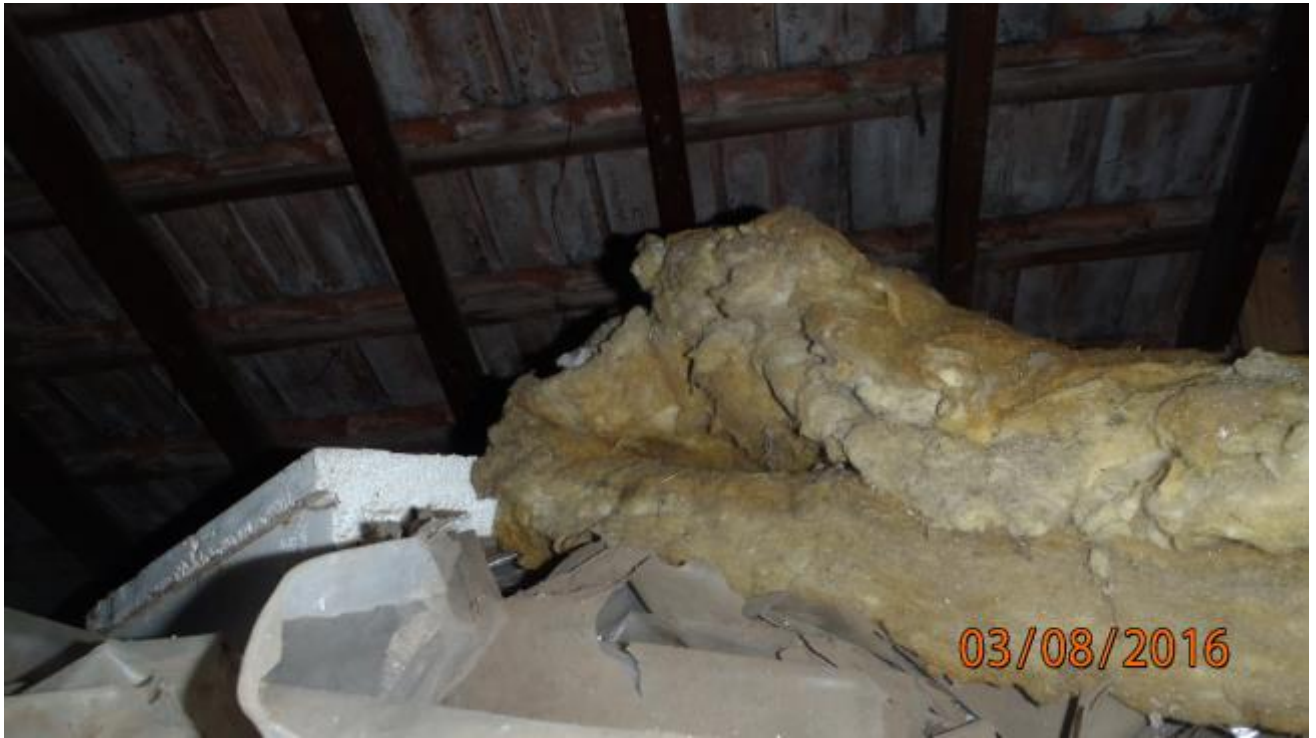
We noted that the common roof space to the adjoining properties is of traditional cut and pitched timber construction with Synthetic Mineral Fibre (SMF) batt insulation throughout the roof space. **[Photograph 21]**

We also noted that there was no sarking provided to the underside of the roofing tiles. **[Photograph 21]**

Photograph 21 shows the roof tiles have no sarking provided and SMF batt insulation.
