Dilapidation Assessment Report

Prepared for: Cape Cod Australia Pty. Limited
Job address: 2 Crabbes Avenue, North Willoughby.
Property Owner/s: Mr. James & Mrs. Allison Campbell.
Report reference: **WILLOUGHBY CITY COUNCIL**
Development Application No: not available
Date of assessment: 3rd August 2016

Re: Dilapidation Report

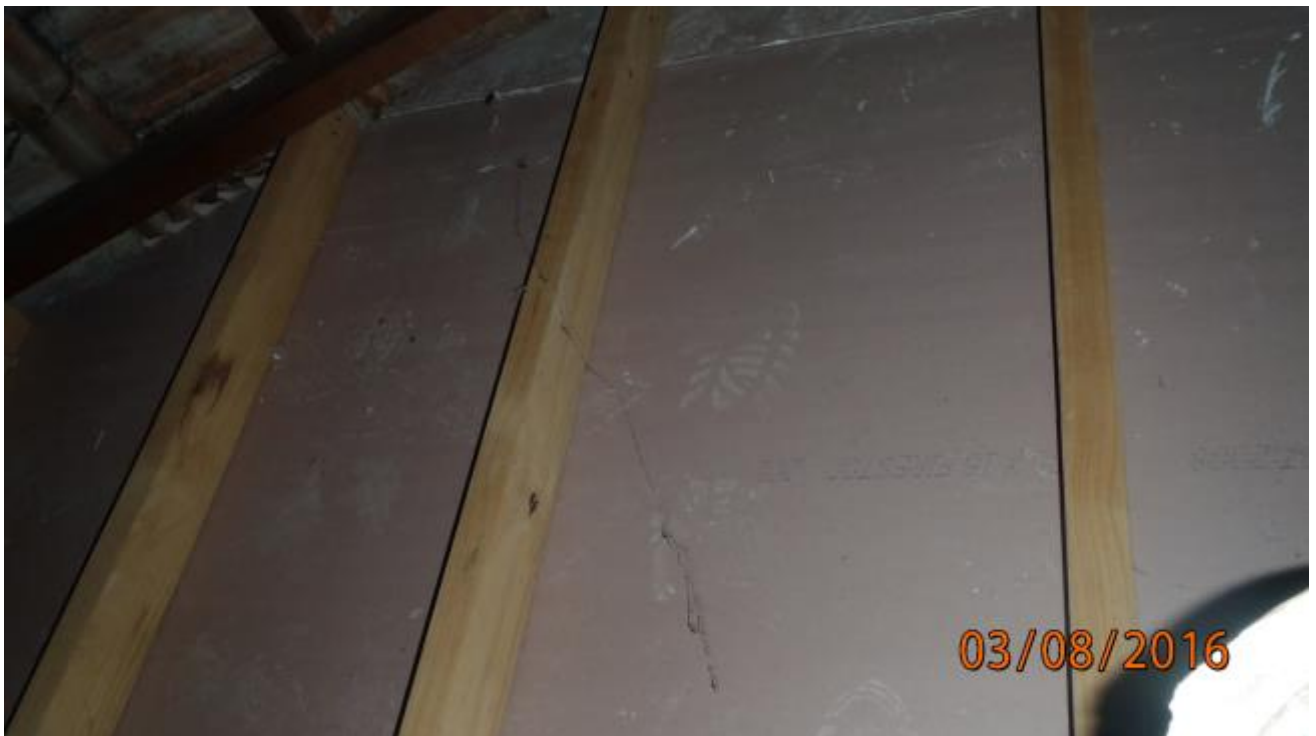
We noted that there is a *common party wall* (stud wall) extending to the underside of the roofing members that is lined with plasterboard in the roof space. **[Photograph 22]**

Photograph 22 shows the plasterboard lined stud *common party wall* in the common roof space.

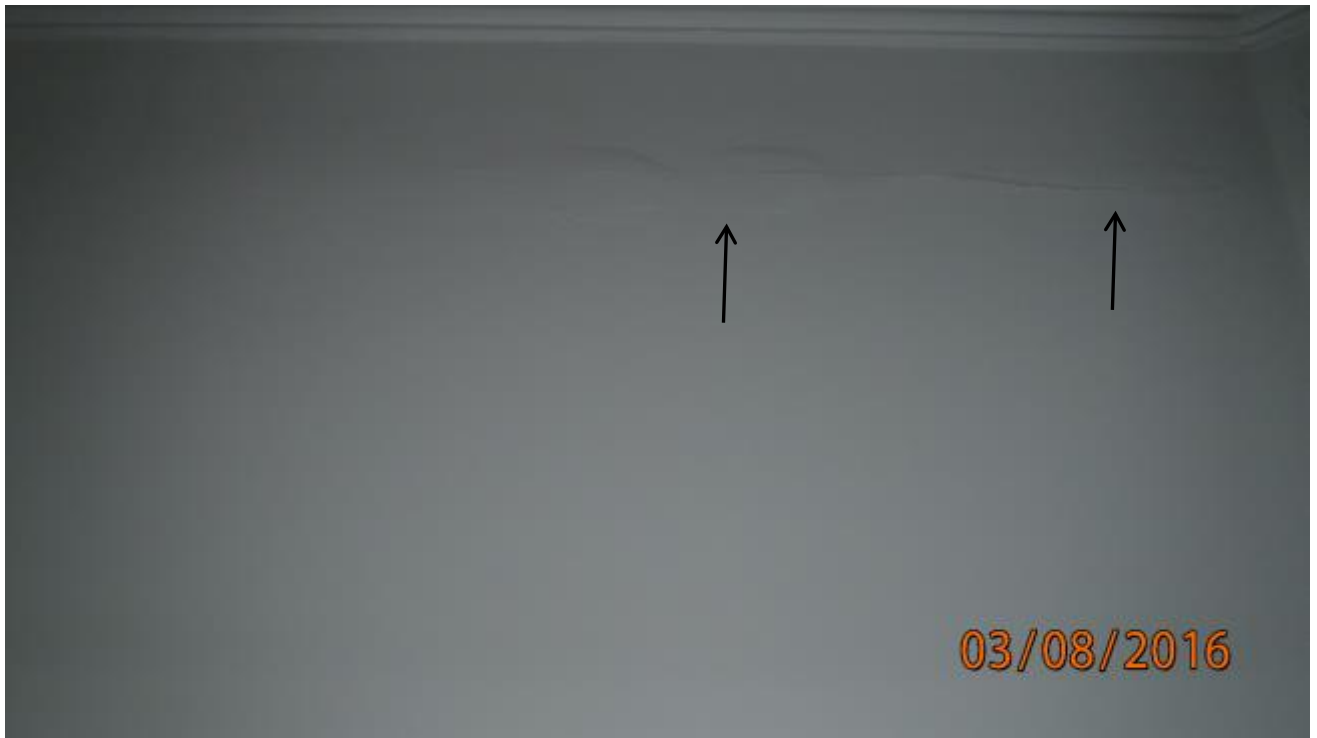
We noted a horizontal crack and previous repair to the wall above the fireplace, under the picture rail. **[Photograph 23]**

Photograph 23 shows previous repairs to a horizontal crack in Bedroom 1.

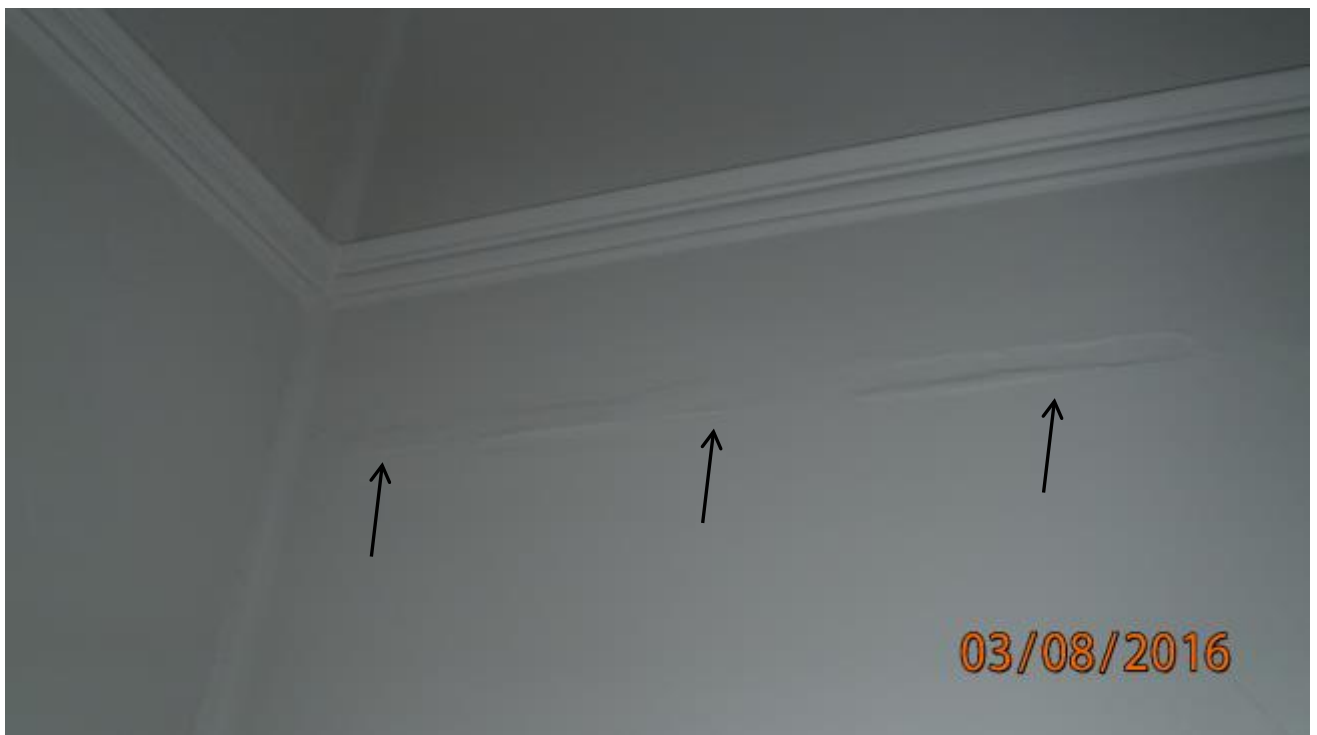
We also noted a previous repair to the wall above the door, under the picture rail. **[Photograph 24]**

Photograph 24 shows evidence of previous repairs in Bedroom 1.

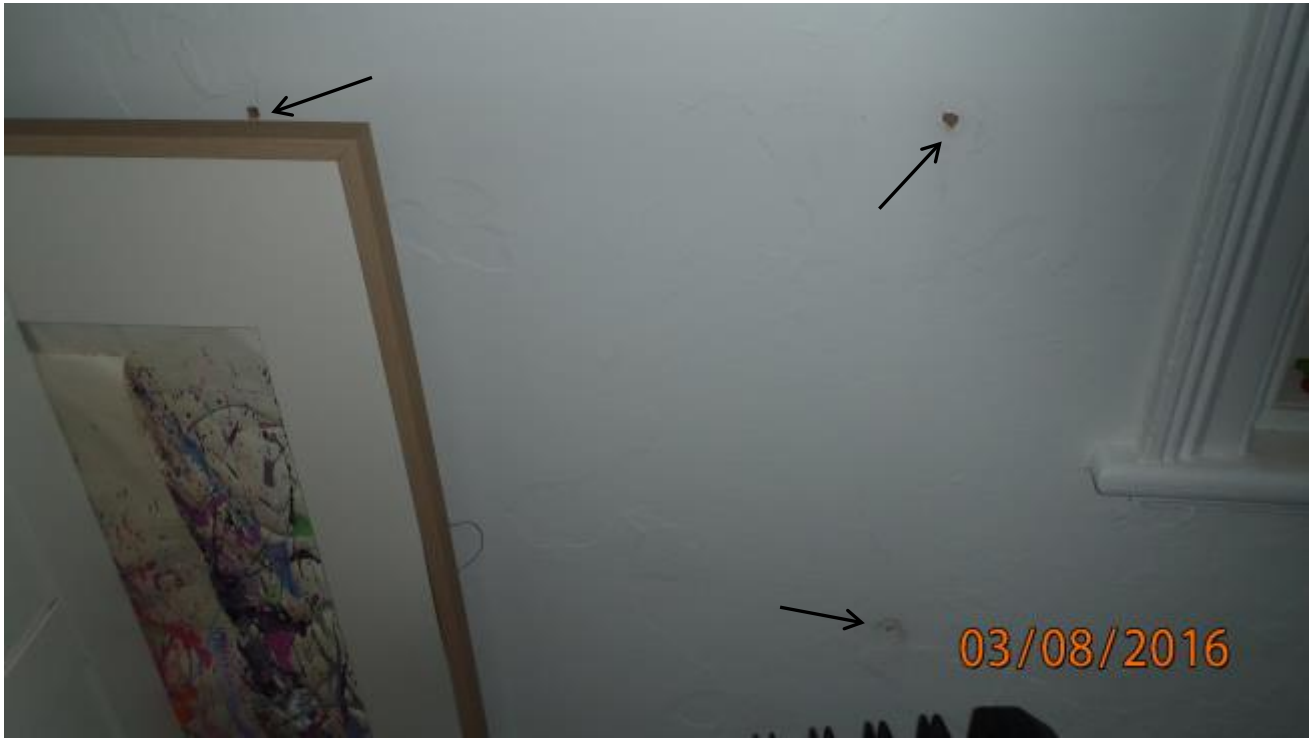
We noted holes drilled in the cement rendered wall adjacent to the window. **[Photograph 25]**

Photograph 25 shows holes drilled in the cement rendered wall adjacent to the window in Bedroom 1.

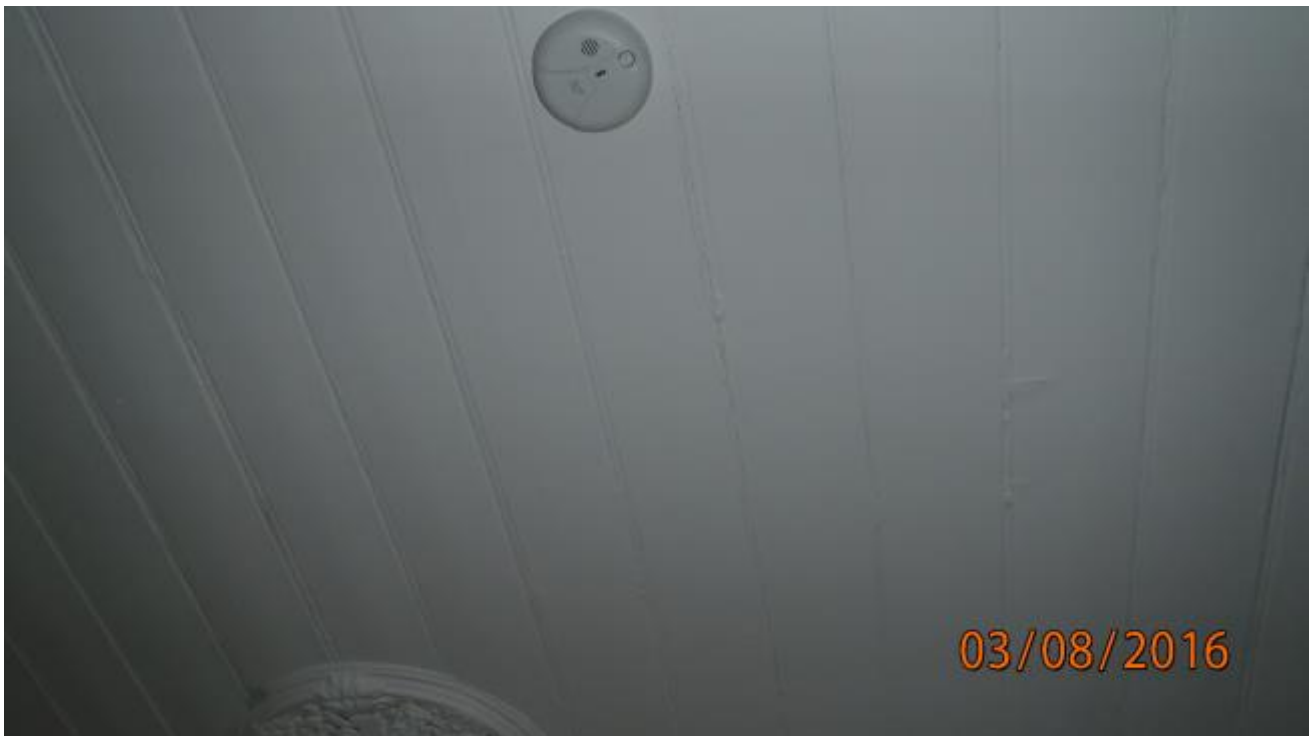
We noted general separation cracking to the timber lined ceiling. **[Photograph 26]**

Photograph 26 shows the general condition of the timber lined ceiling in Bedroom 1.

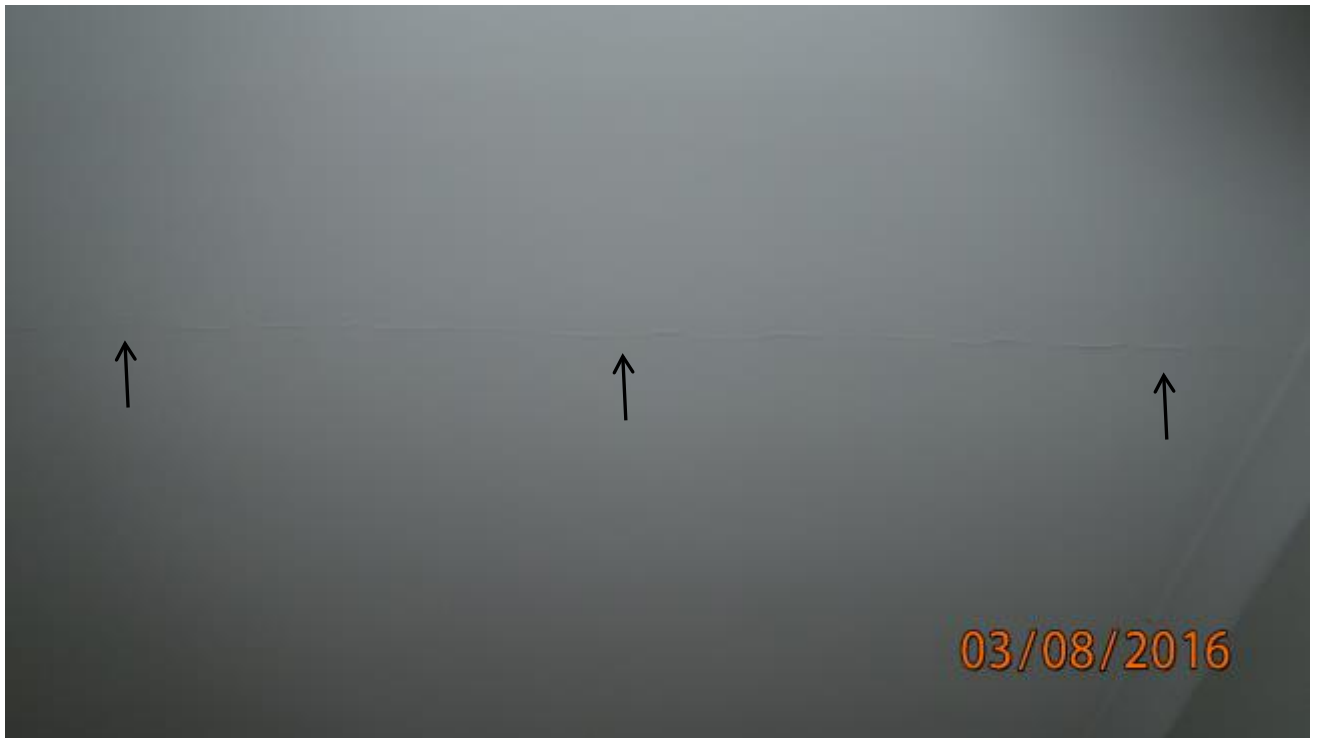
We observed a crack to the plaster ceiling lining extending from the front northern wall towards the centre of the room. **[Photograph 27]**

Photograph 27 shows a crack to the plaster ceiling lining in the Lounge room.

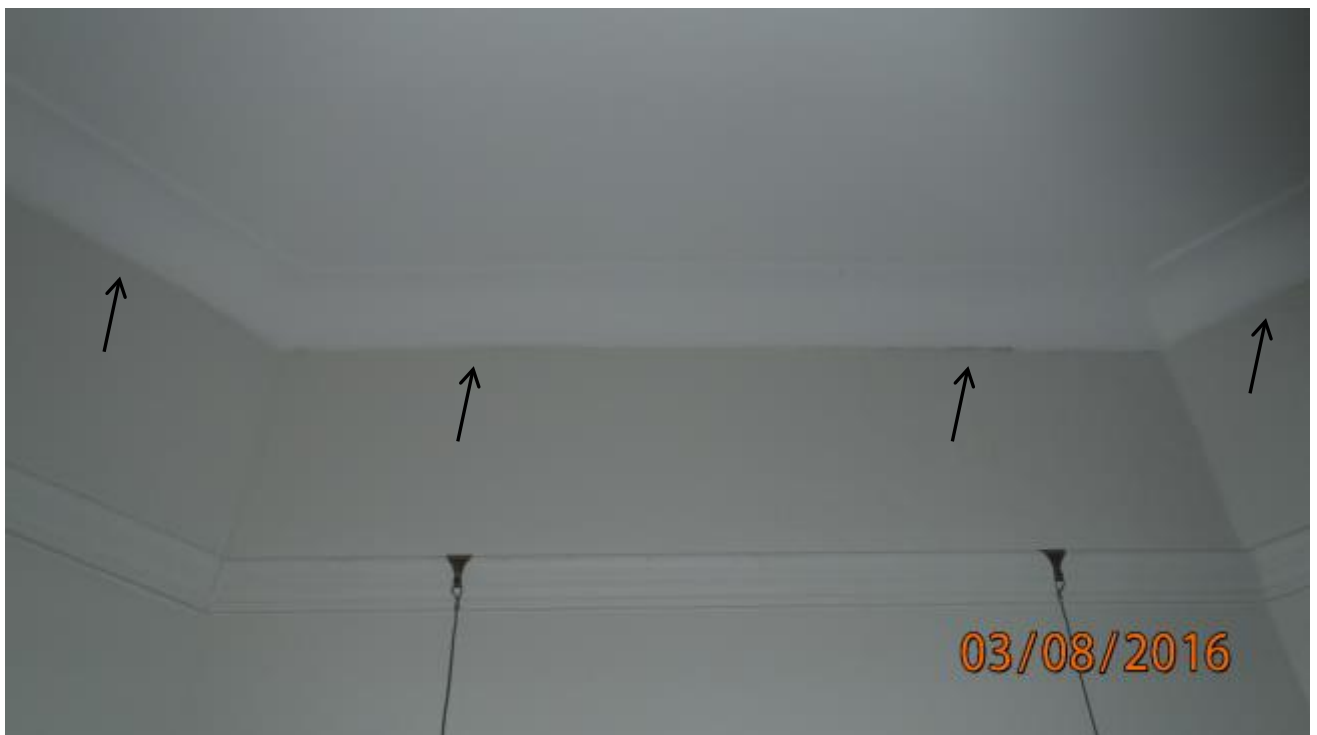
We observed separation cracking to the wall / cornice junction in the south western corner above the fireplace adjacent to the *common party wall* with No. 4 Crabbles Avenue. **[Photograph 28]**

Photograph 28 shows separation cracking to the wall / cornice junction in the south western corner above the fireplace adjacent to the *common party wall* with No. 4 Crabbles Avenue.

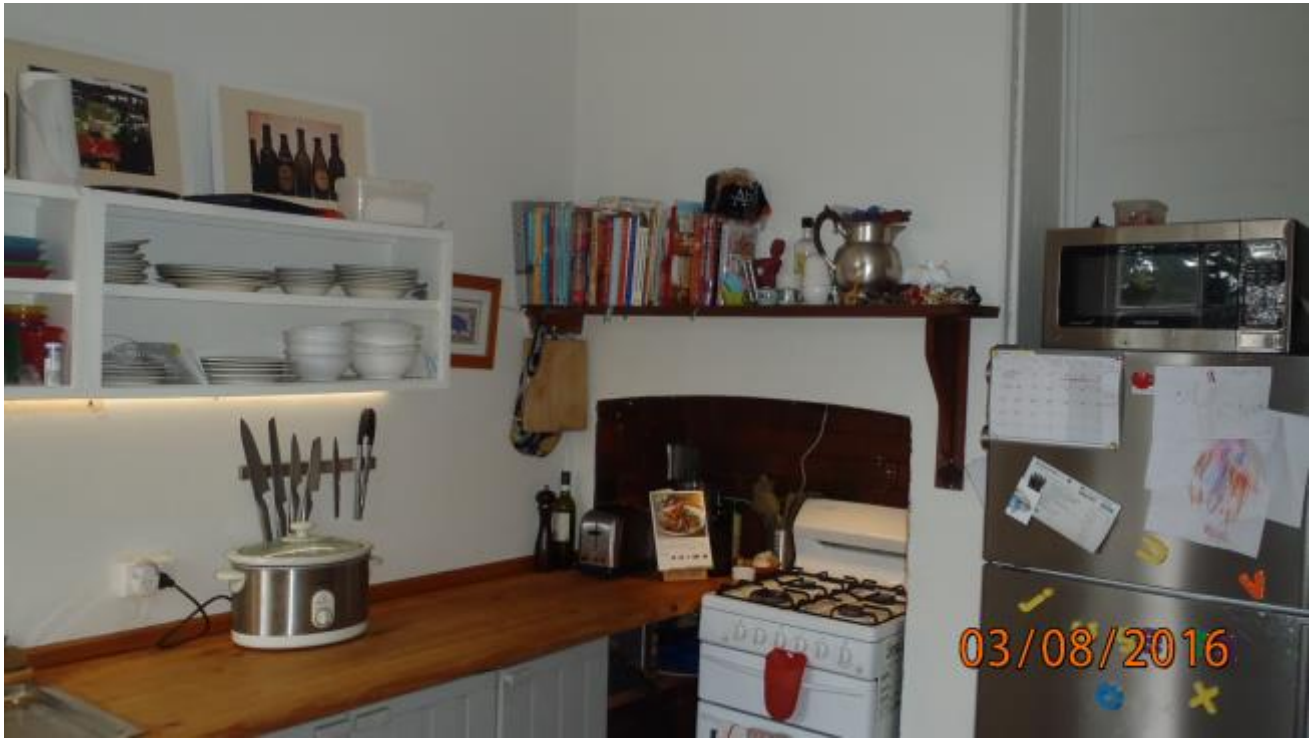
We noted that the kitchen bench top is set adjacent to the *common party wall* and that the stove resides in the back of the Lounge fireplace **[Photograph 29]**

Photograph 29 shows the kitchen bench top is set adjacent to the *common party wall*.

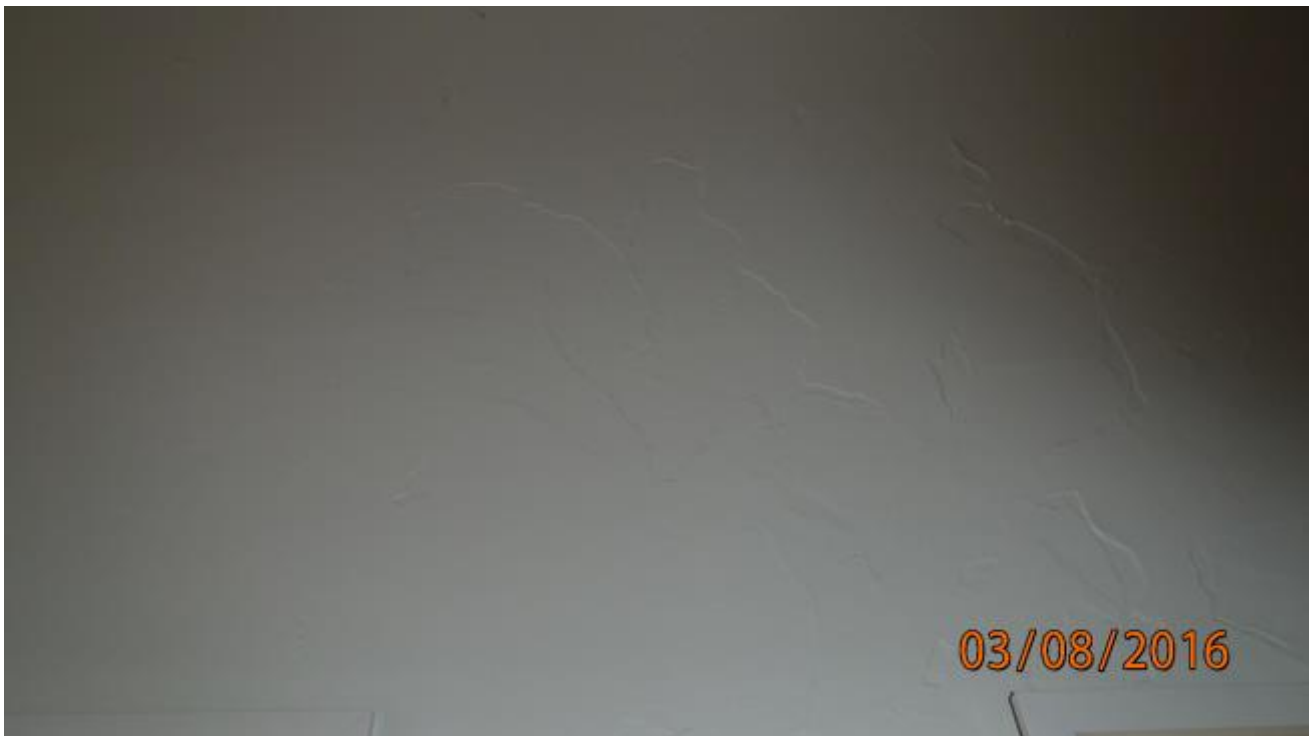
We observed evidence of previous repairs and flaking paint to the *common party wall* above the kitchen bench **[Photograph 30]**

Photograph 30 shows evidence of previous repairs and flaking paint to the *common party wall* above the kitchen bench.

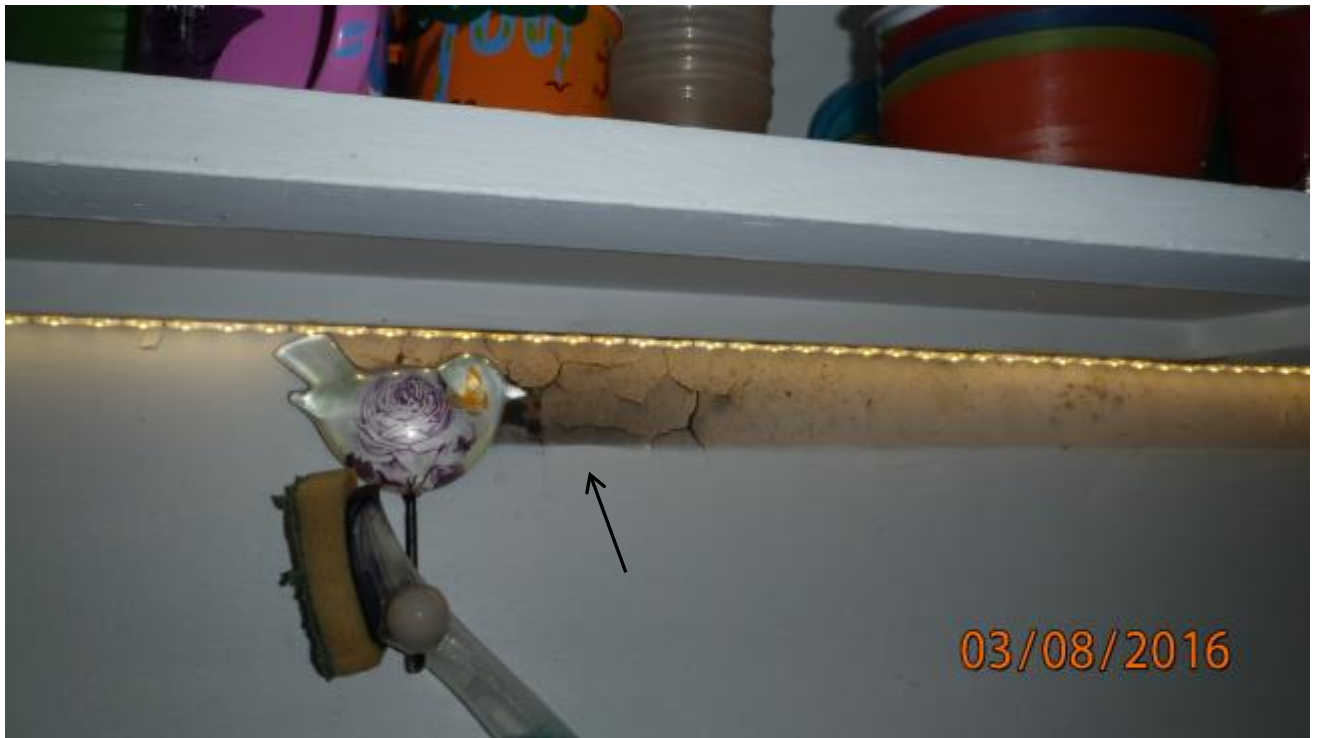
We noted flaking paint to the *common party wall* under the kitchen shelf above the kitchen bench **[Photograph 31]**

Photograph 31 shows flaking paint to the *common party wall* under the kitchen shelf above the kitchen bench.

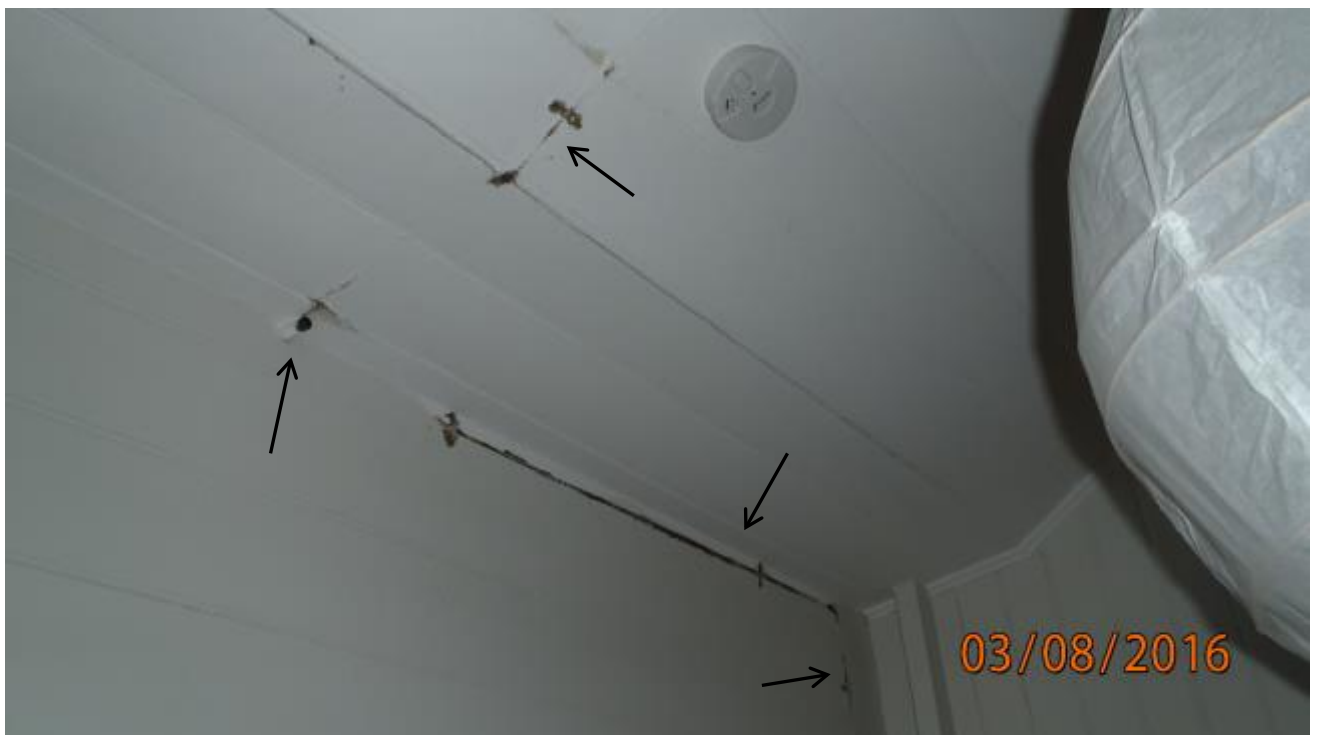
We noted there was evidence of an electrical conduit that has been removed from the south western corner of the room extending from the ceiling down to the existing light switch. **[Photograph 32]**

Photograph 32 shows evidence of a removed electrical conduit in Bedroom 3.

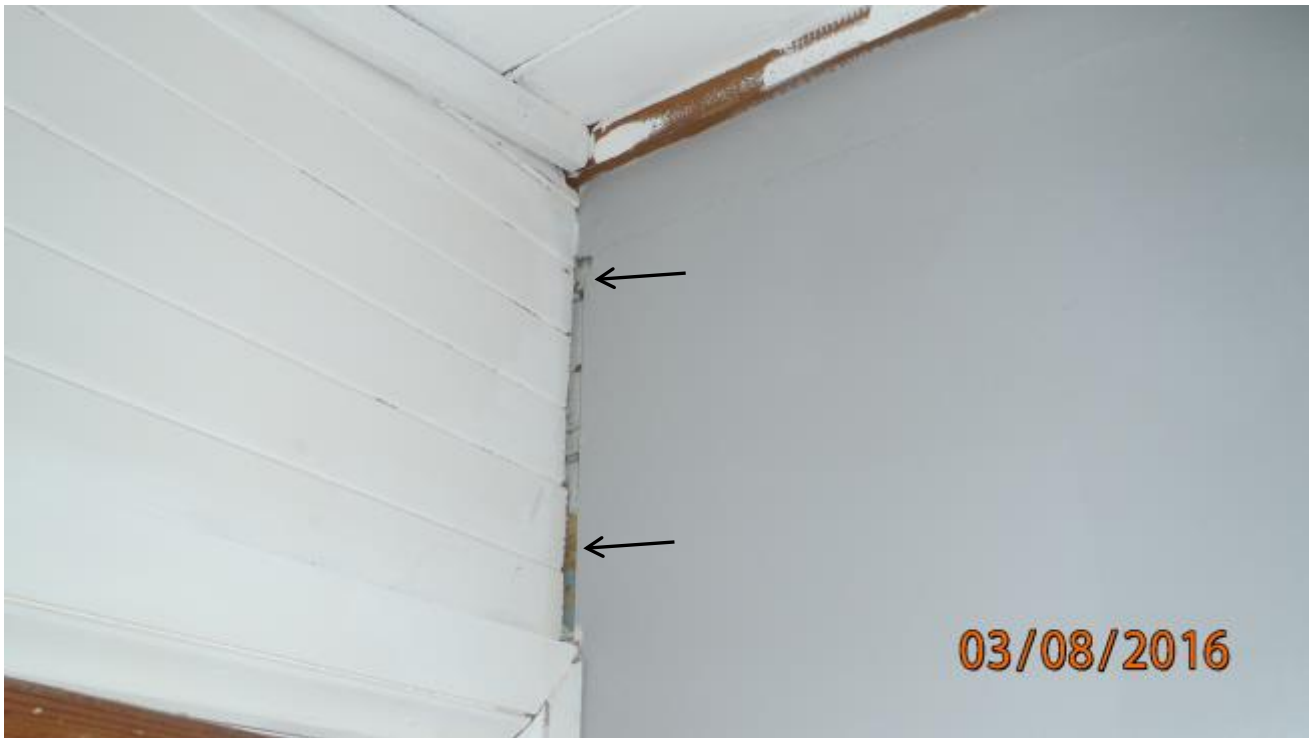
We noted gaps to the junction between the timber lining boards and the wall common to Bedroom 3 above the door. **[Photograph 33]**

Photograph 33 shows gaps between the lining board and Bedroom 3 wall in the Bathroom.

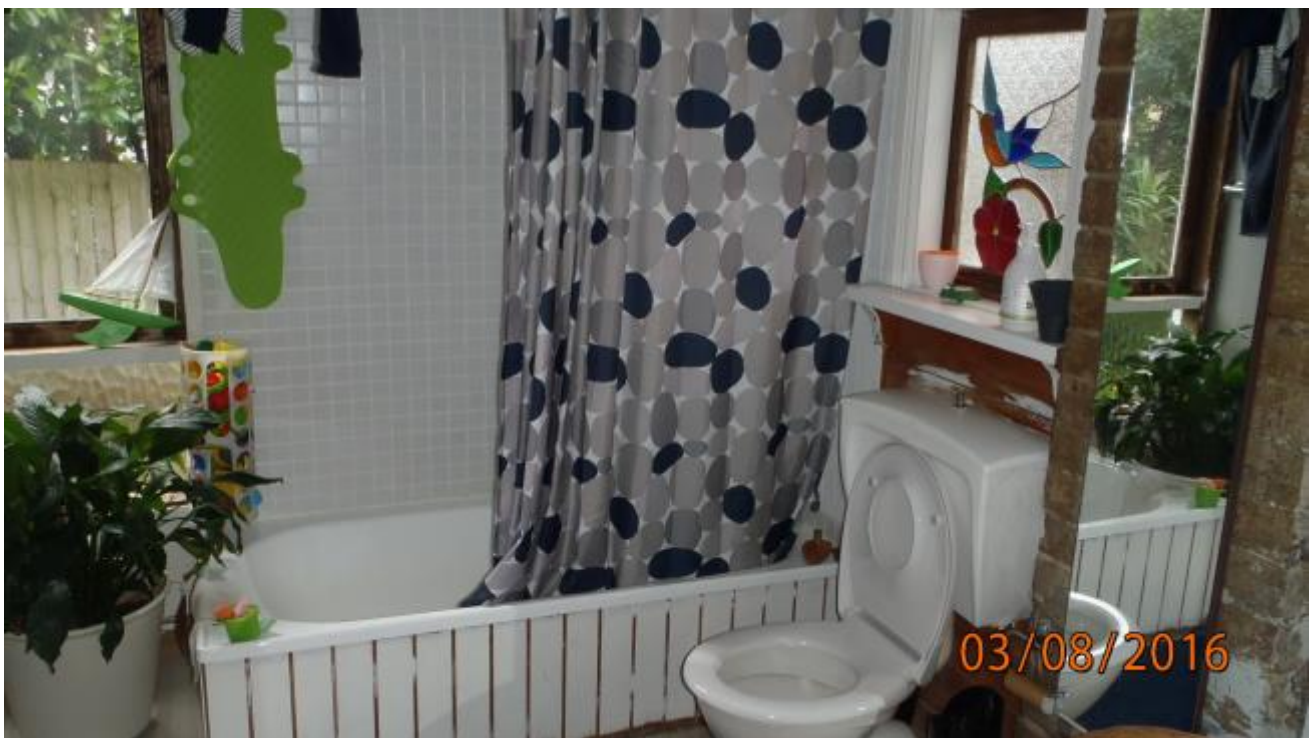
We noted that the grout to the wall tiles is complete and that the tiles when randomly “tap” tested appeared to be sound. We did not observe any recent cracking to the tile grout at the wall / wall, wall / floor junctions. **[Photograph 34]**

Photograph 34 shows the general condition of the Bathroom.

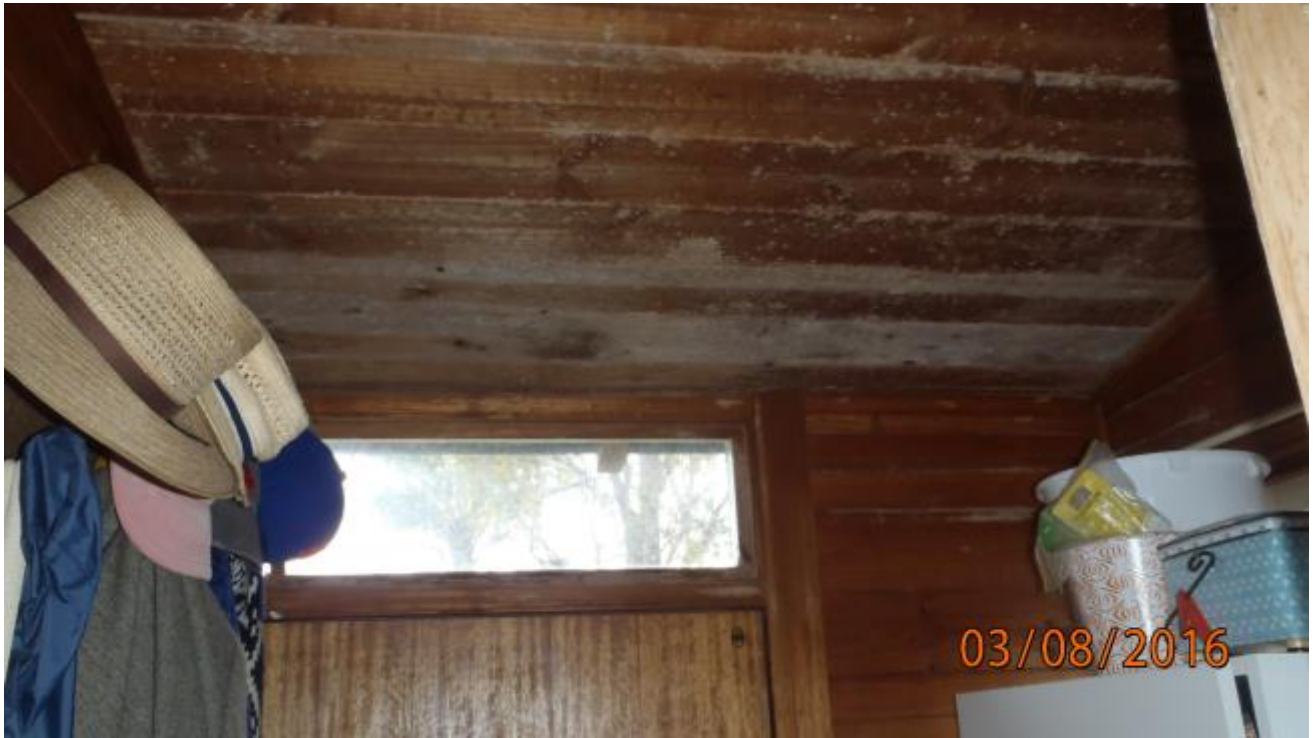
We observed general deterioration to the surface coating of the timber lined ceiling and walls **[Photograph 35]**

Photograph 35 shows the general condition of the Laundry wall and ceiling lining.
