HAZARDOUS MATERIALS ASSESSMENT REPORT

Job details: Owner/s: Mr. D. Barton & Ms. M. Hudson
Location: 21 Ian Street, Maroubra NSW

Plans for Job No: 7609/14 Revision No: D Dated: 06-03-15

Our reference: HM03790315

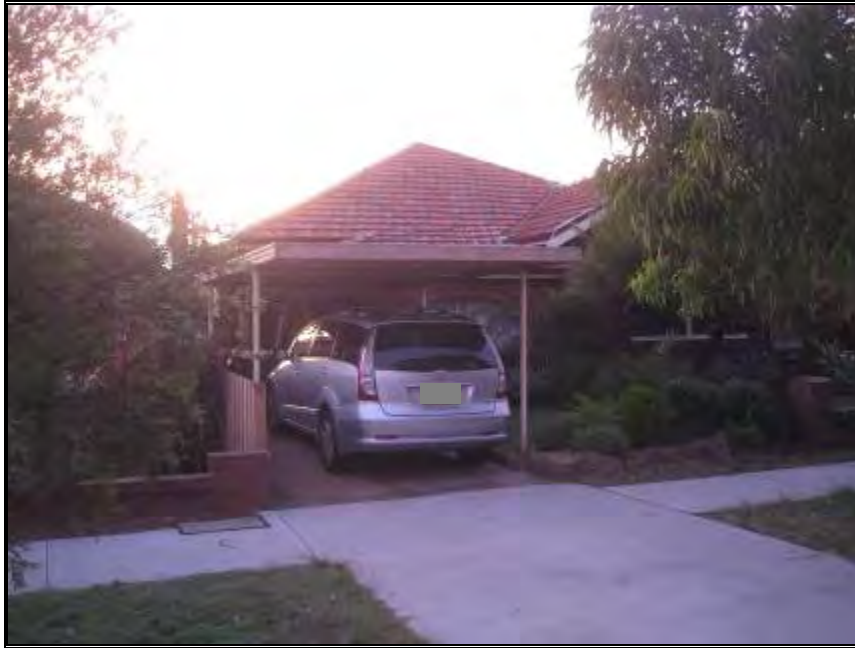
**Front western elevation of the adjoining properties:
No. 21 and No. 23 Ian Street, Maroubra**
