HAZARDOUS MATERIALS ASSESSMENT REPORT

Job details: Owner/s: Mr. B. Carr & Mrs. N. Shepherd
Location: 99 Rainbow Street, Kingsford NSW

Our reference: HM03370914

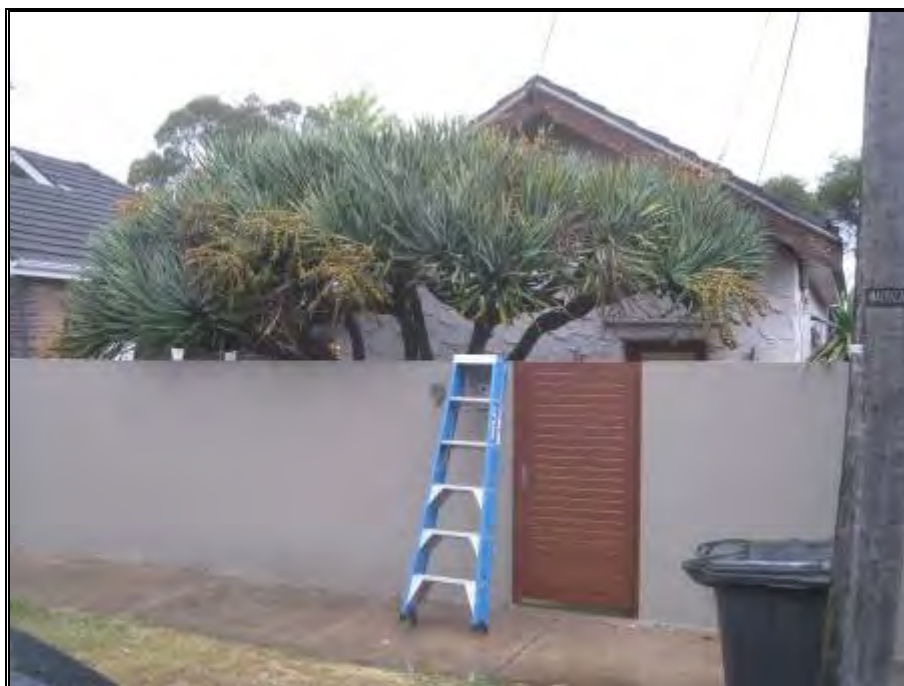
Front northern elevation of the residence
