HAZARDOUS MATERIALS ASSESSMENT REPORT

Job details: Owner/s: Mr. A. & Mrs. K. Roland
Location: 65 Glenayr Avenue, North Bondi

Our reference: HM04750316

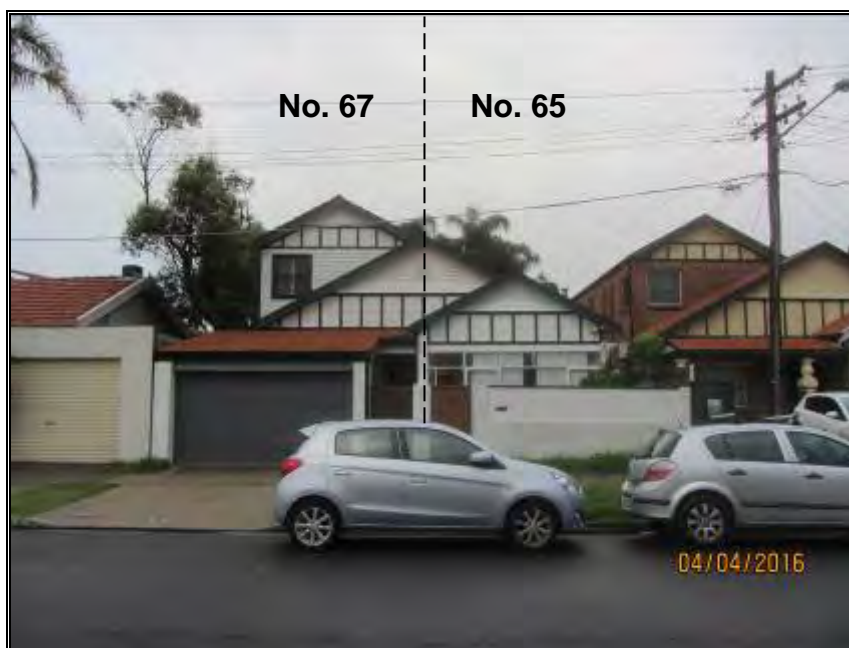
Front eastern elevation of the adjoining properties:
No. 65 & No. 67 Glenayr Avenue, North Bondi
