Dilapidation Assessment Report

Prepared for: Cape Cod Australia Pty. Limited
Job address: 5 Darling Street, Bronte.
Property Owner/s: Mr. Peter Engel.
Report reference: **WAVERLEY COUNCIL**
Development Application No: not available
Date of assessment: 8th March 2017

Re: Dilapidation Report – No. 5 Darling Street, Bronte.

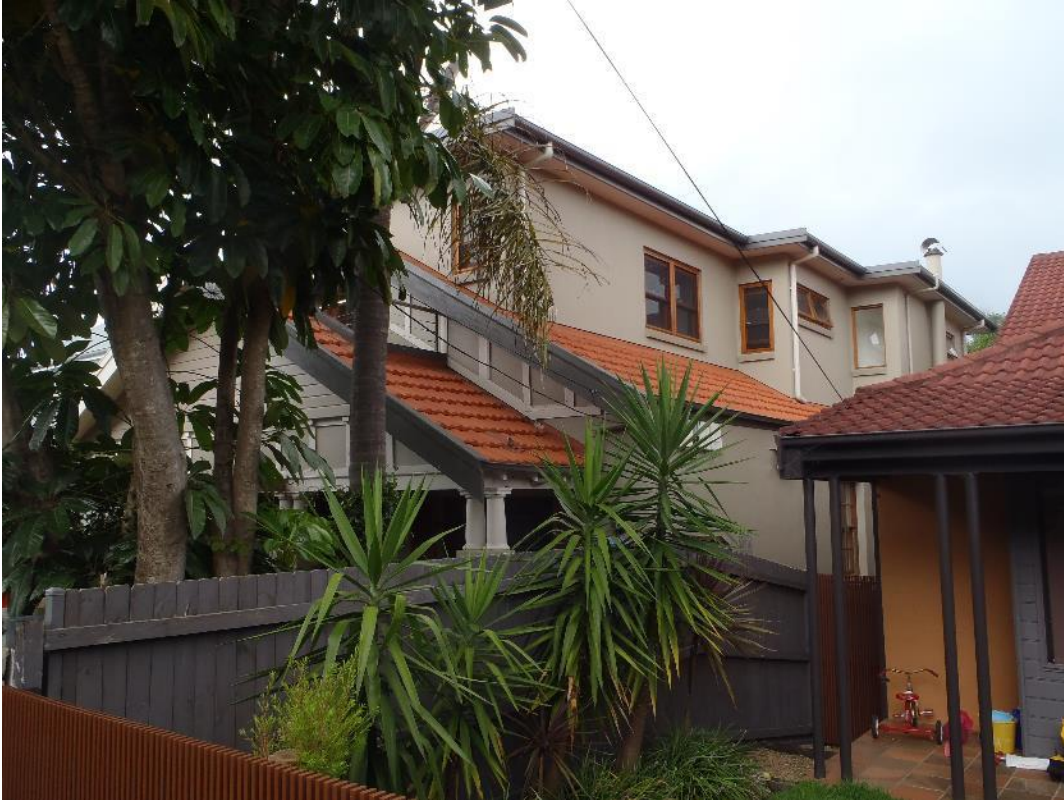
We observed that the terracotta roof tiles to the original roof surfaces are generally interlinked and securely bedded, in our opinion forming a weather resistant cover to the residence. **[Photograph 1]**

Photograph 1 shows the general condition of the north-western elevation.

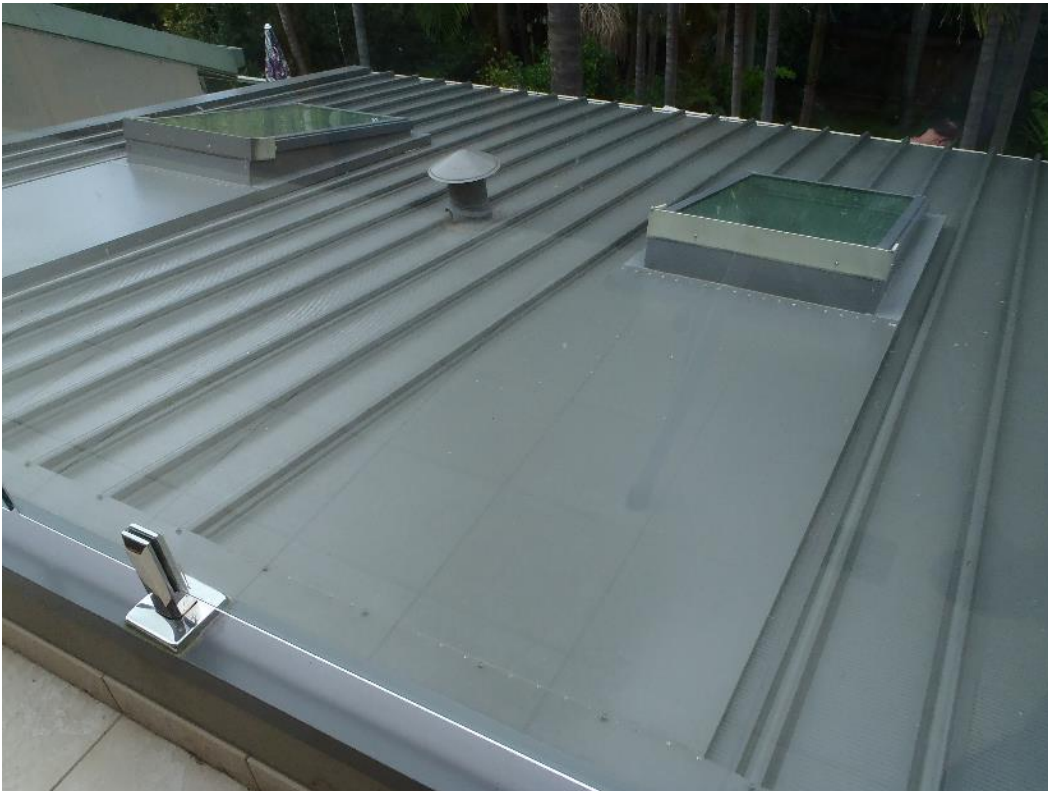
We noted that the pan profile sheet metal roofing to the rear addition skillion roof is in good condition and is securely fixed, in our opinion forming a weather resistant cover to the rear addition. **[Photograph 2]**

Photograph 2 shows the general condition of the rear skillion roof surface.

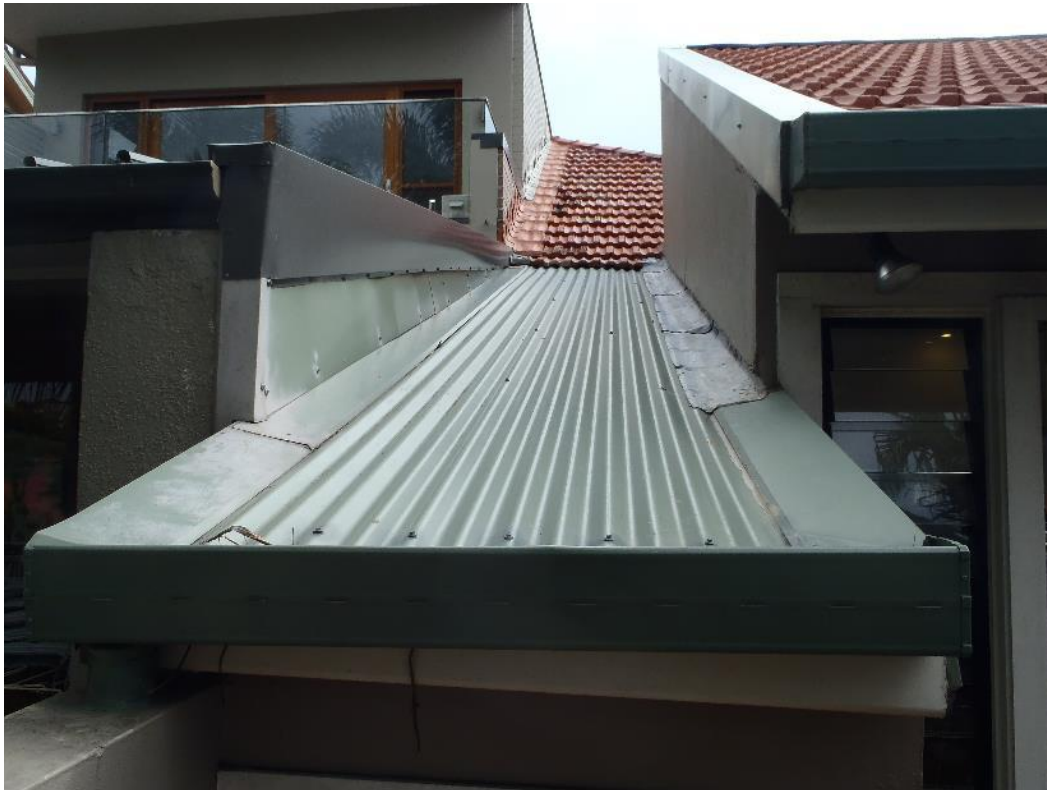
We also noted that the side flashing between the brick wall of upper floor addition and the metal and tile roofs of the adjoining property, No. 5A Darling Street is in good condition and forming a weather resistant seal between the wall and the roof surface. **[Photograph 3]**

Photograph 3 shows the side flashing between the brick wall of upper floor addition and the metal and tile roofs of the adjoining property, No. 5A Darling Street.

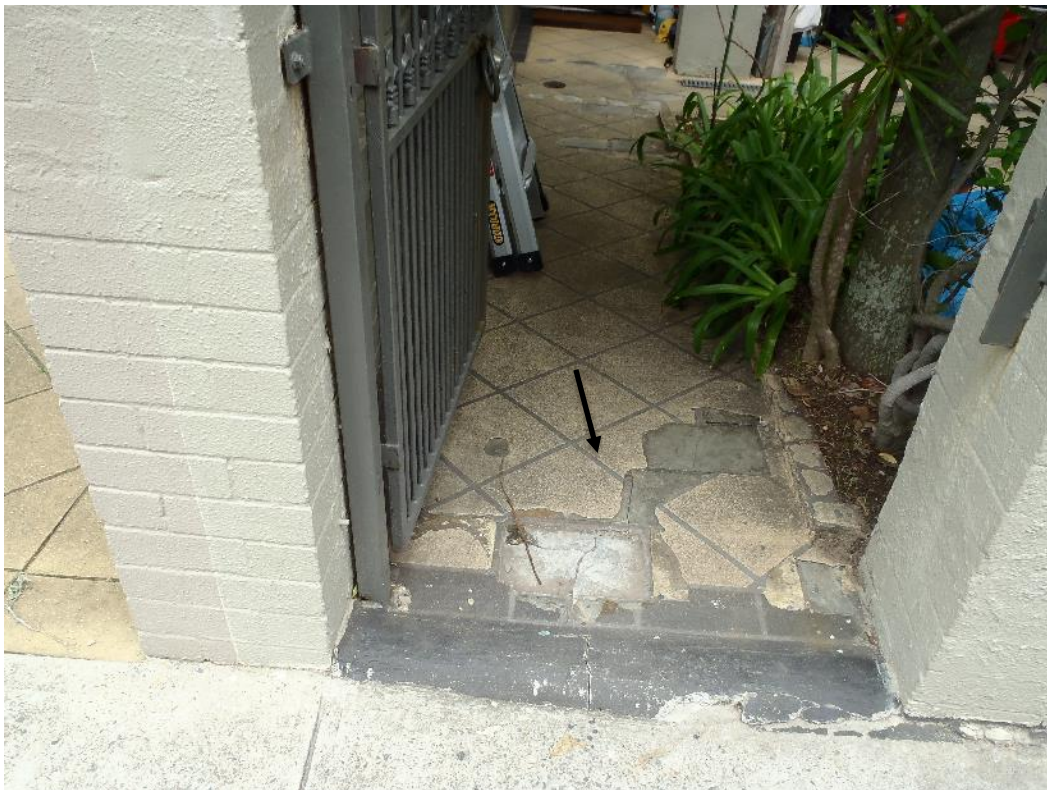
We noted cracking and deterioration of the concrete entry pathway. **[Photographs 4 & 5]**

Photograph 4 shows cracking and deterioration of the concrete entry pathway.

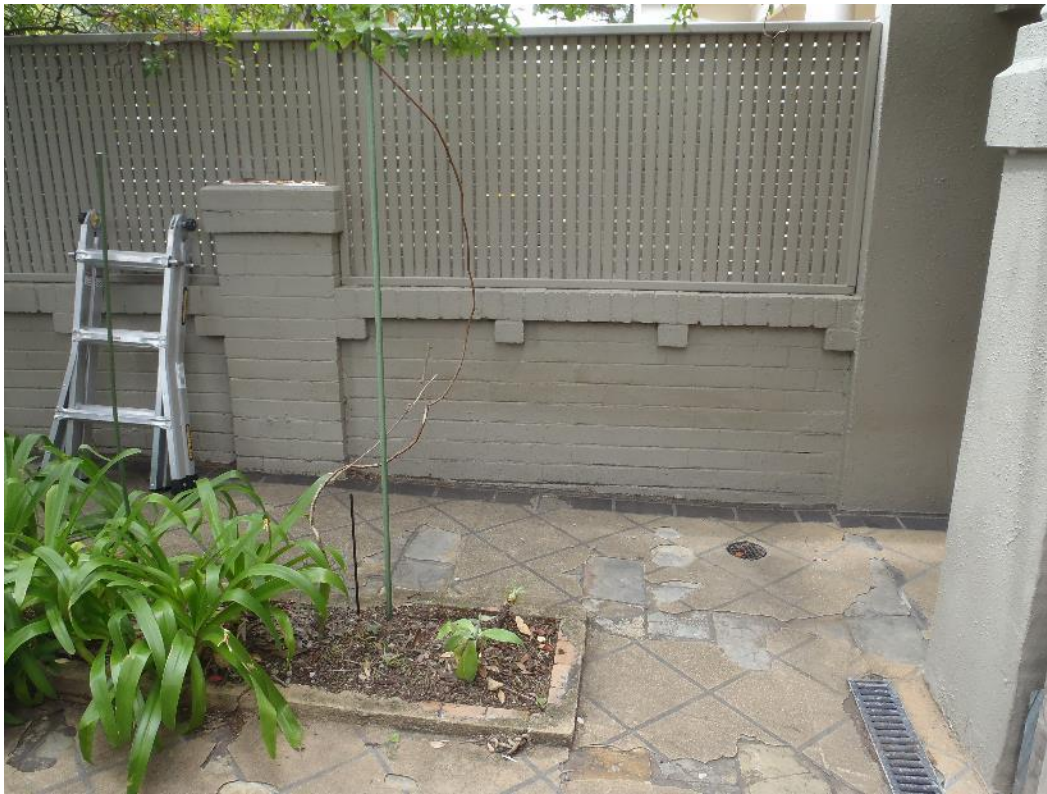
We noted that the *common* boundary wall with the adjoining property, No. 5A Darling Street is of surface coated clay masonry brickwork construction with timber lattice overlay panels. **[Photograph 5]**

Photograph 5 shows the front *common* boundary wall with the adjoining property, No. 5A Darling Street and cracking to the concrete pathway.

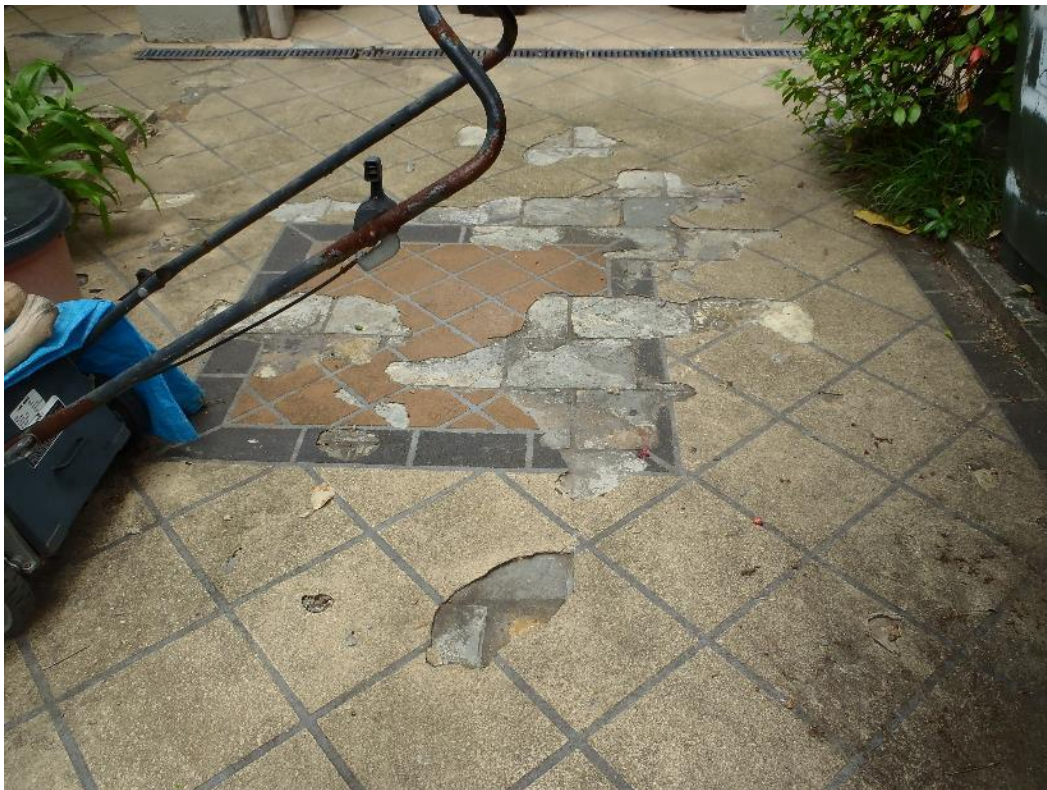
We noted cracking and deterioration of the concrete driveway. **[Photograph 6]**

Photograph 6 shows cracking and deterioration of the concrete driveway.

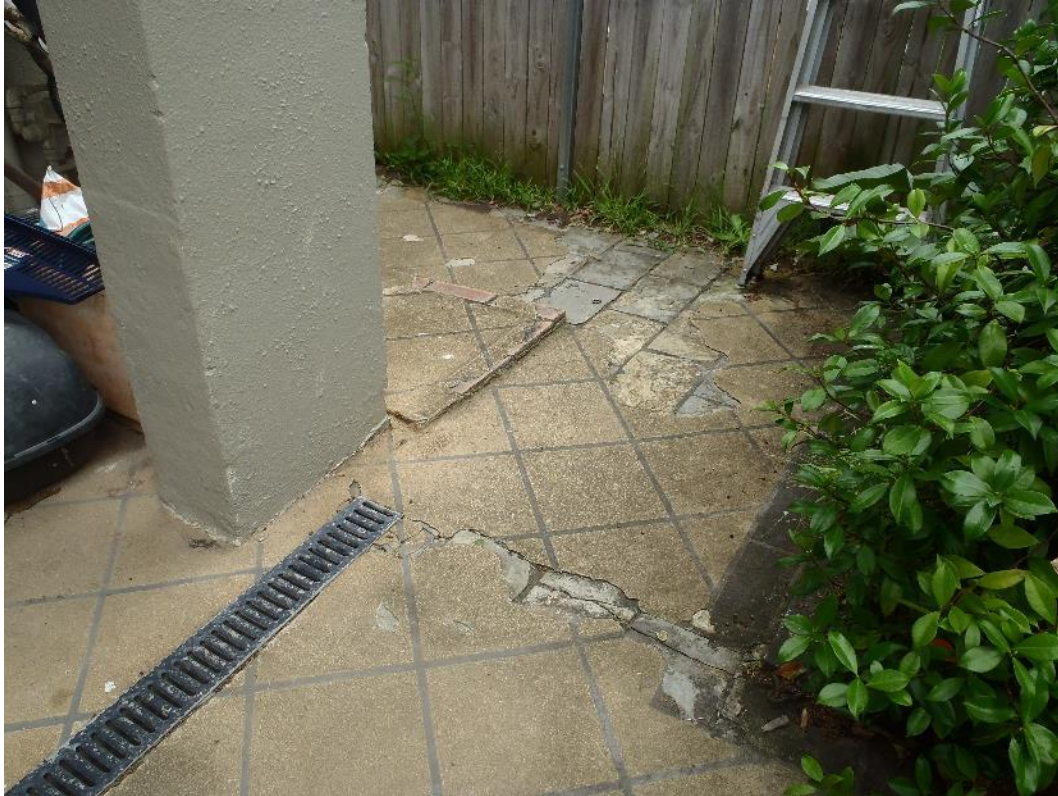
We noted cracking and deterioration of the concrete side pathway. **[Photograph 7]**

Photograph 7 shows cracking and deterioration of the concrete side pathway.

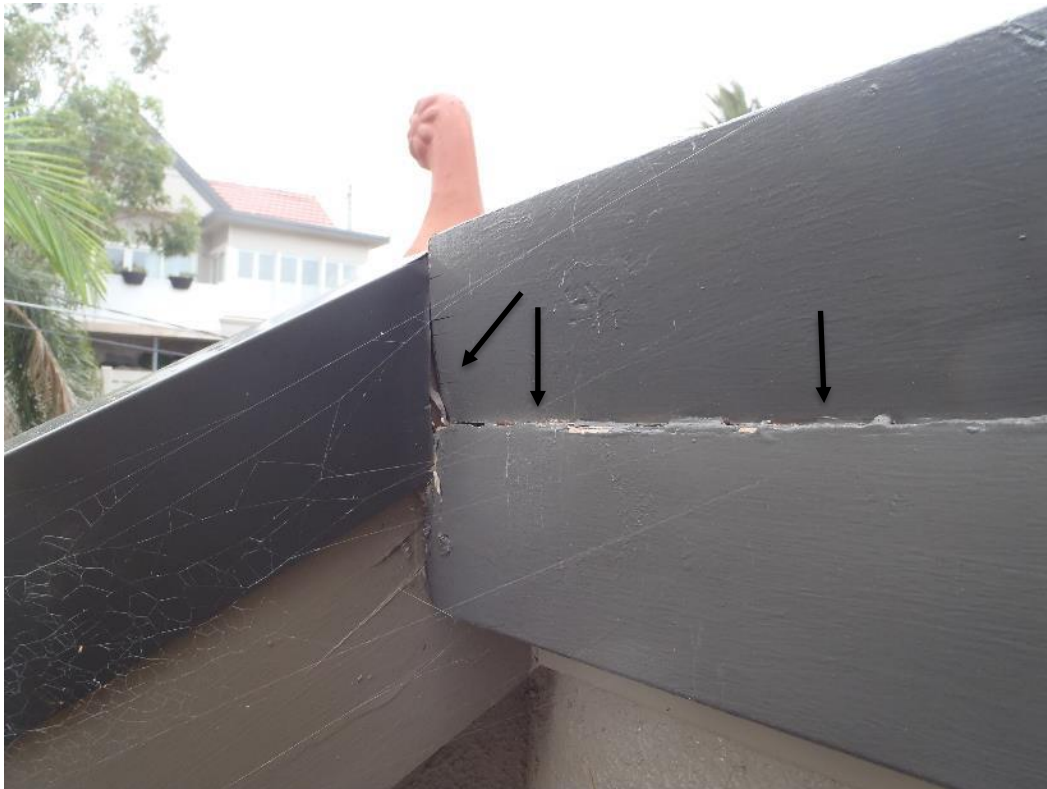
We noted separation cracking and gaps to the timber fascia outside the front balcony. **[Photograph 8]**

Photograph 8 shows separation cracking and gaps to the timber fascia outside the front balcony.

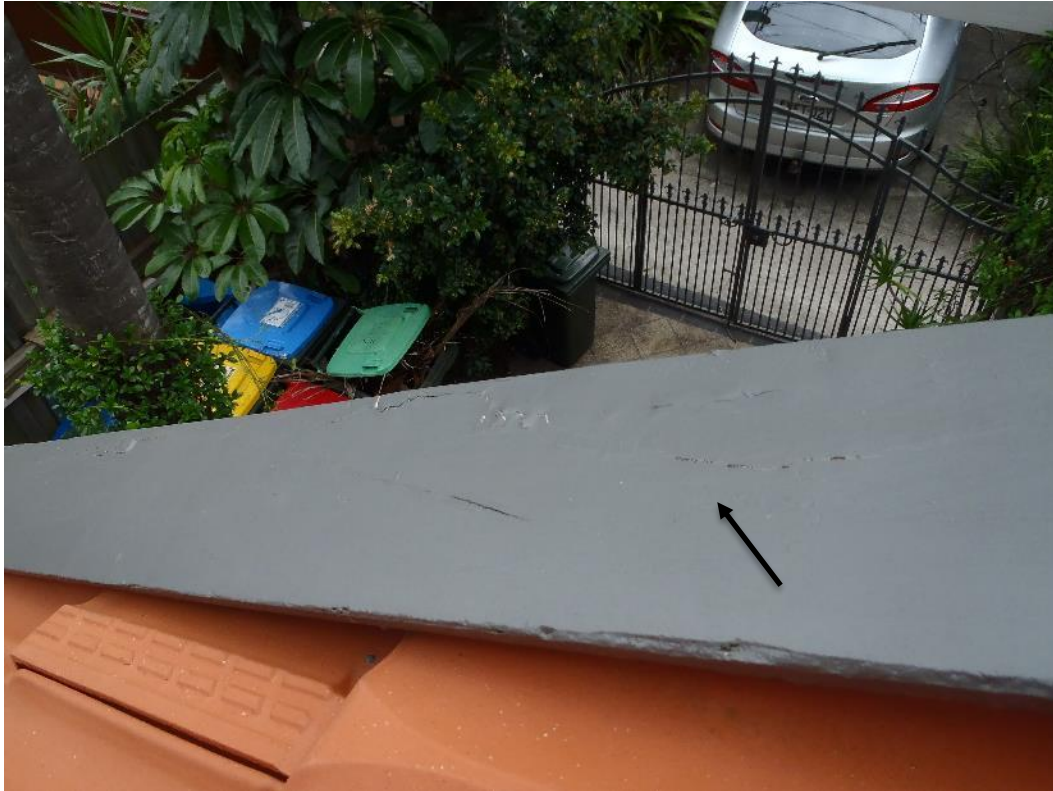
We noted deterioration to the timber barge outside the front balcony on the gable end. **[Photograph 9]**

Photograph 9 shows deterioration to the timber barge outside the front balcony on the gable end.

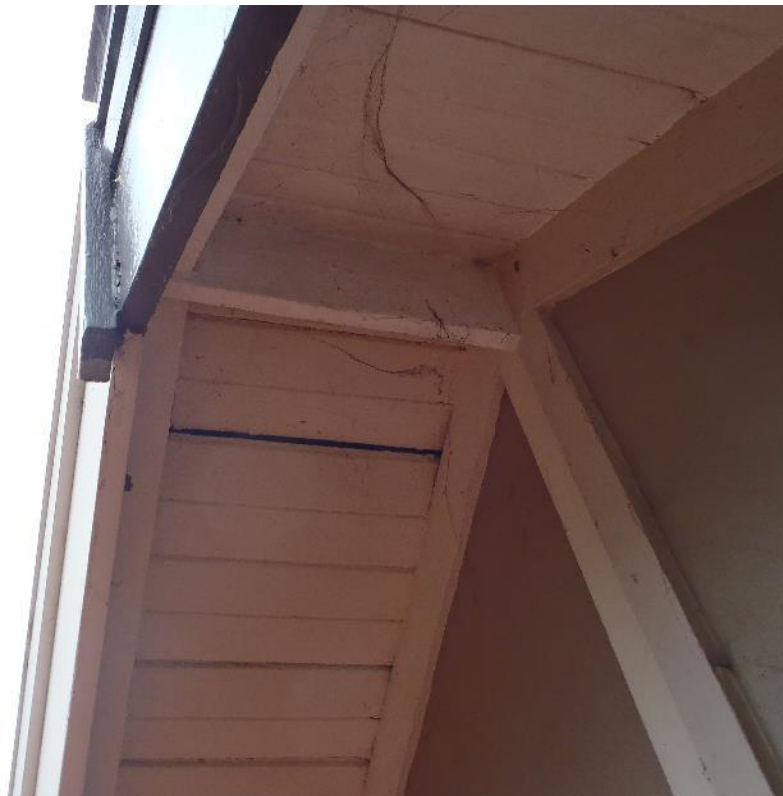
We noted gaps to the timber gable end soffit lining. **[Photograph 10]**

Photograph 10 shows gaps to the timber gable end soffit lining.

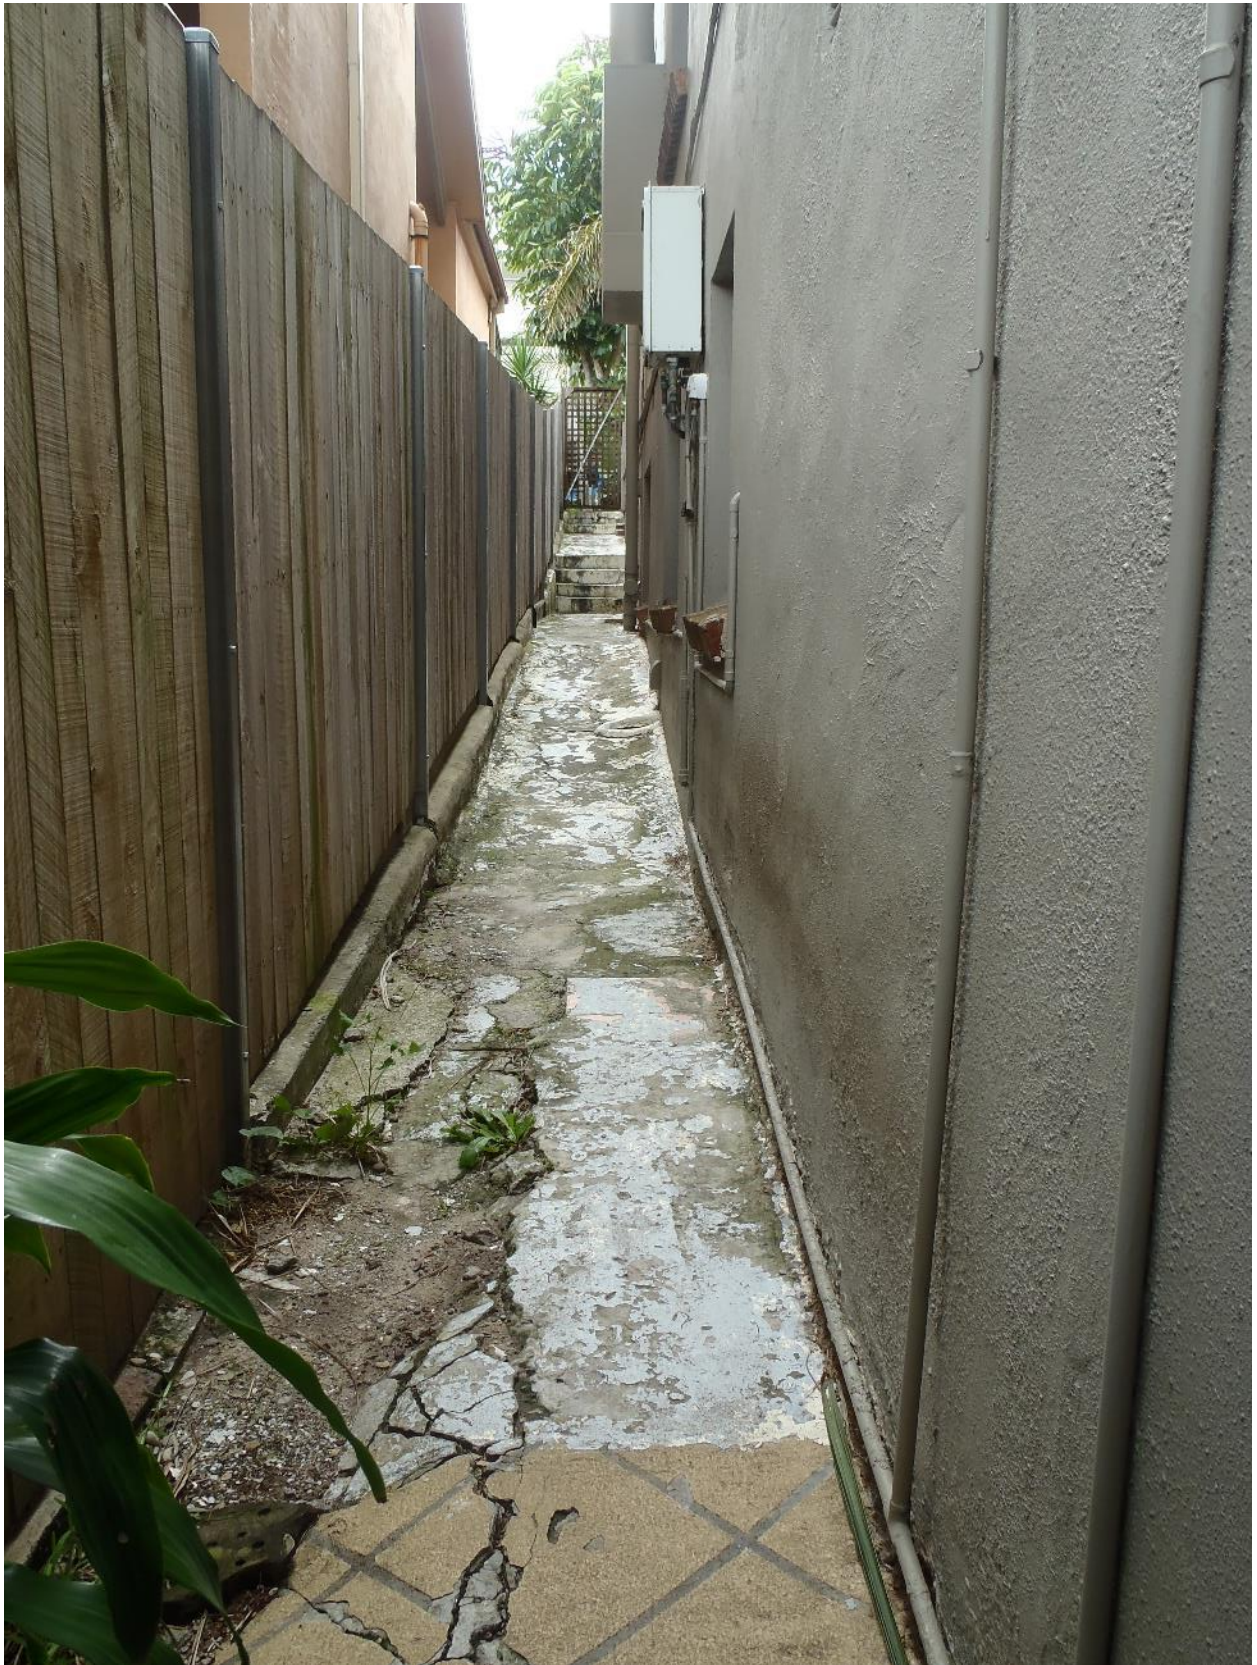
We noted cracking and deterioration of the concrete side pathway. **[Photograph 11]**

Photograph 11 shows the general condition of the side pathway and cement rendered wall.

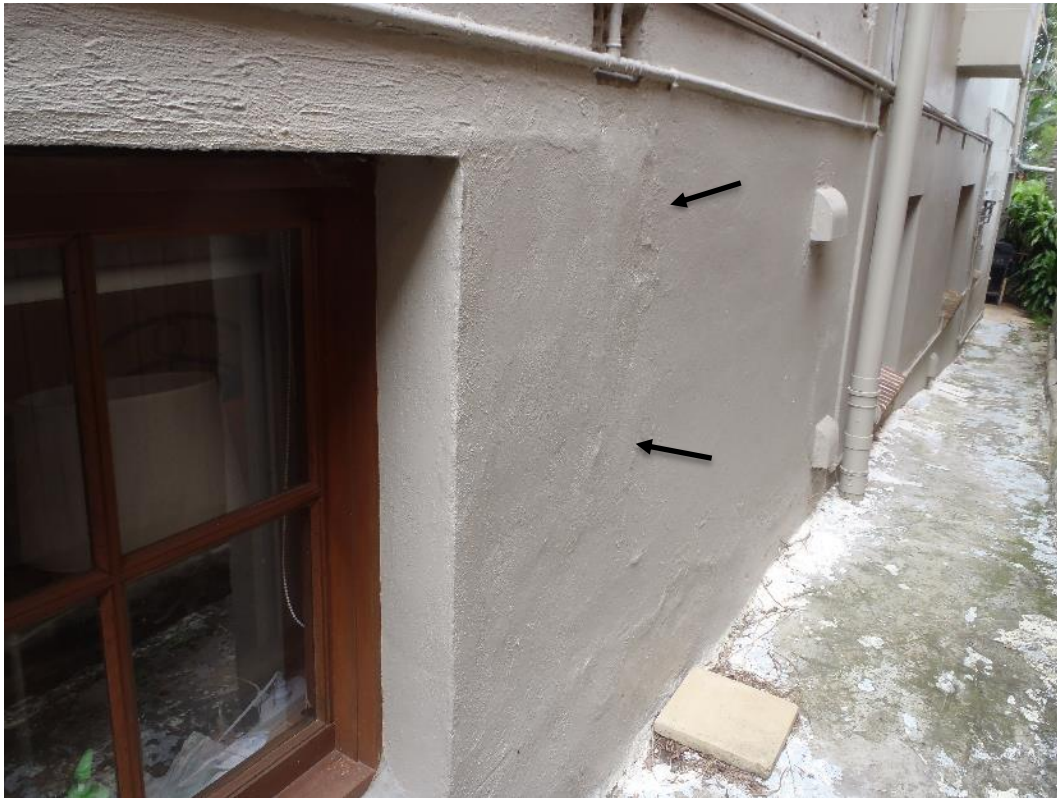
We noted evidence of a previous repair to the surface coated clay masonry brickwork adjacent to the lower ground floor Bedroom 1 window. **[Photograph 12]**

Photograph 12 shows evidence of a previous repair to the surface coated clay masonry brickwork adjacent to the lower ground floor Bedroom 1 window.

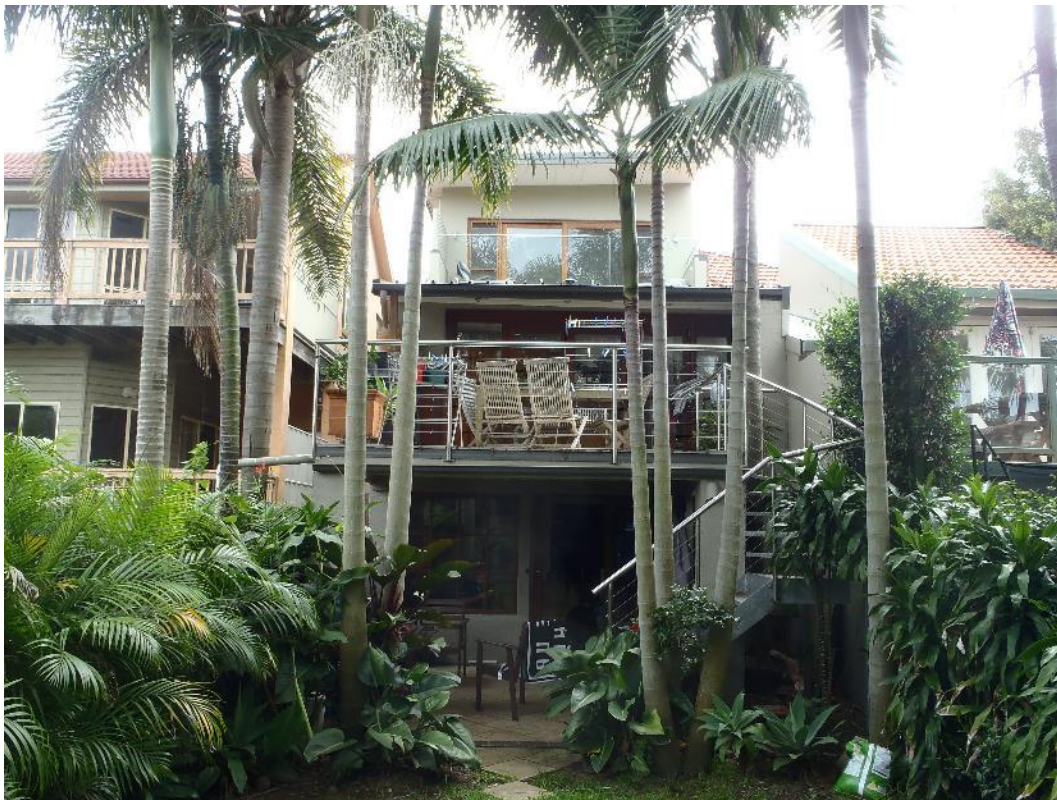
We noted external steps from the ground floor patio to the lower ground floor. We further noted that the rear section of the ground floor has a skillion pan profiled sheet metal roof. **[Photograph 13]**

Photograph 13 shows the general condition of the rear southern elevation.

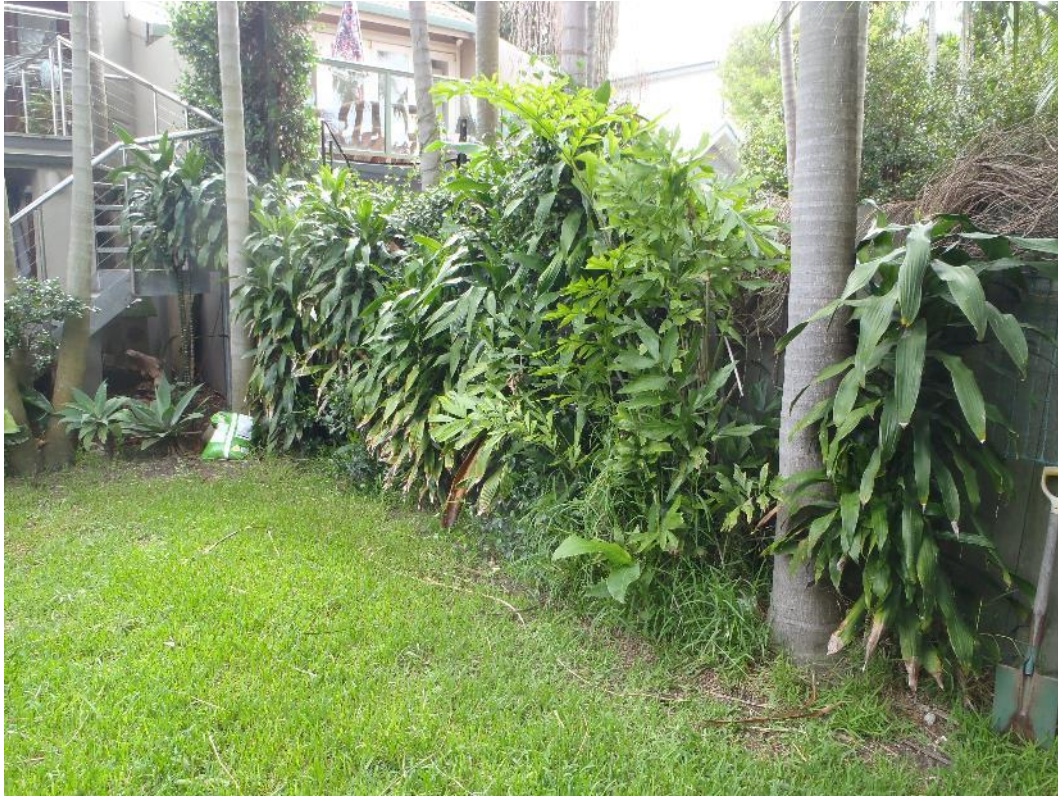
We noted that the *common* boundary fence with the adjoining property, No. 5A Darling Street is of timber post and rail construction. **[Photograph 14]**

Photograph 14 shows the *common* boundary fence with the adjoining property, No. 5A Darling Street.

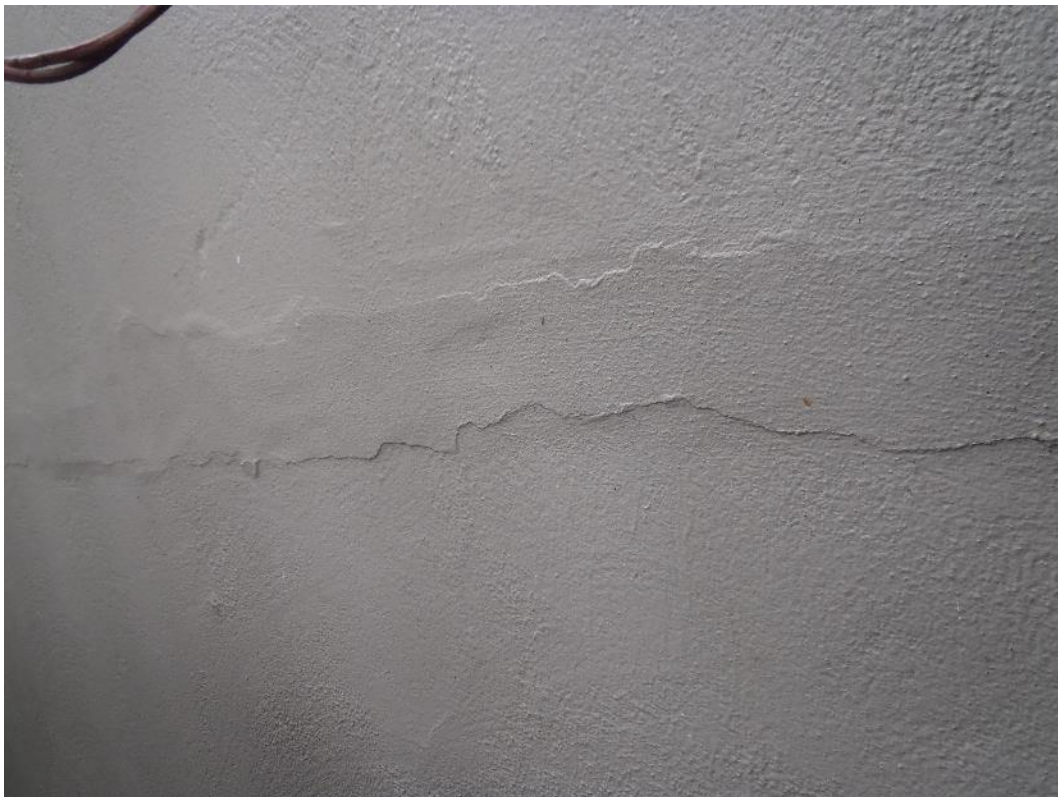
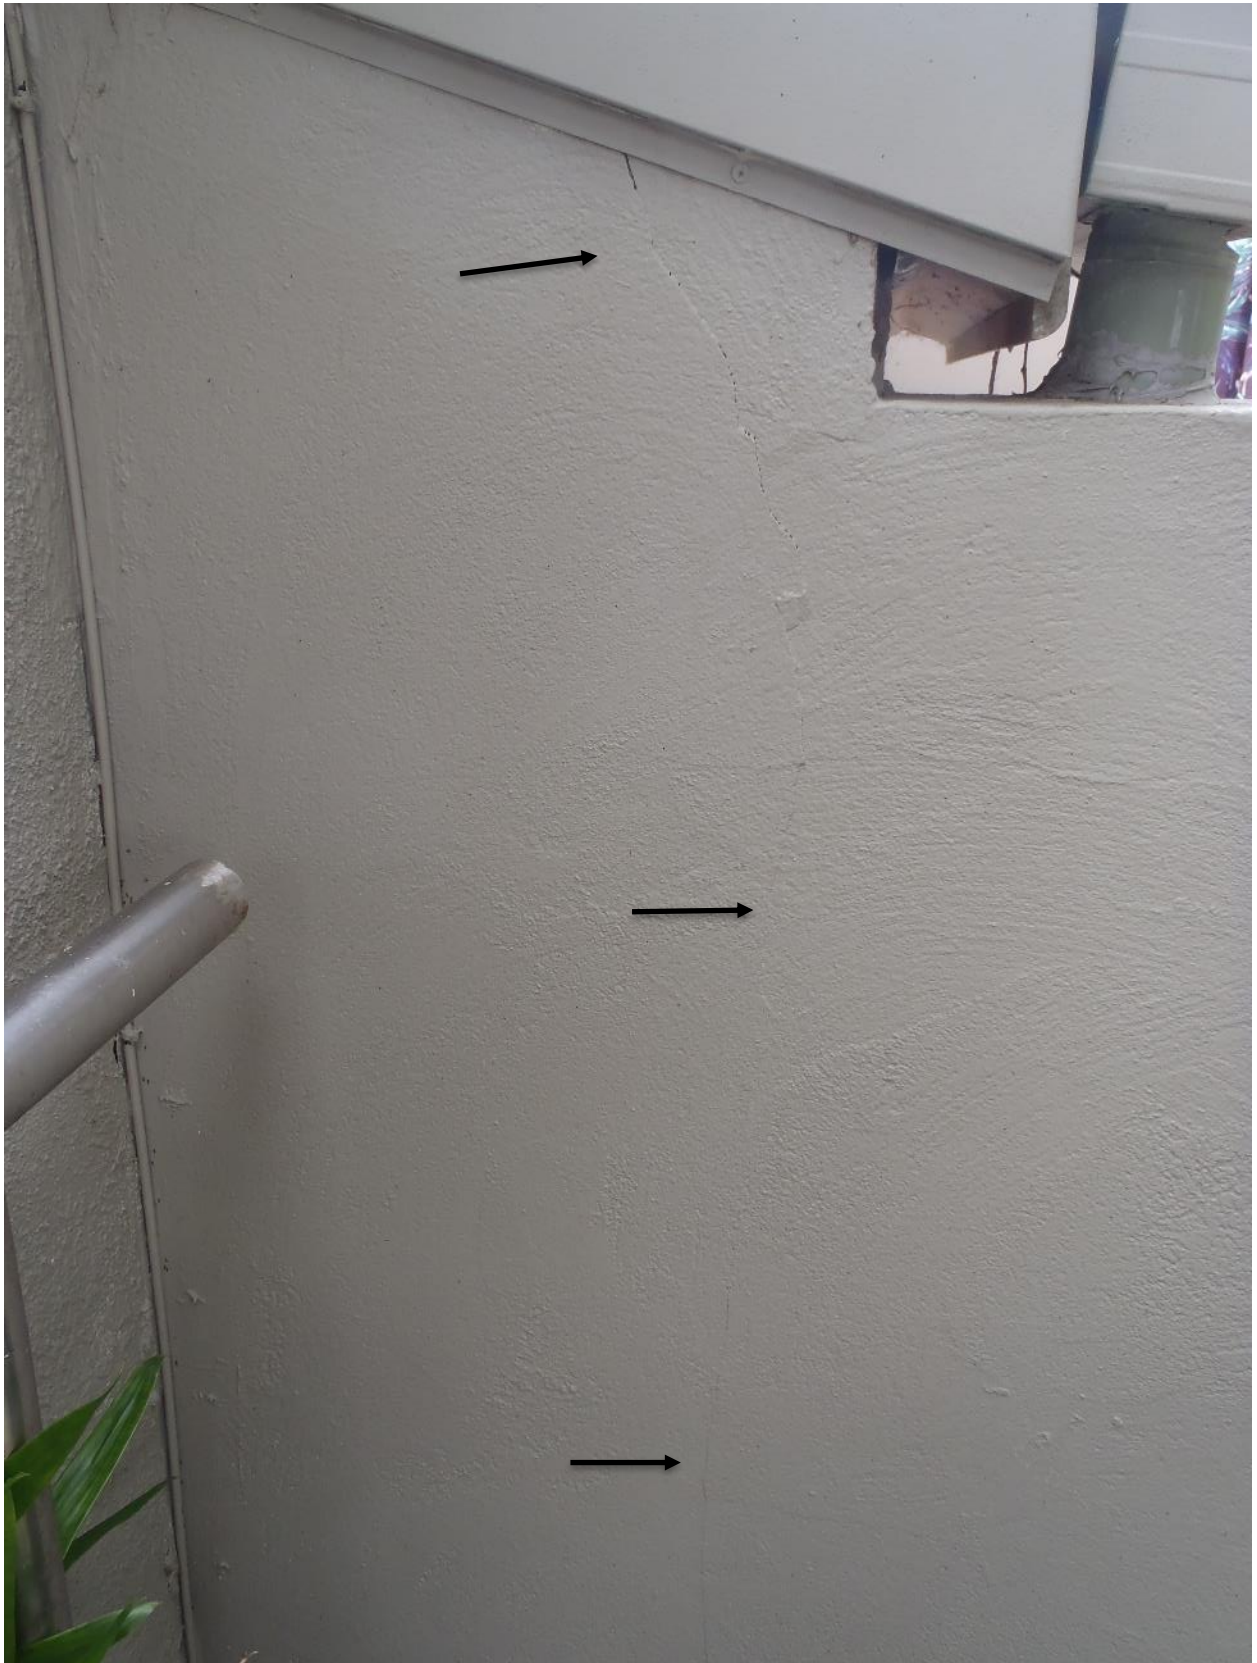
We noted evidence of a previous repair to the surface coated clay masonry brickwork along the common party / separation wall to the lower ground level under the external staircase. **[Photographs 15 & 16]**

Photograph 15 shows evidence of a previous repair to the surface coated clay masonry brickwork along the *common party / separation* wall to the lower ground level under the external staircase.

Photograph 16 shows evidence of a previous repair to the surface coated clay masonry brickwork along the *common party / separation* wall to the lower ground level under the external staircase.

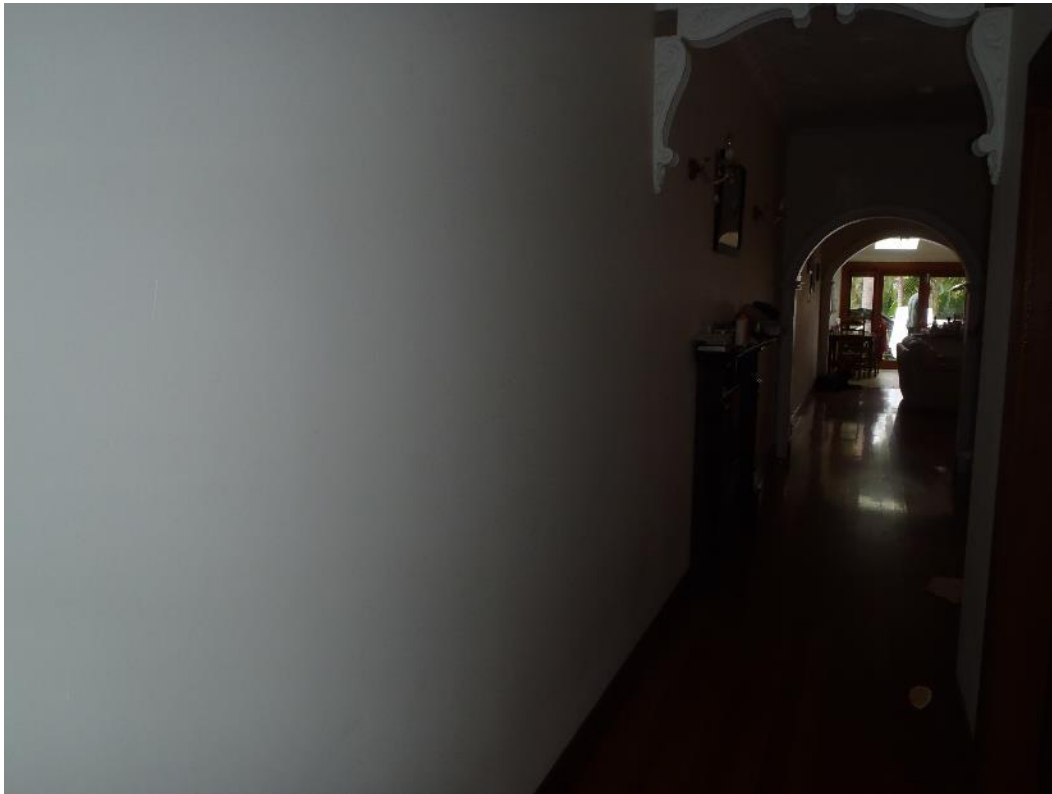
We did not observe any cracking to the cement rendered *common party / separation* wall with the adjoining property, No. 5A Darling Street. **[Photograph 17]**

Photograph 17 shows the general condition of the cement rendered *common party* / *separation* wall with the adjoining property, No. 5A Darling Street.

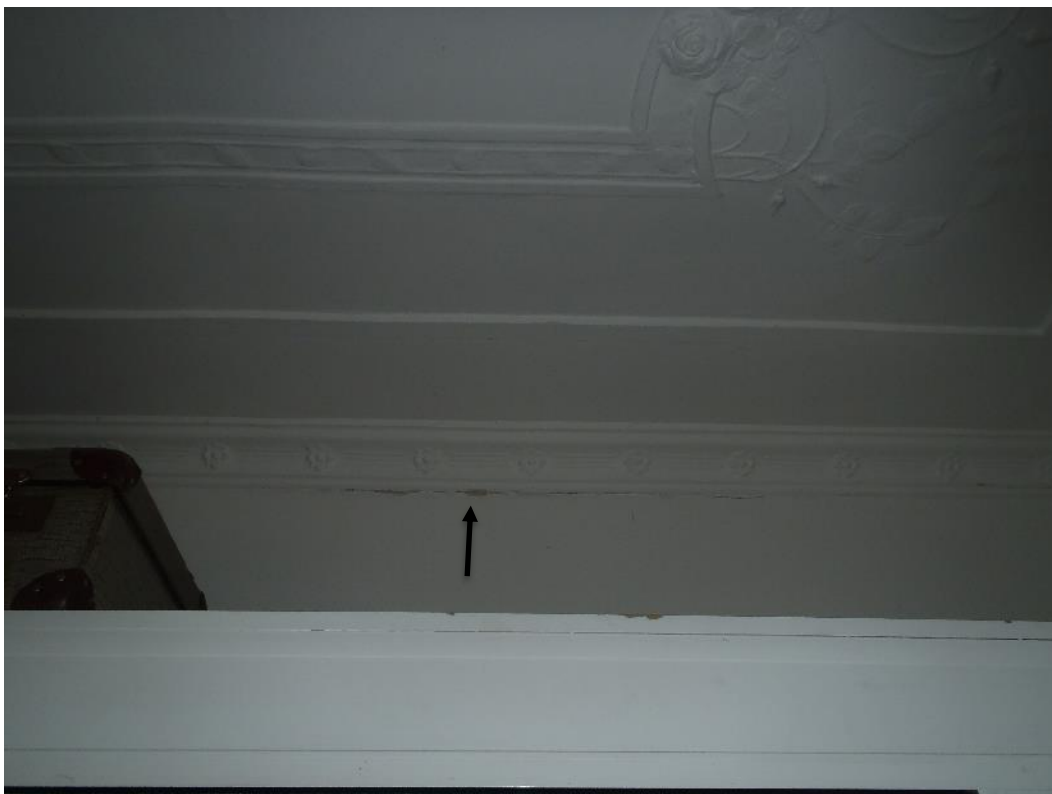
We noted separation cracking [1.0 - 3.0 mm] of the cornice from the wall surface to the southern elevation wall. **[Photograph 18]**

Photograph 18 shows separation cracking of the cornice from the wall surface to the southern elevation wall in Bedroom 1

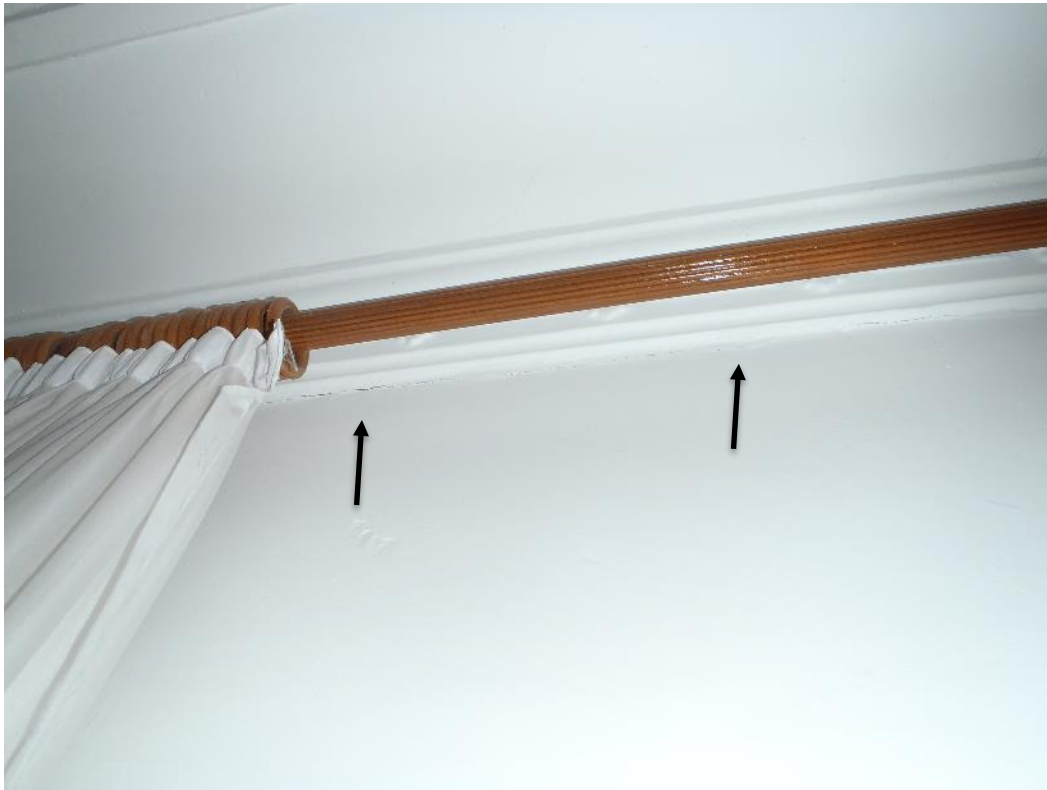
We noted separation cracking [1.0 - 3.0 mm] of the cornice from the wall surface to the northern elevation wall above the window. **[Photograph 19]**

Photograph 19 shows separation cracking [1.0 - 3.0 mm] of the cornice from the wall surface to the northern elevation wall above the window in Bedroom 1.

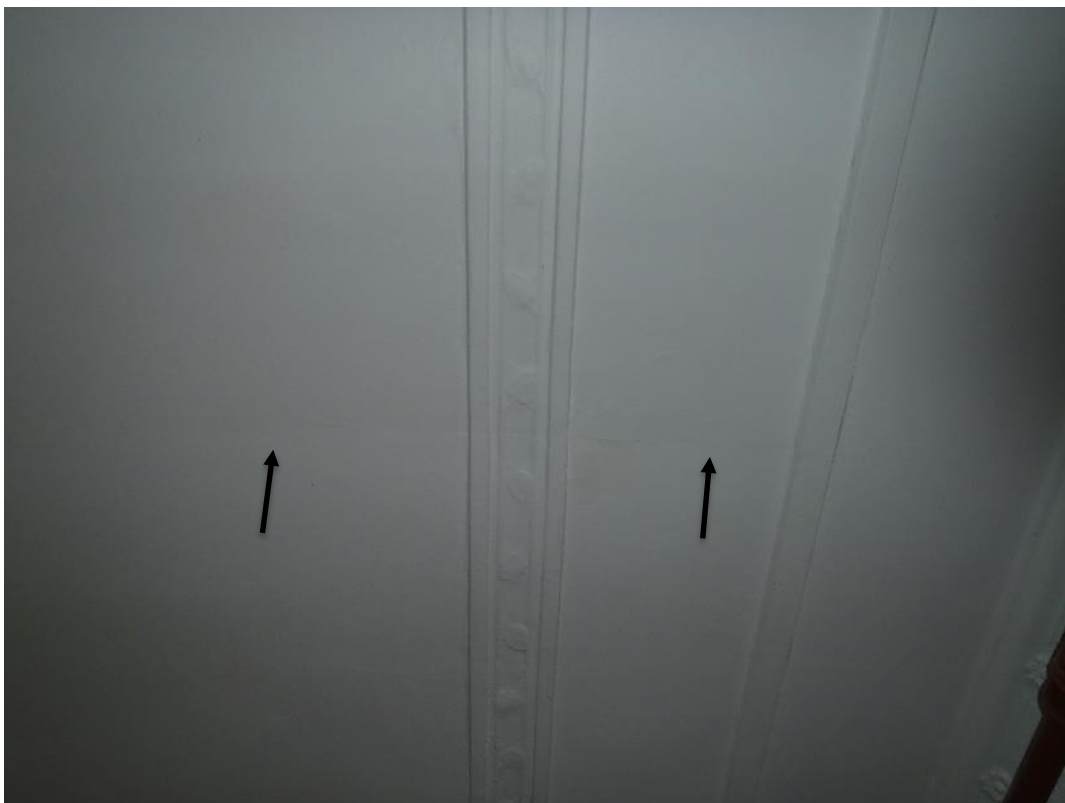
We noted hairline separation cracking [< 1.0 mm] of the decorative fibrous plaster ceiling lining adjacent to the window. **[Photograph 20]**

Photograph 20 shows hairline separation cracking of the decorative fibrous plaster ceiling lining adjacent to the window in Bedroom 1.

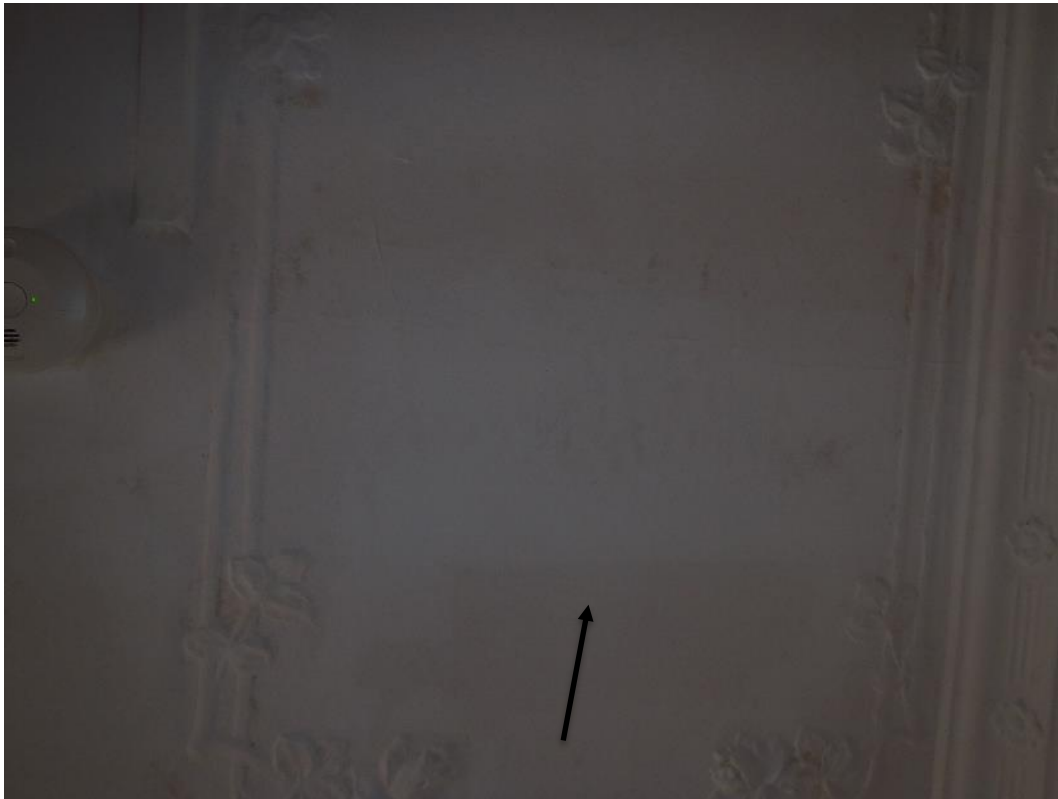
We noted general staining to the decorative plaster ceiling. We further noted evidence of a previous repair and a hairline separation crack [< 1.0 mm] adjacent to the light fitting in the Hallway. **[Photograph 21]**

Photograph 21 shows general staining to the decorative plaster ceiling, evidence of a previous repair and a hairline separation crack adjacent to the light fitting in the Hallway in the Study.

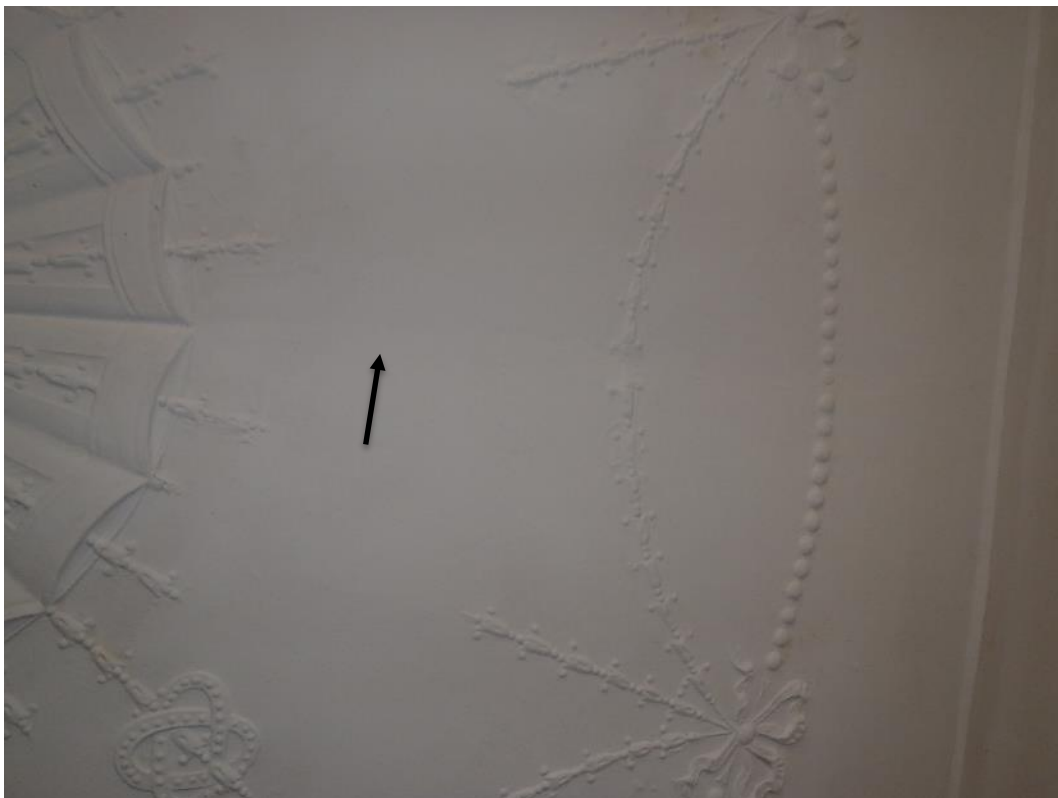
We noted a hairline separation crack [< 1.0 mm] to the decorative plaster ceiling extending toward the decorative ceiling rose from the southern wall. **[Photograph 22]**

Photograph 22 shows a hairline separation crack to the decorative plaster ceiling extending toward the decorative ceiling rose from the southern wall in the Study.
