Dilapidation Assessment Report

Prepared for: Cape Cod Australia Pty. Limited
Job address: 5 Darling Street, Bronte.
Property Owner/s: Mr. Peter Engel.
Report reference: **WAVERLEY COUNCIL**
Development Application No: not available
Date of assessment: 8th March 2017

Re: Dilapidation Report – No. 5 Darling Street, Bronte.

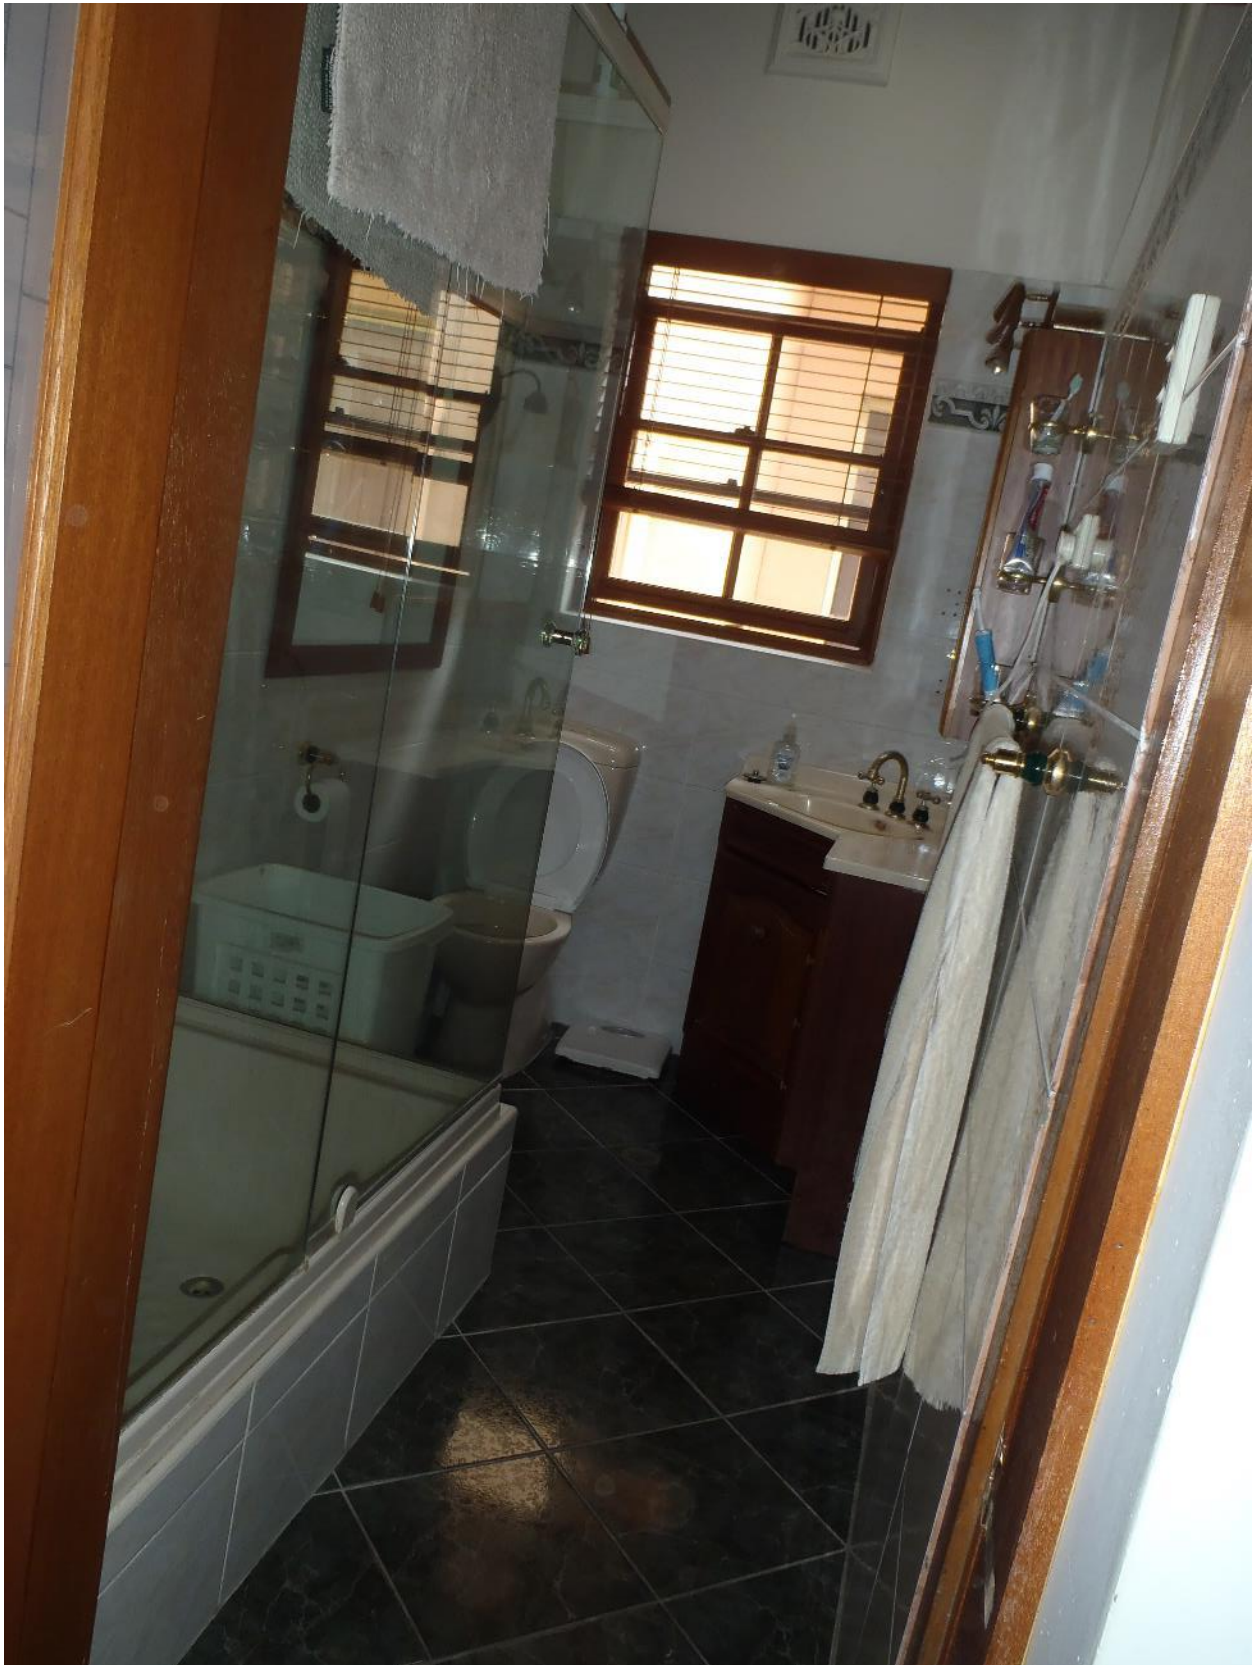
We noted that the grout to the wall and floor tiles is complete and that the wall and floor tiles when randomly “tap” tested appeared to be sound. We did not observe any recent cracking to the tile grout at the wall / wall, wall / floor junctions. **[Photograph 23]**

Photograph 23 shows the general condition of the ground floor Bathroom.

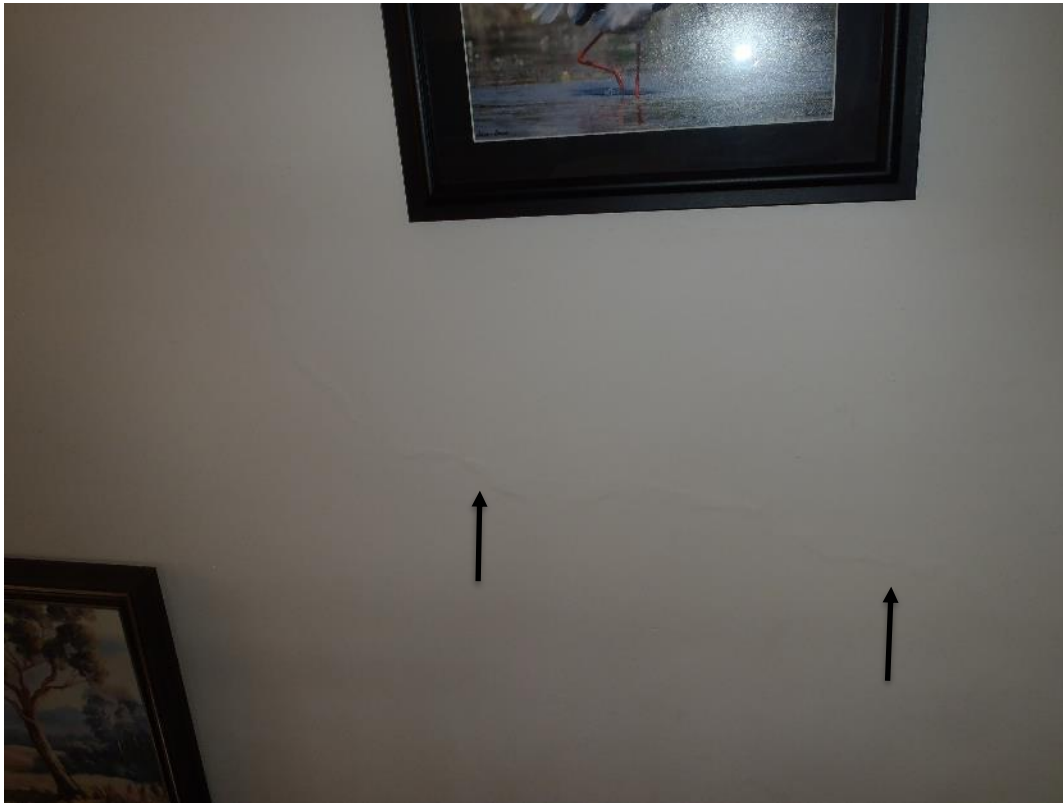
We noted evidence of a previous repair to the painted cement render wall on the northern elevation wall. **[Photograph 24]**

Photograph 24 shows evidence of a previous repair to the painted cement render wall on the northern elevation wall in the stairwell.

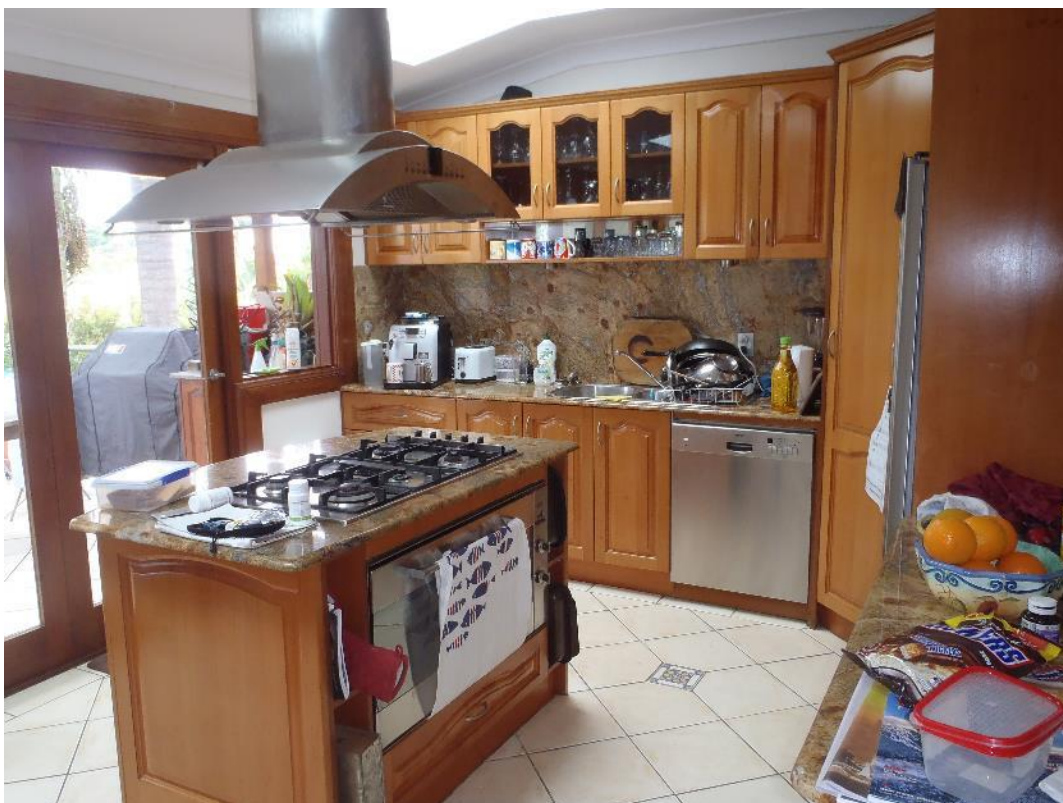
We noted that the Kitchen has an island bench and has skylights installed in the ceiling. **[Photograph 25]**

Photograph 25 shows the general condition of the Kitchen.

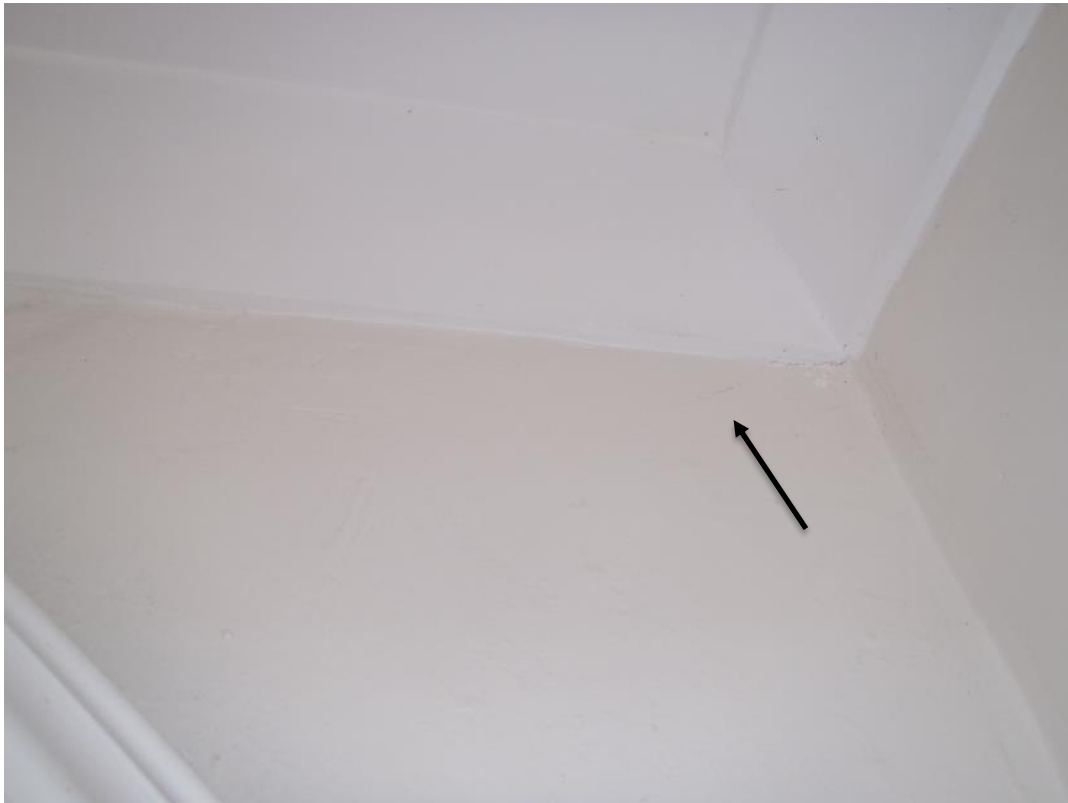
We noted radial cracking [< 1.0 mm] to the wall surface extending from the cornice toward the hallway arch. **[Photograph 26]**

Photograph 26 shows radial cracking to the wall surface extending from the cornice toward the hallway arch in the Kitchen.

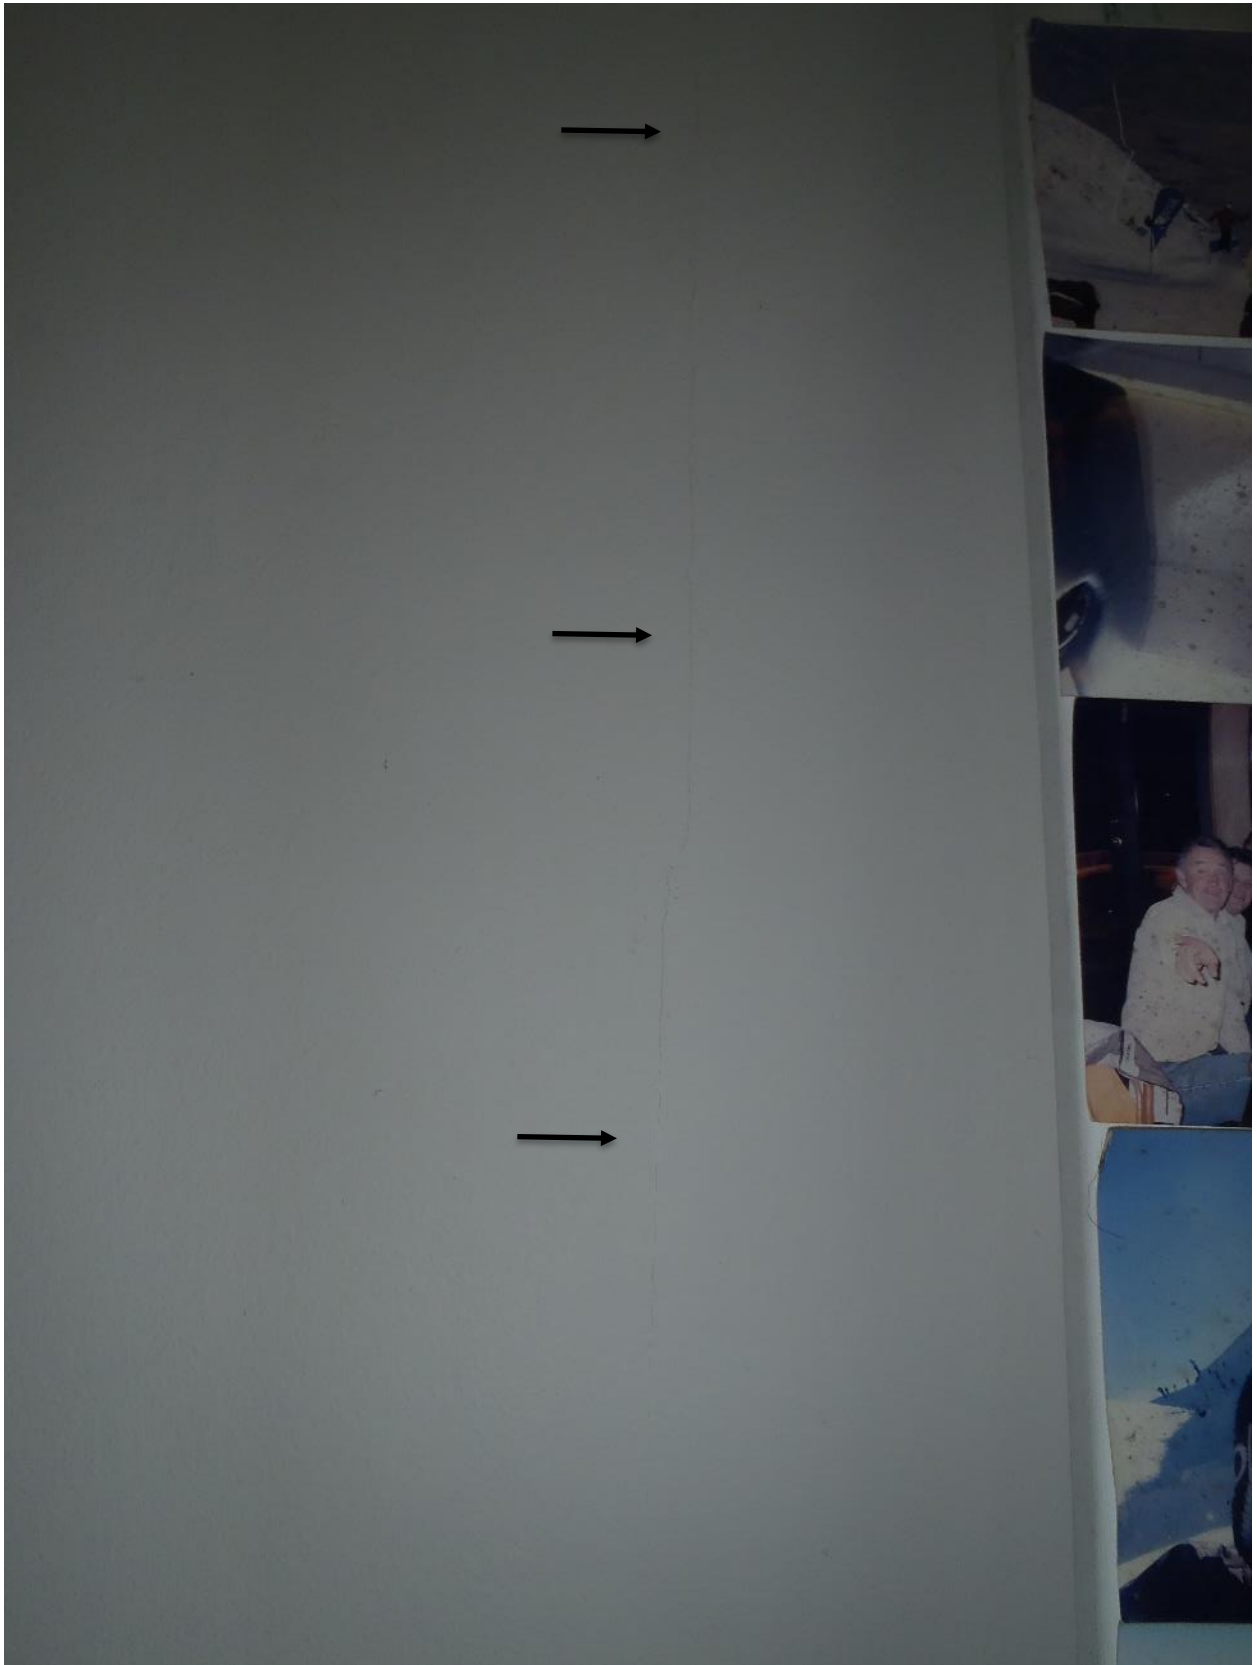
We noted vertical separation cracking [< 1.0 mm] to the plasterboard wall surface extending down from the cornice along the *common party / separation* wall with the adjoining property, No. 5A Darling Street. **[Photograph 27]**

Photograph 27 shows vertical separation cracking to the plasterboard wall surface extending down from the cornice along the *common party / separation* wall with the adjoining property, No. 5A Darling Street.

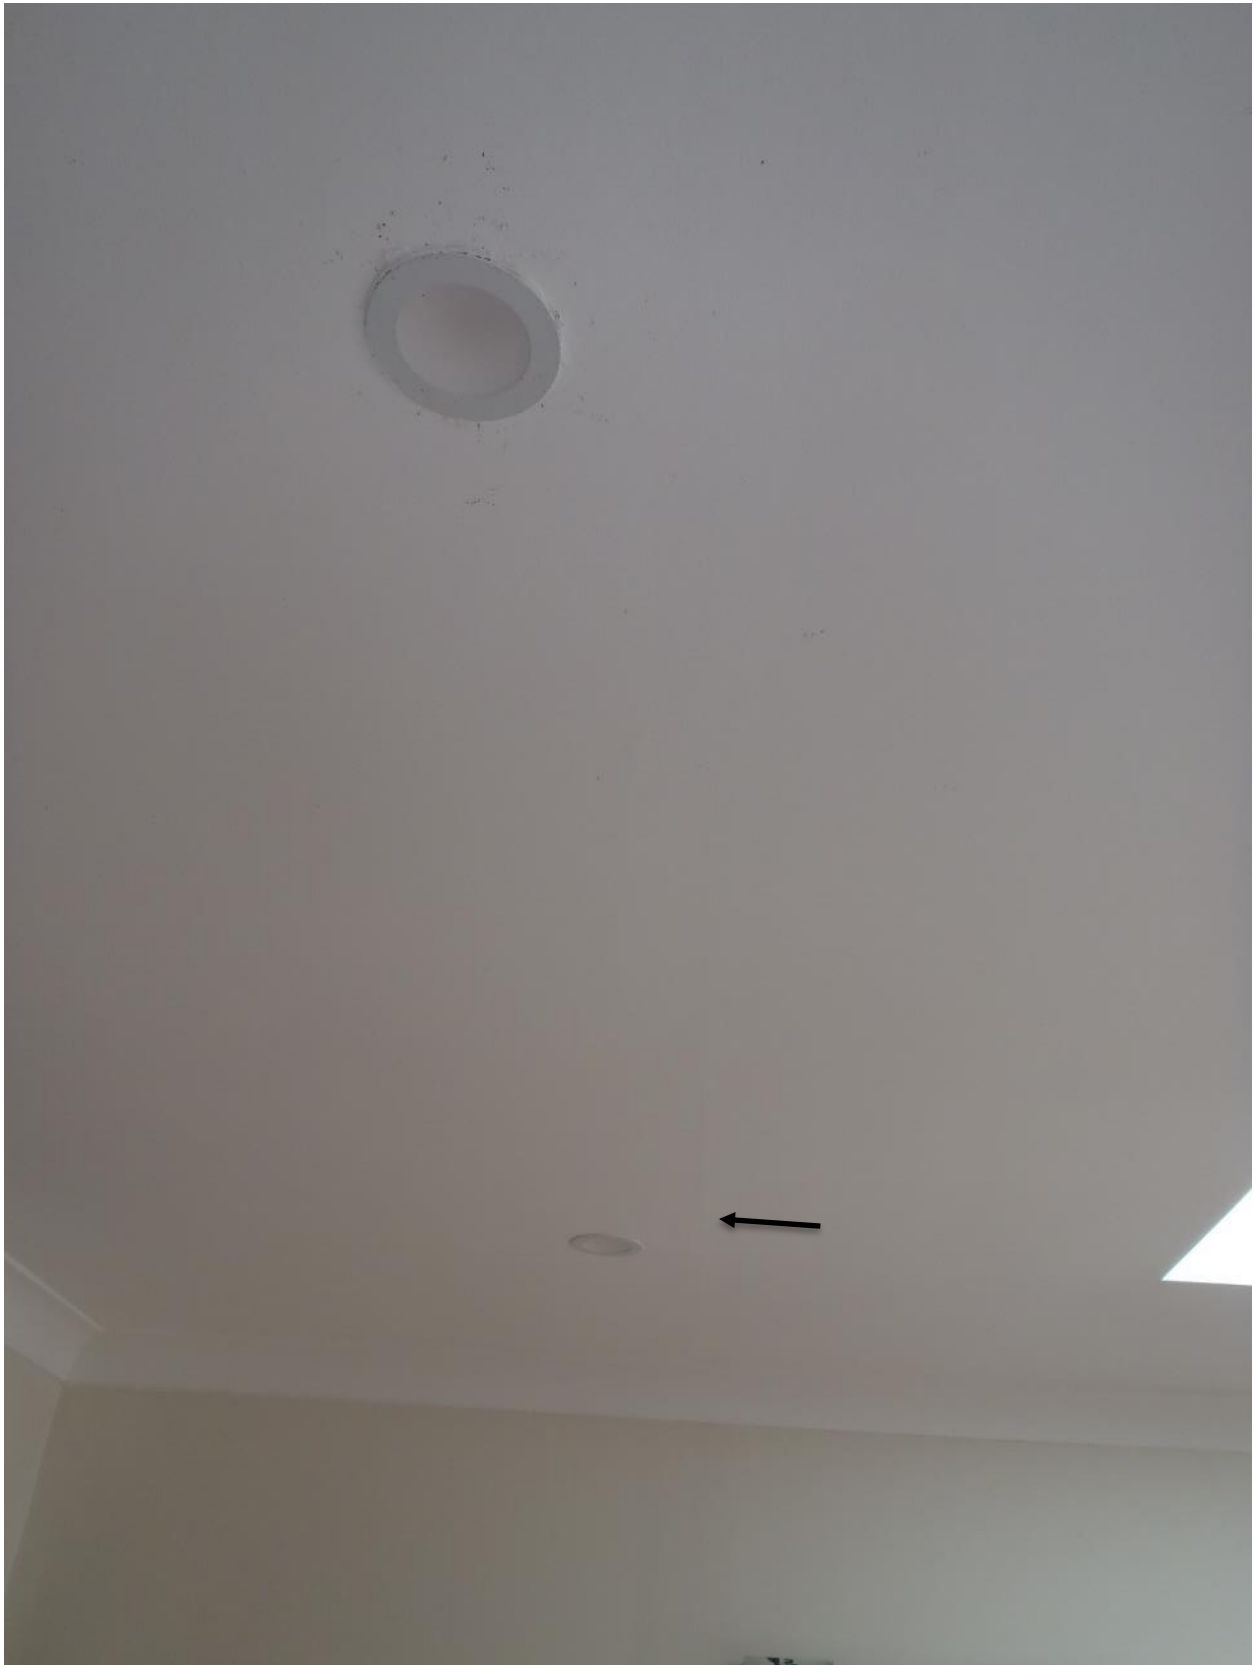
We noted separation cracking [$<1.0\text{mm}$] to the plasterboard ceiling lining adjacent to the *common party / separation* wall with the adjoining property, No. 5A Darling Street. **[Photograph 28]**

Photograph 28 shows separation cracking to the plasterboard ceiling lining adjacent to the *common party / separation* wall with the adjoining property, No. 5A Darling Street.

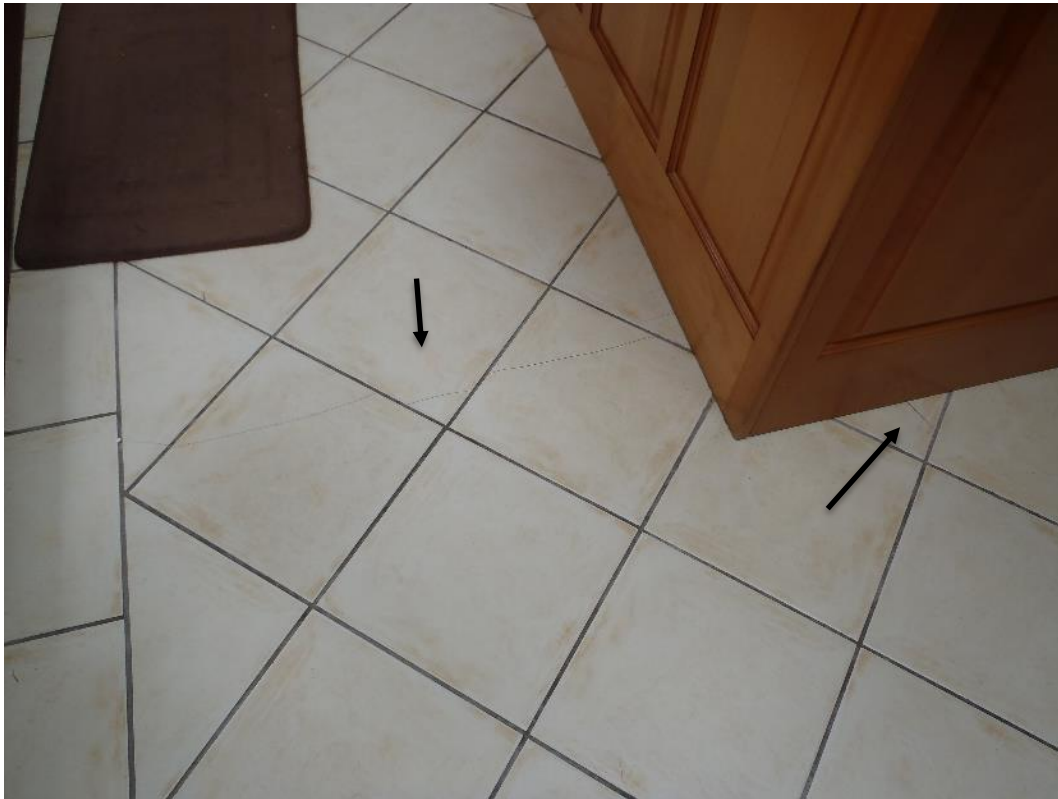
We observed that the floor is finished with ceramic tiles. We noted that the grout to the tiles is complete and that the tiles when randomly “tap” tested appeared to be sound. We noted cracks to the floor tiles extending away from the island bench. **[Photograph 29]**

Photograph 29 shows cracking to the floor tiles extending away from the island bench in the Kitchen.

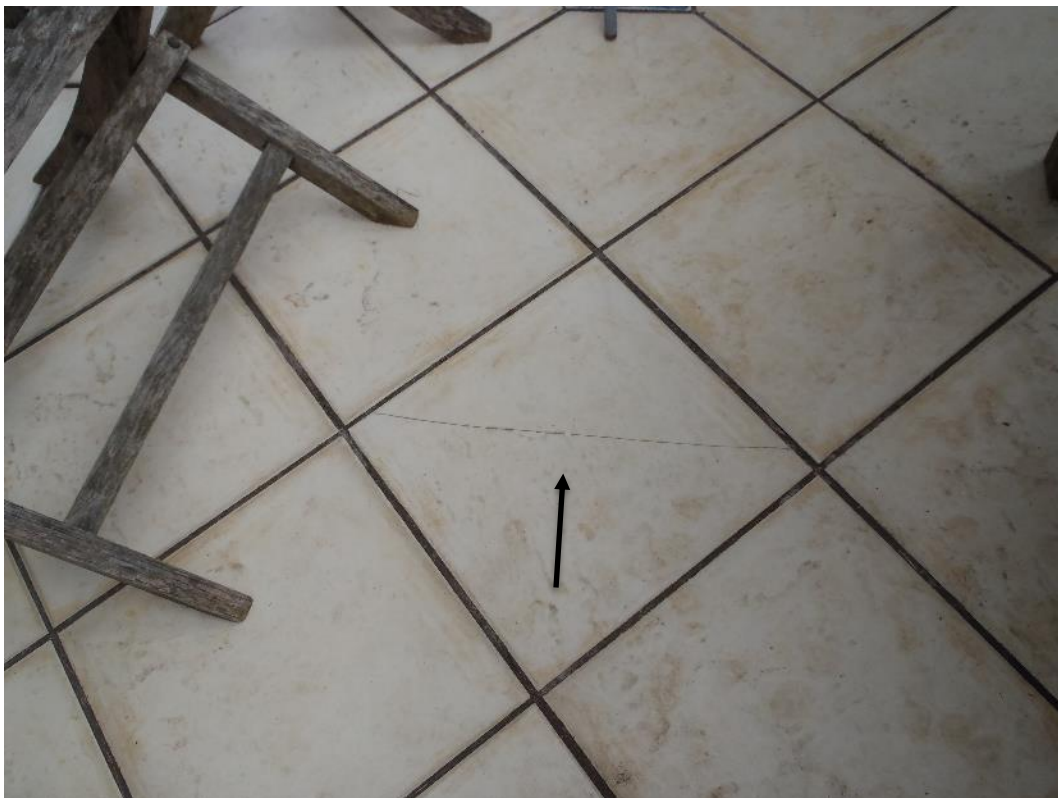
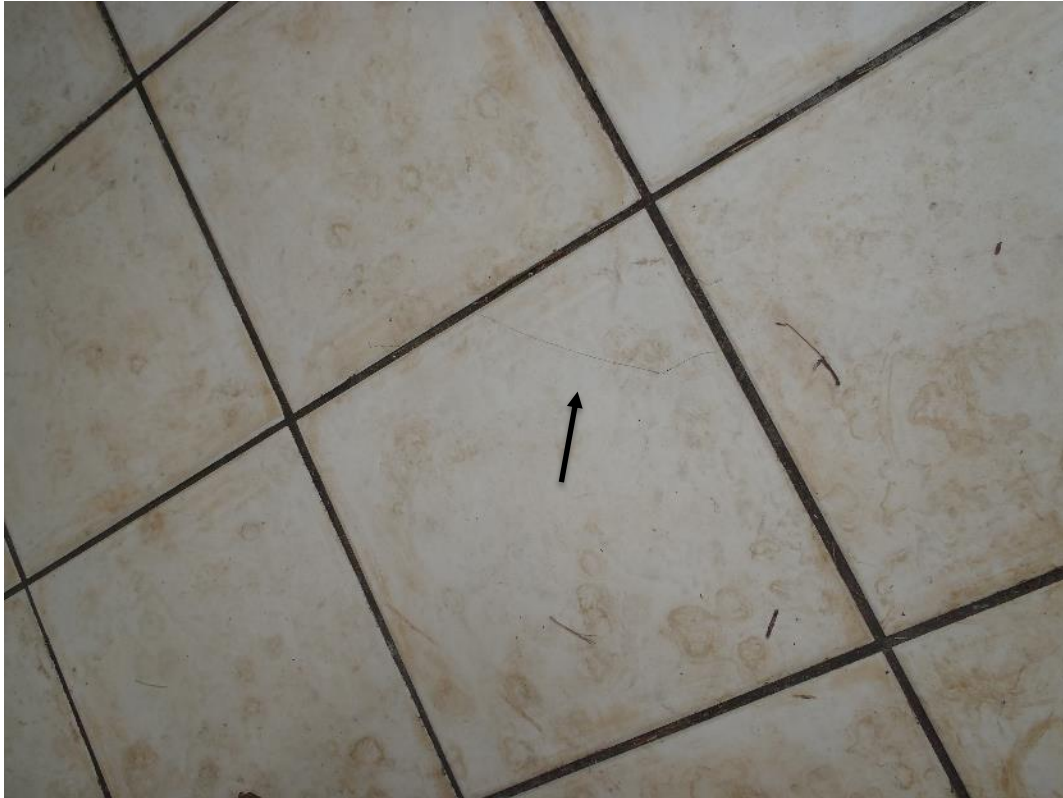
We observed that the floor is finished with ceramic tiles. We noted that the grout to the tiles is complete and that the tiles when randomly “tap” tested appeared to be sound. We noted some cracking to the floor tiles. **[Photographs 30 & 31]**

Photograph 30 shows cracking to the floor tiles to the Rear Ground floor balcony.

Photograph 31 shows cracking to the floor tiles to the Rear Ground floor balcony.

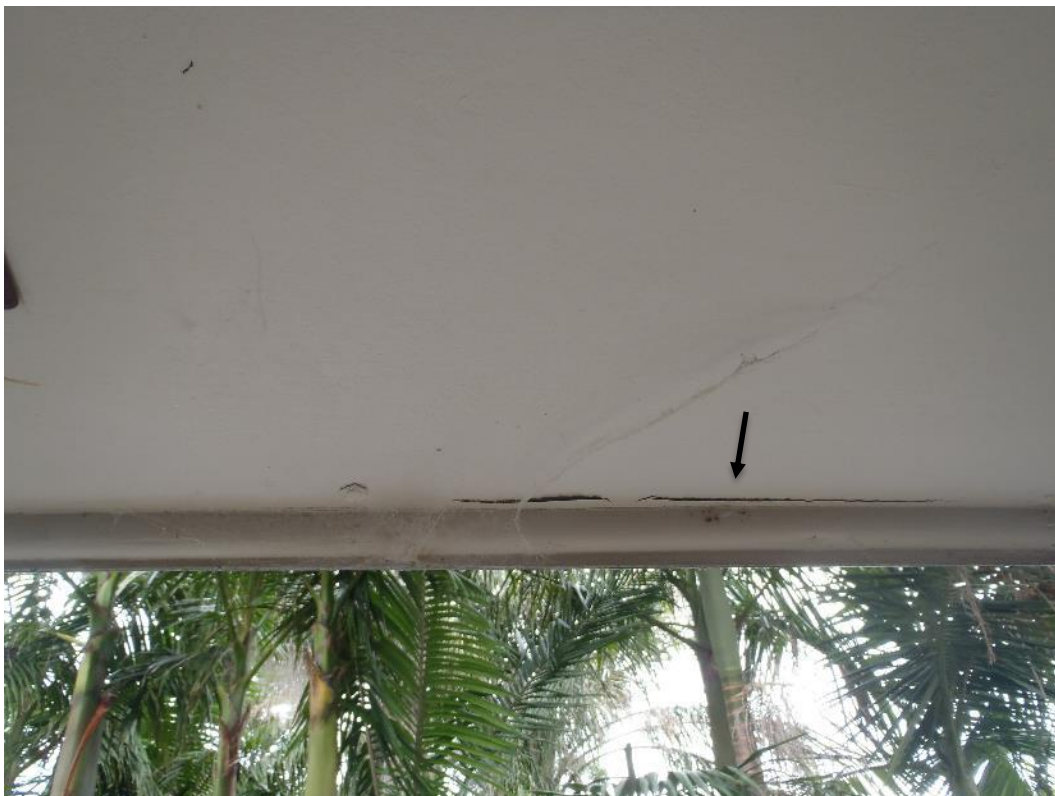
We noted separation cracking [1.0 - 3.0 mm] of the timber mould from the soffit lining. **[Photograph 32]**

Photograph 32 shows noted separation cracking of the timber mould from the soffit lining on the rear ground floor balcony.

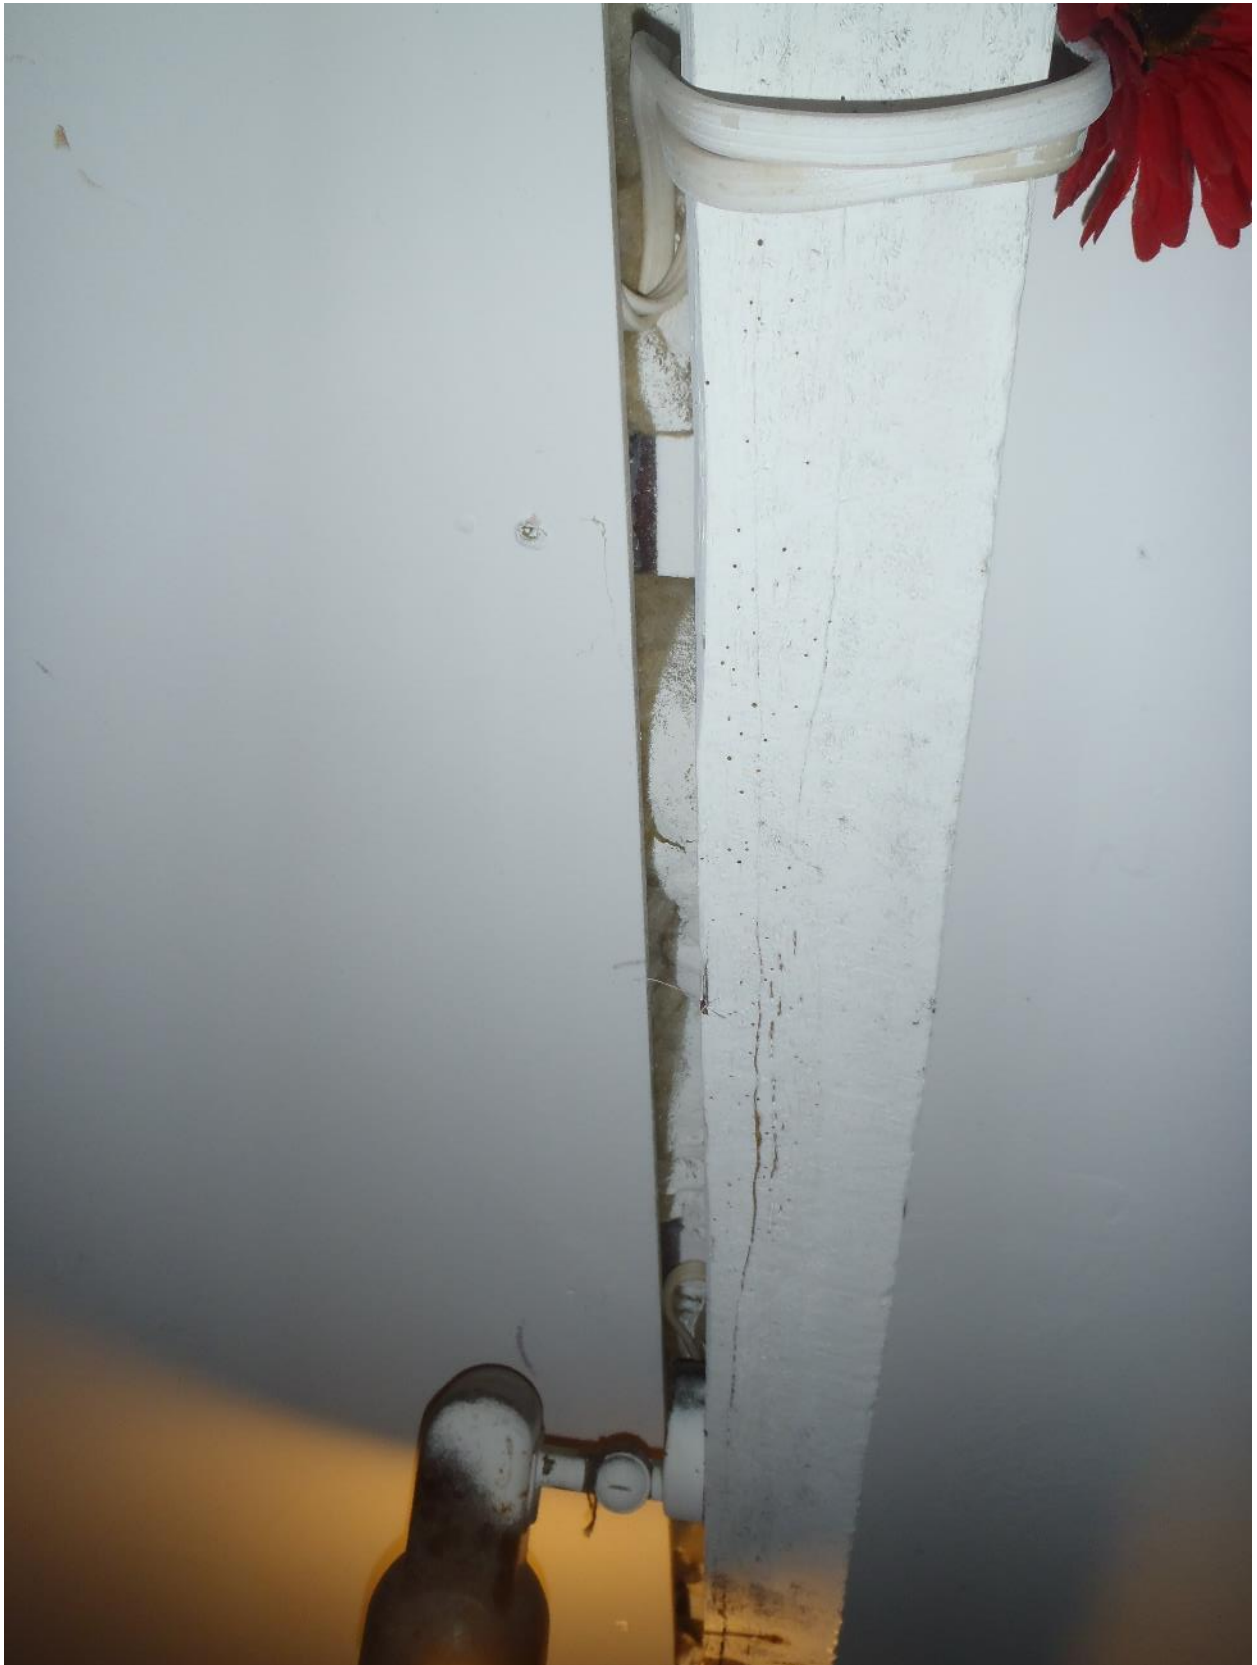
We observed gaps between the plasterboard ceiling lining and the exposed ceiling joist. **[Photograph 33]**

Photograph 33 shows gaps between the plasterboard ceiling lining and the exposed ceiling joist in the Store Room.

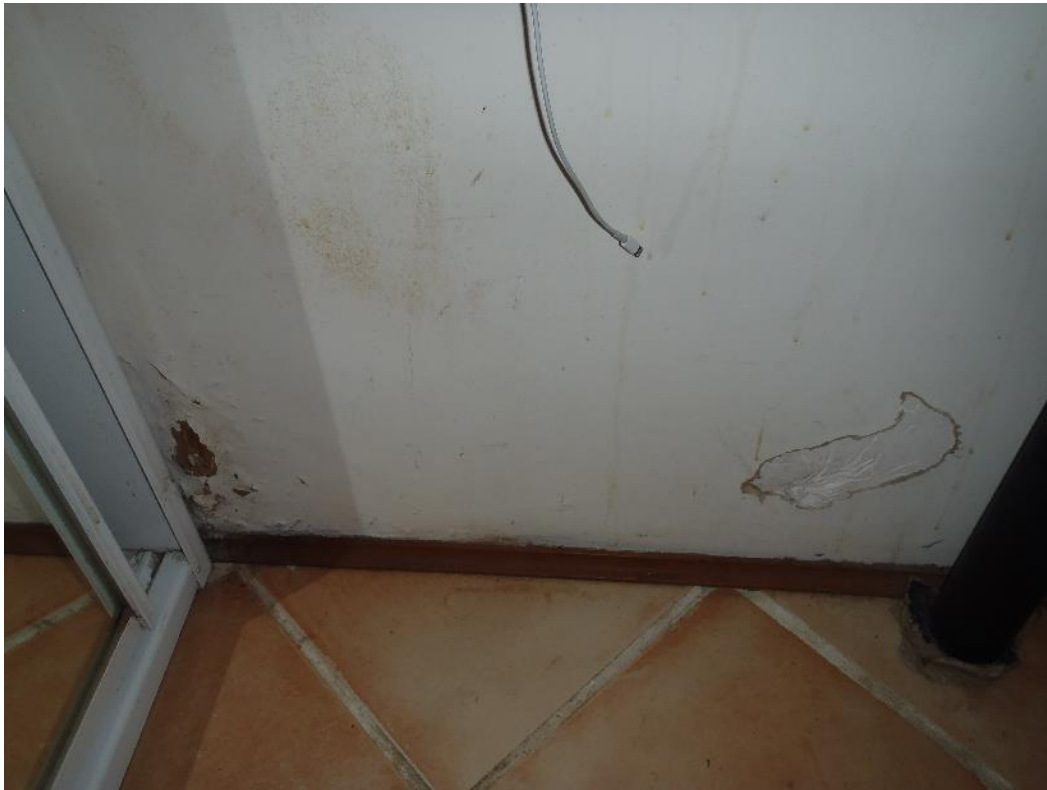
We noted damage to the plasterboard wall lining on the western external wall. **[Photograph 34]**

Photograph 34 shows damage to the plasterboard wall lining on the western external wall of the lower ground floor Bedroom 1.

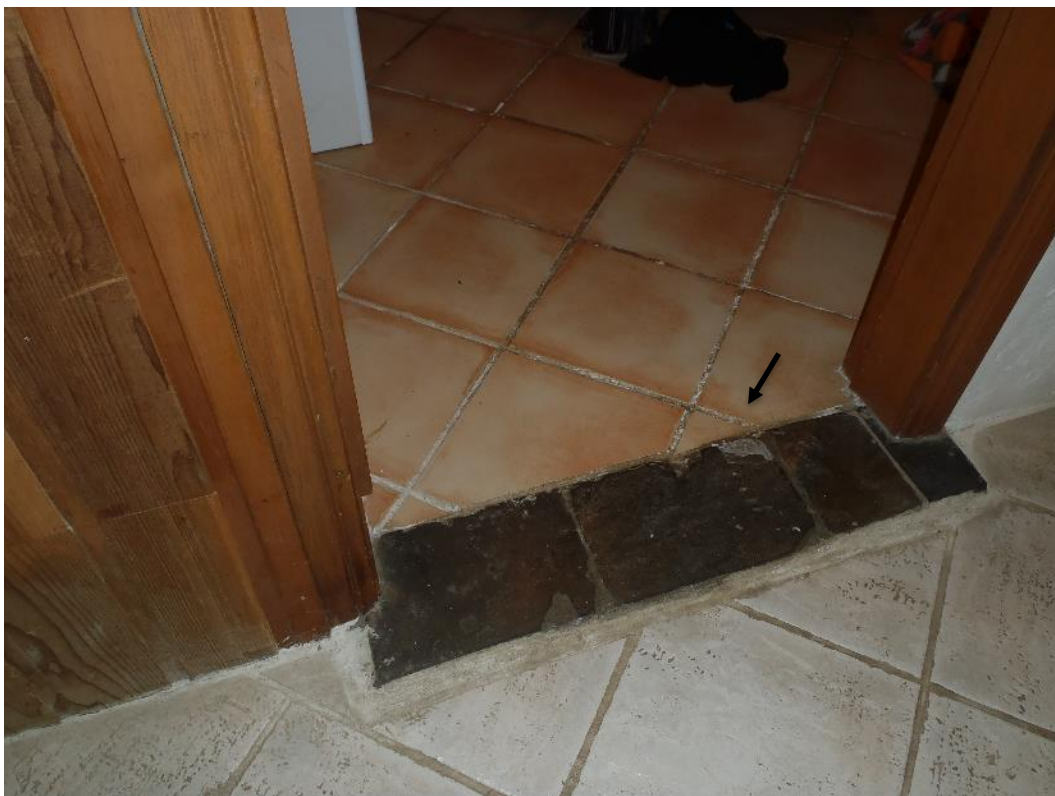
We noted stained grout to the floor tiles and cracked threshold tiles. **[Photograph 35]**

Photograph 35 shows stained grout to the floor tiles and cracked threshold tiles to the lower ground floor Bedroom 1.

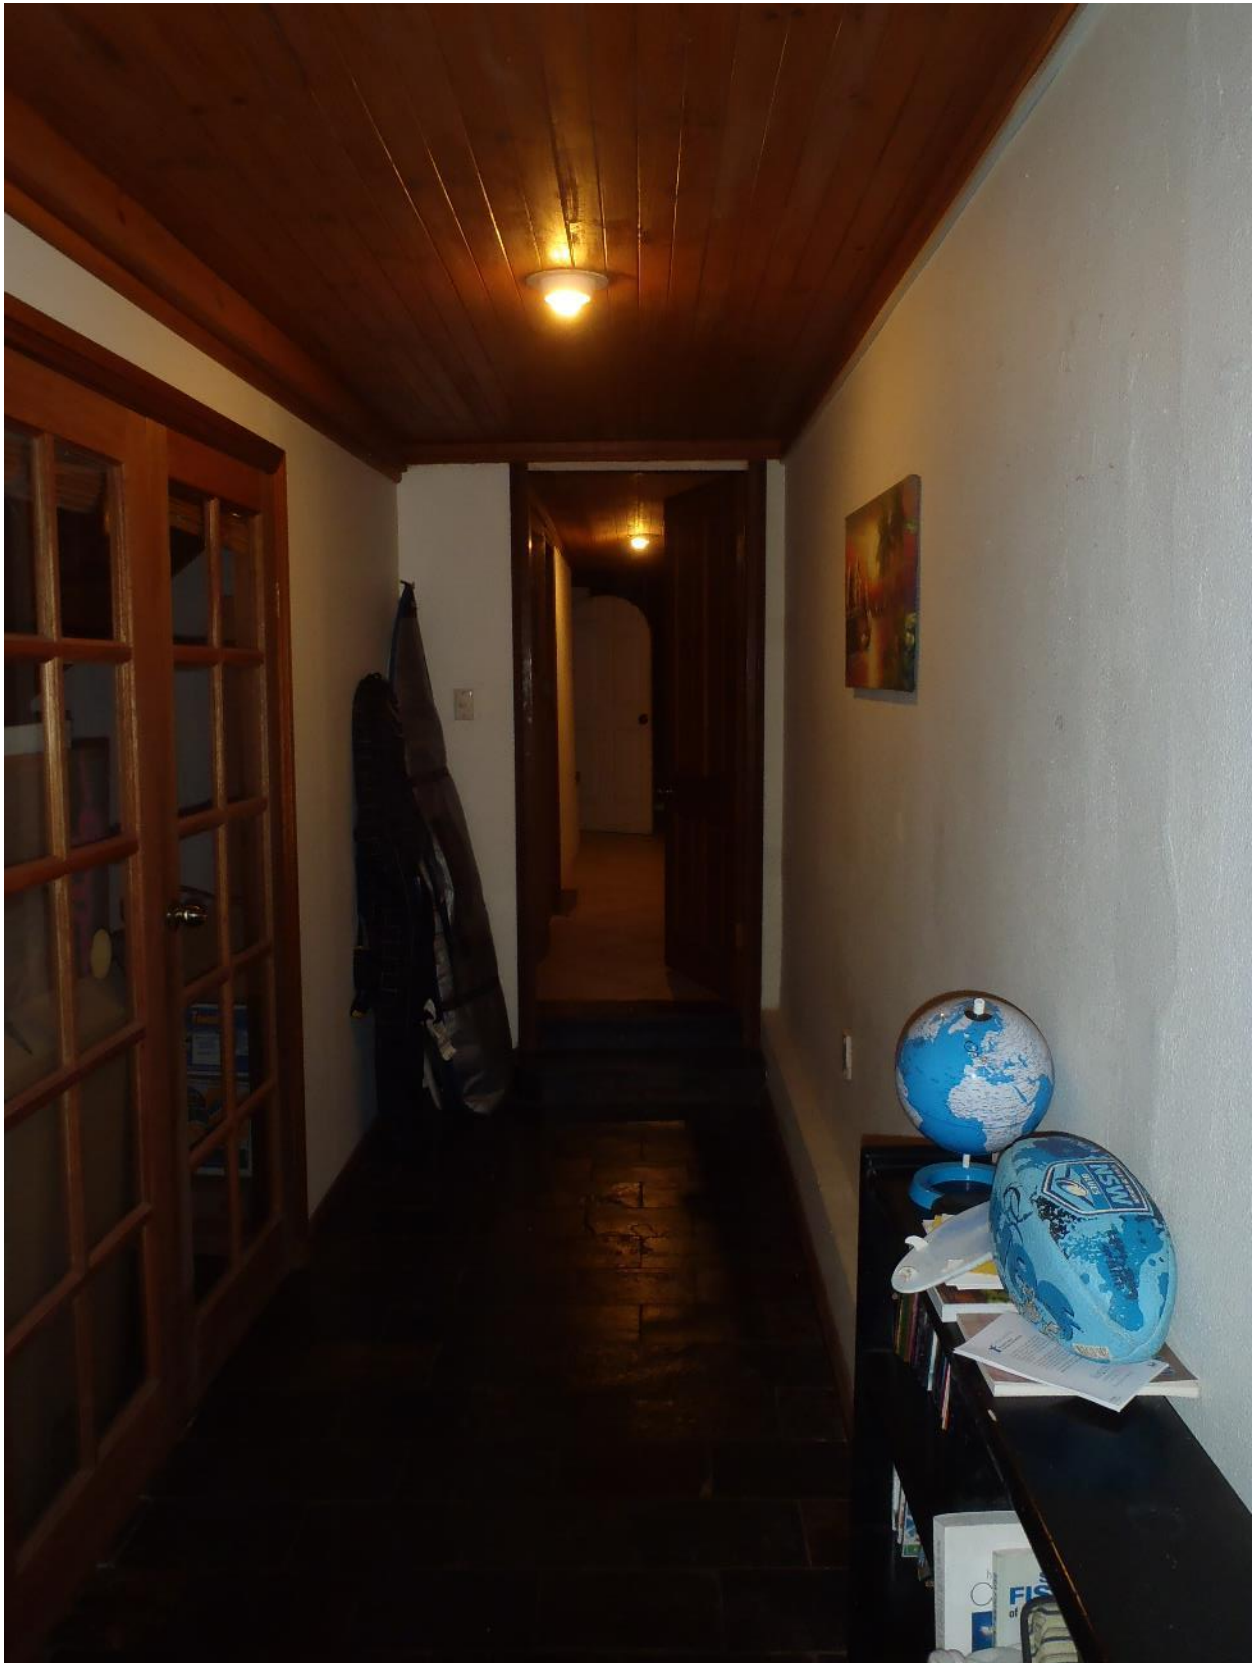
We observed that the floor is finished with slate tiles. We noted that the grout to the tiles is complete and that the tiles when randomly “tap” tested appeared to be sound. **[Photograph 36]**

Photograph 36 shows the general condition of the lower ground floor hallway.

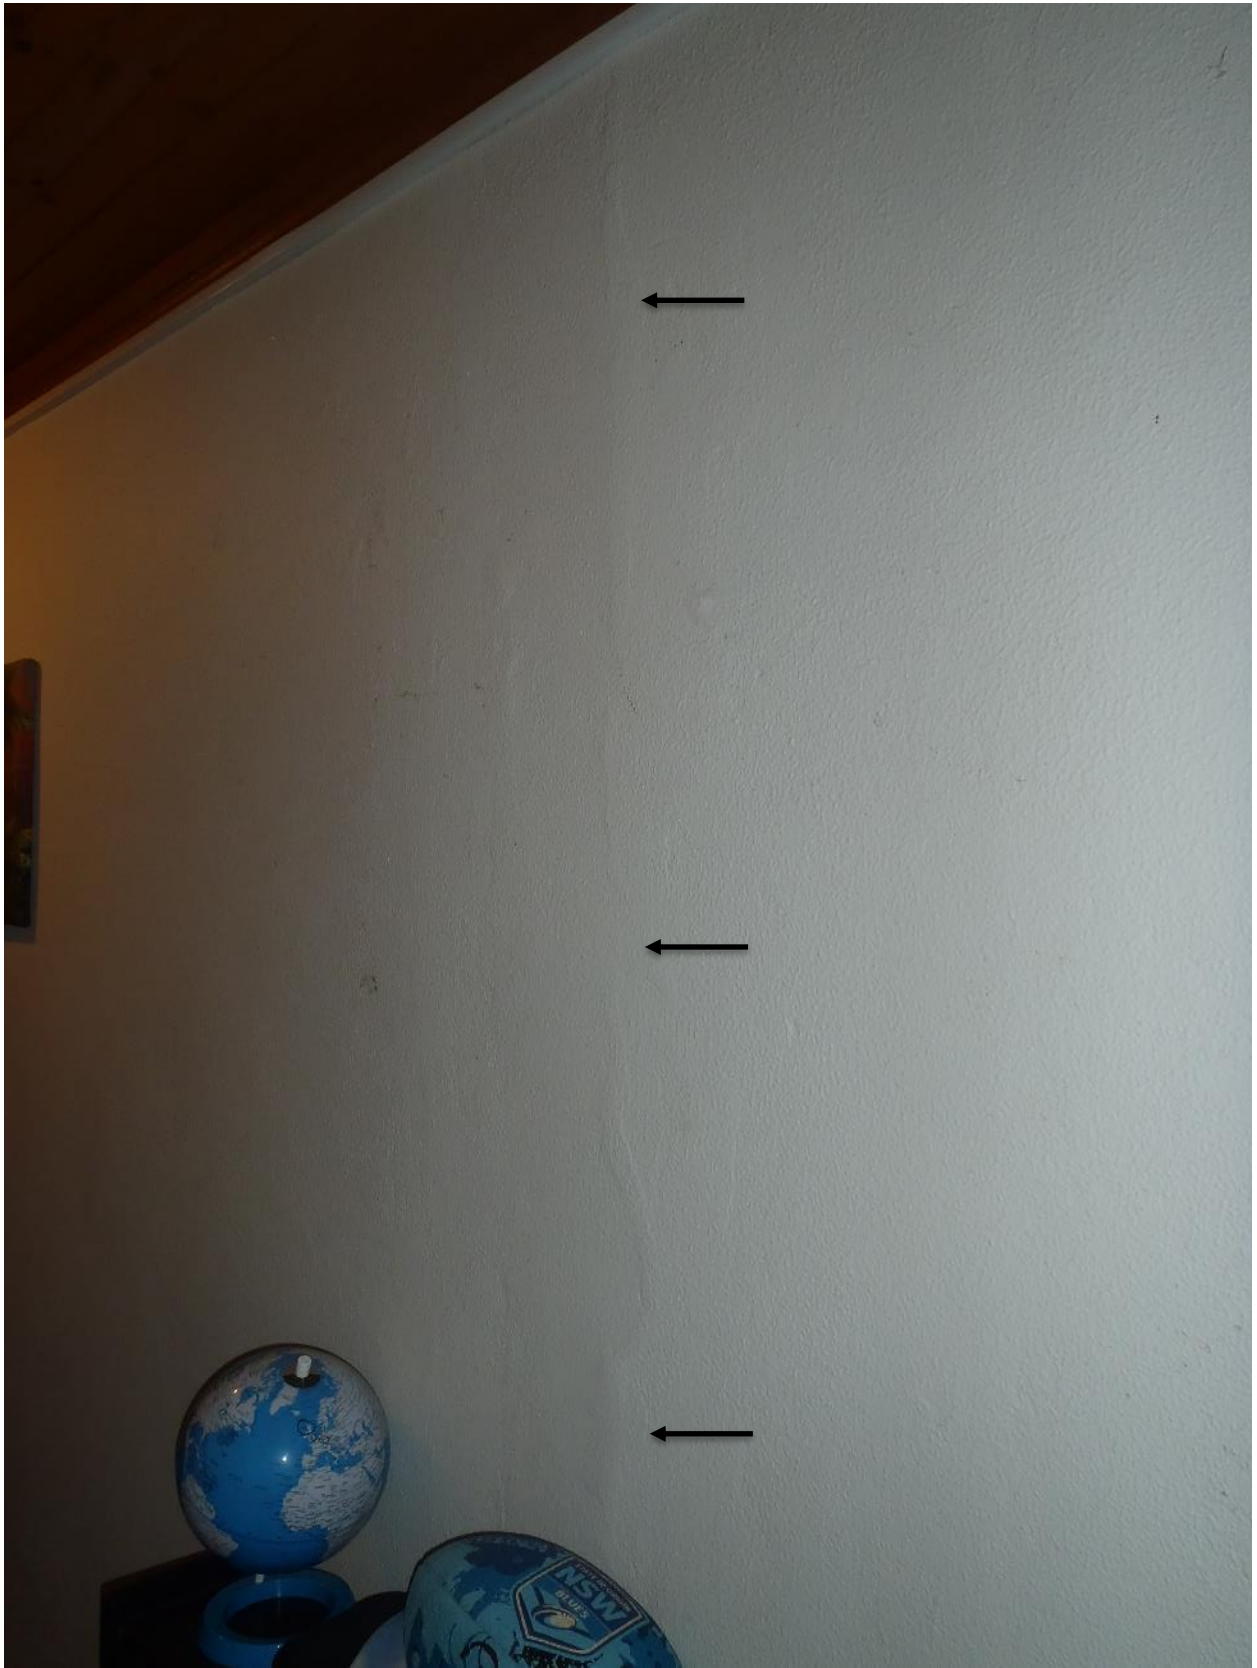
We noted evidence of a previous repair to the surface coated clay masonry brickwork along the common party / separation wall. **[Photograph 37]**

Photograph 37 shows evidence of a previous repair to the surface coated clay masonry brickwork along the common party / separation wall in the lower ground floor.
