Dilapidation Assessment Report

Prepared for: Cape Cod Australia Pty. Limited
Job address: 5 Darling Street, Bronte.
Property Owner/s: Mr. Peter Engel.
Report reference: **WAVERLEY COUNCIL**
Development Application No: not available
Date of assessment: 8th March 2017

Re: Dilapidation Report – No. 5 Darling Street, Bronte.

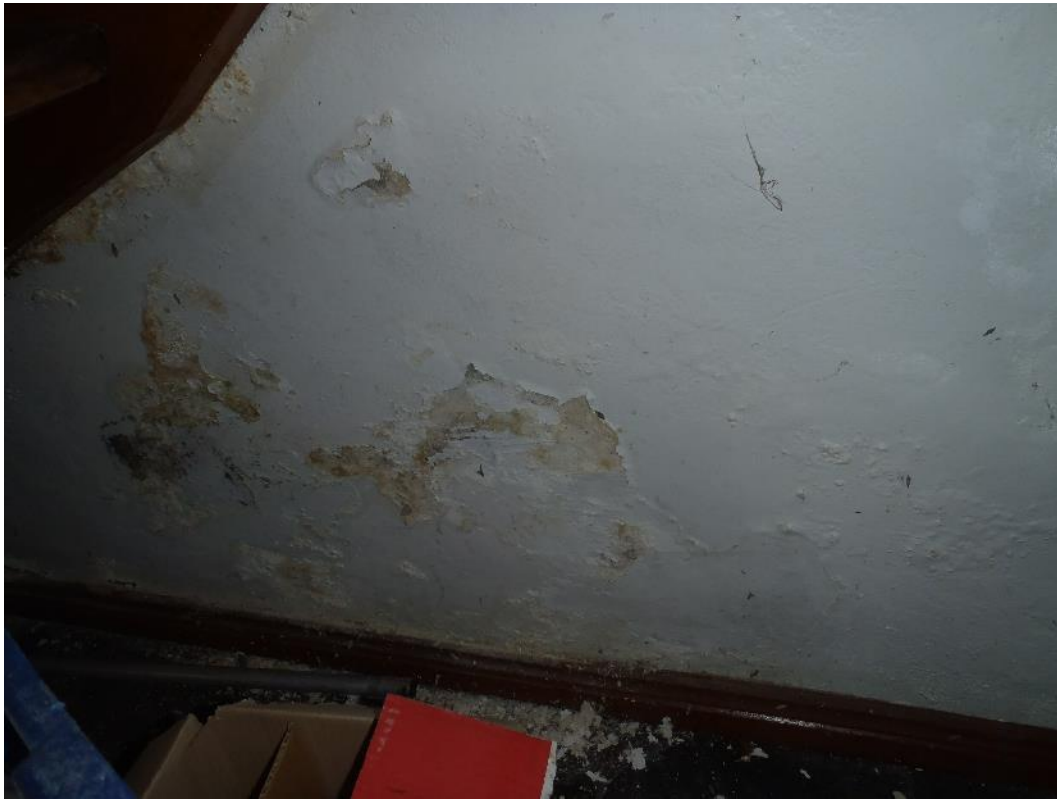
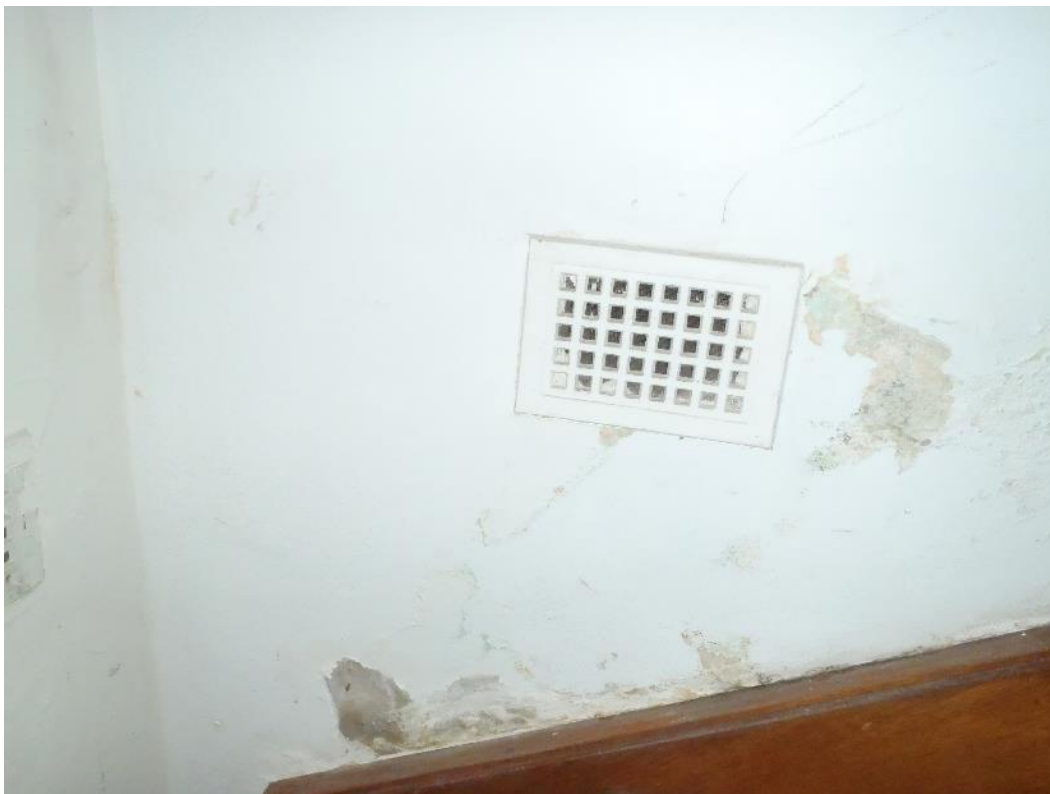
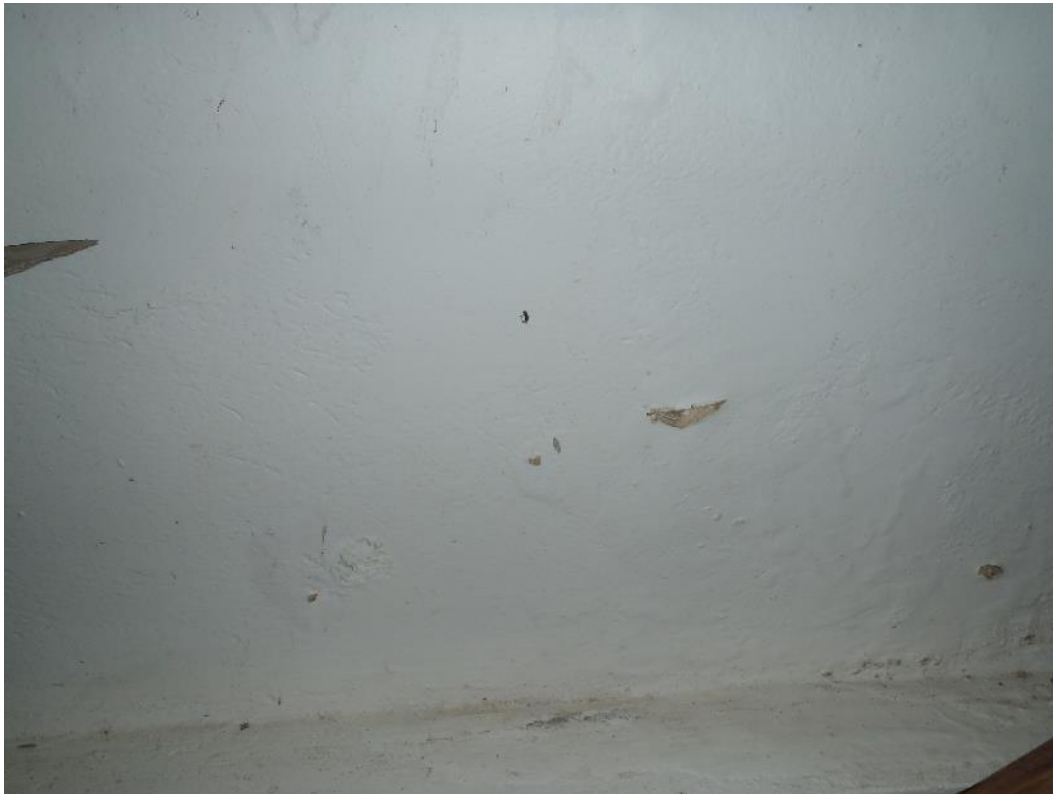
We noted areas of flaking / lifting paint to the northern and western walls. This, in our experience, is consistent with rising damp. **[Photographs 38, 39 & 40]**

Photograph 38 shows flaking / lifting paint to the northern wall under the lower ground floor staircase.

Photograph 39 shows flaking / lifting paint to the northern wall in the lower ground floor stairwell.

Photograph 40 shows flaking / lifting paint to the western wall in the lower ground floor stairs room.

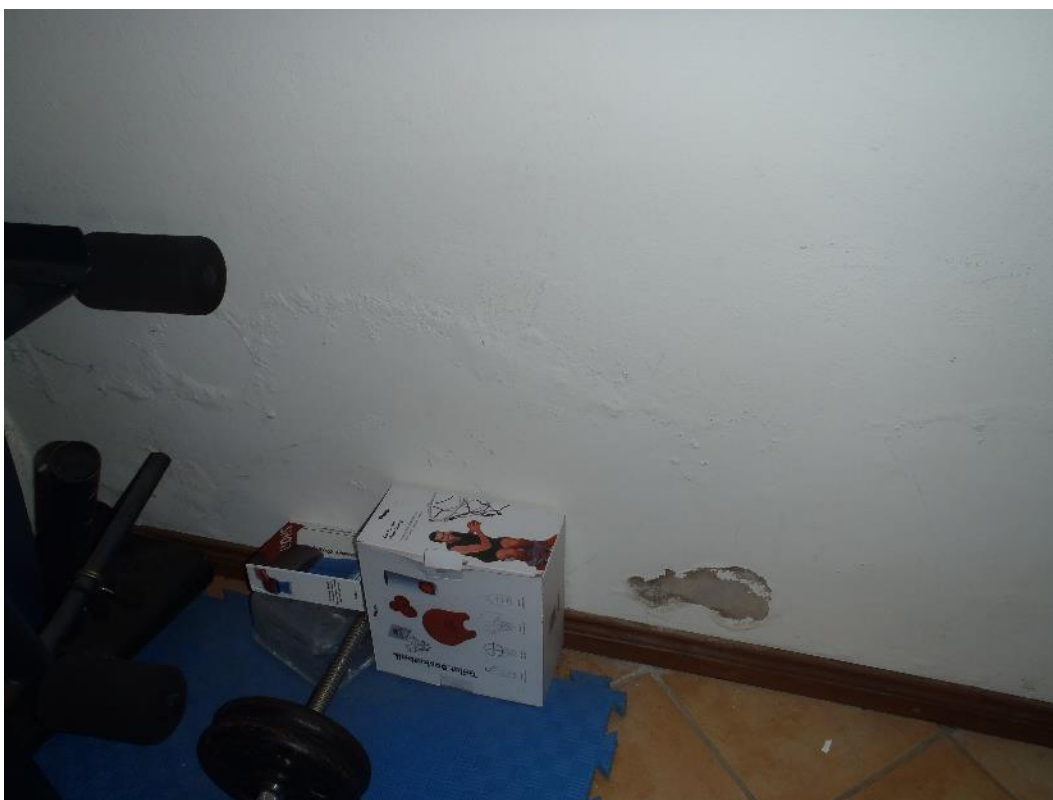
We noted damage to the western external wall surface above the skirting. We further noted areas of flaking / lifting paint to the northern and western walls. This, in our experience, is consistent with rising damp. **[Photograph 41]**

Photograph 41 shows damage to the western external wall surface and areas of flaking / lifting paint to the northern and western walls in the Study.

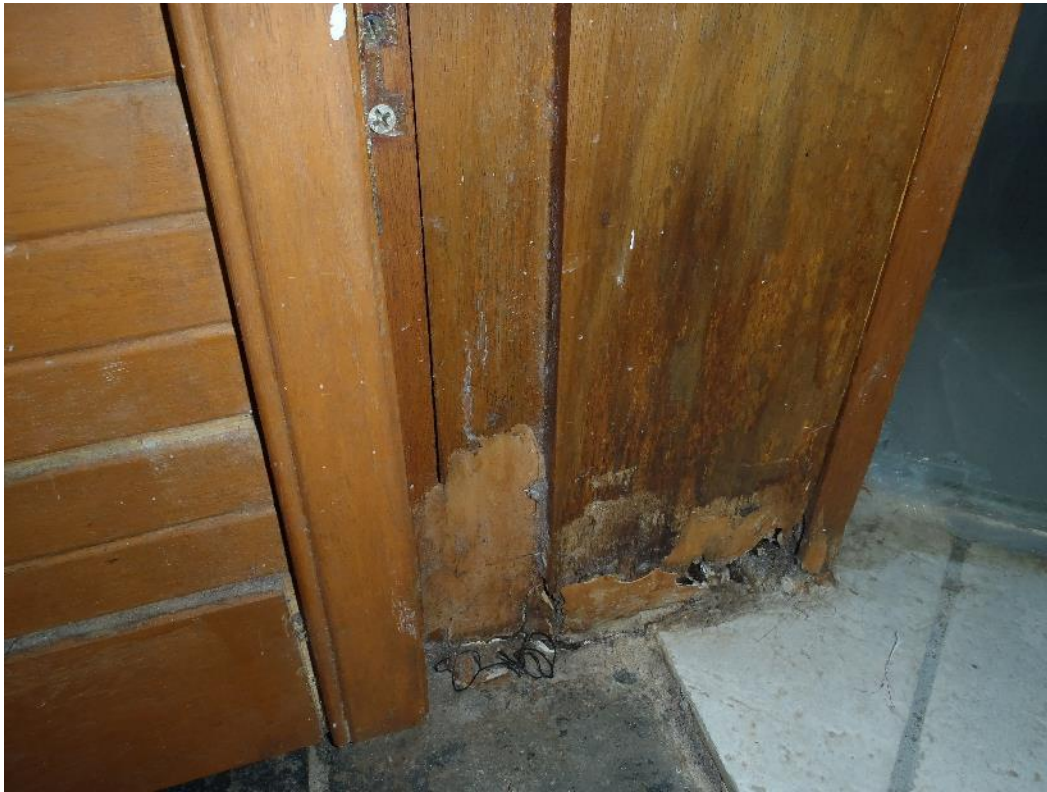
We noted rotting to the door jamb adjacent to the shower. **[Photograph 42]**

Photograph 42 shows rotting to the door jamb adjacent to the shower in the Bathroom / Laundry.

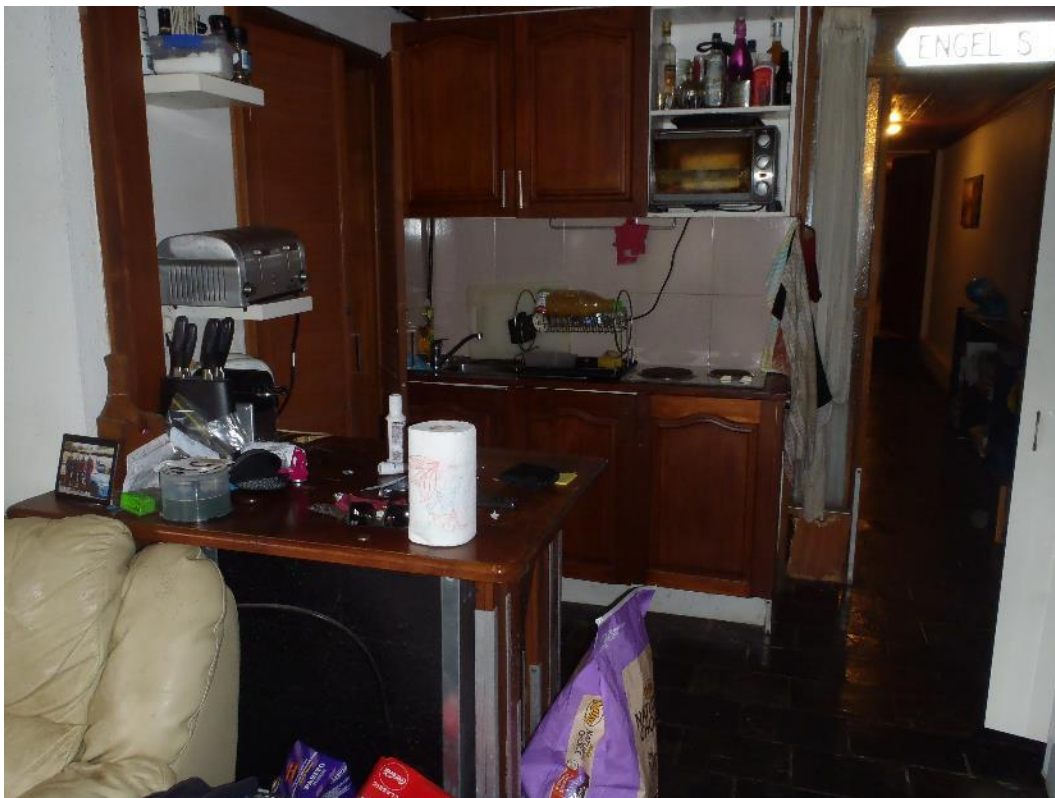
We did not observe any recent cracking to the ceramic wall tiles or to the painted cement rendered walls above the wall tiles. **[Photograph 43]**

Photograph 43 shows the general condition of the Kitchenette.

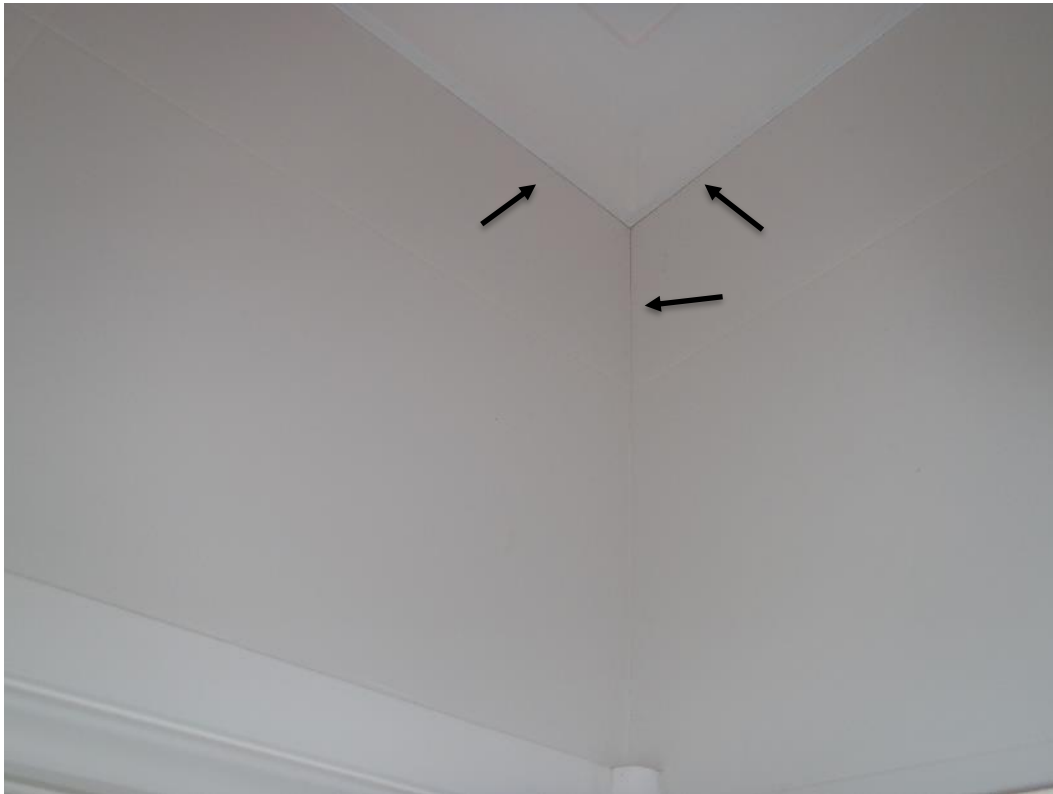
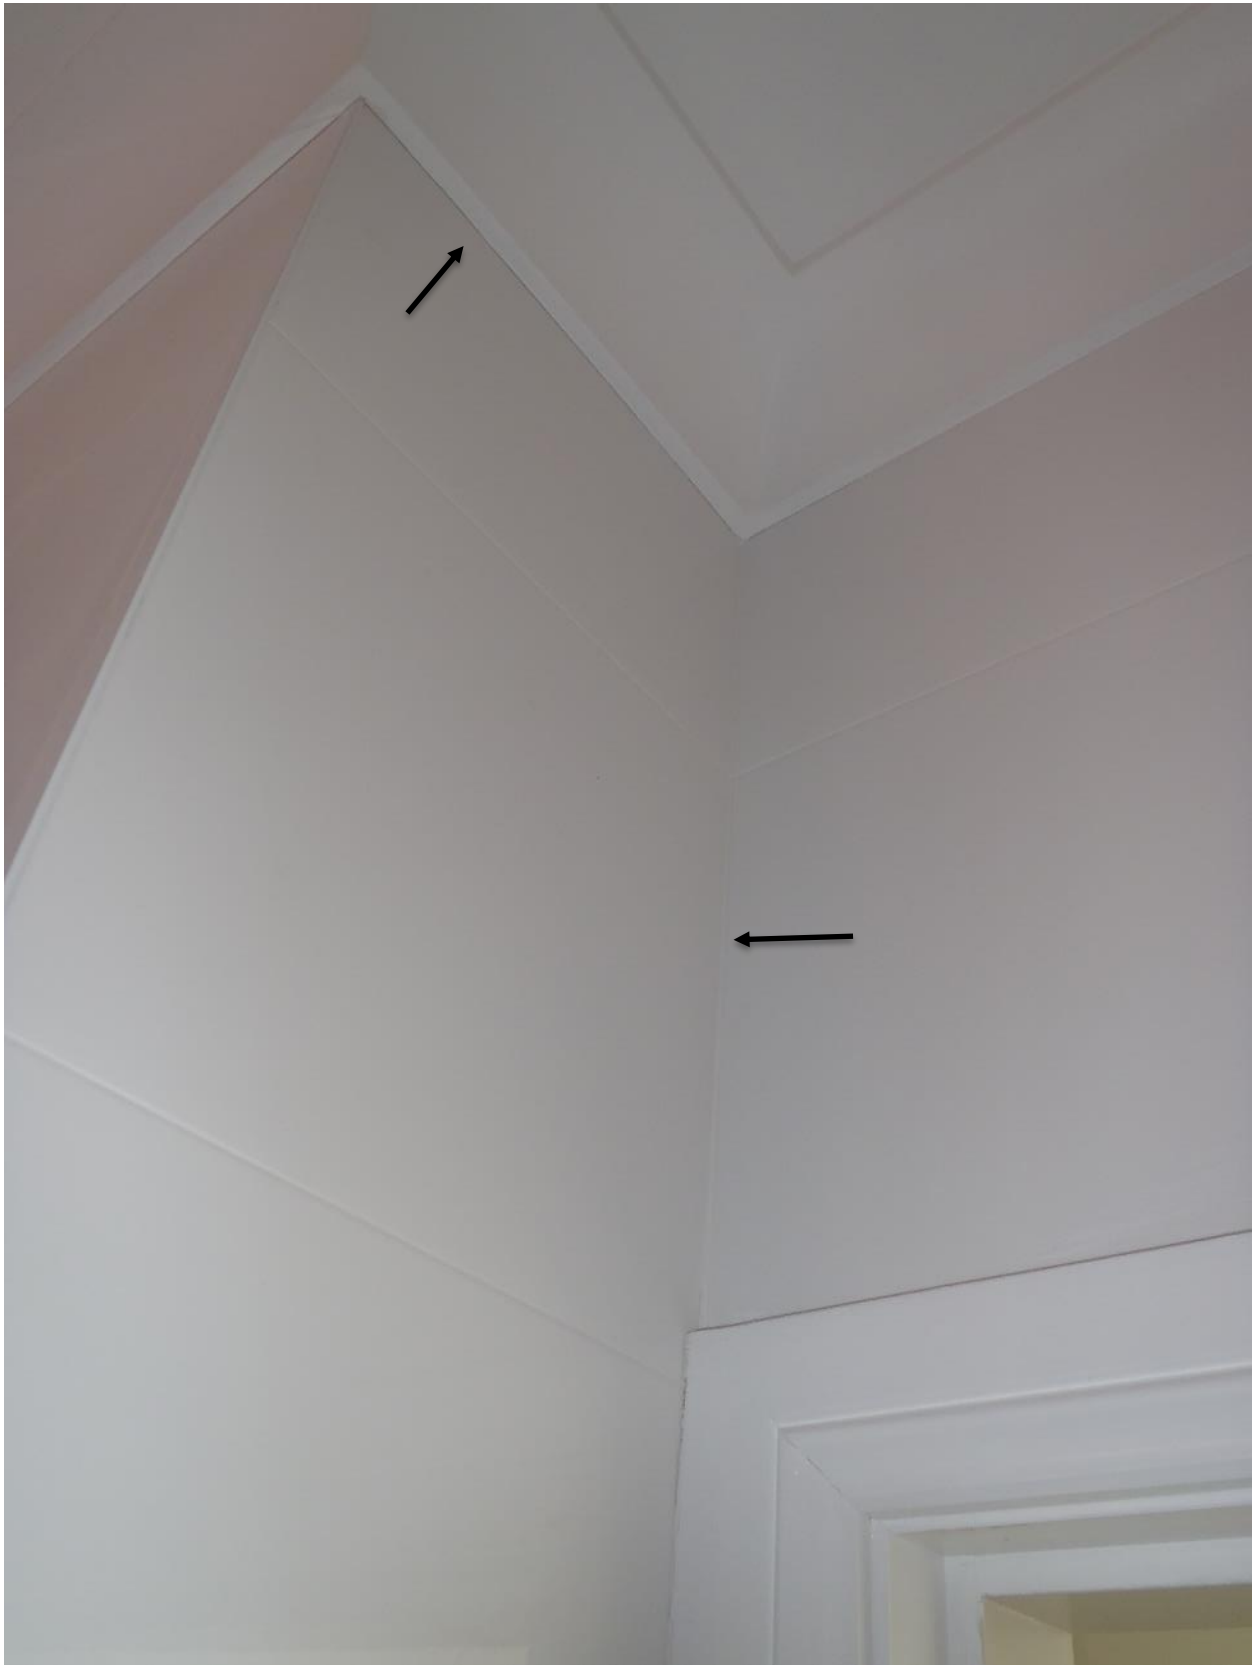
We noted separation cracking [$< 1.0\text{mm}$] to the wall / wall, wall / ceiling junctions above the door. **[Photographs 44 & 45]**

Photograph 44 shows separation cracking to the wall / wall, wall / ceiling junctions above the door in the first-floor Bathroom.

Photograph 45 shows separation cracking to the wall / wall, wall / ceiling junctions above the door in the first-floor Bathroom.

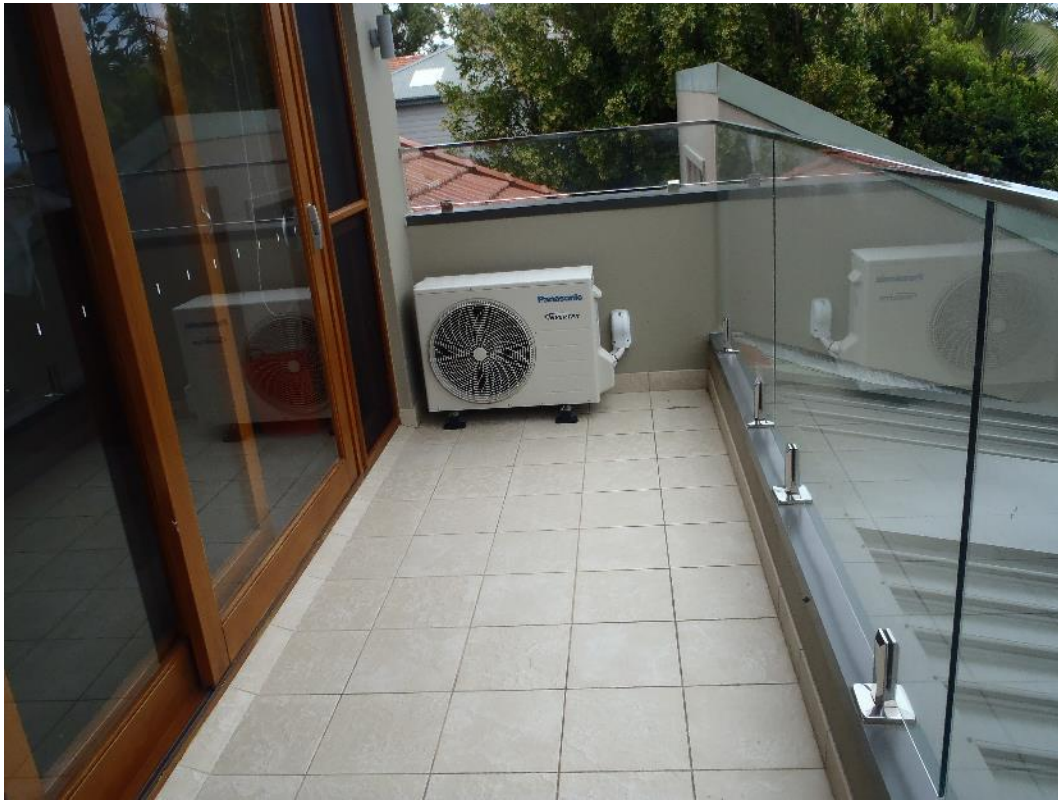
We observed that the floor is finished with ceramic tiles. We noted that the grout to the tiles is complete and that the tiles when randomly "tap" tested appeared to be sound. **[Photograph 46]**

Photograph 46 shows the general condition of the first-floor rear balcony.
