HAZARDOUS MATERIALS ASSESSMENT REPORT

Job details: Owner: Mrs. D. Grant
Location: 19 Wheatleigh Street, Crows Nest

Date of assessment: 12th August 2015

Our reference: HM04170815

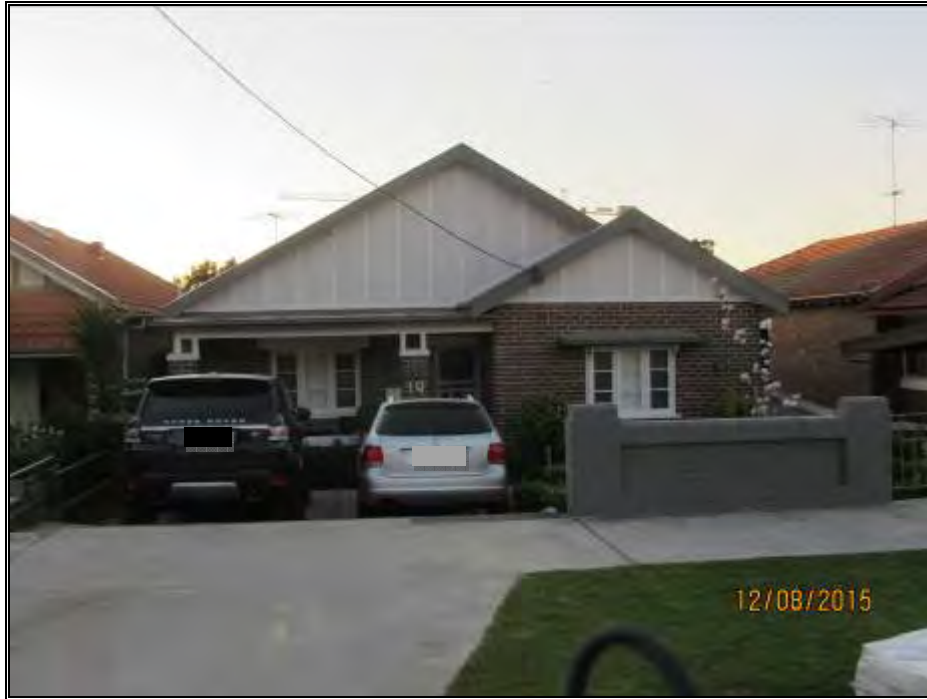
Front western elevation of the residence
