HAZARDOUS MATERIALS ASSESSMENT REPORT

Client: Cape Cod Australia Pty. Limited

Job details: Owner: Mr. M. Percy.
Location: 22 Nareen Parade, North Narrabeen.

Our reference: HM05550217

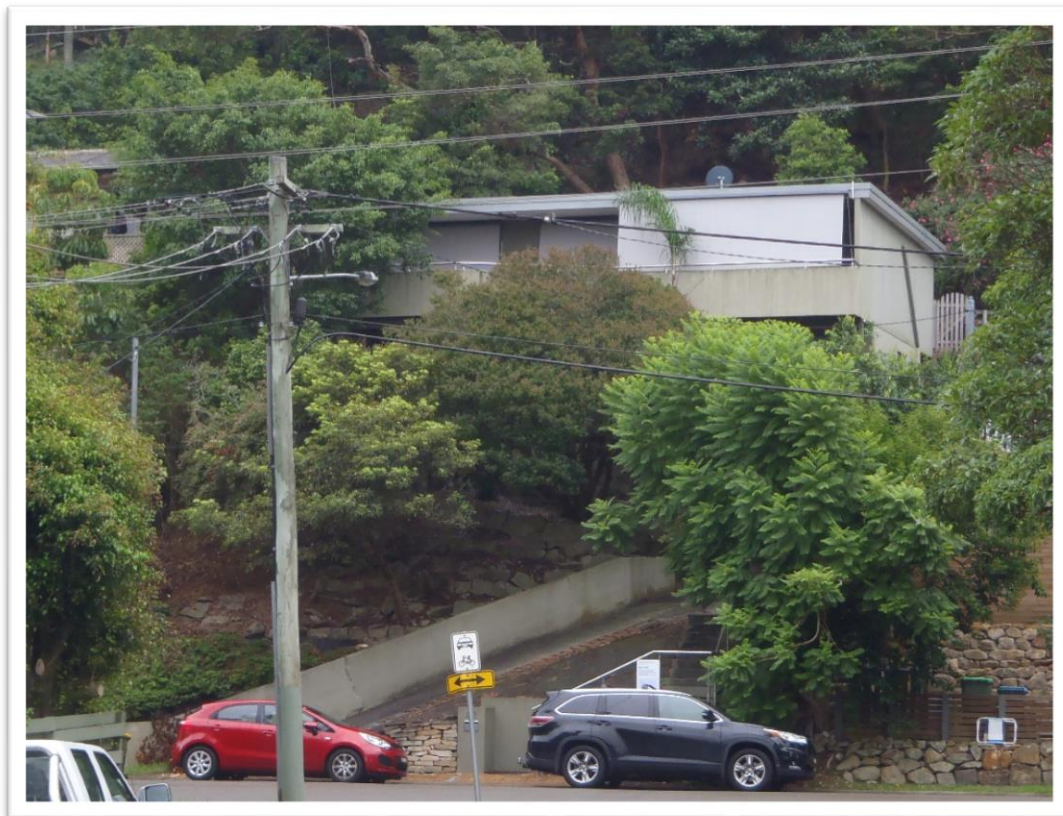
Front south western elevation of the residence
