HAZARDOUS MATERIALS ASSESSMENT REPORT

Job details: Owner: Mr. C. Zheng & Ms. W. Li.
Location: 12 Bell Street, Maroubra.

Our reference: HM05900717

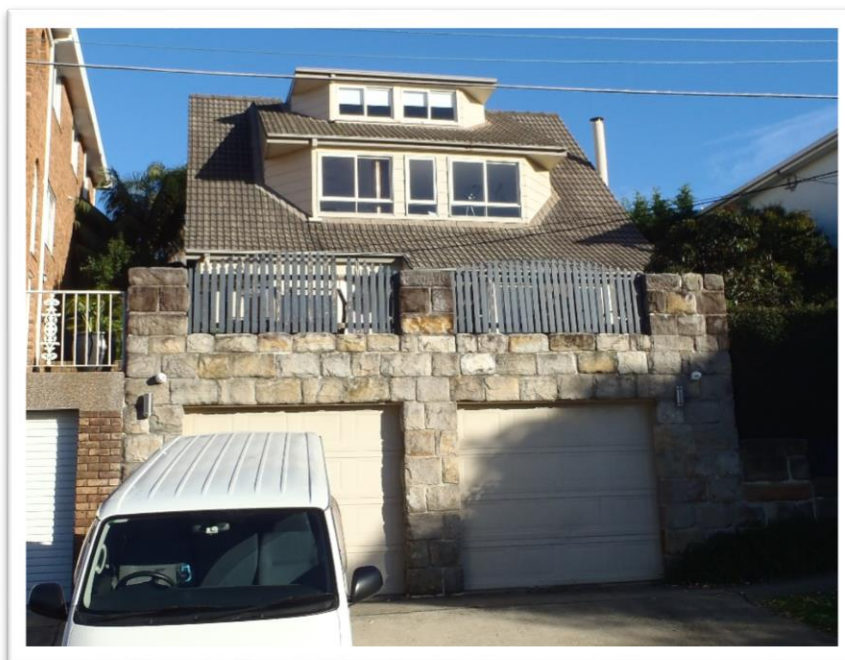
Front eastern elevation of the residence
