HAZARDOUS MATERIALS ASSESSMENT REPORT

Job details: Owner: Mr Geoff Rumble & Miss Edwina Lambkin
Location: 28 Parraween Street, CREMORNE.

Date of assessment: 1st July 2016

Our reference: HM05020716

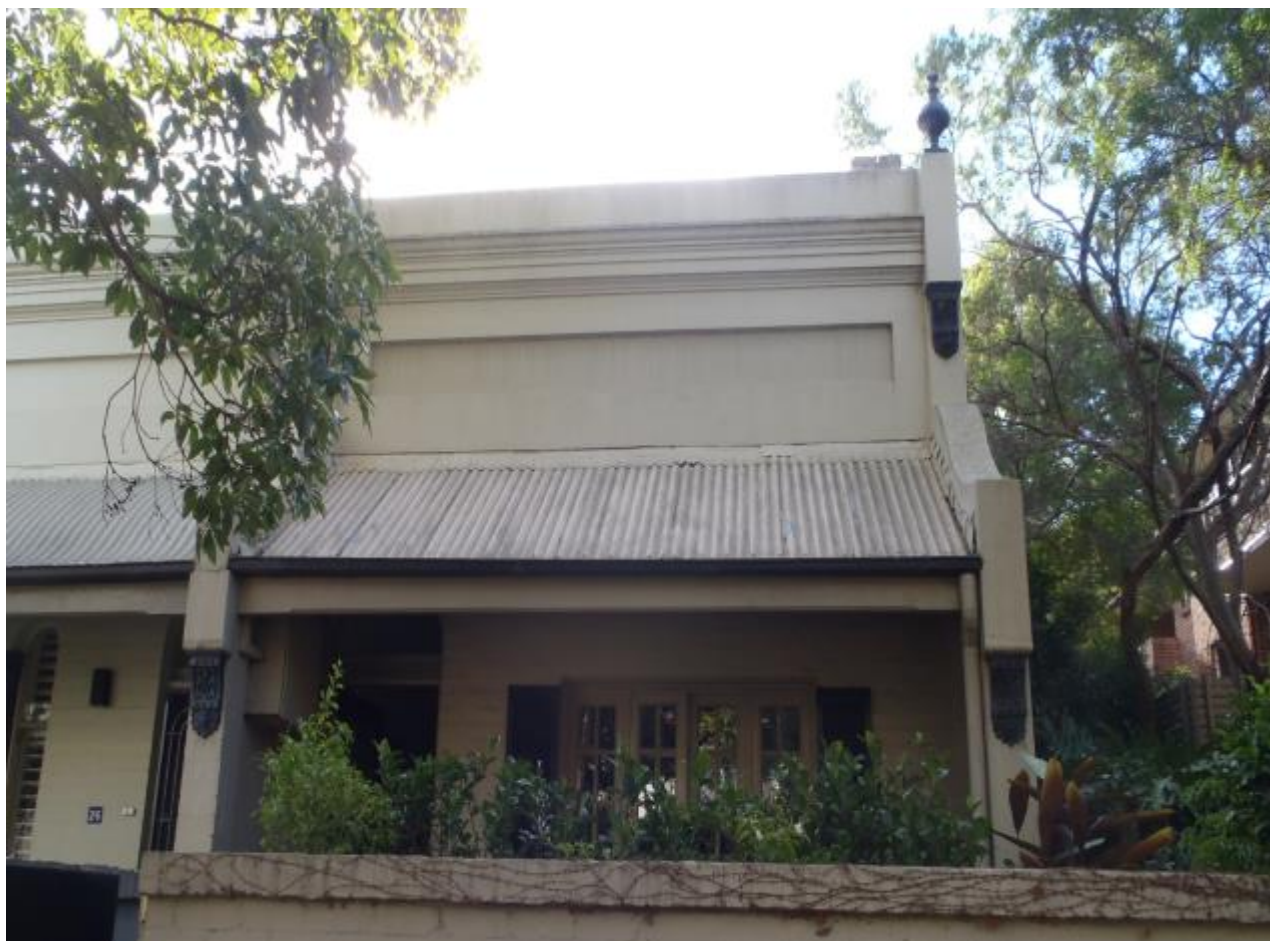
Front south eastern elevation of the residence
