## **HAZARDOUS MATERIALS ASSESSMENT REPORT**

**Job details:** Owner: Ms. D. Richmond  
Location: 14 Union Street, Dulwich Hill NSW

**Date of assessment:** 23<sup>rd</sup> November 2015

**Our reference:** HM04411115

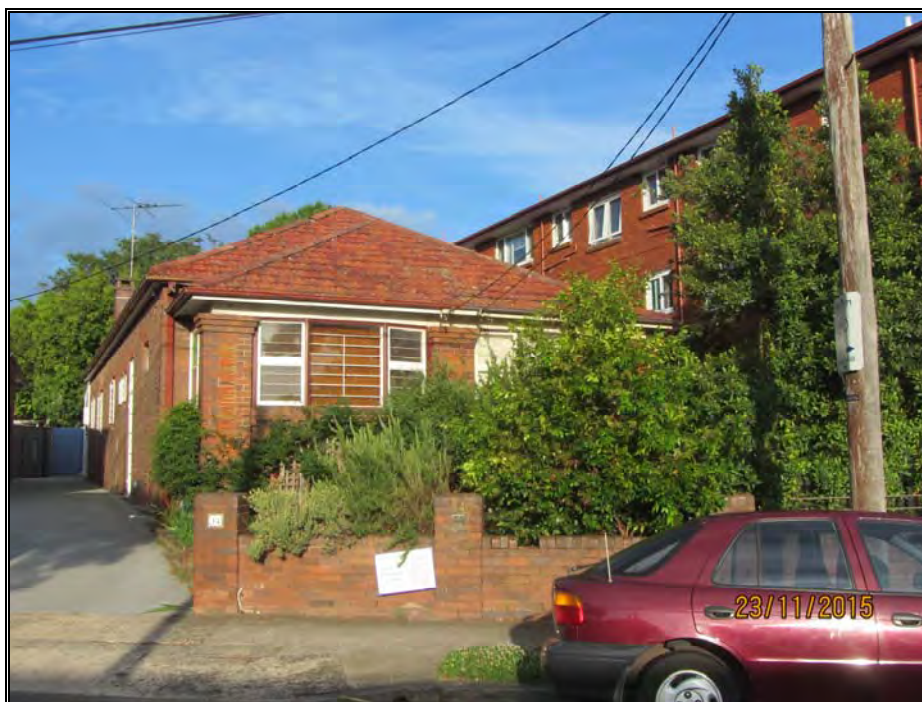
Front eastern elevation of the adjoining properties:  
No. 12 & No. 14 Union Street, Dulwich Hill
