Dilapidation Assessment Report

Prepared for: Cape Cod Australia Pty. Limited
Job address: 32 Gilderthorpe Avenue, Randwick NSW 2031
Property Owner: Mr. D. & Mrs. A. Cotterell
Report reference: **RANDWICK CITY COUNCIL**
Development Application No: not available
Date of assessment: 27th April 2016

Re: Dilapidation Report - No. 32 Gilderthorpe Avenue, Randwick

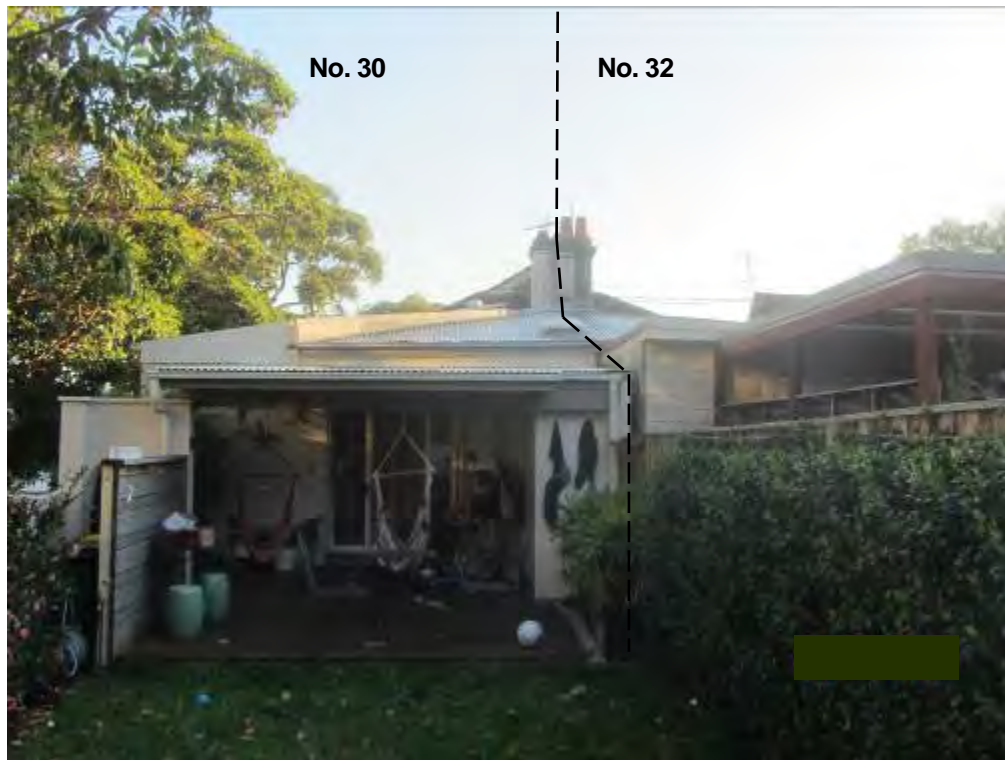
We noted that the corrugated profile sheet metal roofing to the rear *common* pitched hipped roof and skillion roof surfaces is in good condition and appears to be securely fixed, in our opinion forming a weather resistant cover to the property. **[Photograph 1]**

We noted that there is a void of approximately 75mm between the brick *common party / separation* wall of the rear addition and the adjoining property, No. 30 Gilderthorpe Avenue. **[Photographs 1 and 12]**

Photograph 1 shows the junction of the rear roof surfaces between the adjoining properties

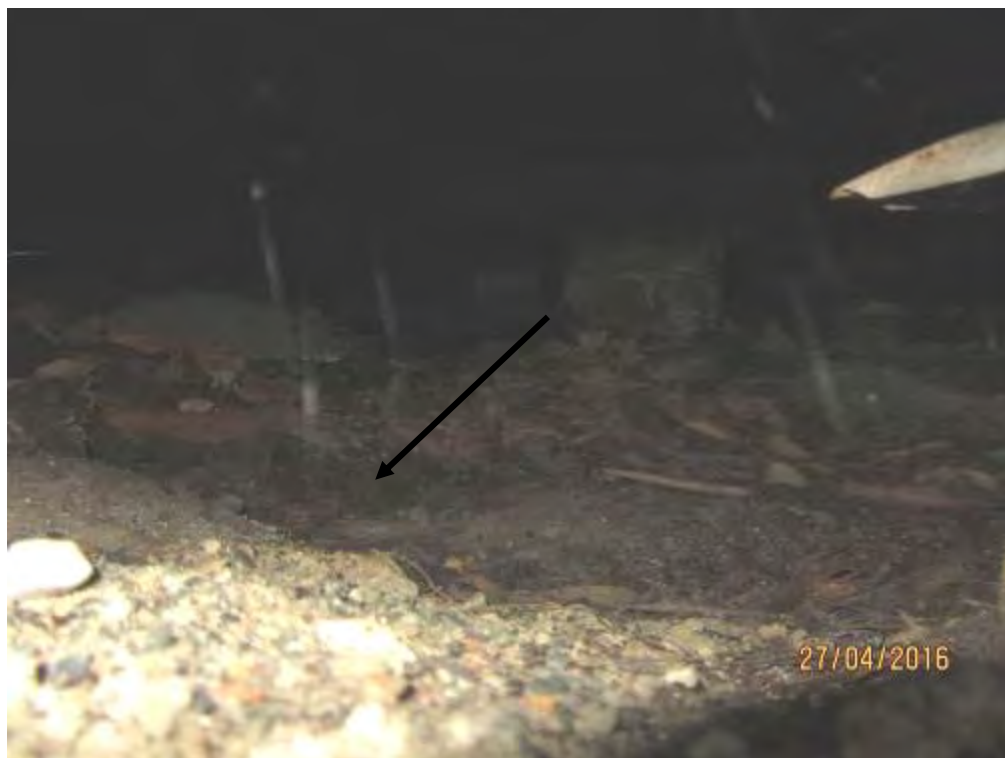
We noted that there are areas of dampness [ground water seepage] and ponding water in the under floor area including along the *common separating / party* wall with the adjoining property, No. 30 Gilderthorpe Avenue. We also noted building debris in the underfloor area. **[Photograph 2]**

Photograph 2 shows dampness and building debris to the underfloor area

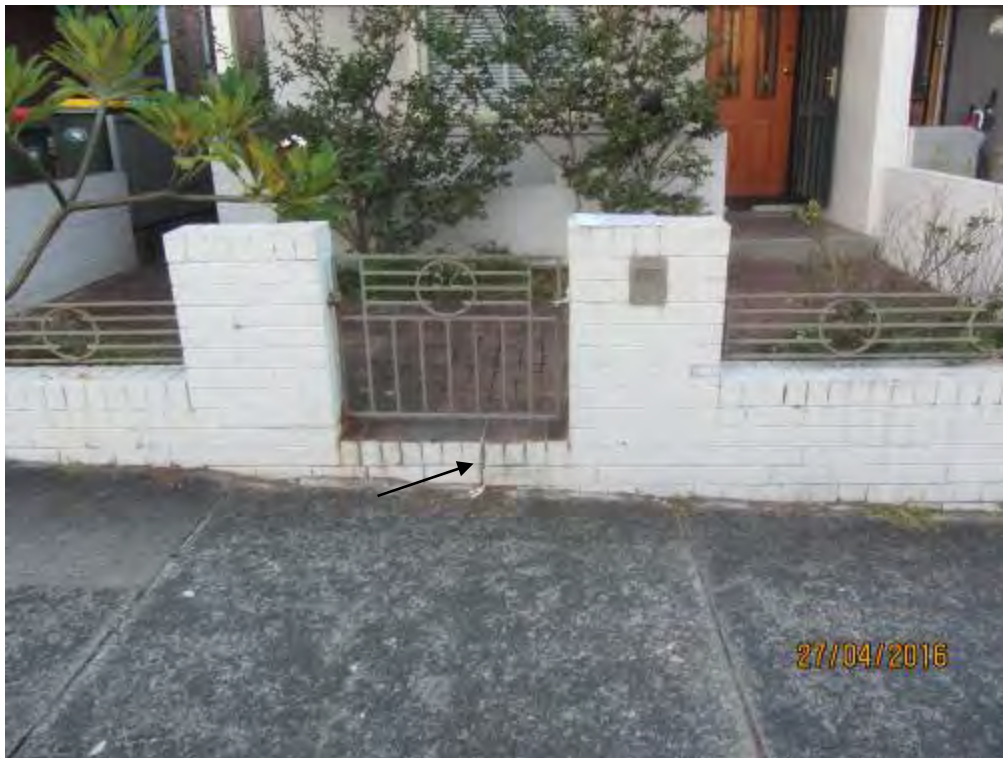
We noted hairline crack [$<1.0\text{mm}$] and lateral displacement [3.0mm] to the header course of brickwork at the front gate. **[Photograph 3]**

Photograph 3 shows displacement of the header brick at the front gate

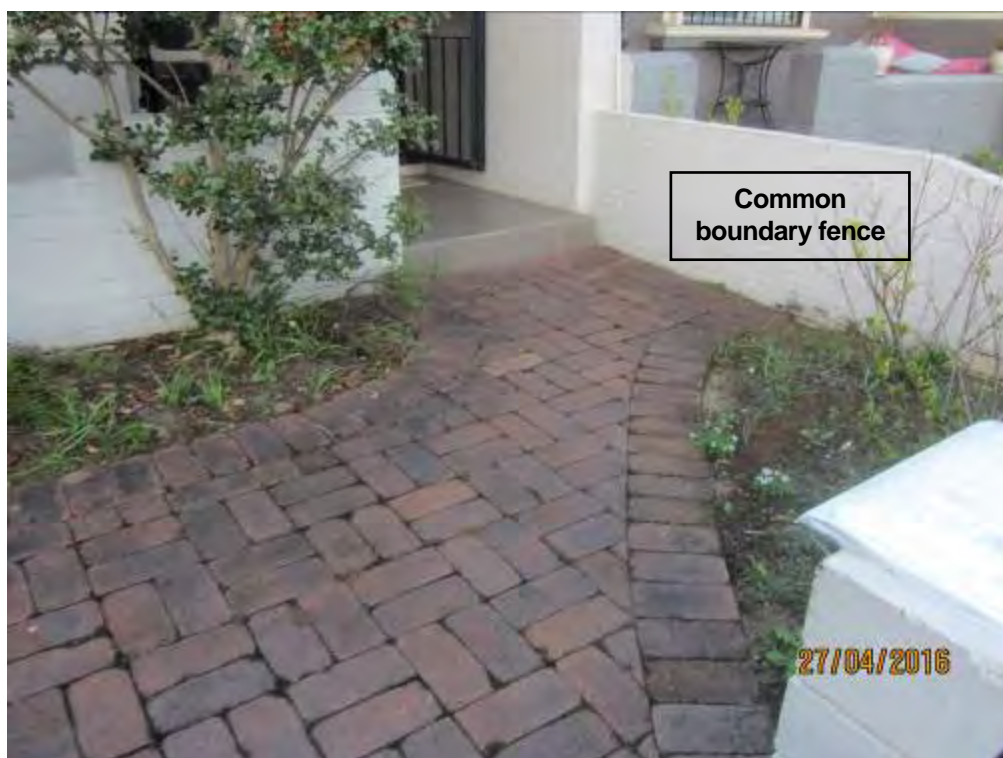
We did not note any cracking to the surface coated to the *common boundary* wall between the properties. **[Photograph 4]**

We noted that clay brick pavers to the courtyard are generally level in plane and were generally sound. We noted dampness and moss growth between the dry joints of the pavers. Due to concealment we are unable to comment on the base strata to the clay brick pavers. **[Photograph 4]**

Photograph 4 shows the condition of the clay pavers in the front courtyard area

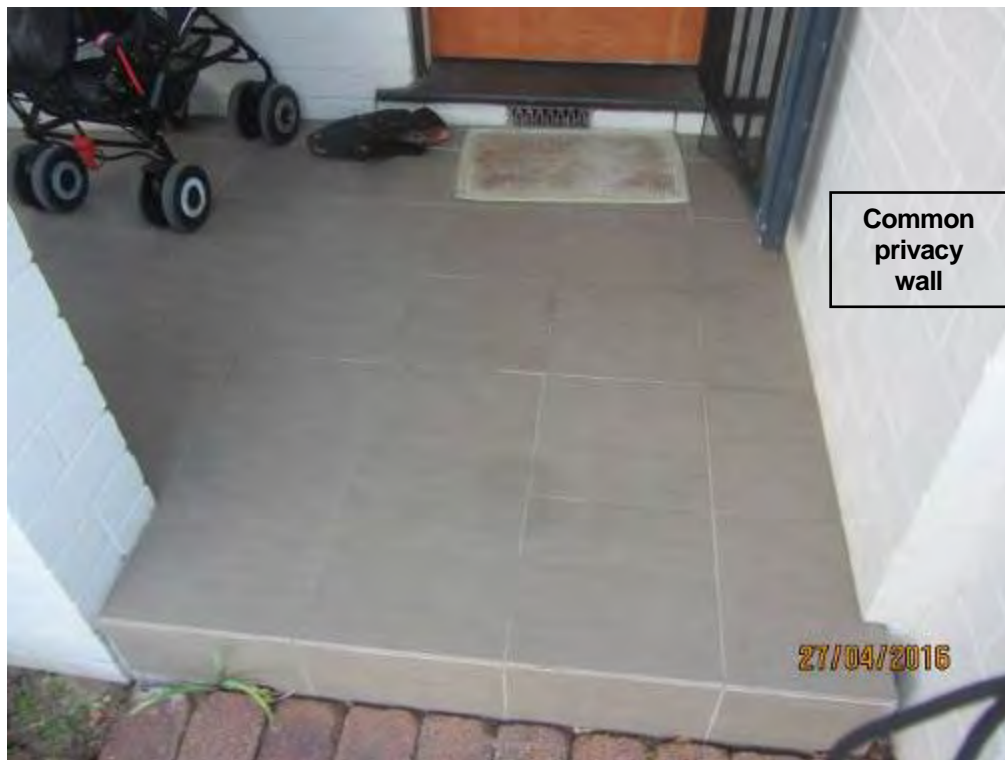
We noted that the front verandah is finished with ceramic tiles. We did not observe any recent cracking to the tiles. **[Photographs 5 and 6]**

Photograph 5 shows the condition of the tiles to the front Verandah

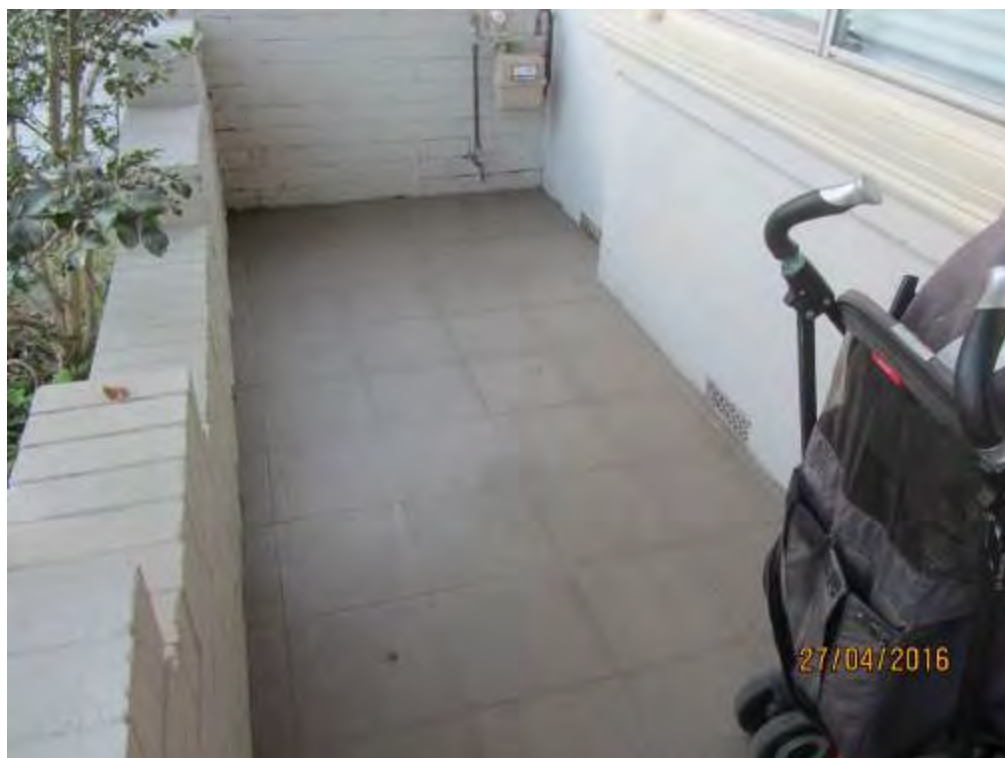
Photograph 6 shows the condition of the tiles to the front Verandah

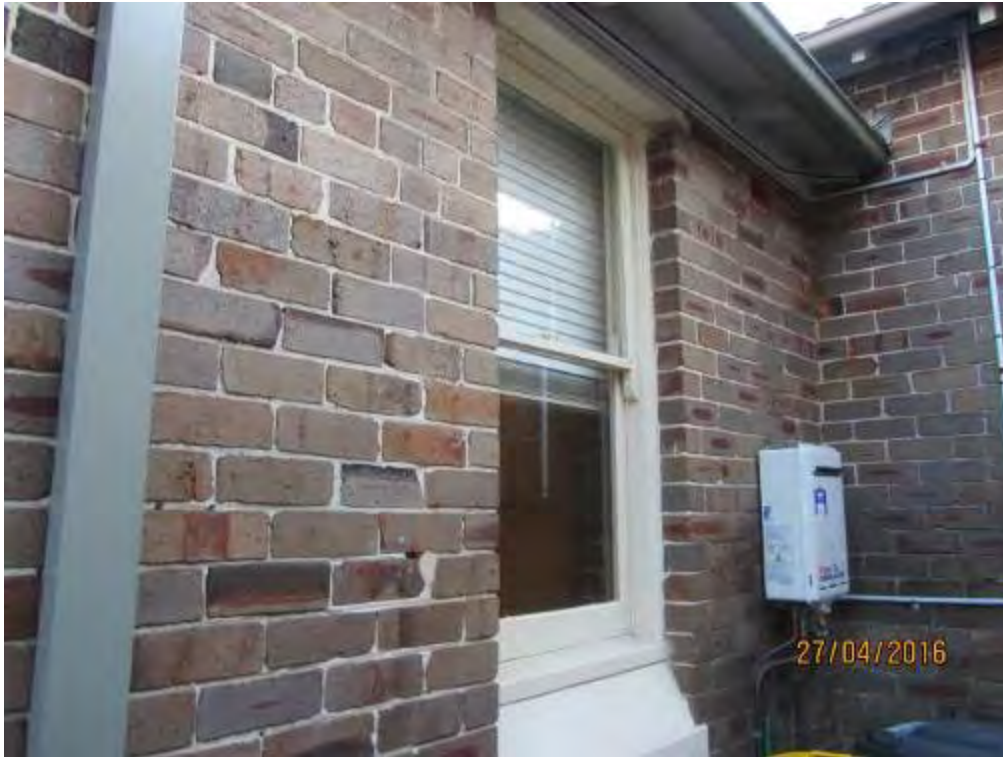
We did not observe any recent cracking to the face clay masonry brickwork. Notwithstanding this we did note areas of fretting and displaced mortar from the brickwork overall the length of the wall. From our experience, this is common for the age of the residence. **[Photograph 7- typical]**

Photograph 7 shows typical condition of the brickwork and mortar to the eastern elevation

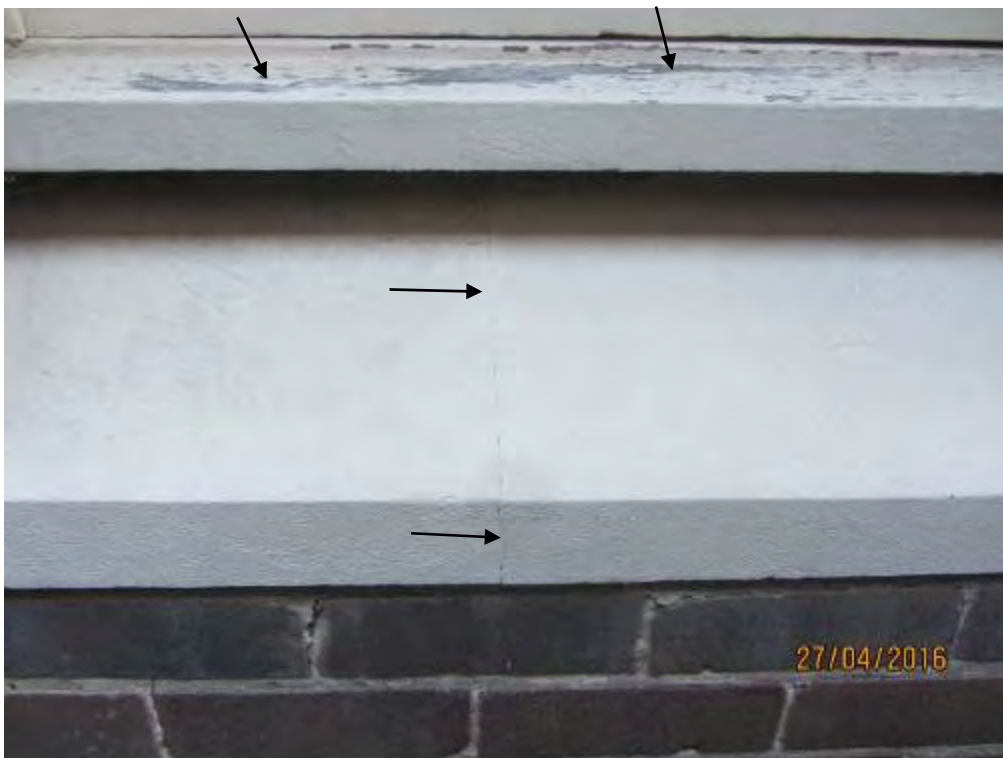
We noted a hairline shrinkage crack [$<1.0\text{mm}$] to the cement rendered window sill to the Lounge room. **[Photograph 8]**

Photograph 8 shows a hairline crack to the rendered sill to the Lounge room window – Note: ageing and general deterioration of paint to the timber window sill

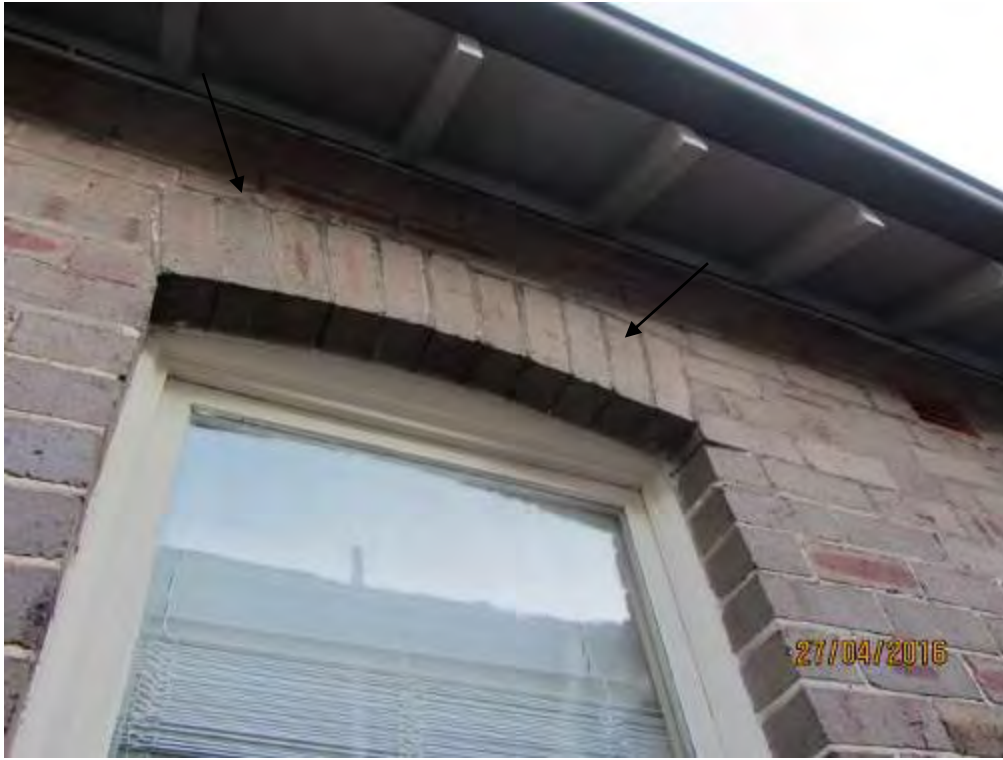
We also noted evidence of previous repairs to the mortar to brickwork above the Lounge room window. **[Photograph 9]**

Photograph 9 shows previous repairs to the mortar joints to the brick head over the Lounge room window

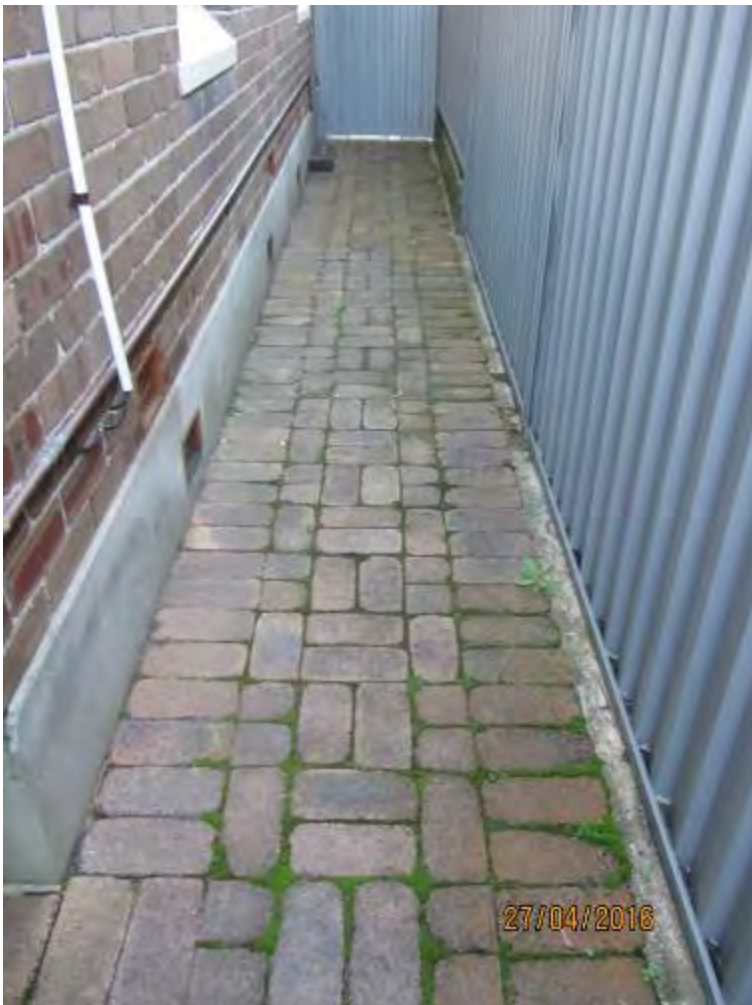
We noted that the clay brick pavers between the base of the wall and the eastern boundary are generally level in plane and were generally sound. We noted dampness and moss growth between the dry joints the pavers. Due to concealment we are unable to comment on the base strata to the clay brick pavers. **[Photographs 10 and 11 - typical]**

Photograph 10 shows the typical condition of the clay pavers to the eastern boundary – Note: dampness and moss growth between the pavers

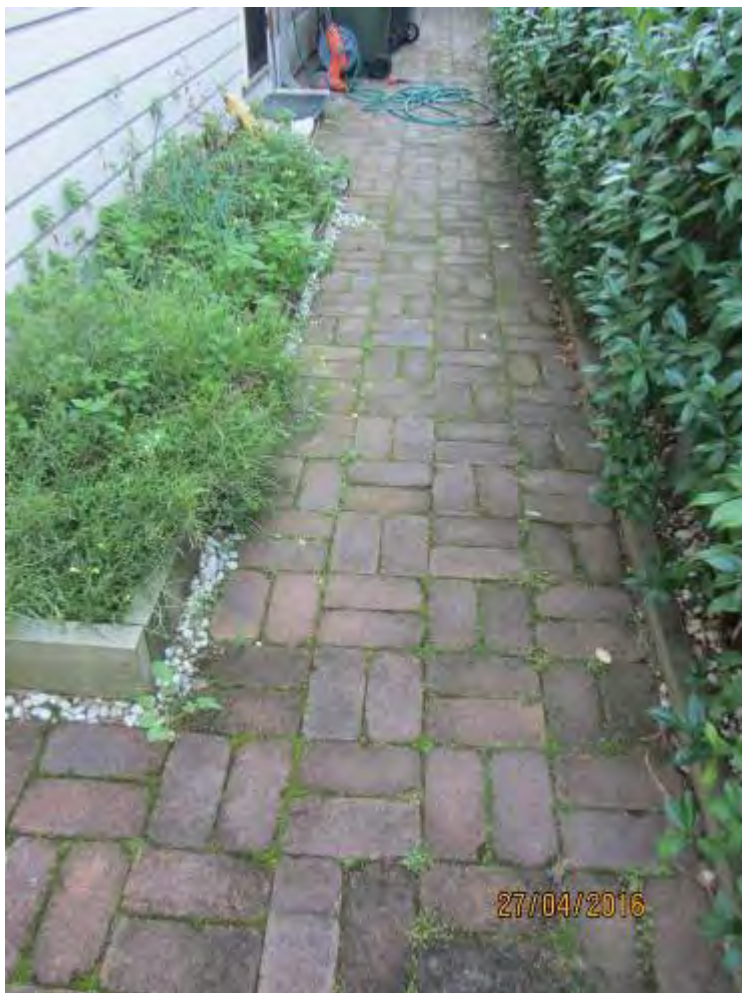
Photograph 11 shows typical condition of the clay pavers to the eastern boundary –
Note: dampness and moss growth between the pavers

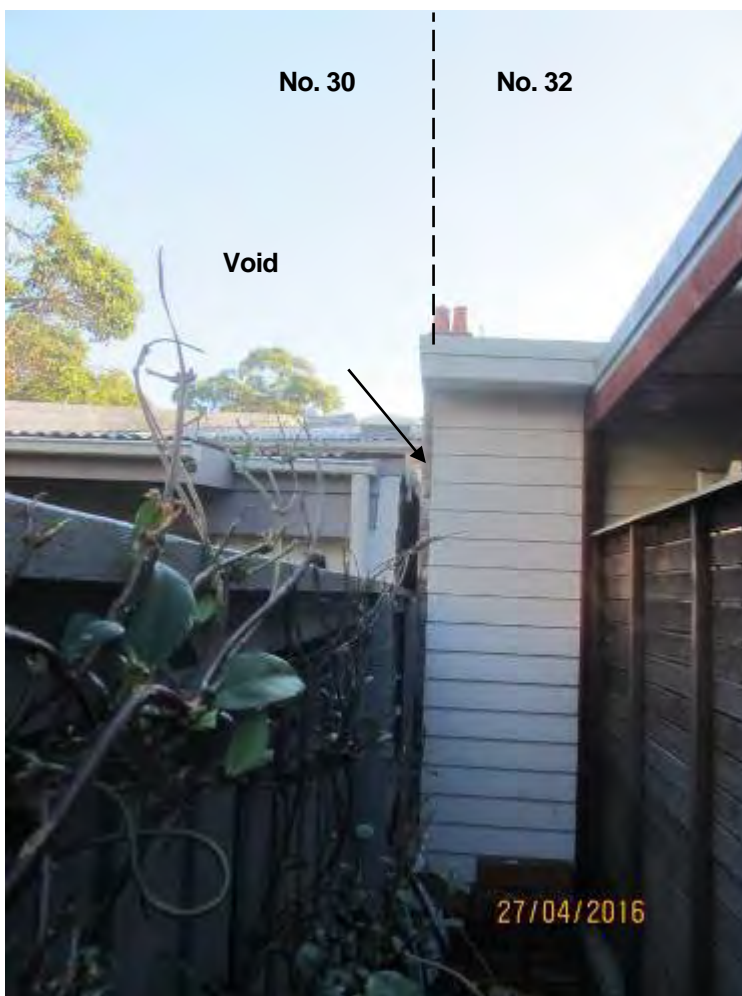
Photograph 12 shows the junction of the rear elevations of the properties

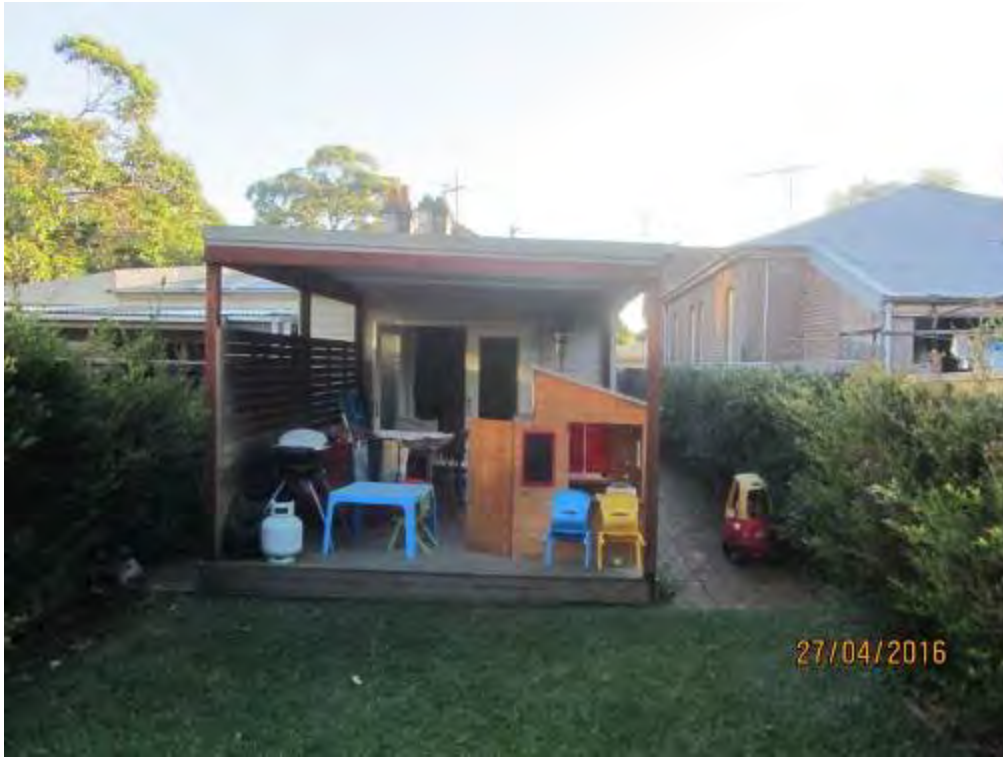
We noted that the entertainment structure is timber framed construction with a flat roof and pan profile acrylic roofing with a suspended timber deck structure. We also noted that the structure is in good condition. **[Photograph 13]**

Photograph 13 shows the rear southern elevation of the property

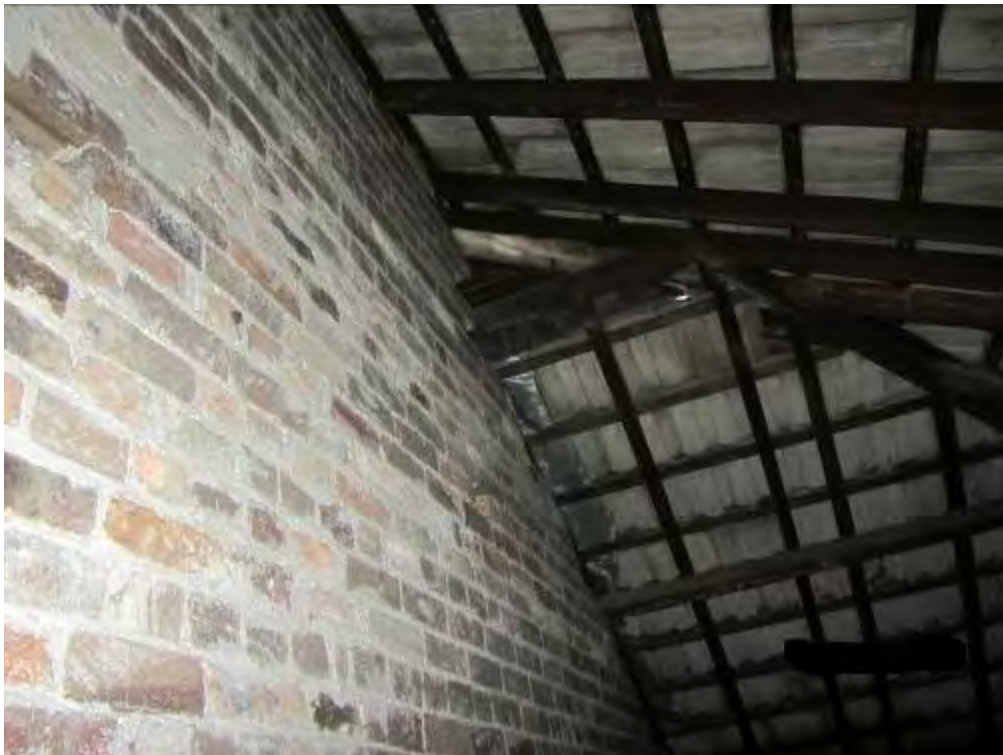
- The *common* roof to the properties is of traditional cut and pitched timber construction.
- Timber ceiling joists are built into the *common party/ separation* wall and the *common* ridge to the roof structure are located over the *common party/ separation* wall.
- There is clay brick *common separating / party* wall within the roof space and that the wall most probably terminates just below the roof covering. **[Photograph 14]**

Photograph 14 shows the *common party / separation* wall within the roof space of the adjoining property: No. 30 Gilderthorpe Avenue

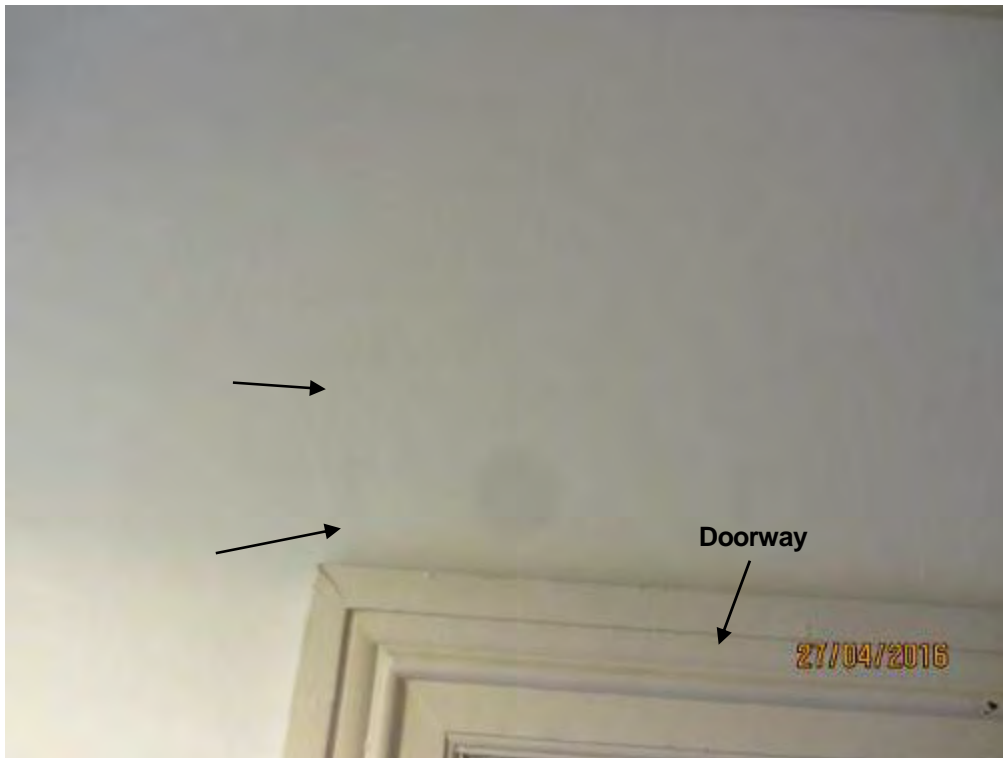
Notwithstanding this, we noted evidence of a previously repaired radial crack extending from the left hand side of the doorway head to Bedroom 1 towards the cornice. **[Photograph 15]**

Photograph 15 shows previously repaired crack above the left hand side of the door head into Bedroom 1

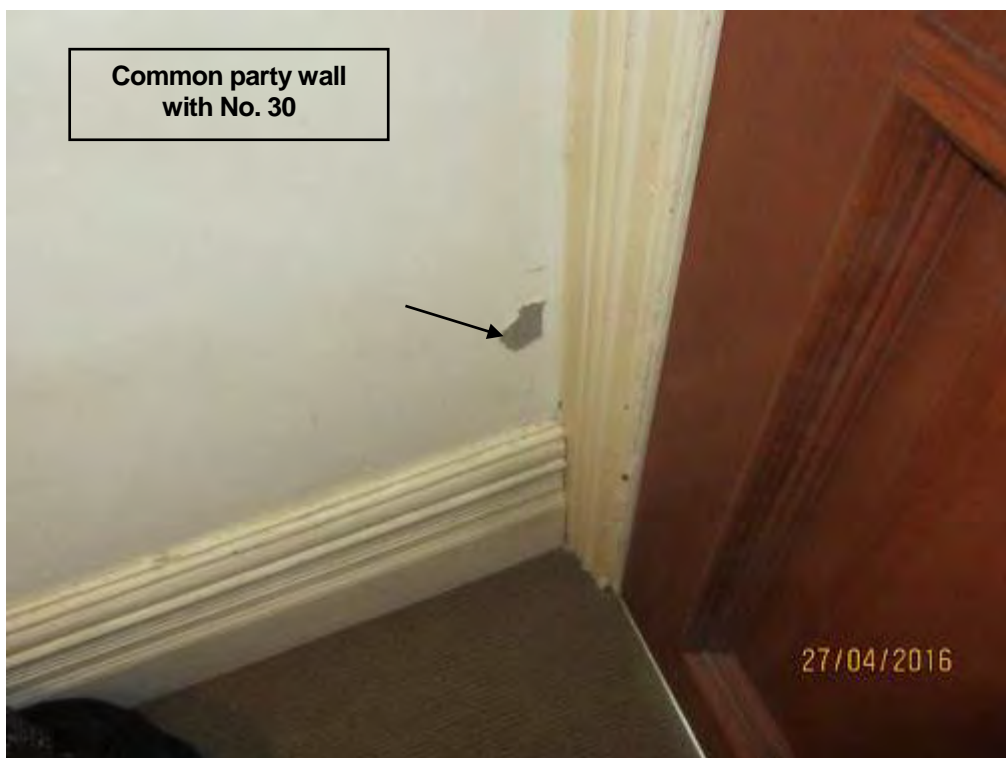
We noted an area of flaking surface coating from the base of the *common party / separation* wall abutting the front entry doorway. **[Photograph 16]**

Photograph 16 shows flaking paint to the base of the *common party / separation* wall adjacent to the front entry door

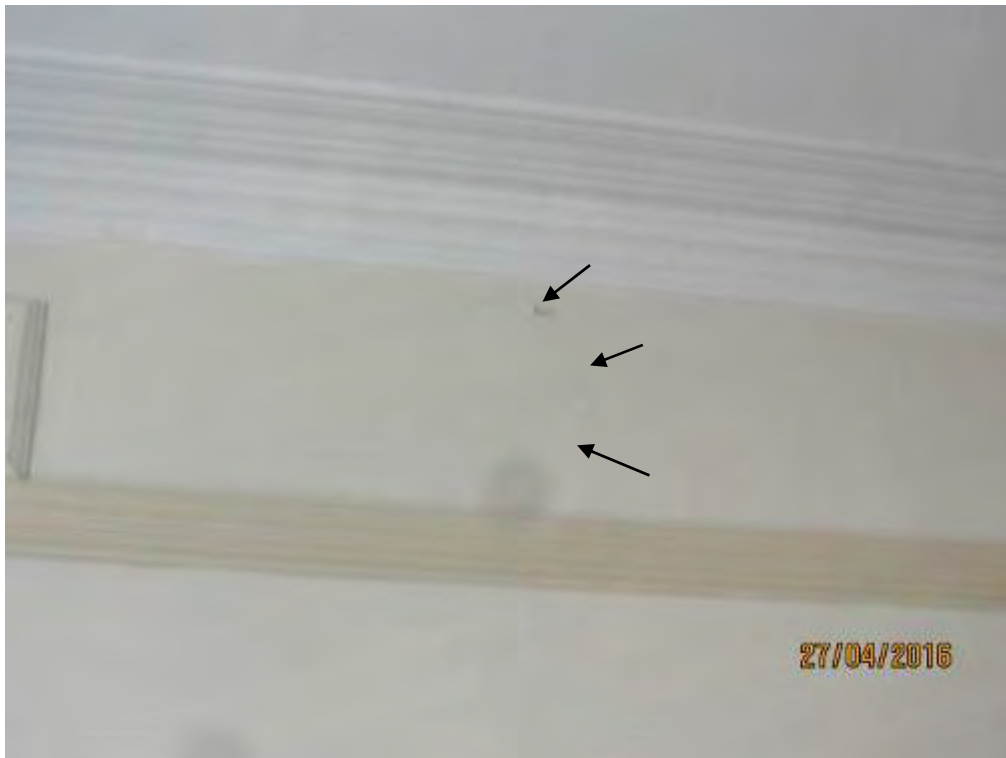
We noted an area of flaking paint and fine hairline cracks [$<0.1\text{mm}$] to the wall surface and to the cornice at the external eastern wall of the room. **[Photograph 17]**

Photograph 17 shows flaking paint and a hairline crack to the cornice to the eastern wall of Bedroom 1

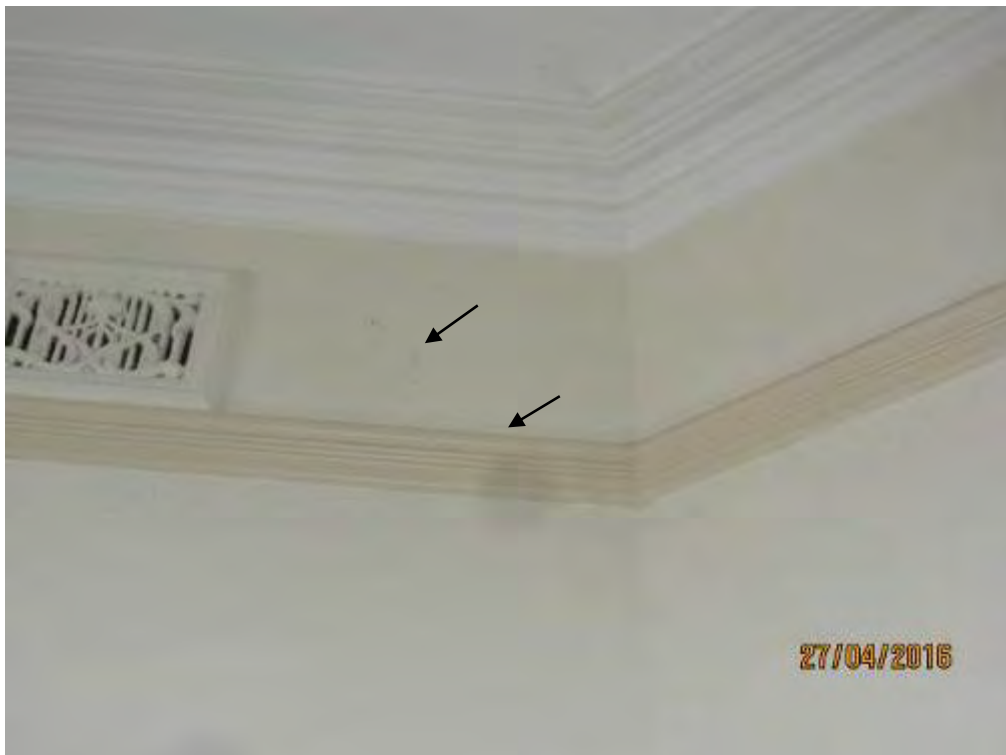
We noted an area of flaking paint and fine hairline cracks [$<0.1\text{mm}$] to the wall surface adjacent to the wall vent in the external eastern wall at the southeast corner of the room. **[Photograph 18]**

Photograph 18 shows flaking paint to the southeast corner of Bedroom 1

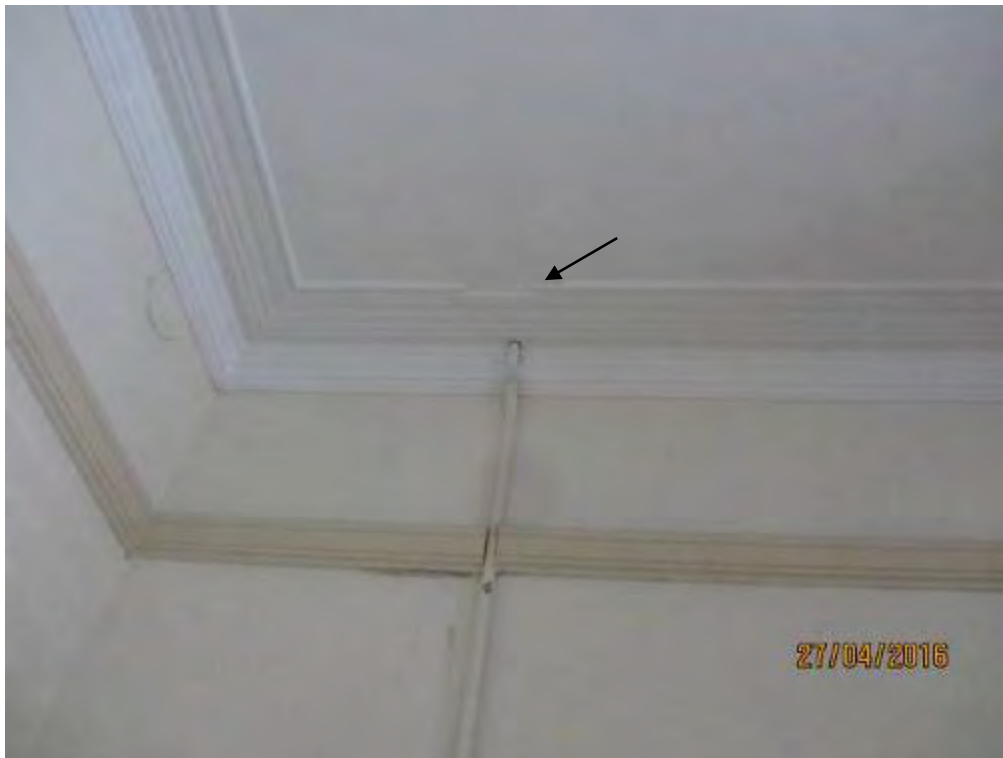
We also noted previous damage to the cornice to the south western corner of the room. **[Photograph 19]**

Photograph 19 shows damage to the cornice to the southwest corner of Bedroom 1

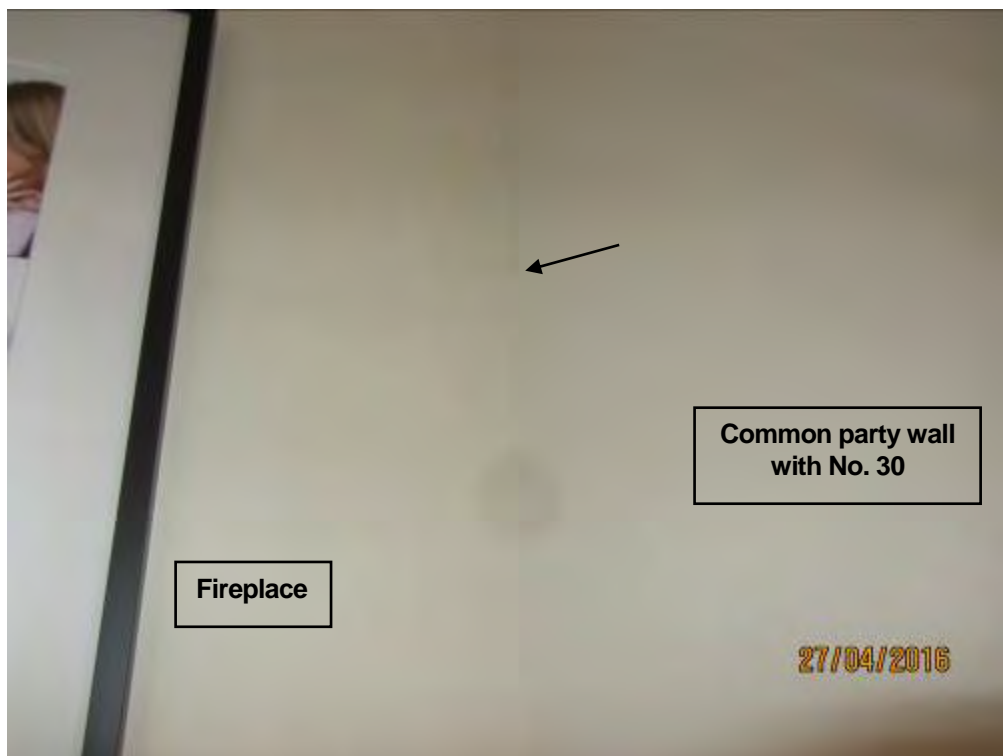
Notwithstanding this, we noted evidence of a previously radial crack to the wall of the fireplace and abutting the *common party / separation* wall. **[Photograph 20]**

Photograph 20 shows the location of previously repaired crack to the southwest corner of the Lounge room

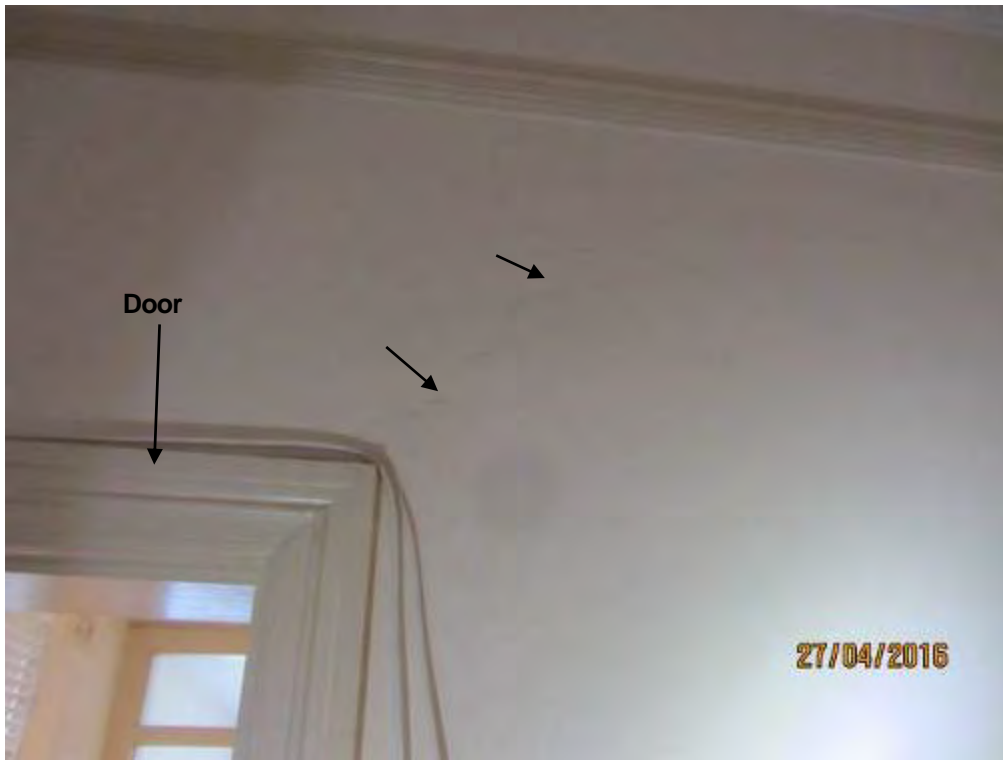
We noted evidence of a previously radial crack to the wall abutting the right hand side of the doorway into the Dining room. **[Photograph 21]**

Photograph 21 shows previously repaired radial crack adjacent to the doorway from the Lounge room into the Dining room

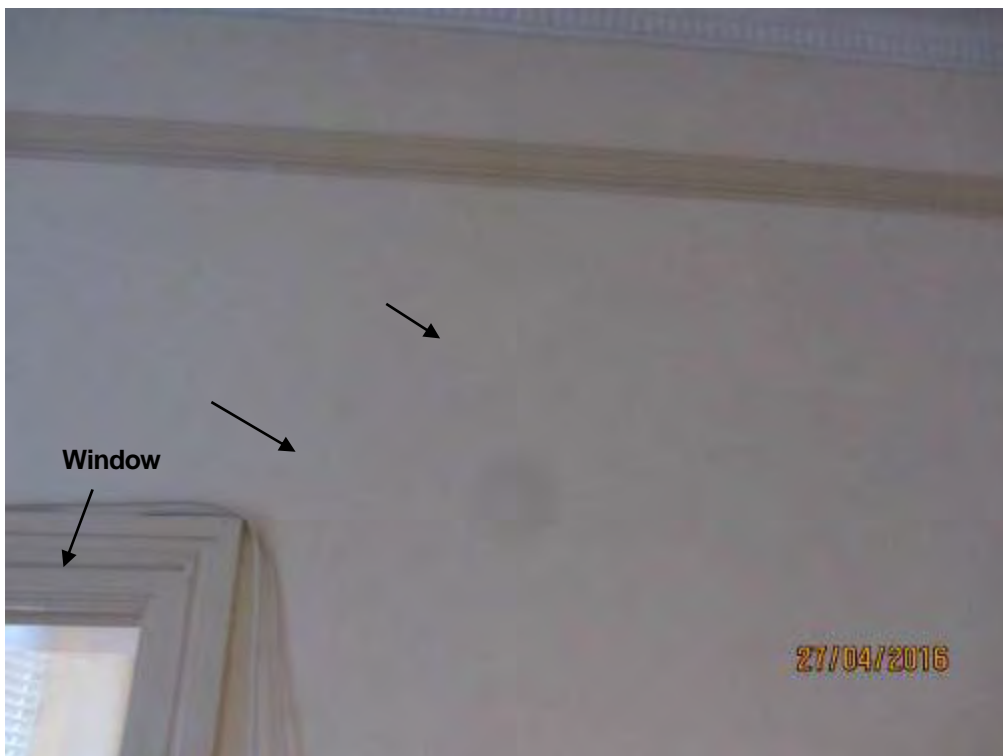
We noted evidence of a previously radial crack to the wall abutting the right hand side of the window head. **[Photograph 22]**

Photograph 22 shows the location of previously repaired radial crack above the window head in the Lounge room

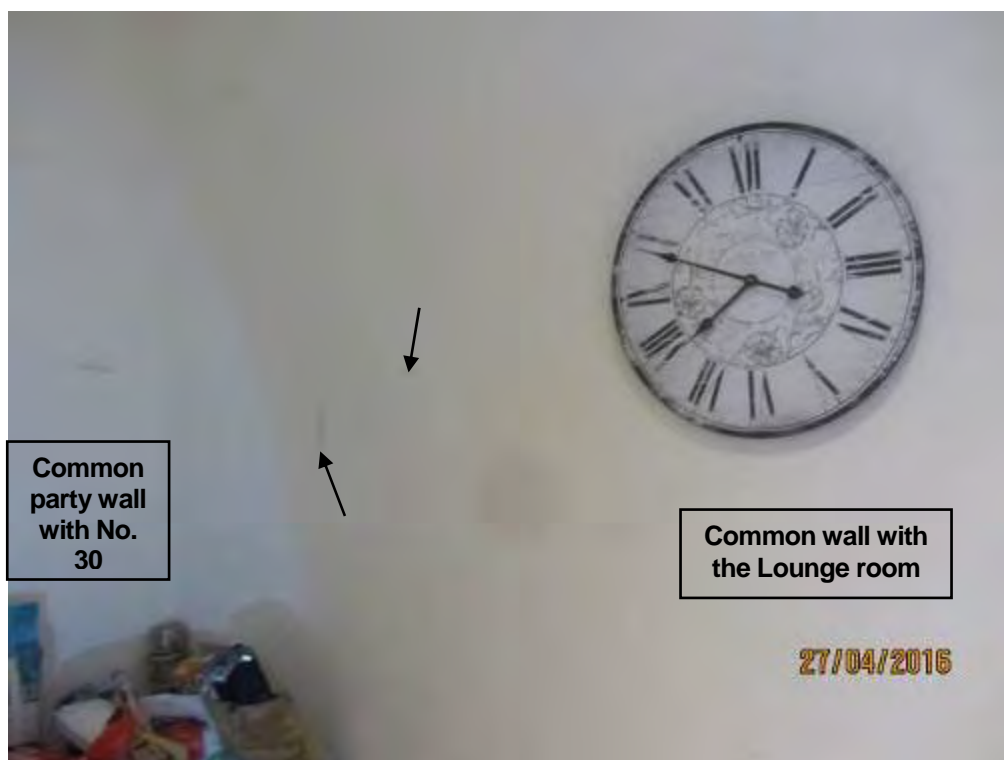
We noted interlinked hairline cracks [$<1.0\text{mm}$] to the surface coated cement render wall and flaking surface coating in the immediate vicinity of the cracks in the northwest corner of the room including to the *common* internal wall with the Lounge room and to the *common party / separation* wall with the adjoining property, No. 30 Gilderthorpe Avenue. We further noted that the cracking is directly behind the brick fireplace located in the south western corner of the Dining room. **[Photographs 23, 24, 25, 26 and 27]**

Photograph 23 shows hairline cracks and lifting paint to the wall at the northwest corner of the Dining room

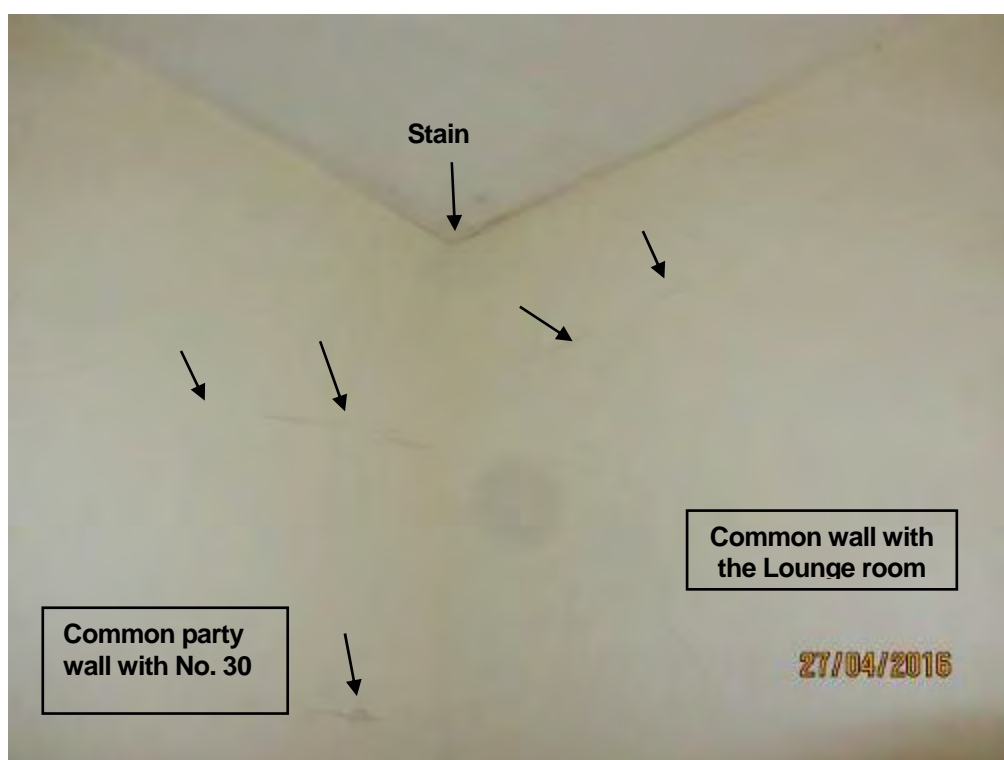
Photograph 24 shows hairline cracking and lifting paint to the northwest corner of the Dining room –
Note: staining to the ceiling

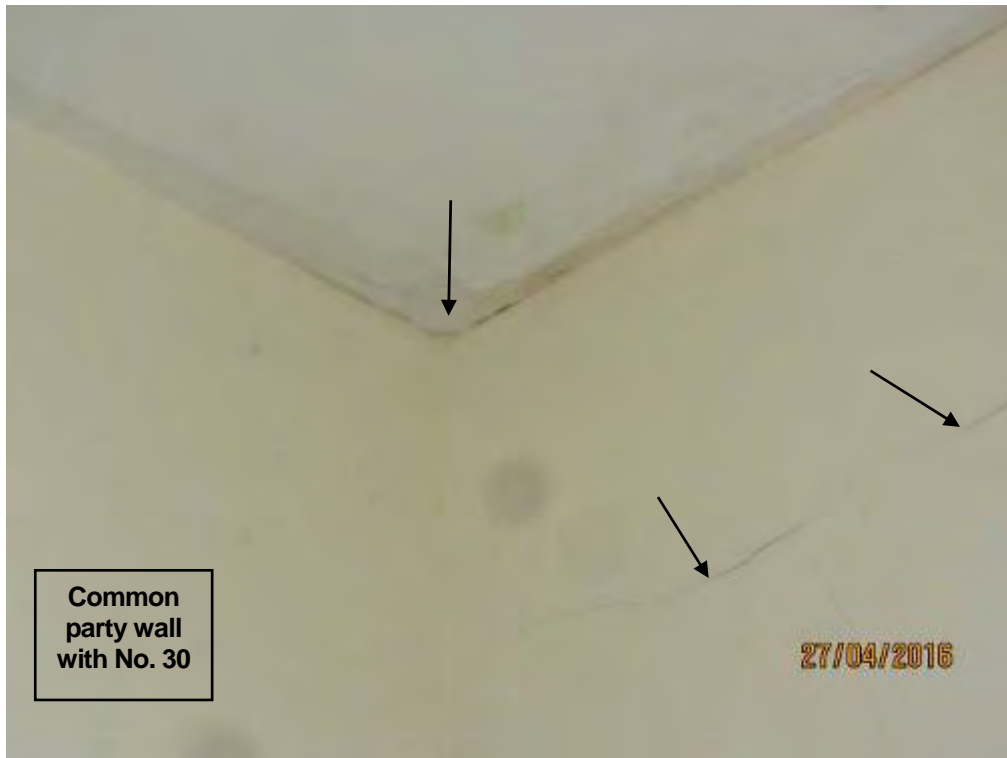
Photograph 25 shows the staining and hairline cracks and lifting paint to the southwest corner to the Dining room

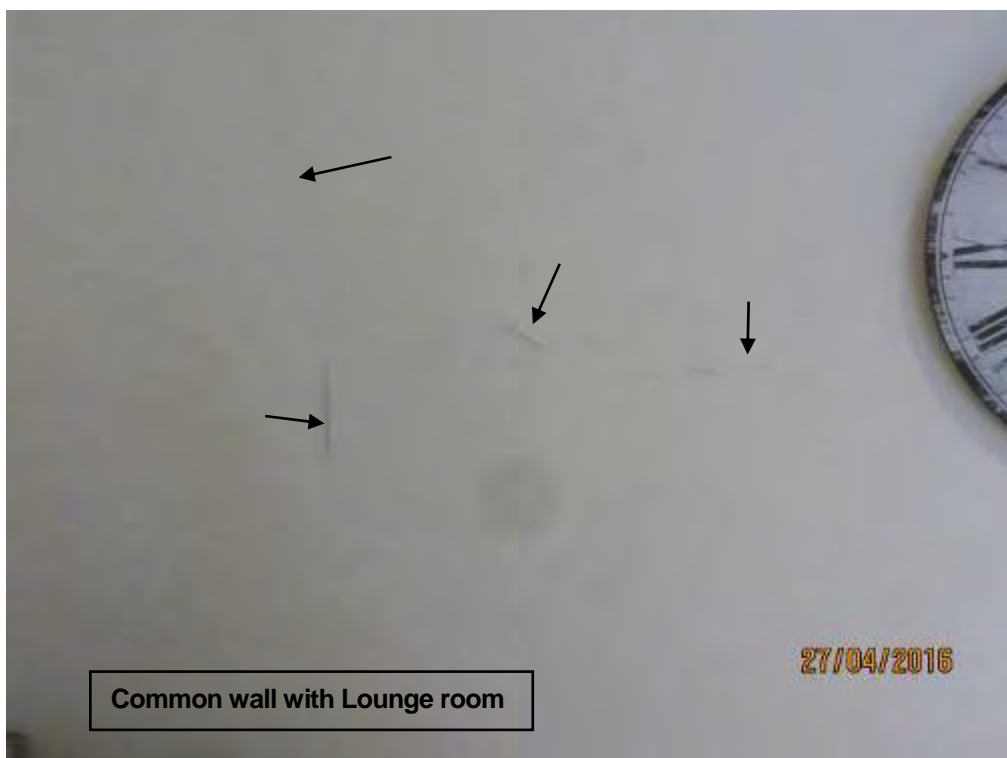
Photograph 26 shows interlinked hairline cracks and lifting paint from the common wall with the Lounge room

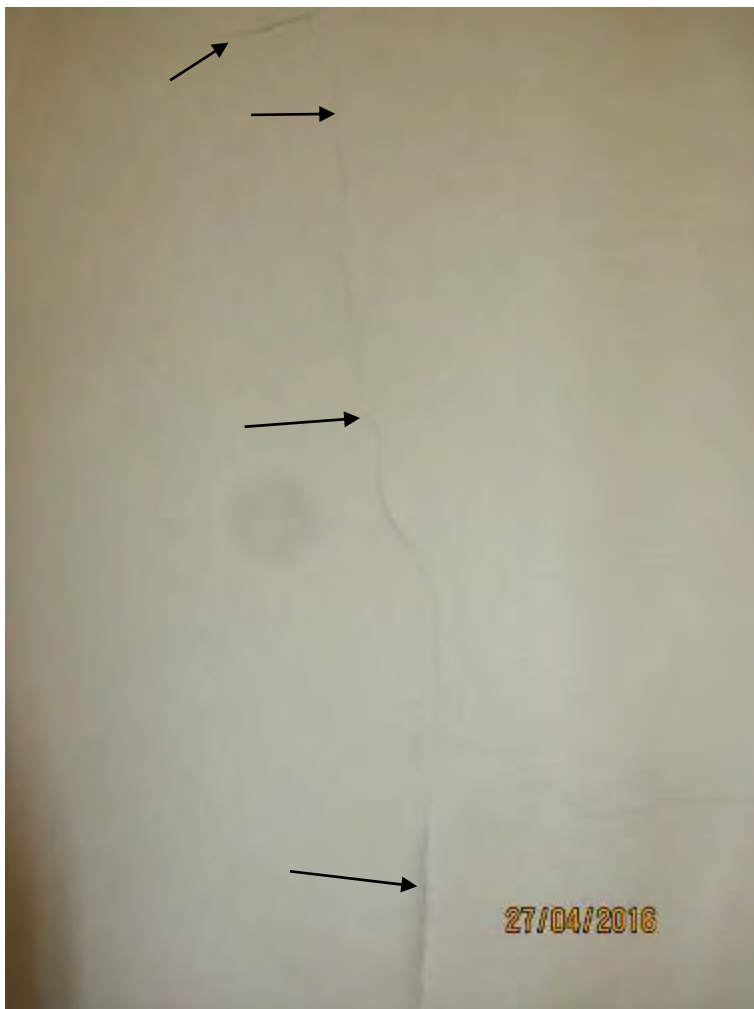
Photograph 27 shows interlinked hairline cracks to the northern wall of the Dining room
