Dilapidation Assessment Report

Prepared for: Cape Cod Australia Pty. Limited
Job address: 32 Gilderthorpe Avenue, Randwick NSW 2031
Property Owner: Mr. D. & Mrs. A. Cotterell
Report reference: **RANDWICK CITY COUNCIL**
Development Application No: not available
Date of assessment: 27th April 2016

Re: Dilapidation Report - No. 32 Gilderthorpe Avenue, Randwick

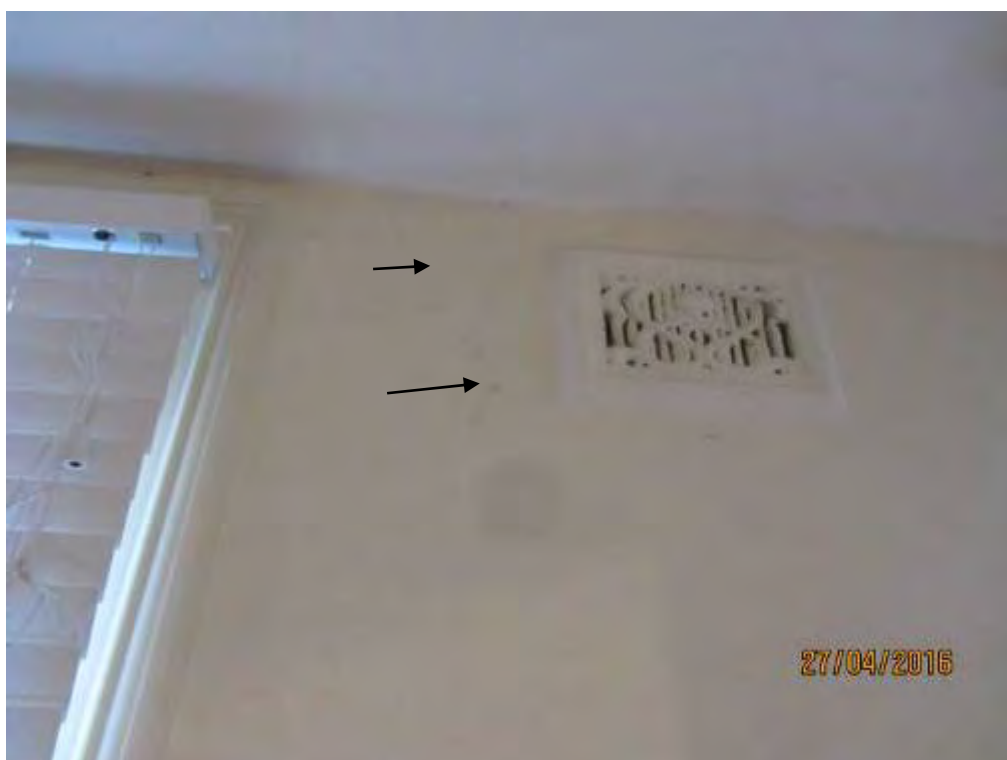
We noted an area of flaking paint and fine hairline cracks [$<0.1\text{mm}$] to the wall surface adjacent to the wall vent in the external eastern wall at the southeast corner of the room. **[Photograph 28]**

Photograph 28 shows hairline cracks adjacent to the wall unit to the southeast corner of the Dining room

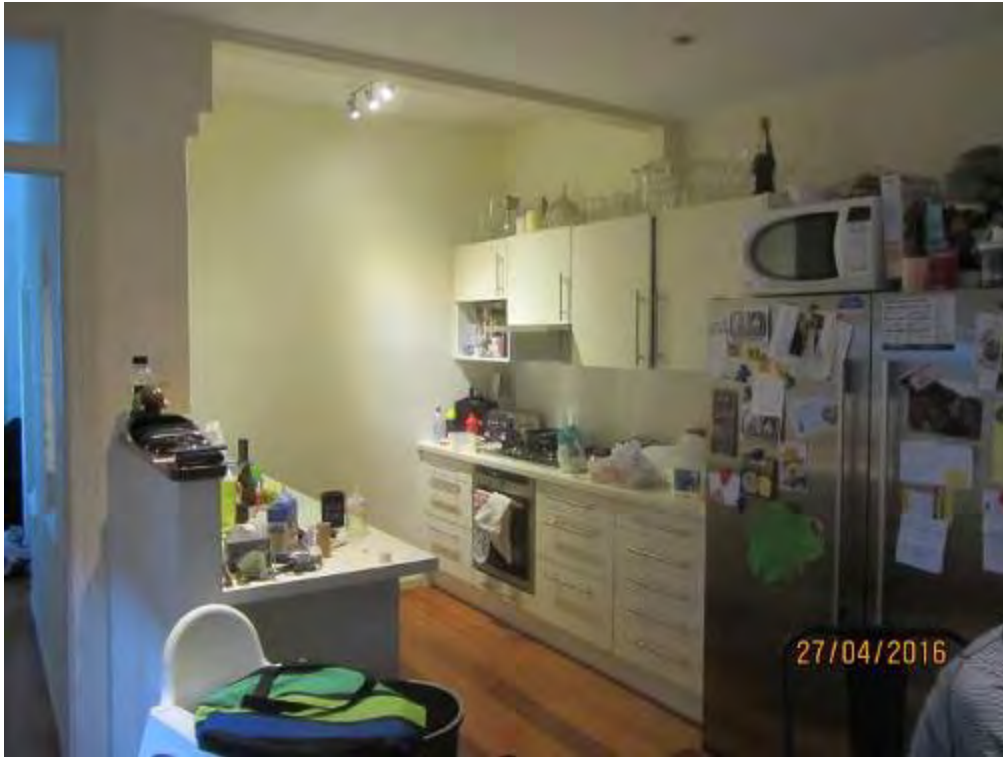
We noted that the *common party / separation* wall is partially concealed by floor and wall mounted cupboards. **[Photograph 29]**

Photograph 29 shows the Kitchen layout

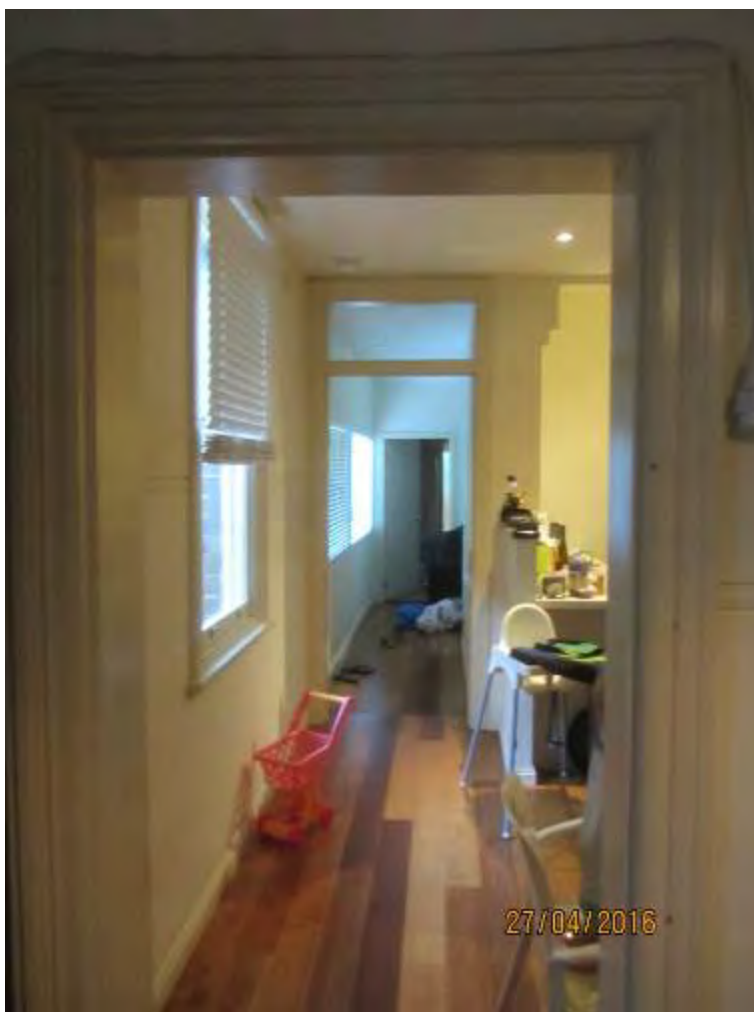
We observed that the floor is finished with polished strip timber flooring. **[Photograph 30]**

Photograph 30 shows the rear Hallway / Kitchen

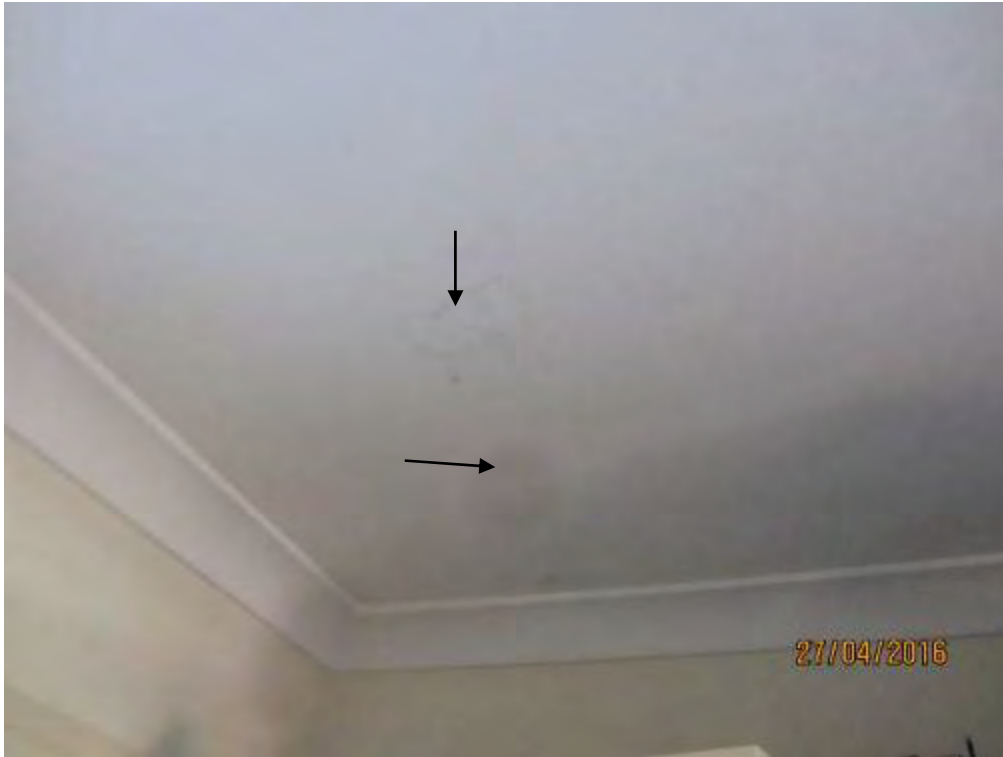
We did not observe any cracking to the plasterboard ceiling or to the cove profiled plaster cornices and particularly to the *common party / separation* wall with the adjoining property, No. 30 Gilderthorpe Avenue. Notwithstanding this we did note staining to the ceiling lining to the north eastern corner of the room.
[Photograph 31]

Photograph 31 shows staining to the ceiling at the northeast corner of the rear Sunroom
