HAZARDOUS MATERIALS ASSESSMENT REPORT

Job details: Owner/s: Mr. P. Danckwerts & Ms. Y. Hamilton
Location: 10 Westbourne Street, Stanmore

Our reference: HM03360914

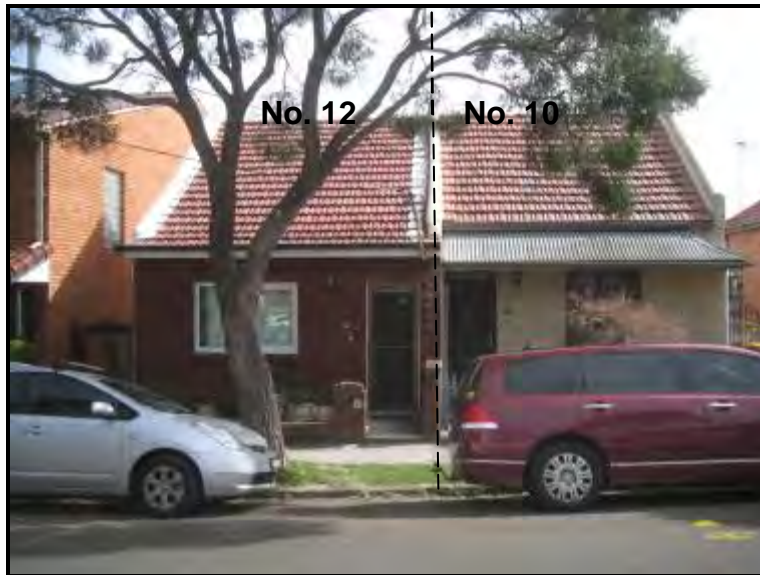
Front south eastern elevation of the adjoining properties:
No. 10 & No. 12 Westbourne Street, Stanmore
