HAZARDOUS MATERIALS ASSESSMENT REPORT

Client: Cape Cod Australia Pty. Limited

Job details: Owner: Mr. Marcello & Mrs. Kathleen Correa.
Location: 26 Peacock Parade, FRENCHS FOREST NSW.

Our reference: HM04910516

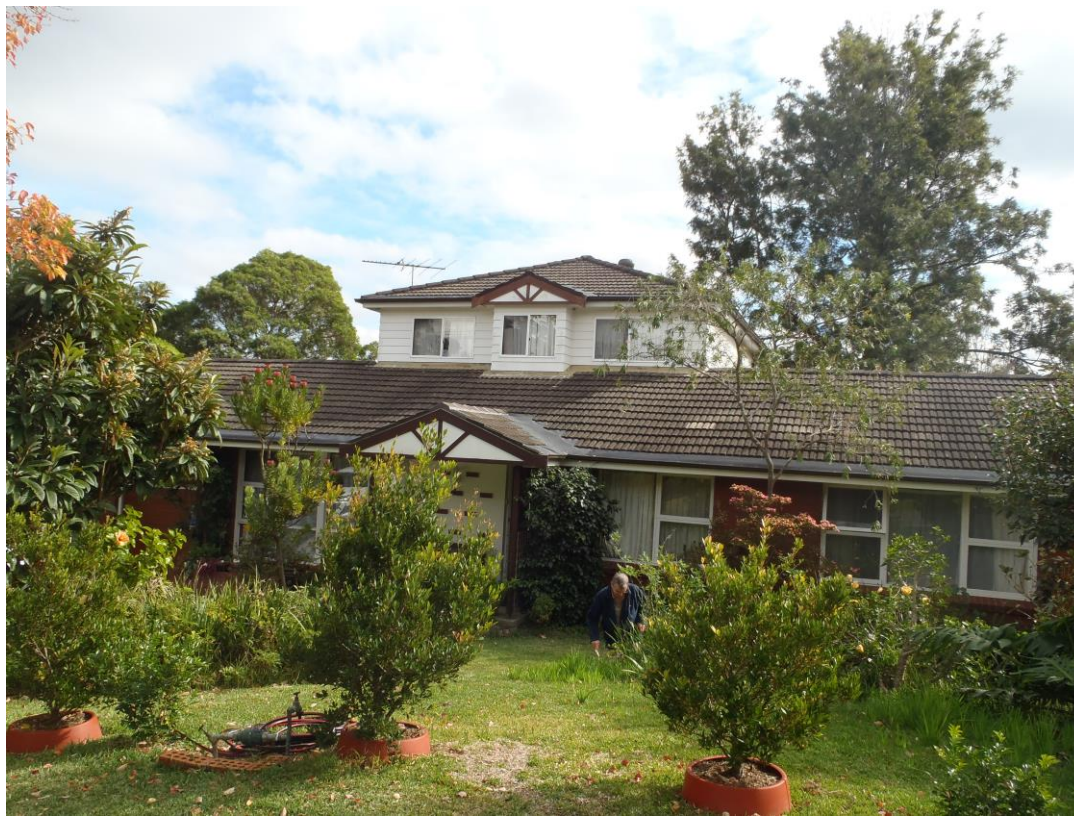
Front south eastern elevation of the residence
