HAZARDOUS MATERIALS ASSESSMENT REPORT

Job details: Owner: Ms. A. Raju
Location: 16 Hayes Avenue, Northmead NSW

Plans for Job No: 7595/14 Revision No: C Dated: 07-11-14

Our reference: HM03491114

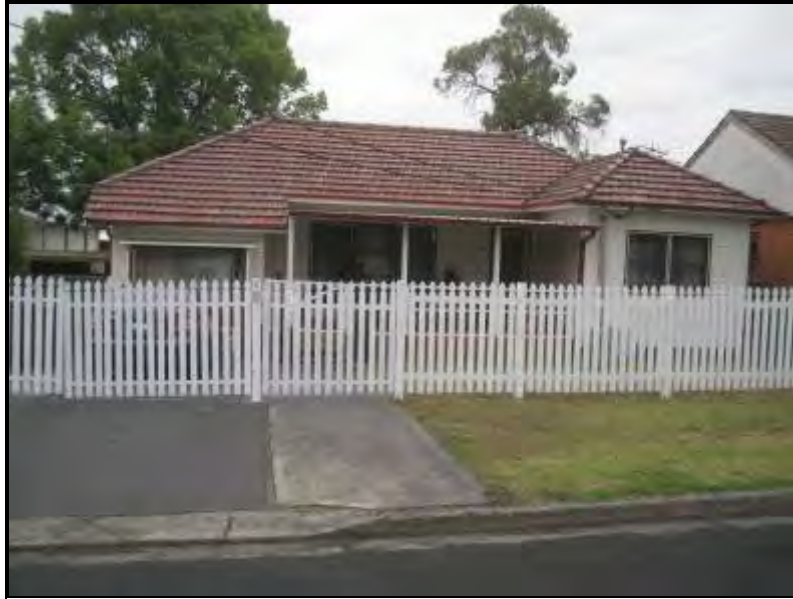
Front southeast elevation of the residence
