HAZARDOUS MATERIALS ASSESSMENT REPORT

Client: Cape Cod Australia Pty. Limited

Job details: Owner/s: Mr. N. & Mrs. A. De Silva
Location: 44 Hallam Avenue, Lane Cove West

Our reference: HM03870415

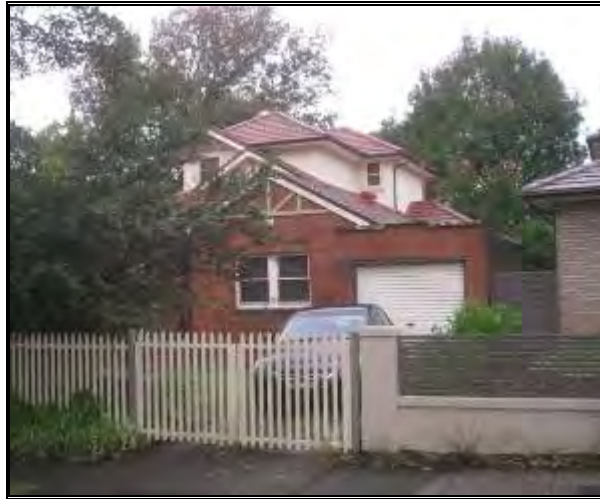
Front northern elevation of the residence
