Dilapidation Assessment Report

Prepared for: Cape Cod Australia Pty. Limited
Job address: 12 Union Street, Dulwich Hill NSW 2203
Property Owner/s: Mr. S. & Mrs. S. Watson
Report reference: **Marrickville Council
Development Application No.: to be advised**
Date of assessment: 23rd November 2015

Re: Dilapidation Report - Development Application No.: not available
Property Address: No. 12 Union Street, Dulwich Hill

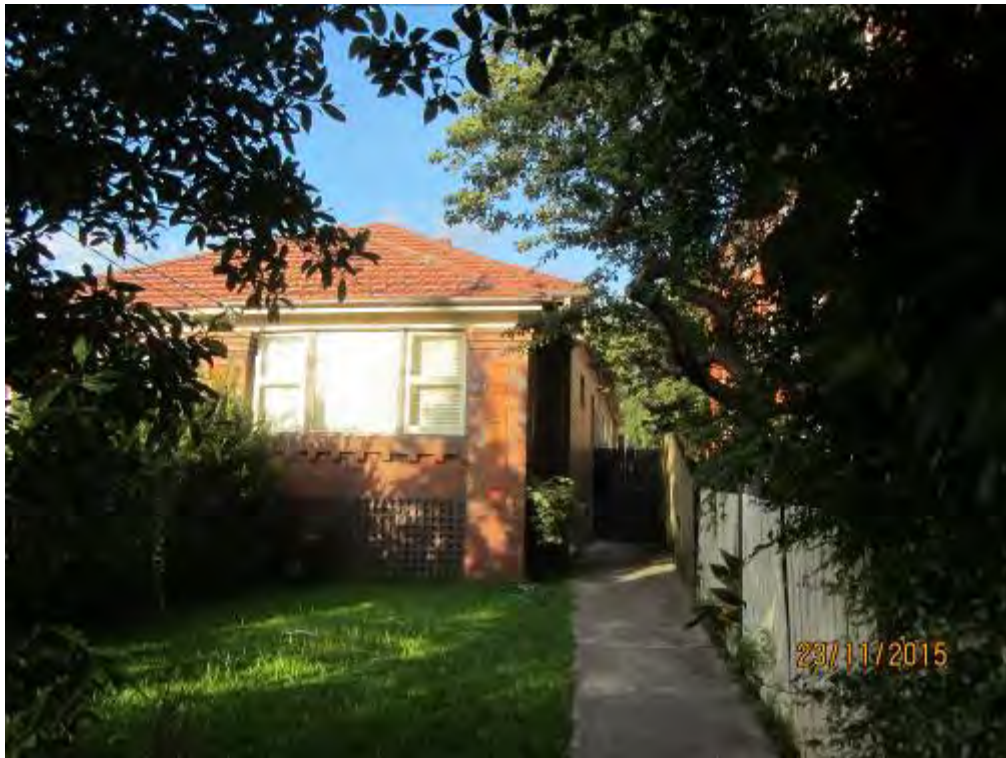
We did not observe any recent noticeable cracking the front entry concrete pathway. **[Photograph 1]**

Photograph 1 shows the condition of the front entry pathway

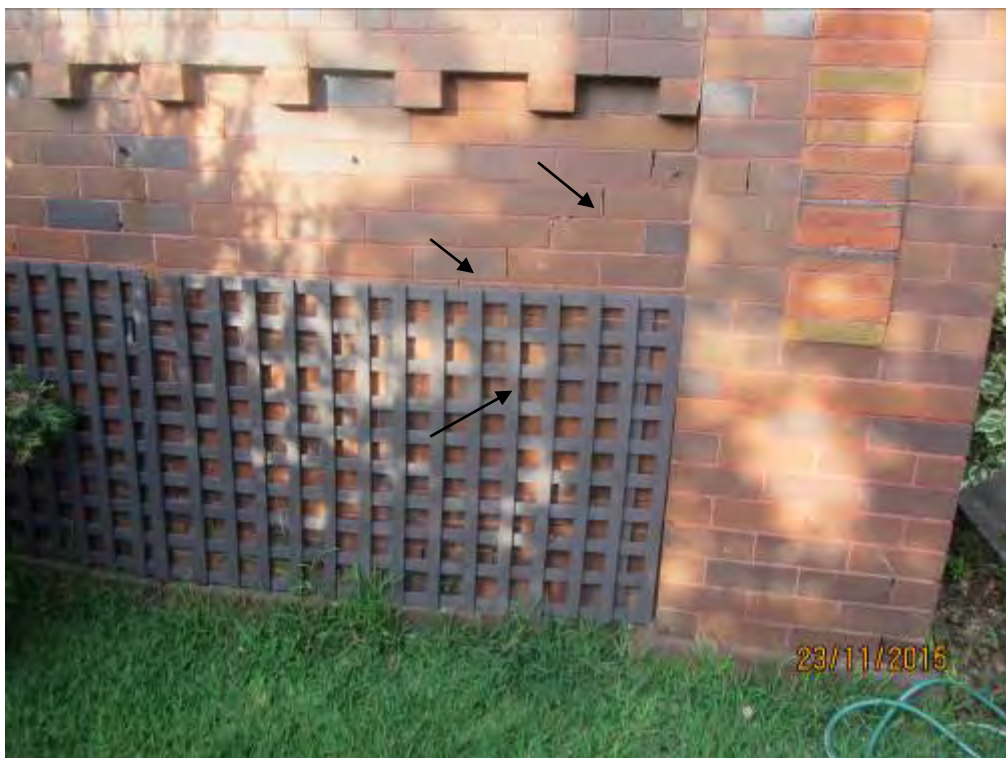
We noted stepping cracking [1.0mm - <5.0mm] to the northern corner of the front Sunroom wall. **[Photograph 2]**

Photograph 2 shows the stepped cracking to the northern corner of the front Sunroom wall

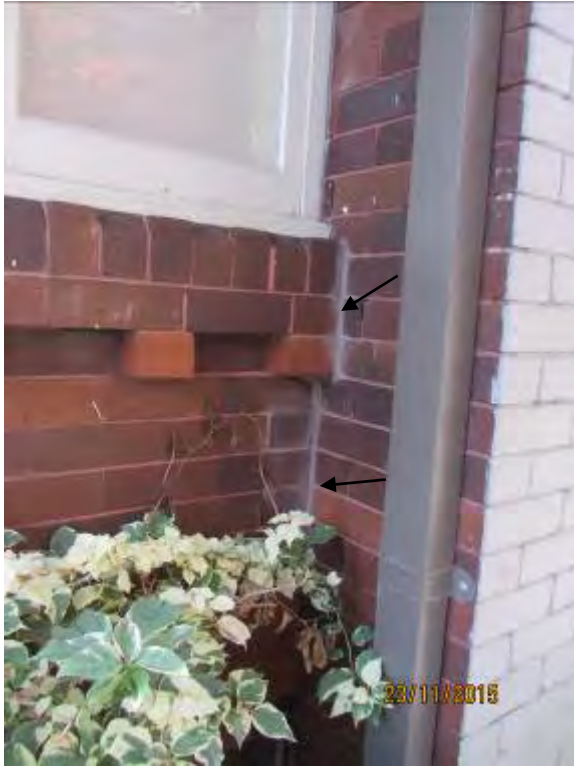
We noted that there is a previously repaired vertical crack at the junction of the Sunroom wall and the front wall of Bedroom 1. **[Photograph 3]**

Photograph 3 shows previous repairs to the internal corner between the Sunroom and Bedroom 1

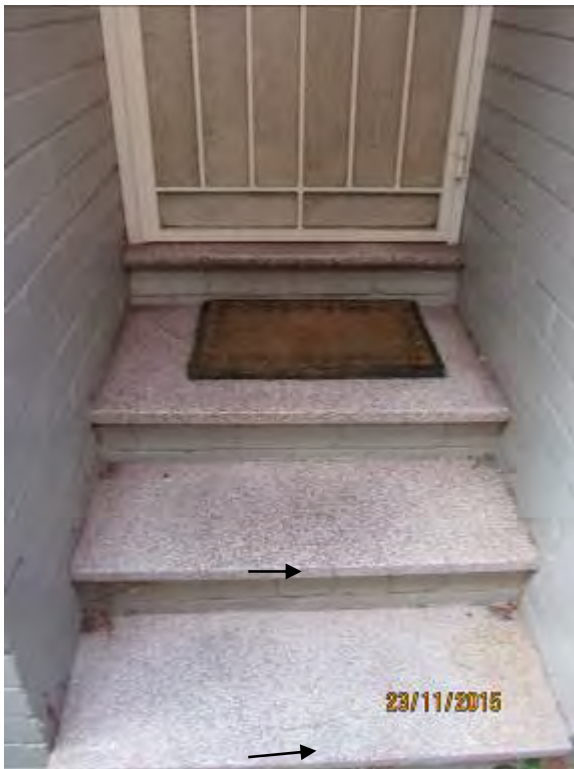
We noted that there is hairline cracking [<0.1mm] to the terrazzo front entry steps. **[Photograph 4]**

Photograph 4 shows hairline cracking to the terrazzo front entry steps

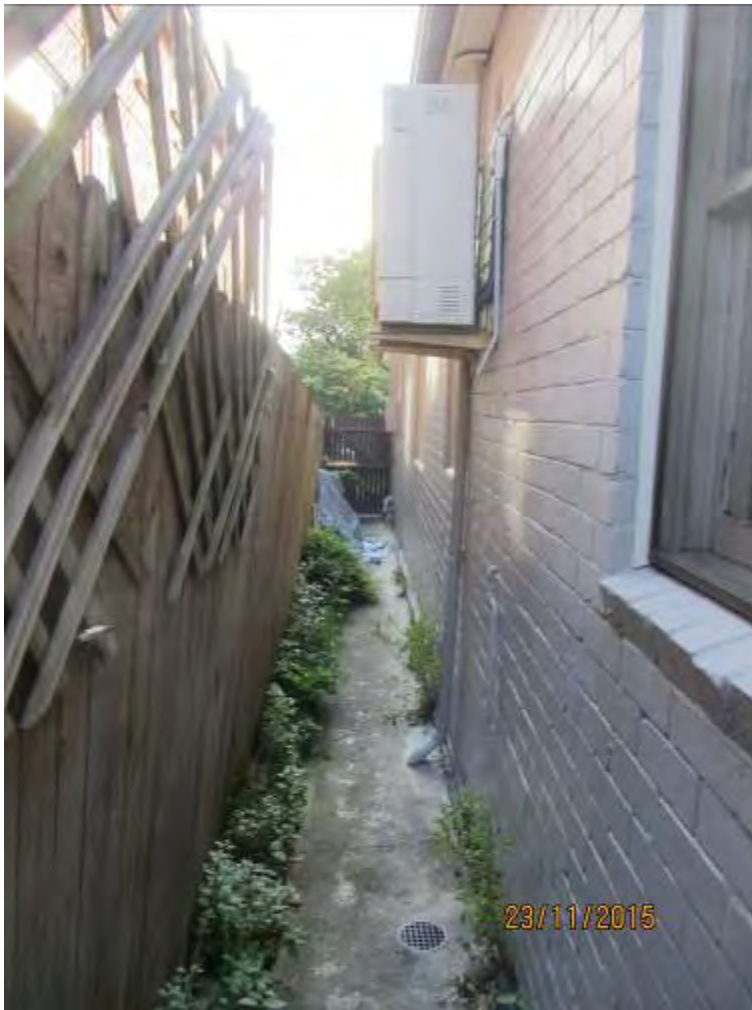
We noted areas of unevenness and dampness and lichen growth to the surface of the concrete pavement between the residence and the northern *common boundary* with the adjoining property. **[Photographs 5 and 6]**

Photograph 5 shows the northern elevation of the residence and the condition of the concrete pavement viewed from the rear to the front

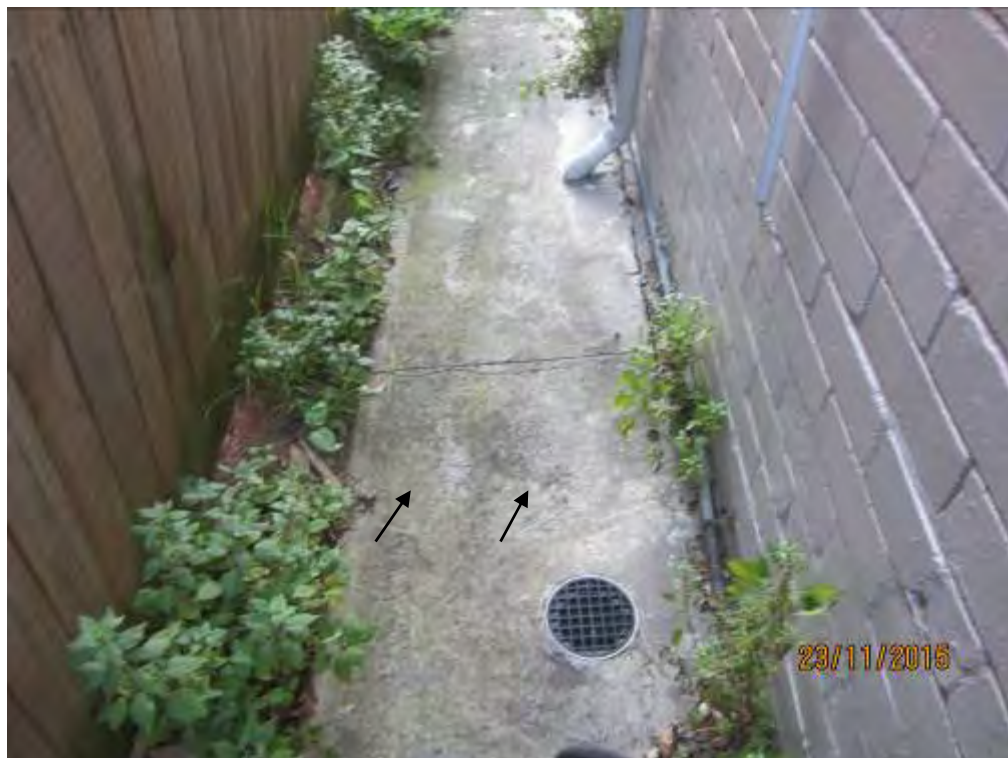
We also noted that there is cracking of the concrete pavement. **[Photograph 6]**

Photograph 6 shows the condition of the concrete pavement and typical cracking to the pavement

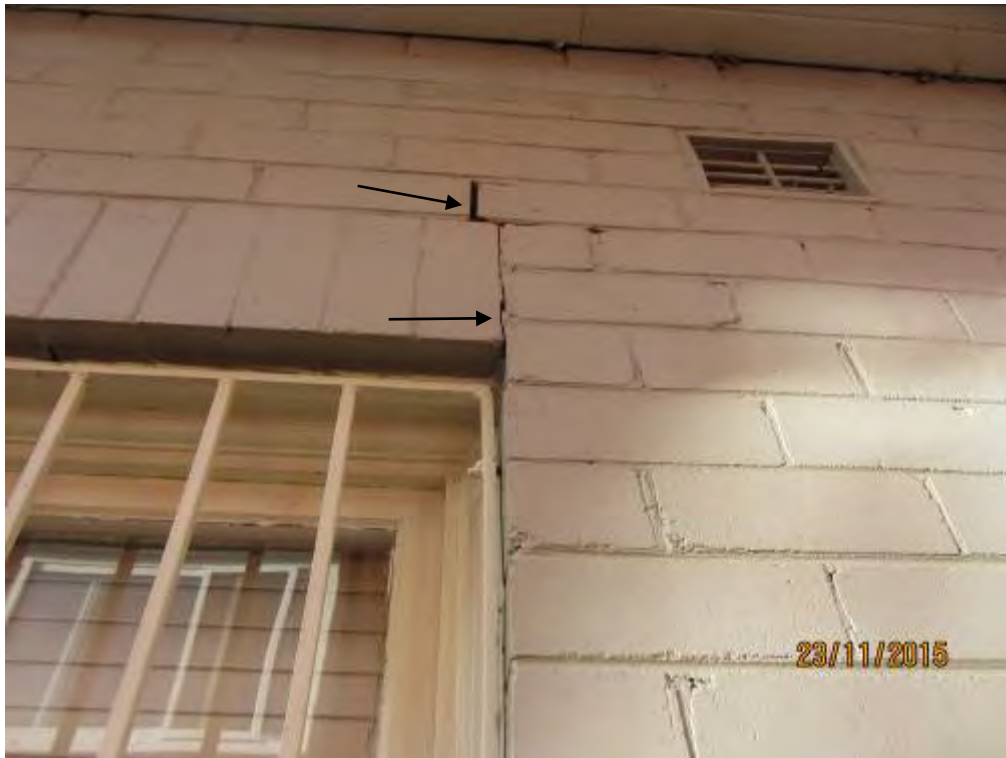
We noted a hairline vertical crack [1.0mm] extending from the right hand side Lounge room window head towards the wall vent. **[Photograph 7]**

Photograph 7 shows a vertical crack above the right hand side of the window head to the Lounge room

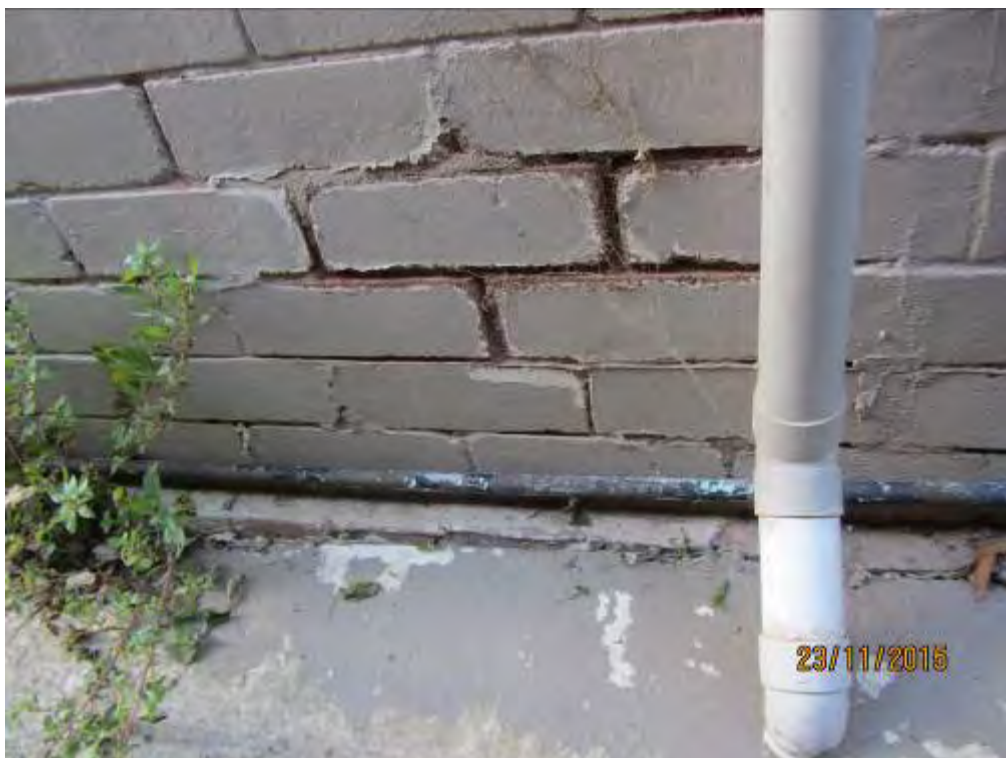
We noted there is displaced mortar from the base brickwork adjacent to the vent pipe. **[Photograph 8]**

Photograph 8 shows displaced mortar adjacent to the vent pipe on the northern wall of the residence

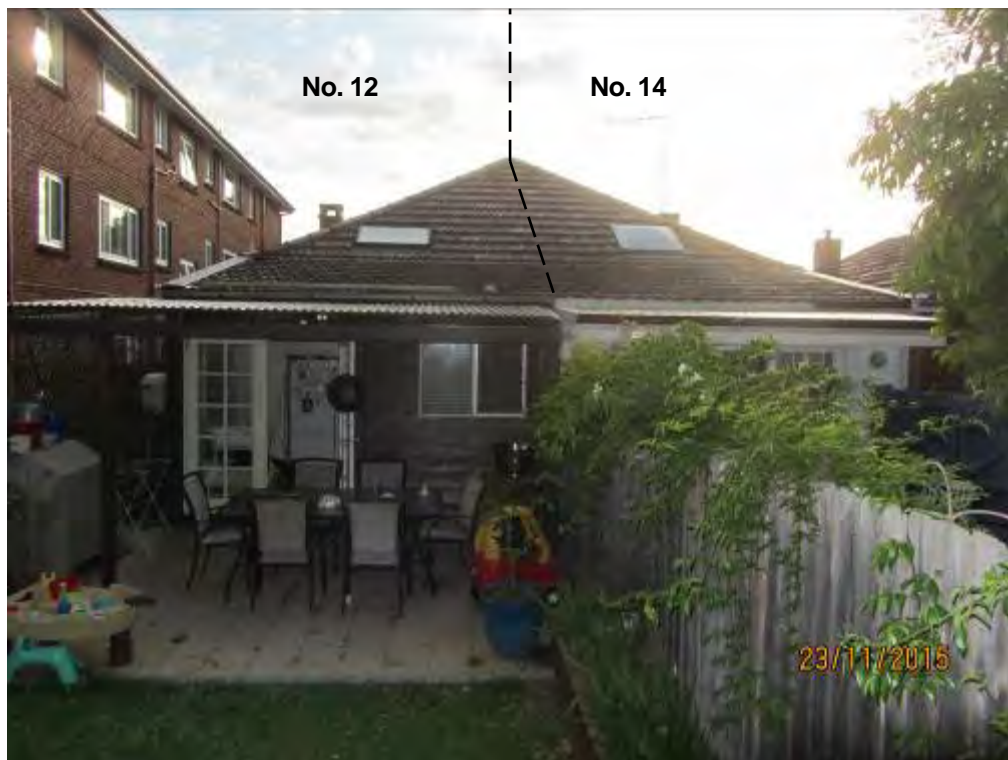
We noted that the opaque acrylic roofing sheets to the patio roof is securely fixed. **[Photograph 9]**

We noted that the framed wall is clad with fibre-cement weatherboards. **[Photograph 9]**

Photograph 9 shows the rear western elevation of the property

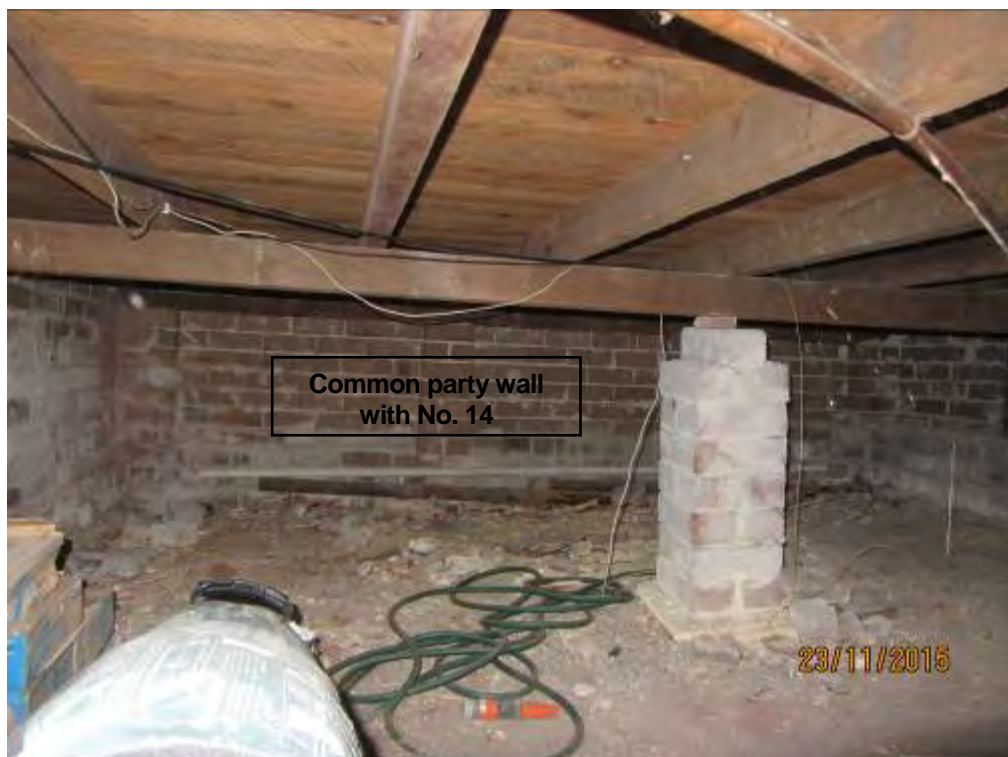
We noted that the floor system is hardwood timber bearers and joists and strip timber flooring and that there is a brick *common separating / party* wall with the adjoining property, No. 14 Union Street that extends to above floor level. We did not observe cracking in the clay brickwork below floor level in the sub floor area. **[Photograph 10]**

We noted that there is no evidence of termite protection to the structural timbers built into or supported upon the base brickwork. **[Photograph 10]**

Photograph 10 shows the *common party / separation* wall in the underfloor area

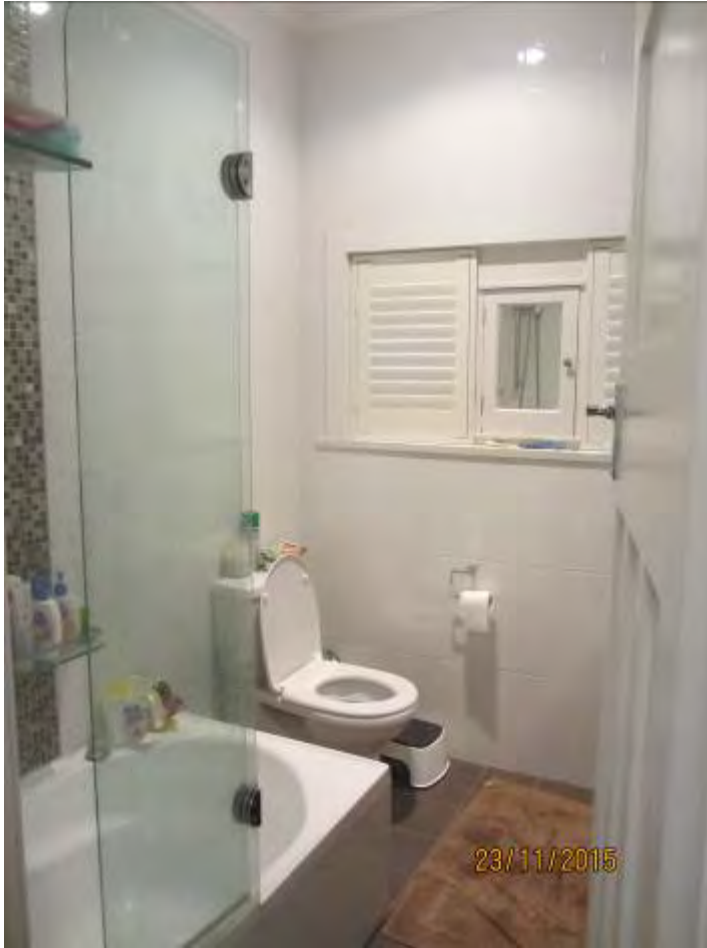
We noted that the wall tiles extend from floor to ceiling level. We did not observe any recent cracking to the ceramic wall tiles. **[Photograph 11]**

Photograph 11 shows the layout of the Bathroom

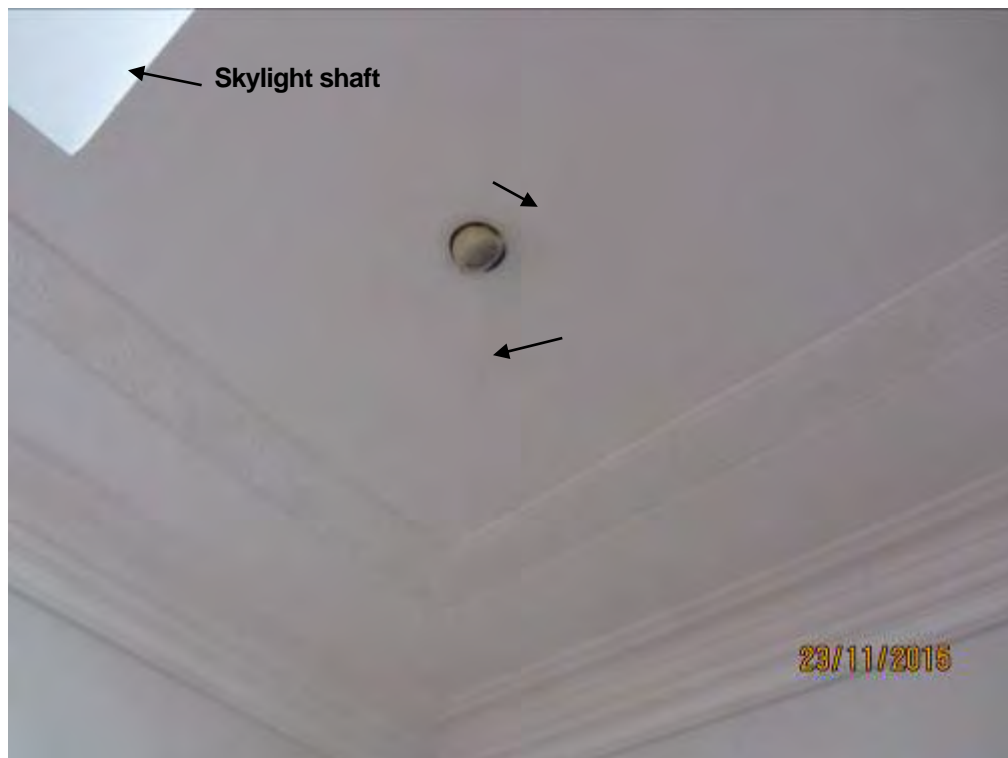
We noted that there is interlinked spider cracking to the ceiling adjacent to the downlight fitting between the skylight shaft and the common internal wall with the Lounge room. **[Photograph 12]**

Photograph 12 shows hairline spider cracking adjacent to the down light in the Dining room ceiling

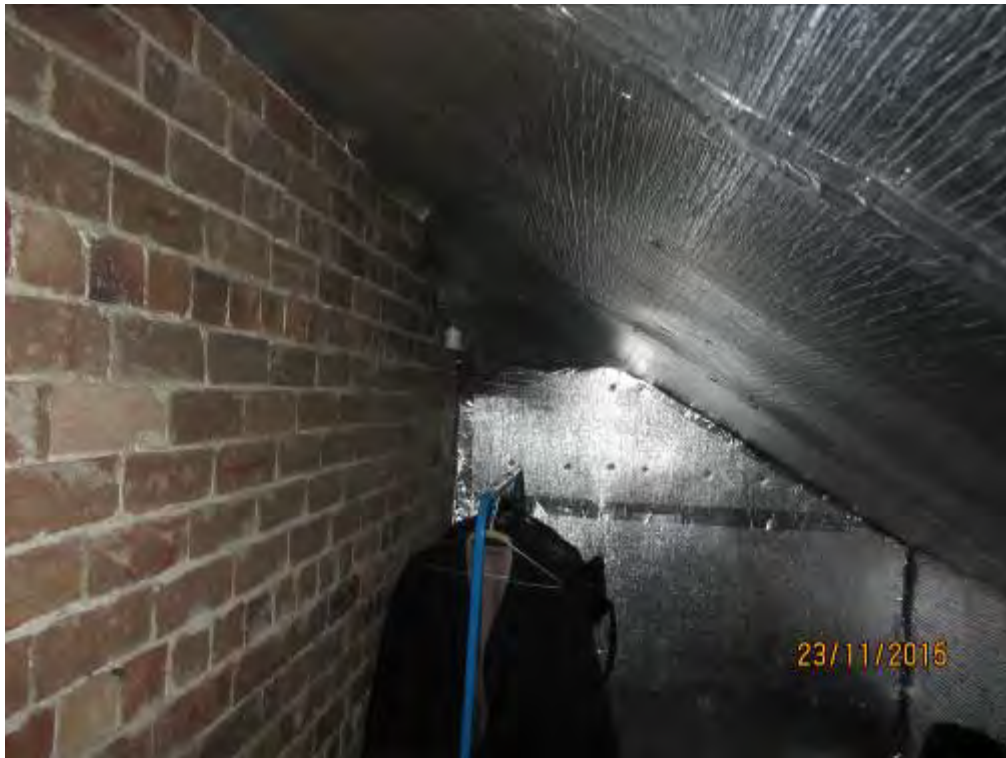
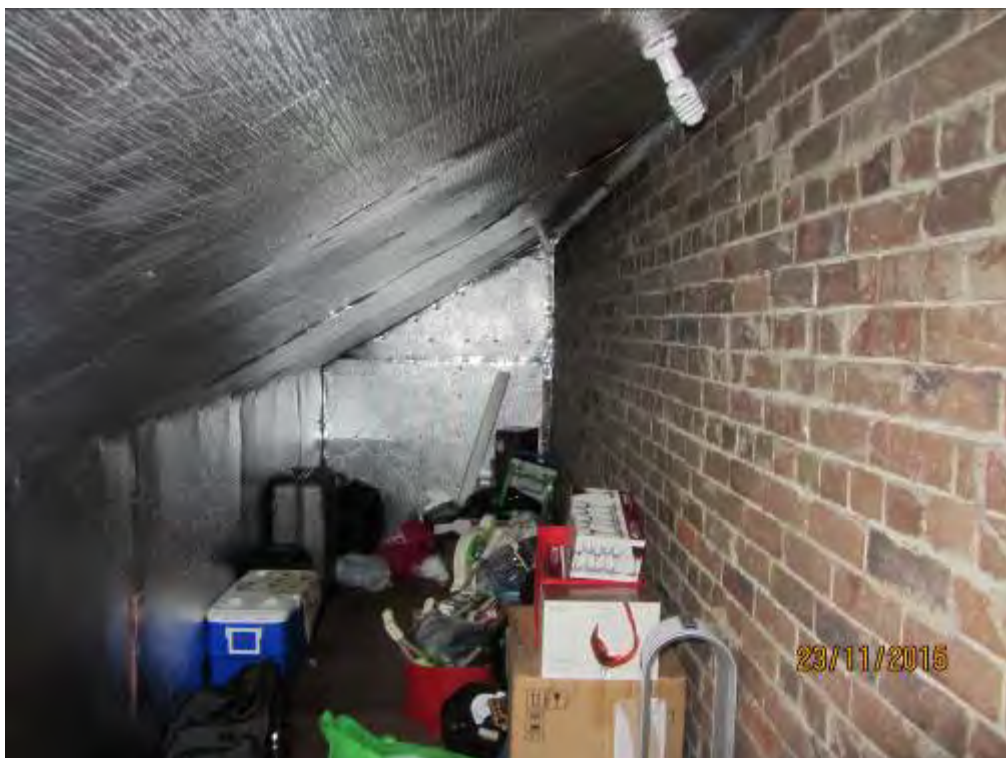
We noted that there is foil backed sarking to the underside of the rafters restricting access to the underside of the roofing tiles and sheet particleboard flooring concealing the ceiling joists. **[Photograph 13 and 14]**

We also noted that the clay brick *common separating / party* wall extends to the underside of the rafters. [**Photographs 13 and 14**]

Photograph 13 shows the *common party / separation* wall in the attic room space

Photograph 14 shows the *common party / separation* wall in the attic room space
