LOOSE-FILL ASBESTOS INSULATION CEILING CAVITY INSPECTION

WC Number : 36808/2016/RAD

Address: 10, Gwandalan Cres, BEROWRA, 2081

Issue Date: 19/03/2017

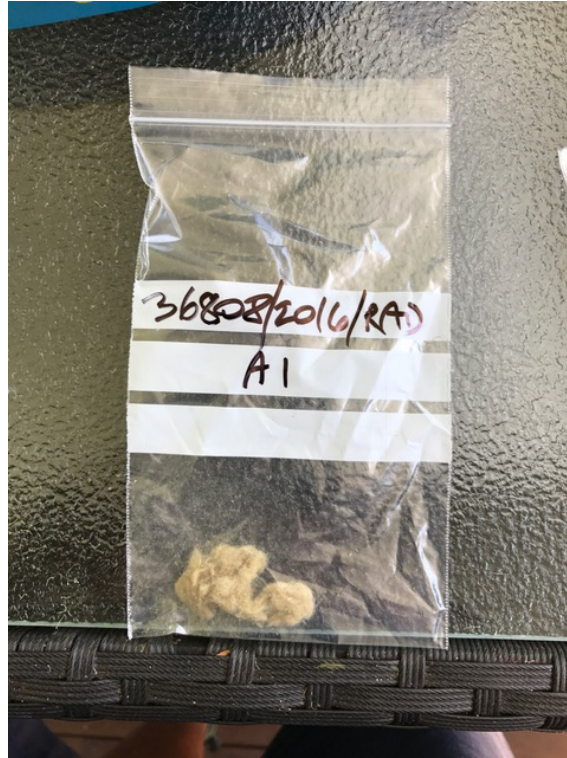
Photograph 1: Sample 1

Sample Reference	Sample Description	Location	Photo	Results
A1	Mineral fibre loose fill	Ground floor roof space	Refer to Appendix C	No Asbestos Detected
A2	Mineral fibre loose fill	Ground floor roof space	Refer to Appendix C	No Asbestos Detected
A3	Mineral fibre loose fill	Ground floor roof space	Refer to Appendix C	No Asbestos Detected

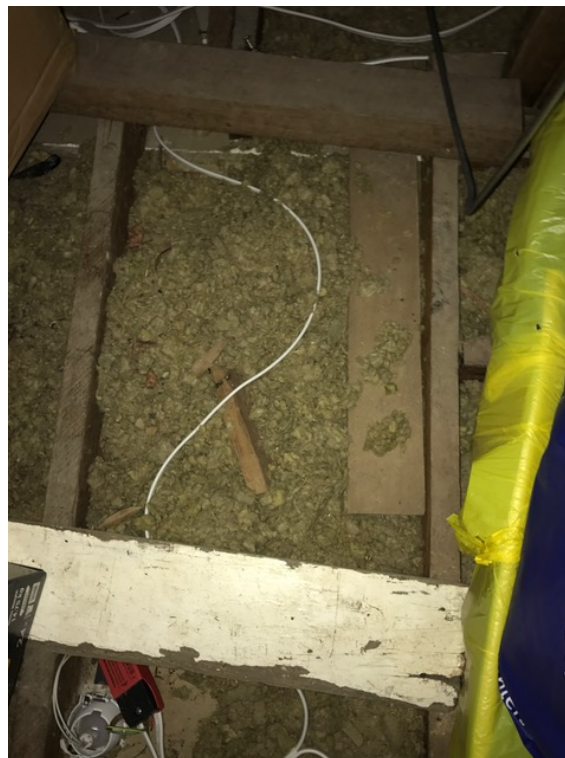
Photograph 4: Roof space

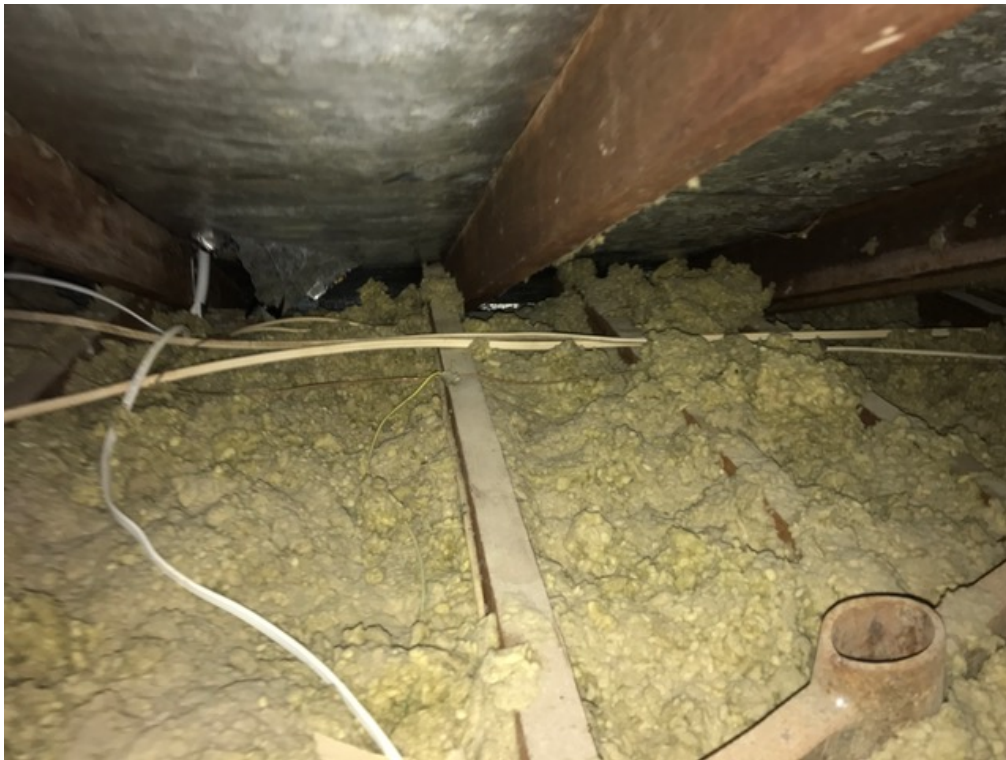
Photograph 5: Roof space

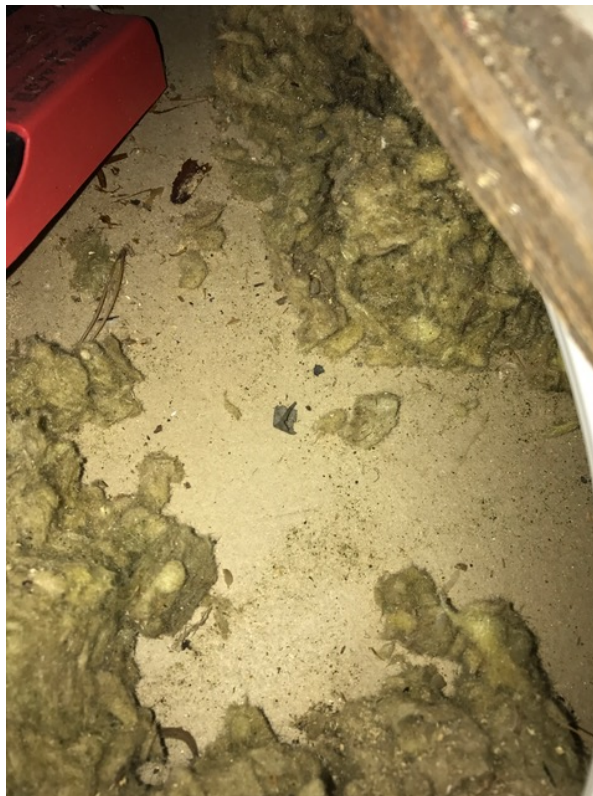
Photograph 6: Roof space
