HAZARDOUS MATERIALS ASSESSMENT REPORT

Job details: Owner: Mr. D. Cardew & Ms. K. Lemon.
Location: 15 Haldane Crescent, Lane Cove.

Our reference: HM05890717

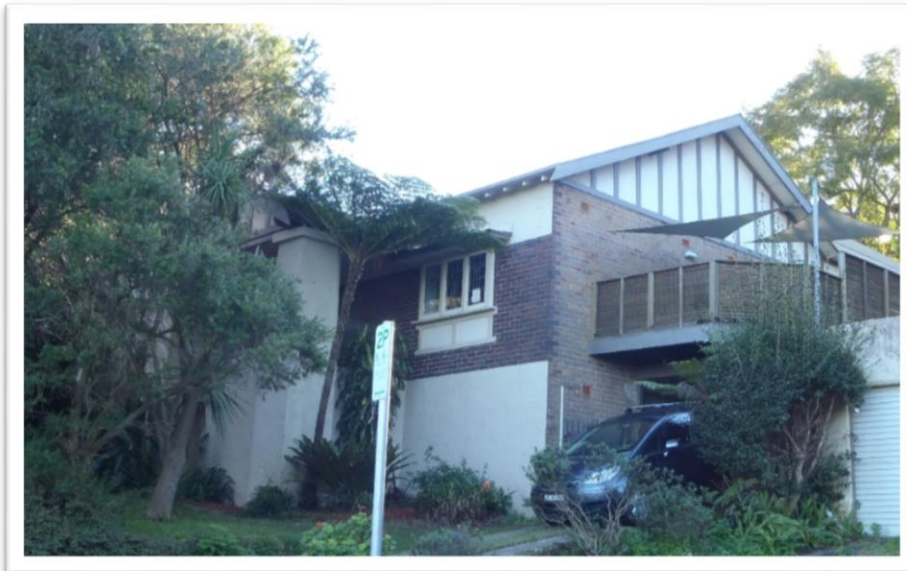
Front south western elevation of the residence
