Dilapidation Assessment Report

Prepared for: Cape Cod Australia Pty. Limited
Job address: 19 Brook Street, Coogee.
Property Owner/s: Mrs. Margaret Bettison.
Report reference: **RANDWICK CITY COUNCIL**
Development Application No: not available
Date of assessment: 4th November 2016.

Re: Dilapidation Report

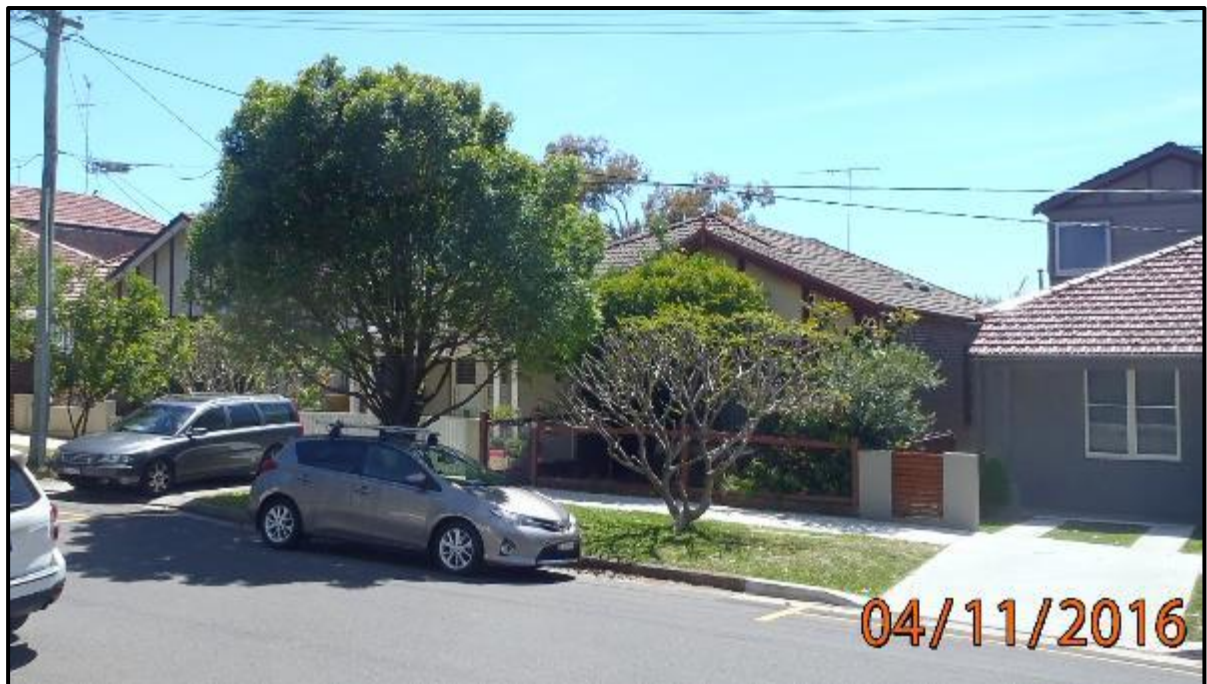
Shows the front southern elevation of the adjoining properties:
No.17 and No.19 Brook Street, Coogee.

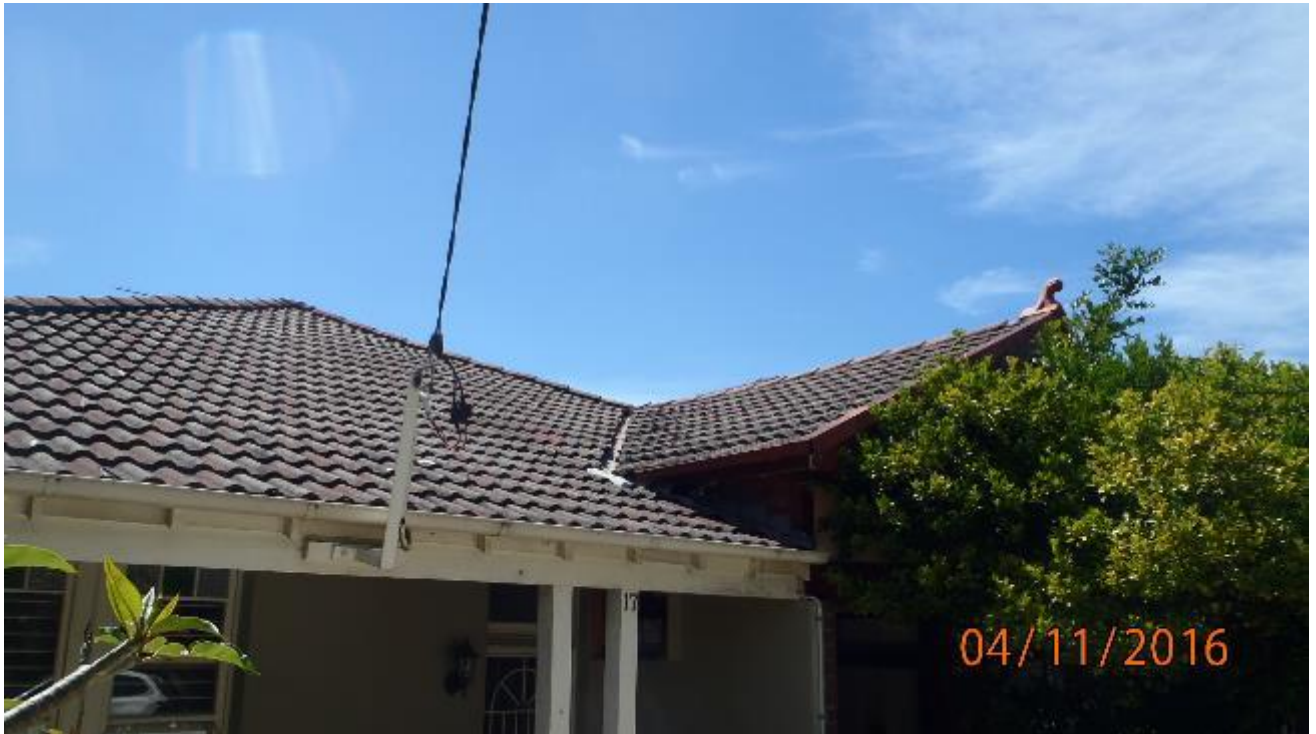
We observed that the concrete roof tiles to the original roof surfaces are generally interlinked and securely bedded, in our opinion forming a weather resistant cover to the residence. **[Photograph 1 and 2]**

Photograph 1 shows the front south-western elevation of the tiled roof surface.

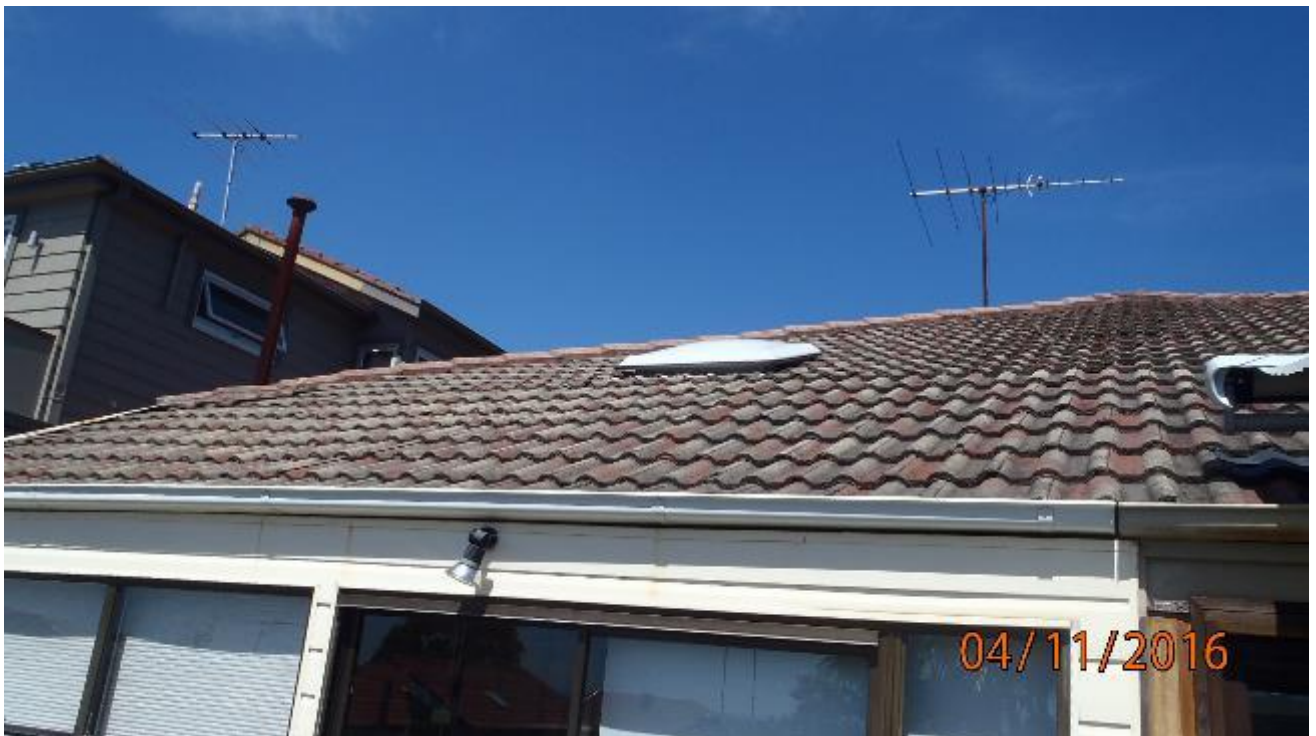
Photograph 2 shows the rear north-eastern elevation of the tiled roof surface.

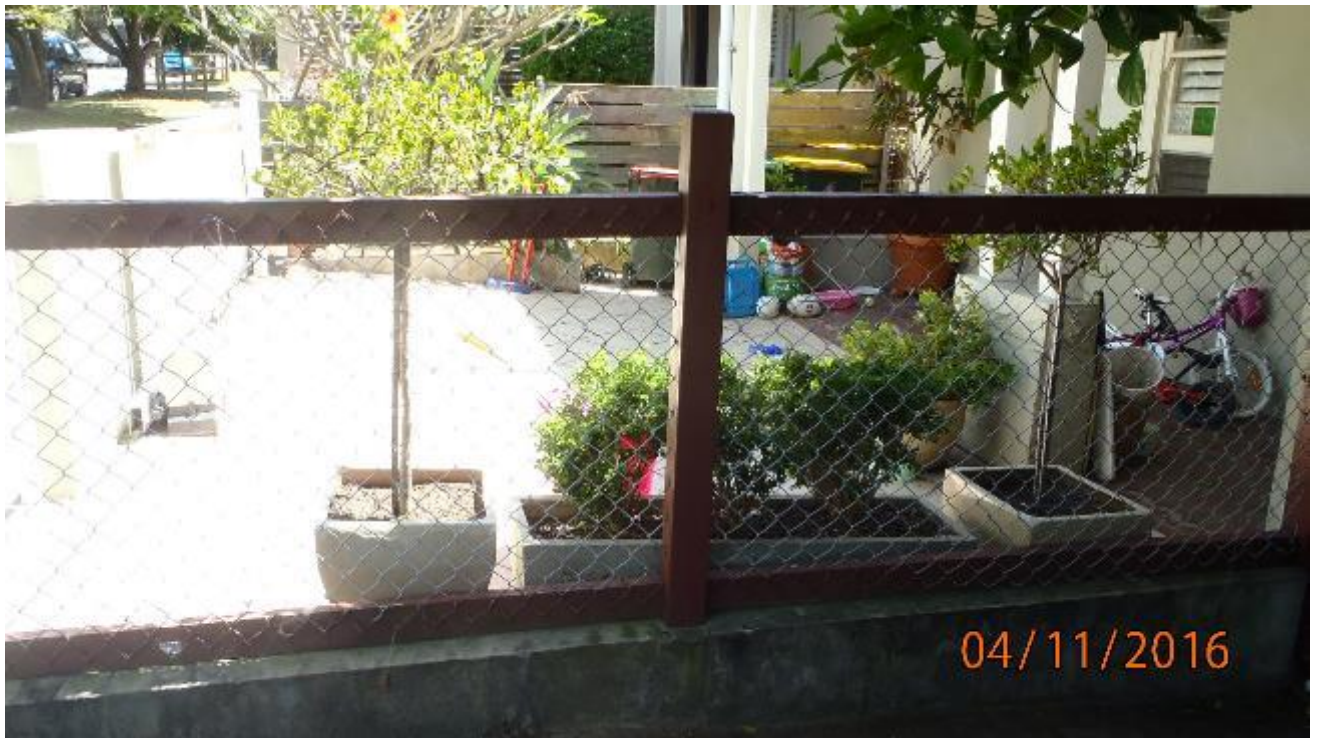
We noted that the front fence and the front common boundary fence was timber framed with chain link fence inserts. **[Photograph 3 and 4]**

Photograph 3 shows the front common boundary fence.

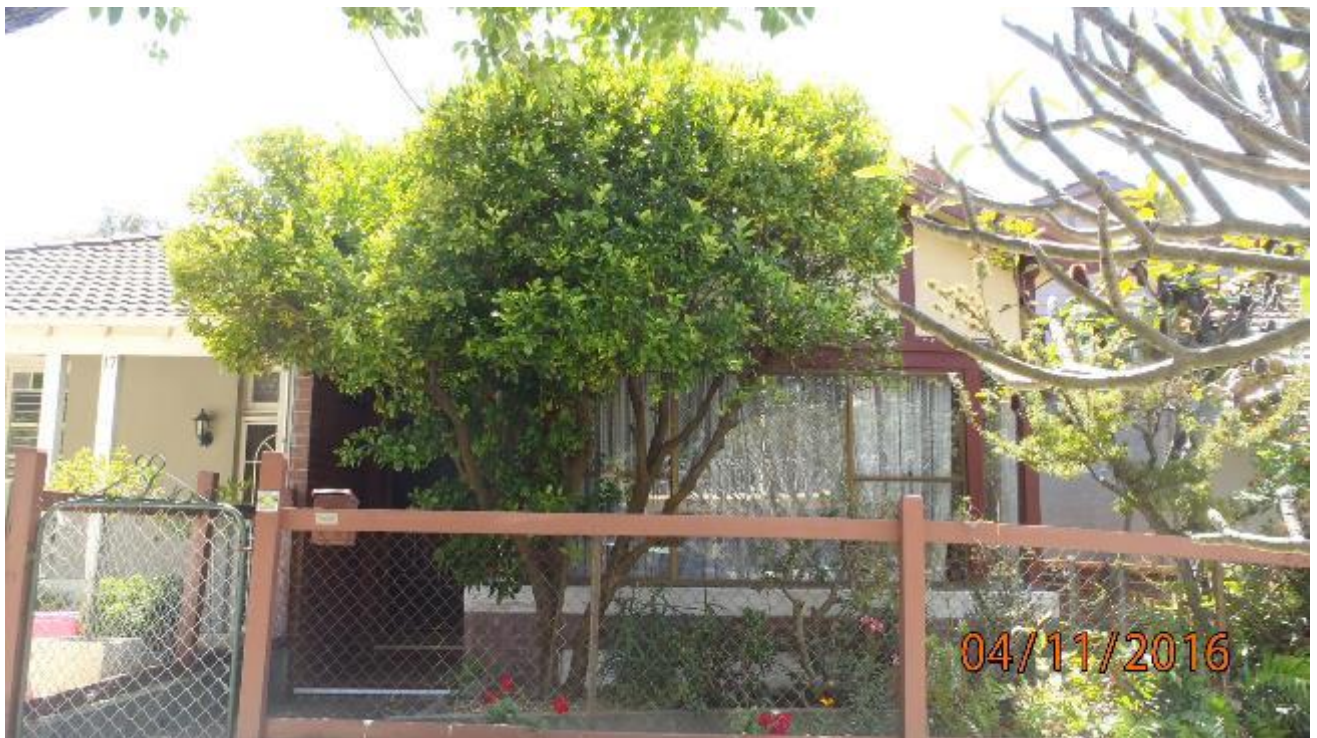
Photograph 4 shows the front boundary fence of the residence.

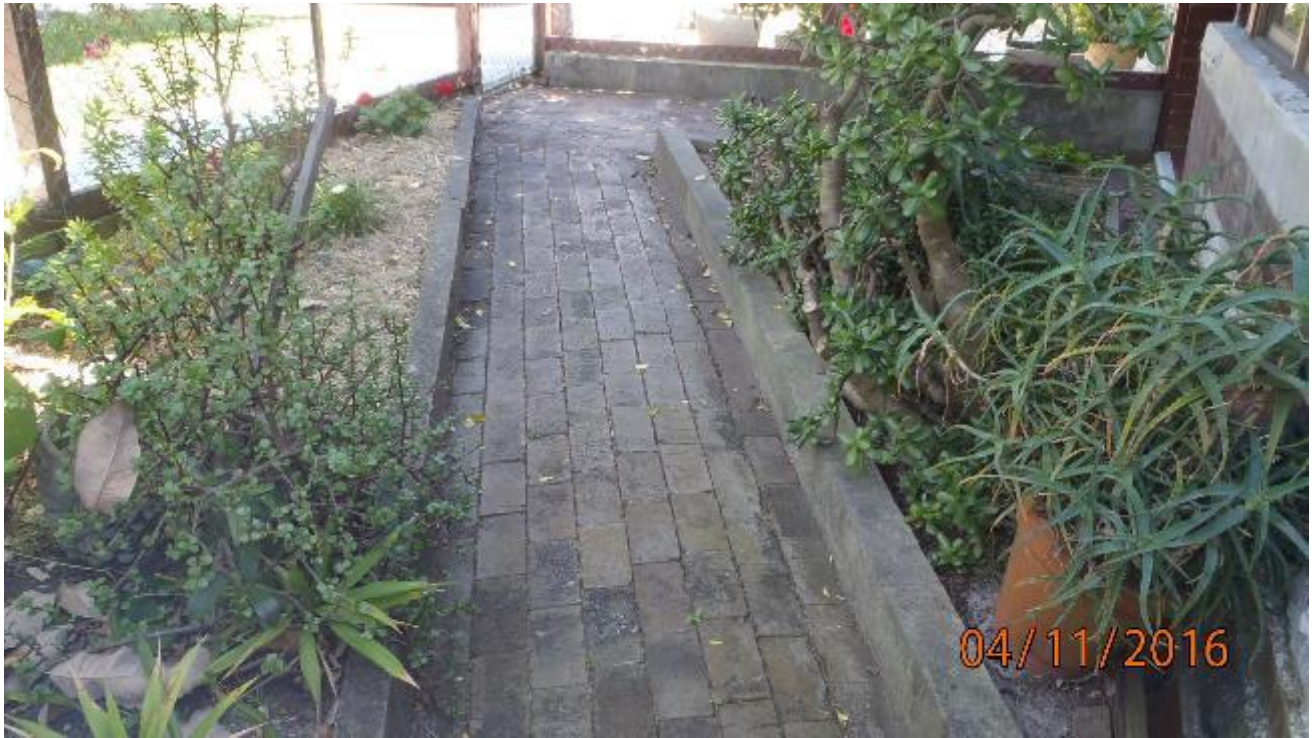
We noted there is a paved pathway to the front, lined with concrete edging. **[Photograph 5]**

Photograph 5 shows the front paved pathway.

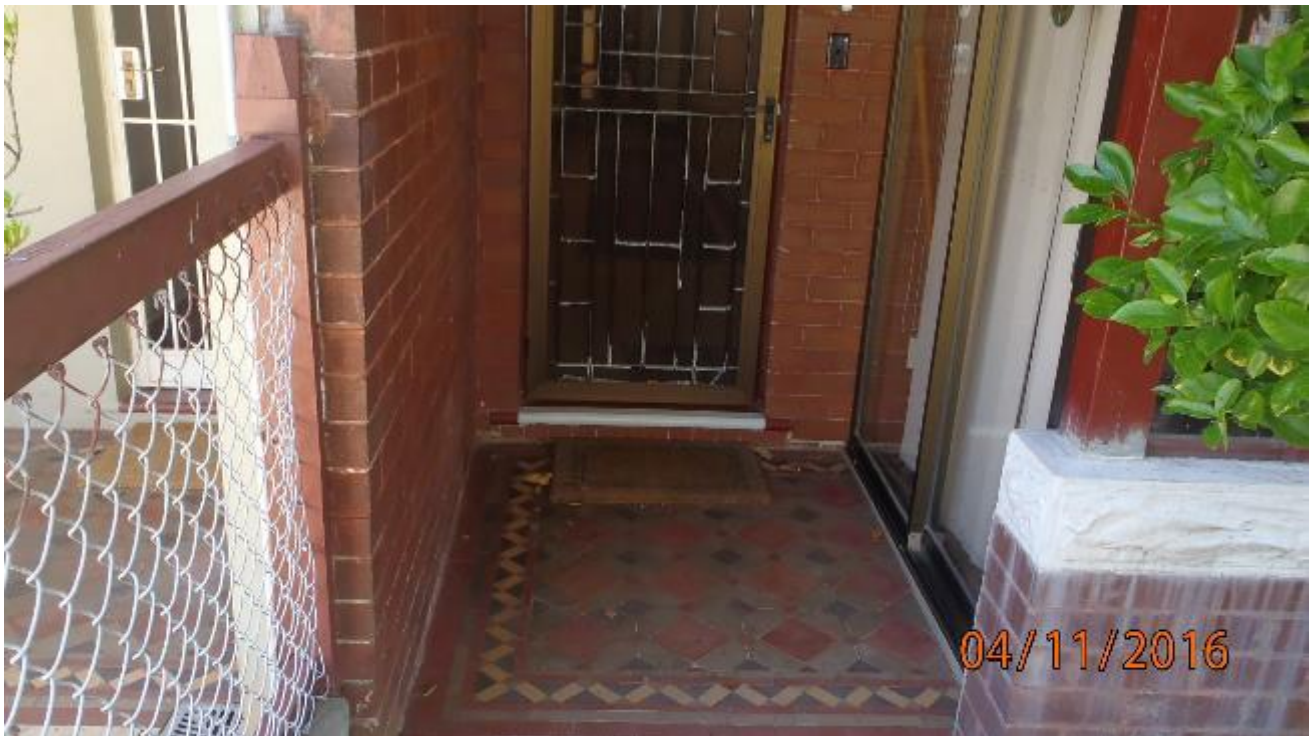
We noted that the patterned vitrified clay tiles to the front porch were generally sound with the grout complete. **[Photograph 6]**

Photograph 6 shows the condition of the tiles on the front porch.

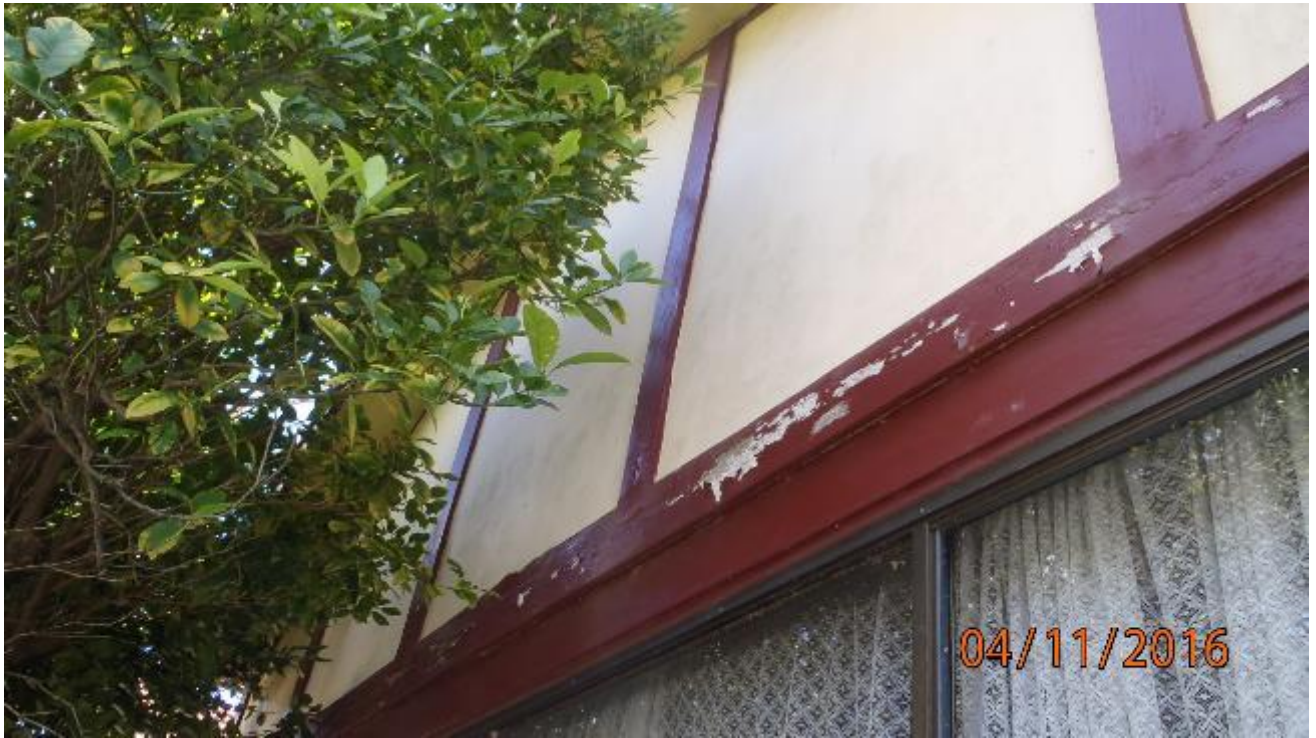
We noted flaking of the surface coating to the front gable end trim. **[Photograph 7]**

Photograph 7 shows flaking paint to the front gable end trim.

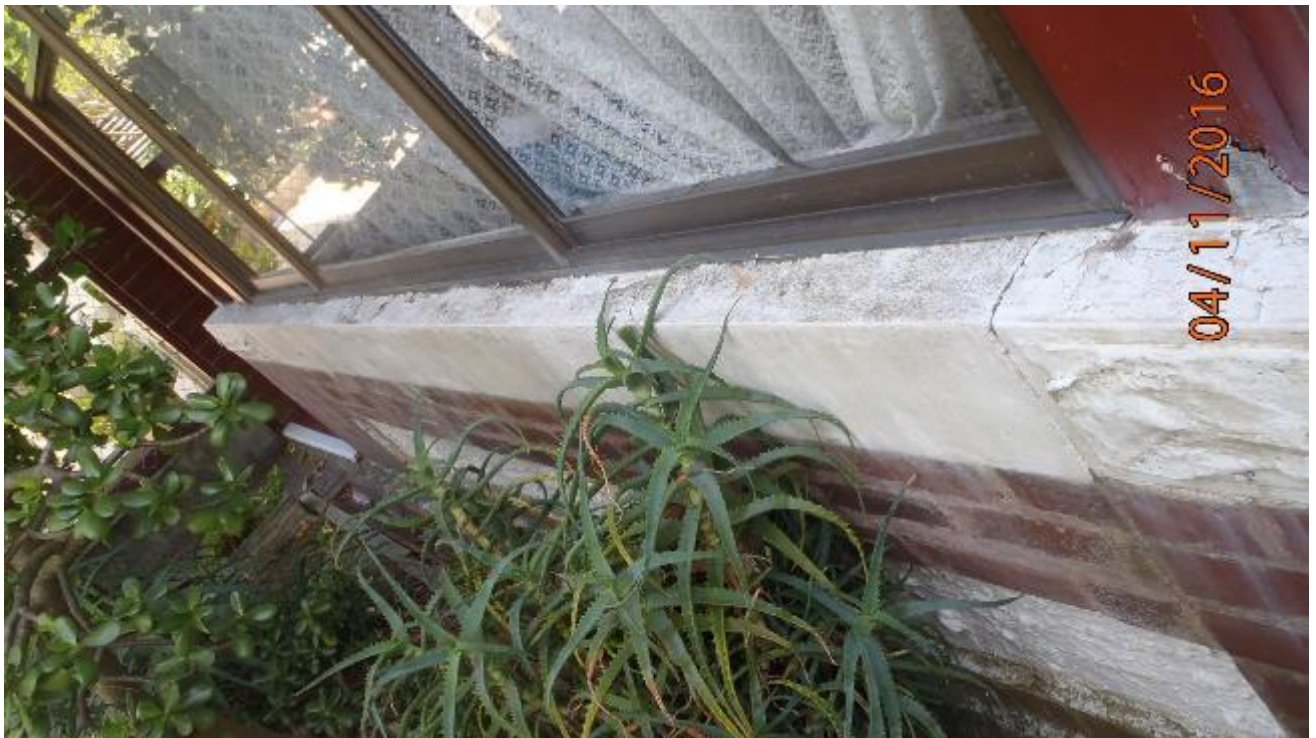
We noted flaking of the surface coating to the front elevation window sill. **[Photograph 8]**

Photograph 8 shows flaking paint to the front elevation window sill.

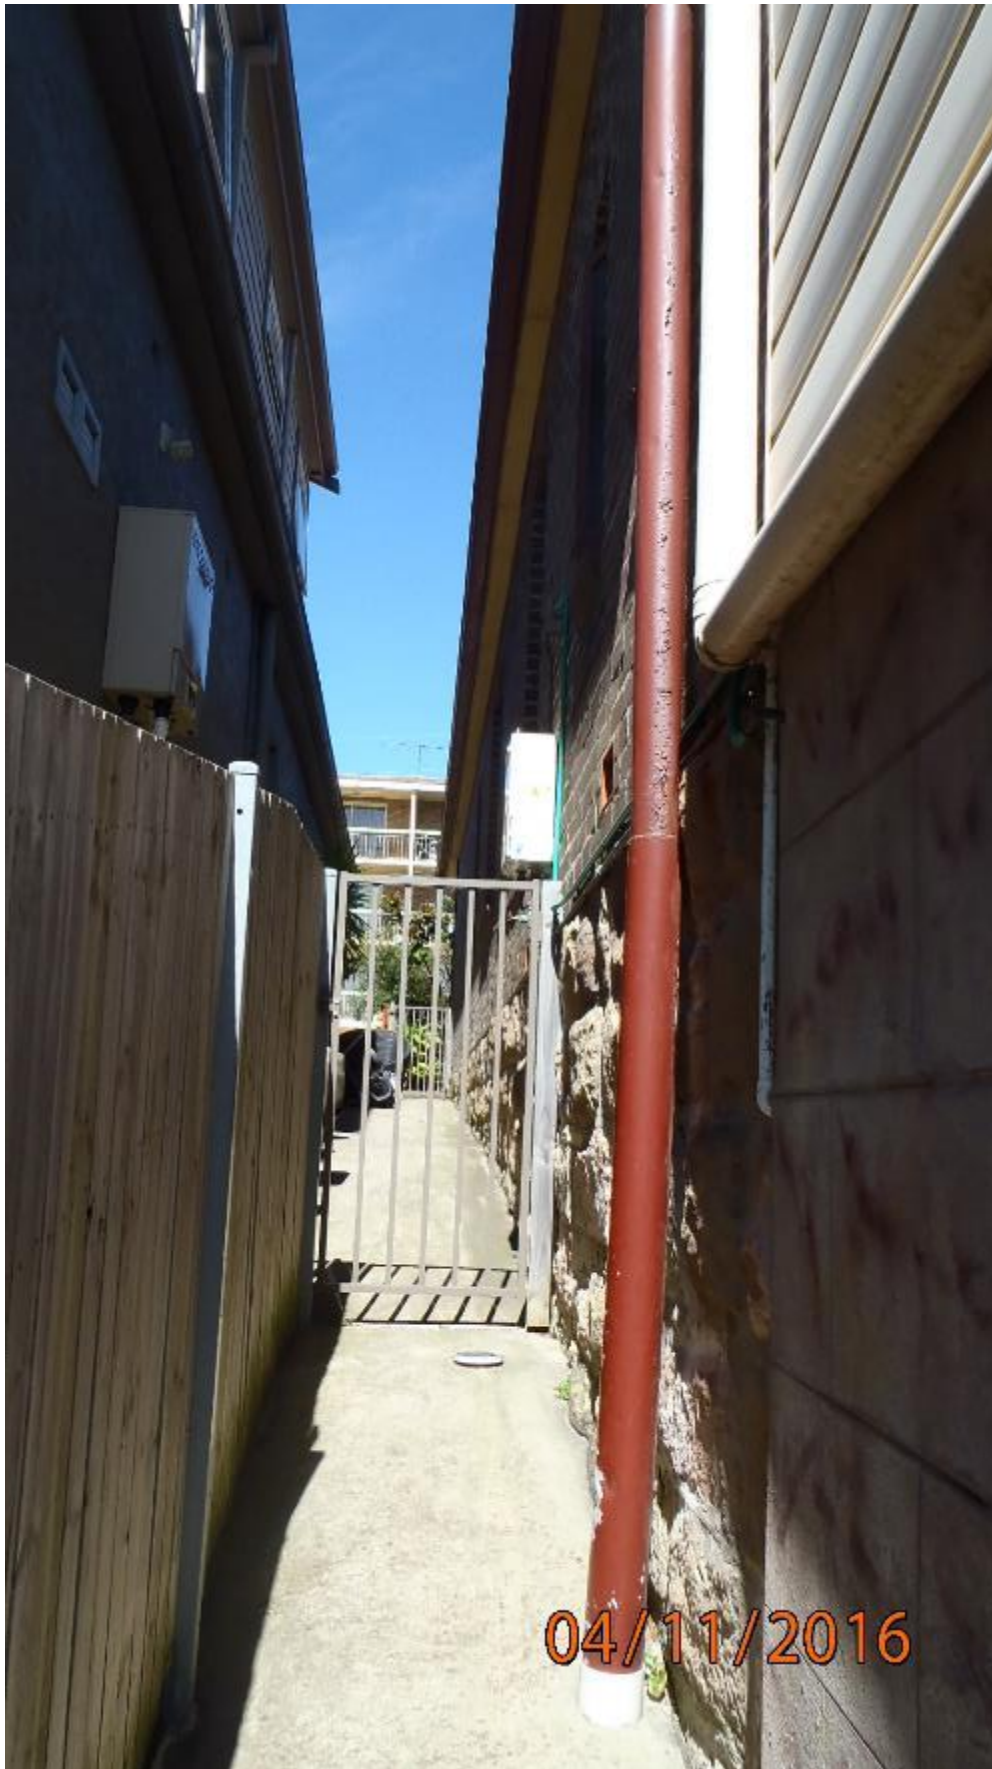
We noted that the side elevation has a concrete pathway along its entirety. **[Photograph 9]**

Photograph 9 shows general condition of the side south-eastern elevation.

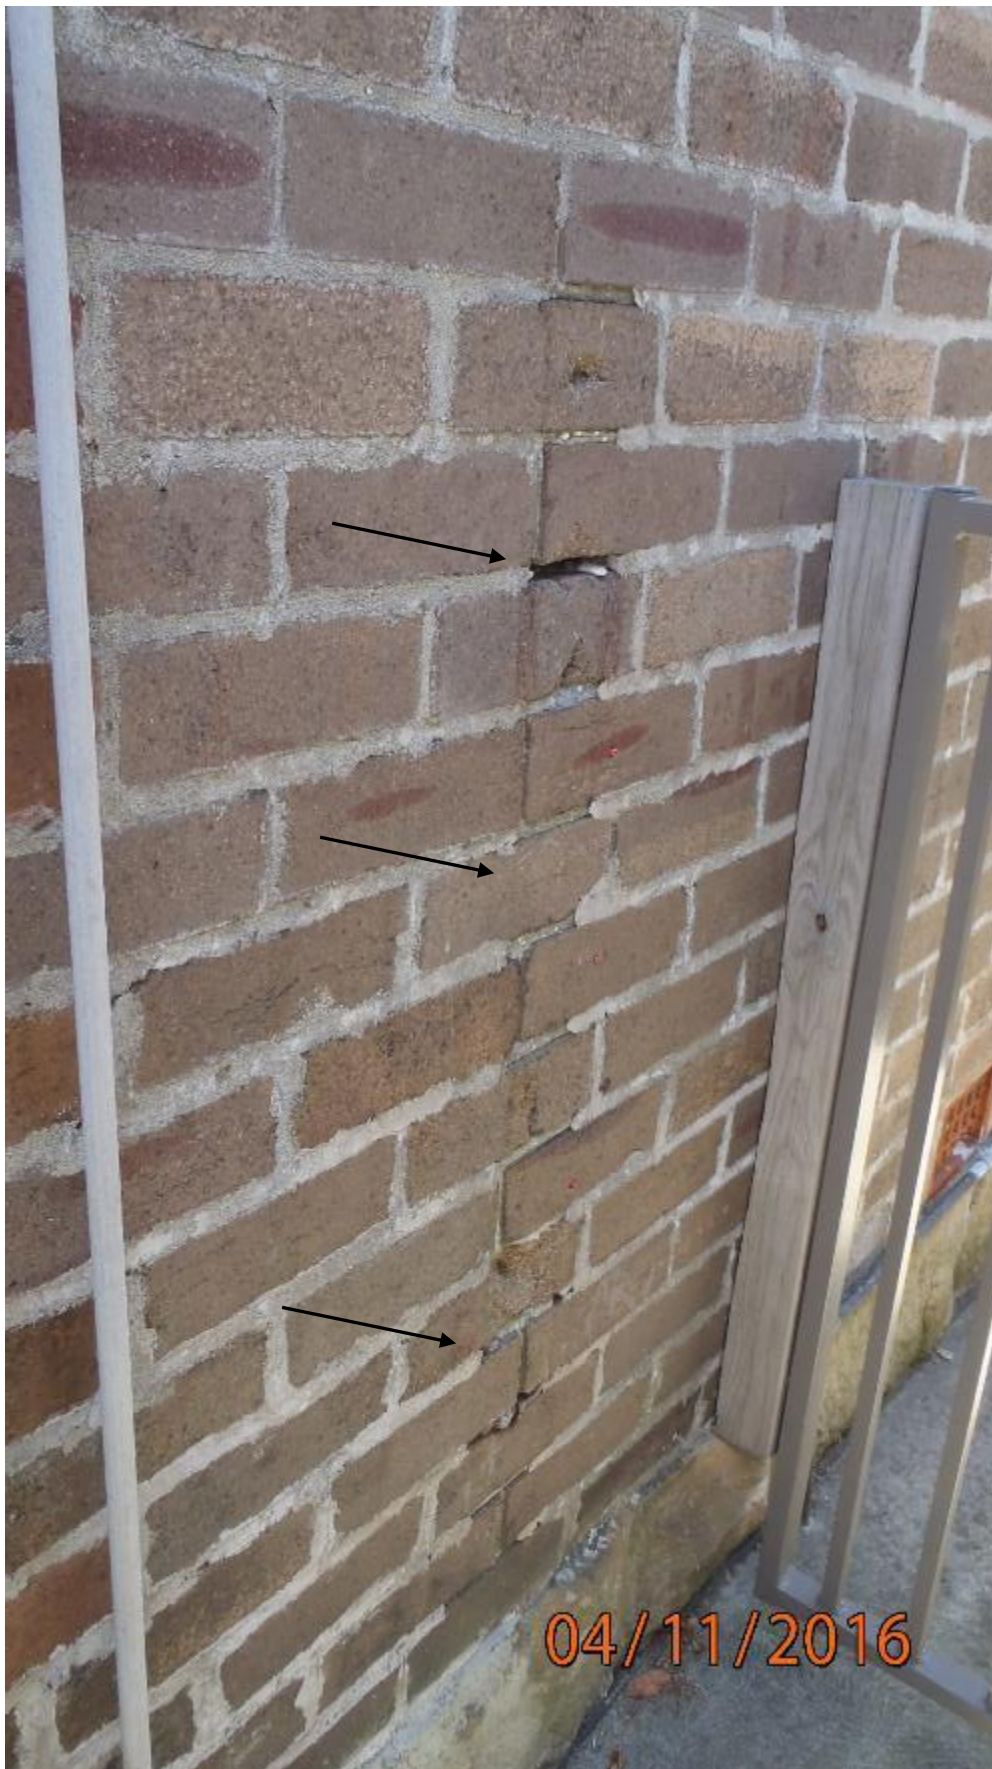
We noted evidence of a previous gate support on the external brickwork. **[Photograph 10]**

Photograph 10 shows evidence of a previous gate on the south-eastern external wall.

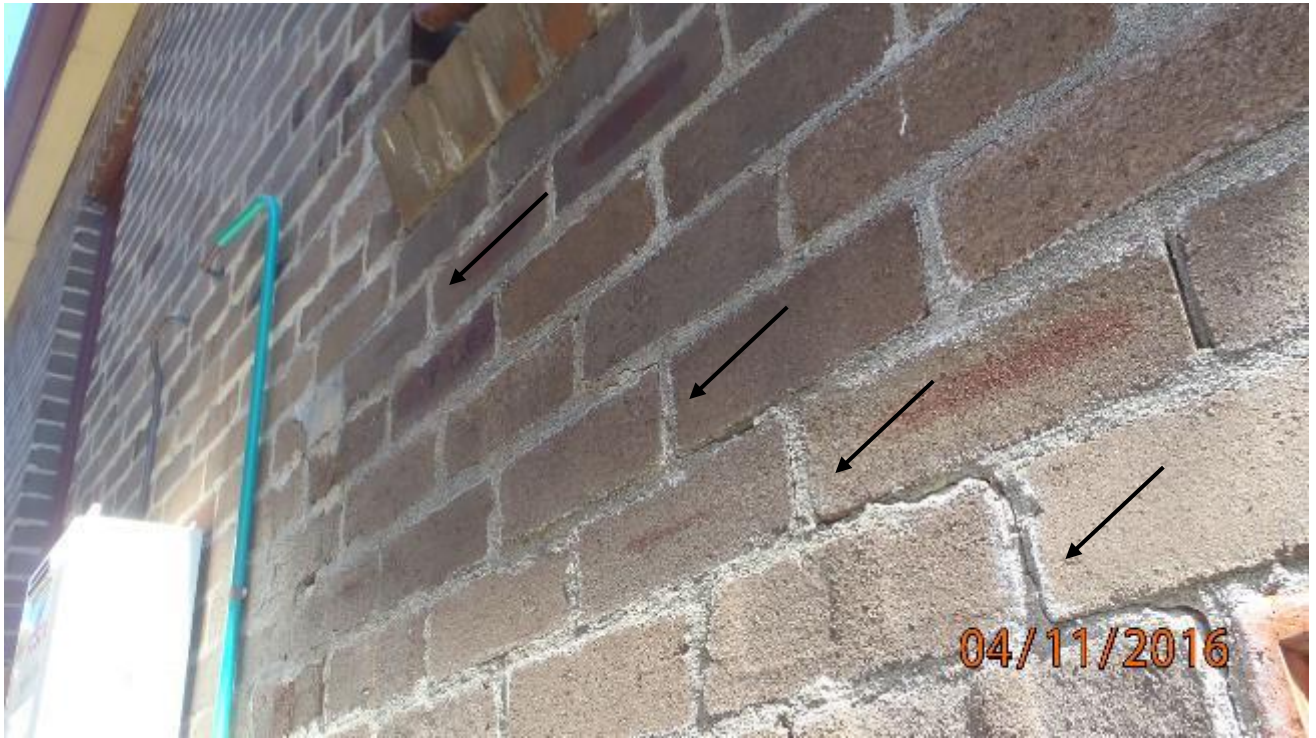
We noted step cracking and displacement of mortar extending down toward the wall vent outside the pantry window **[Photograph 11]**

Photograph 11 shows step cracking and displaced mortar to the brickwork on the south-eastern elevation external wall outside the pantry window.

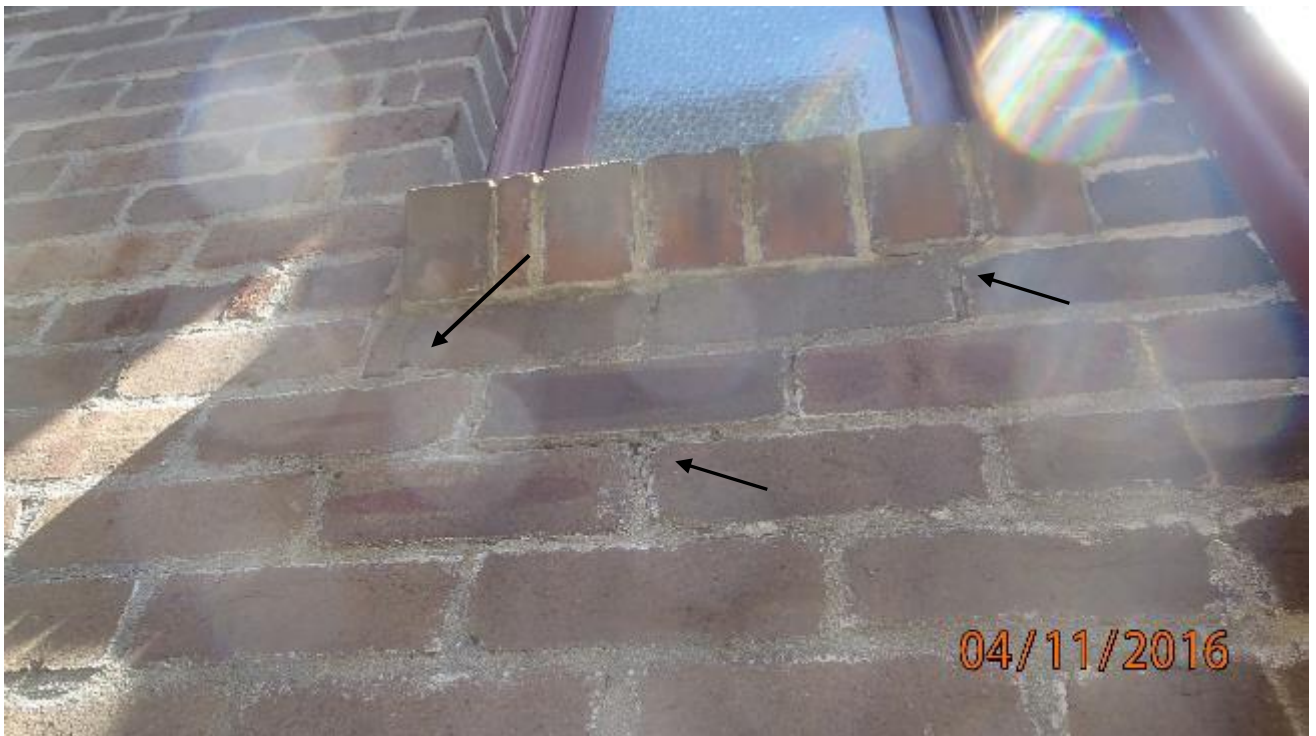
We noted step cracking and displacement of mortar extending down toward outside the WC window **[Photograph 12]**

Photograph 12 shows step cracking and displaced mortar to the brickwork on the south-eastern elevation external wall outside the toilet window.

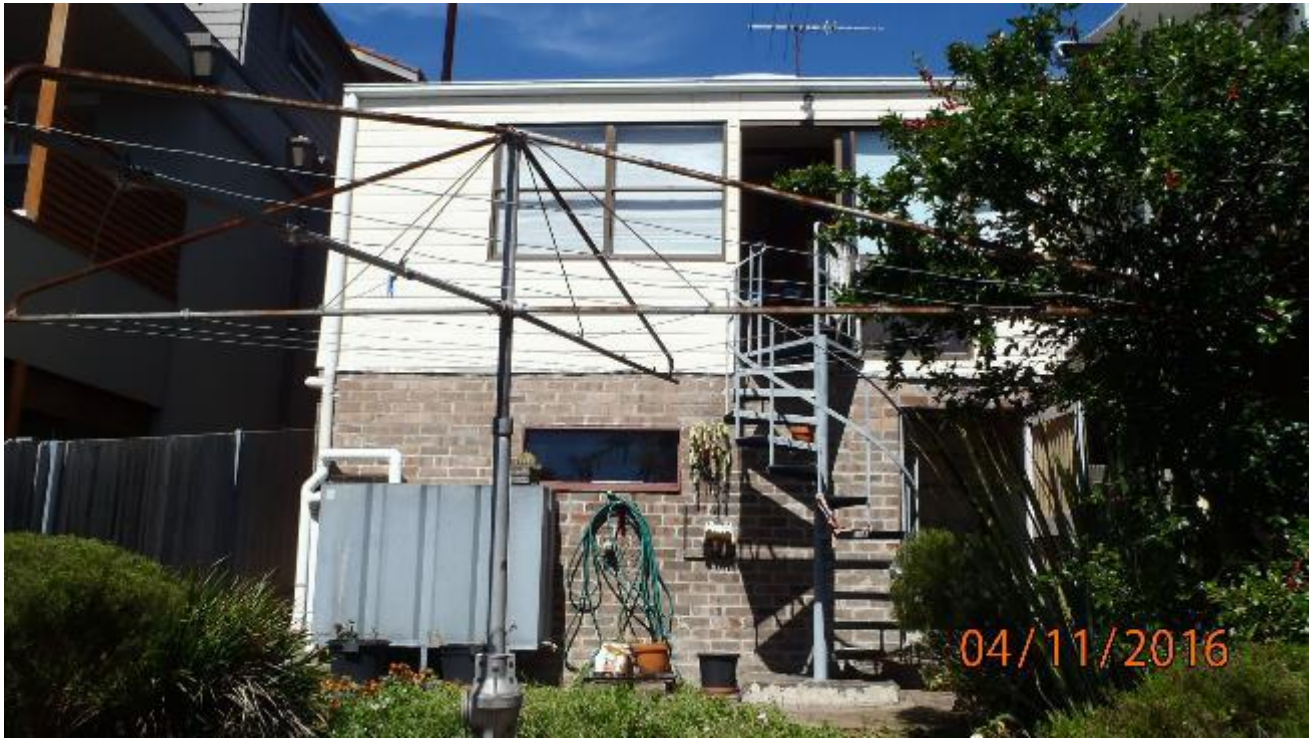
We noted that the Laundry was built in to the Sub floor level at the rear and that a metal spiral staircase provided access to the rear door of the residence **[Photograph 13]**

We noted that the rear elevation of the residence is clad with proprietary vinyl weatherboards **[Photograph 13]**

We noted that the Laundry was built into the subfloor space under the rear sunroom / Kitchen area **Photograph 13]**

Photograph 13 shows the general condition of the rear north-eastern elevation.

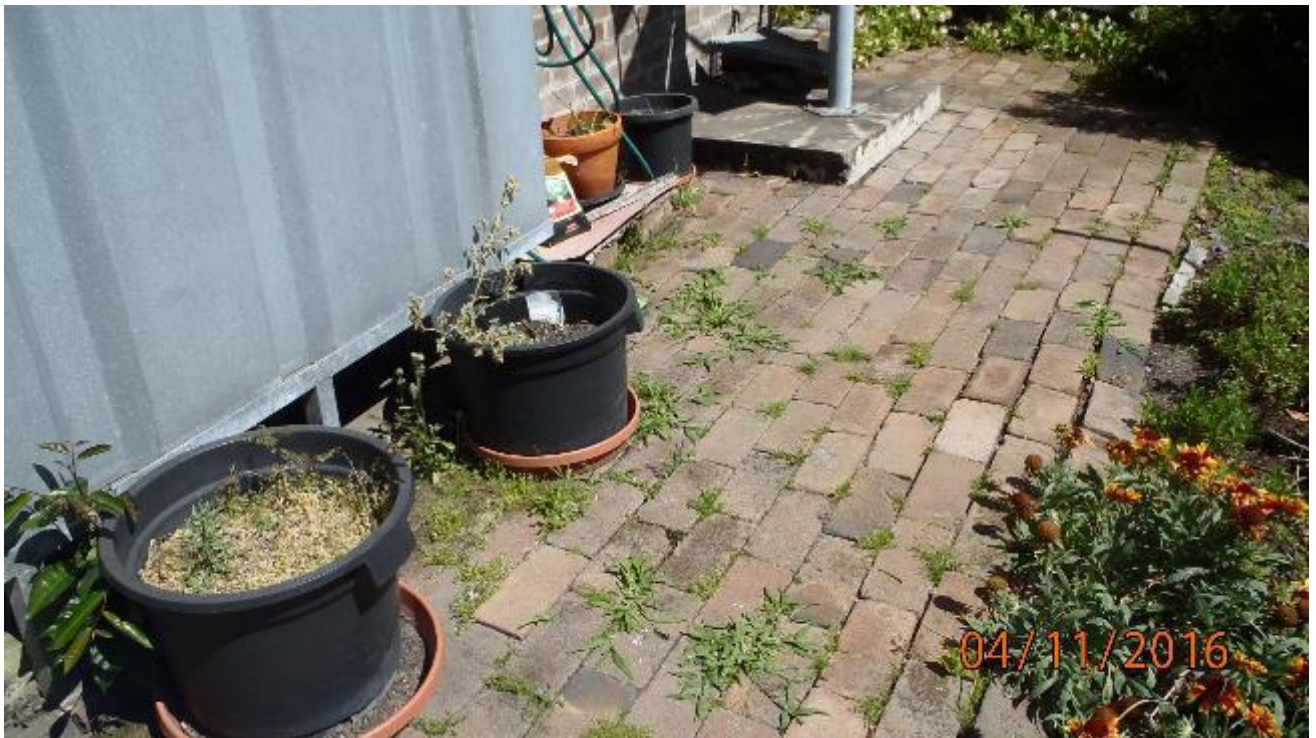
We noted that the rear elevation of the property was paved and had vegetation growth through the paved surface. **[Photograph 14]**

Photograph 14 shows the general condition of the paved area to the rear.

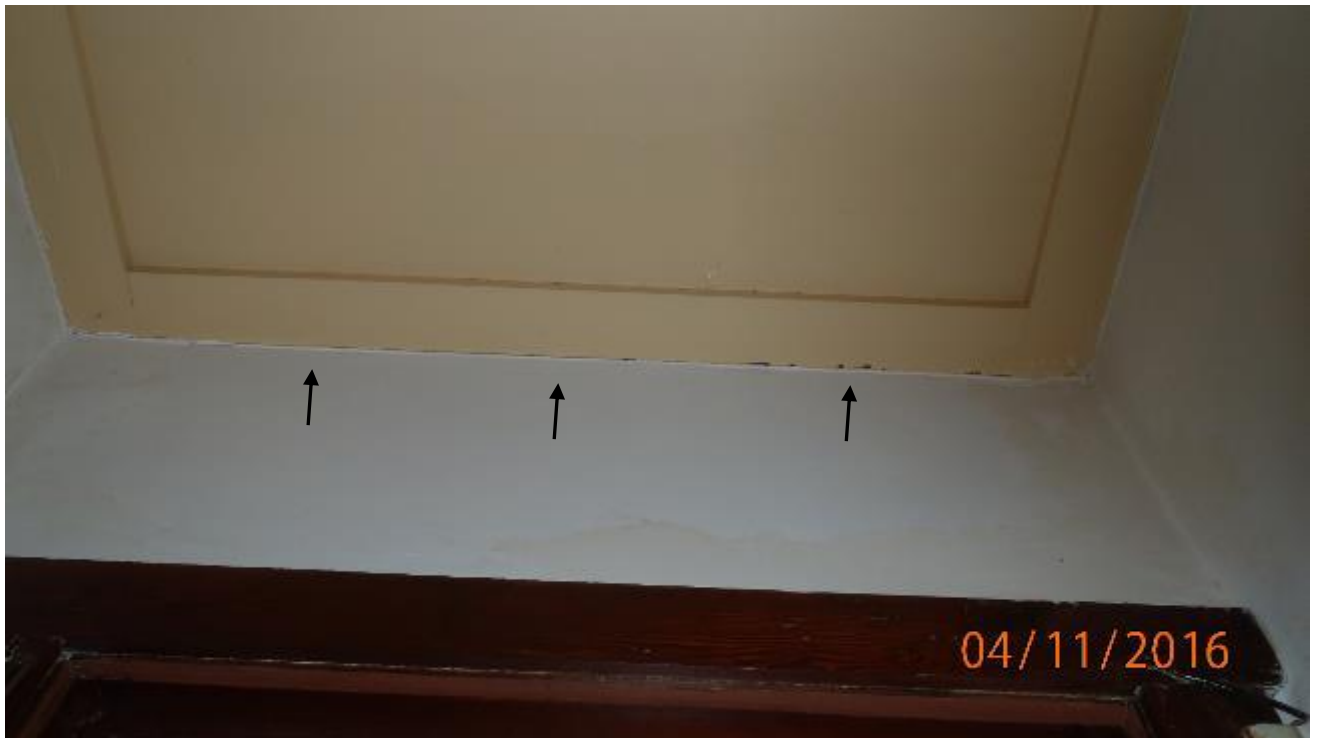
We noted separation cracking [$<1.0\text{mm}$] to the wall / ceiling junction and staining of the wall above the front entry door, adjacent to the *common party / separation* wall with the adjoining property No. 17 Brook Street, Coogee. **[Photograph 15]**

Photograph 15 shows separation cracking to the wall / ceiling junction and staining of the wall above the front entry door, adjacent to the common party / separation wall.

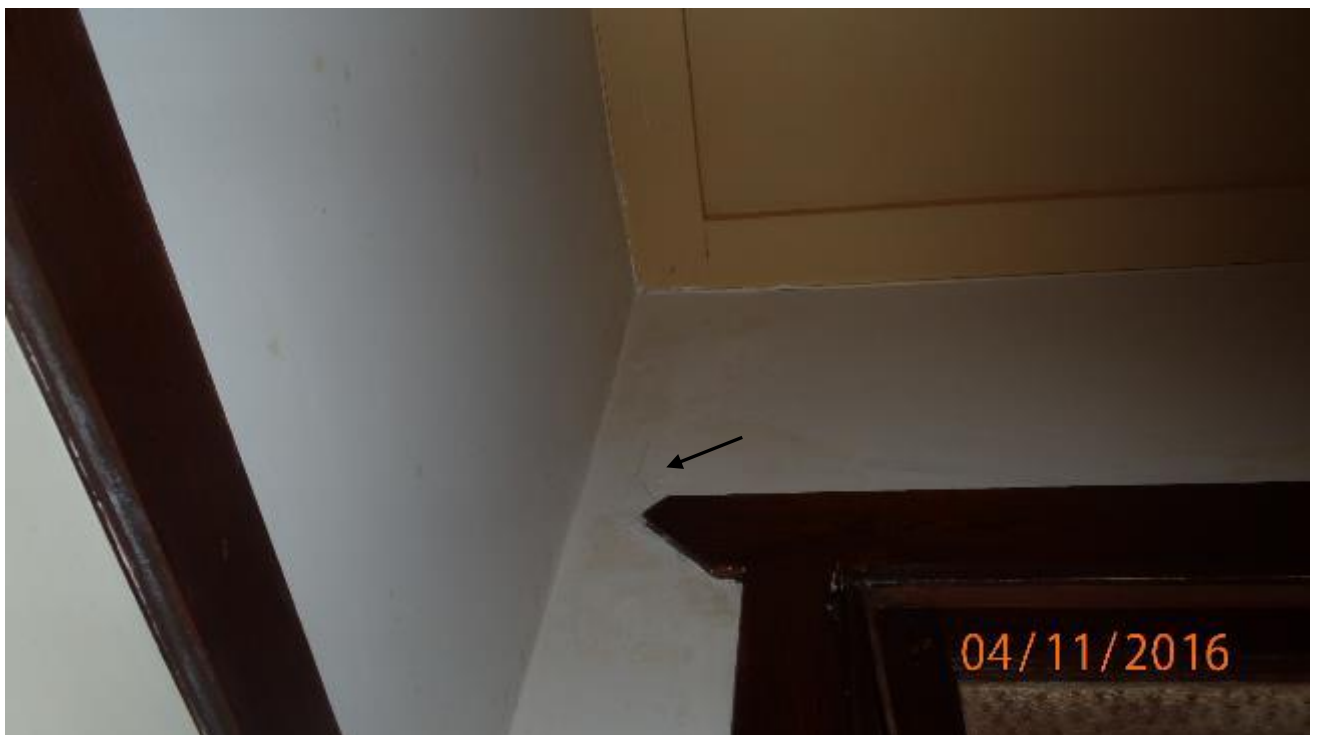
We noted hairline radial cracking extending from the front entry door head toward the ceiling. **[Photograph 16]**

Photograph 16 shows hairline radial cracking extending from the front entry door head toward the ceiling.

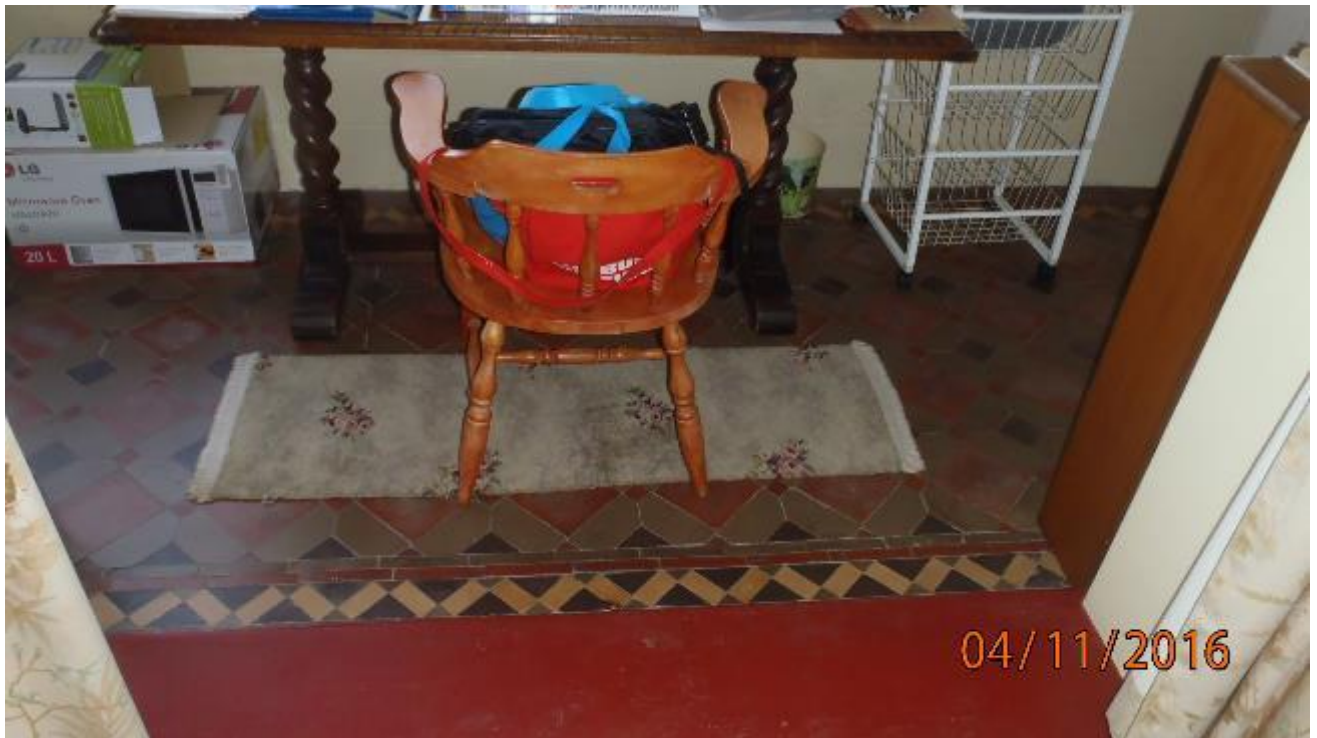
We noted that the front sunroom has tessellated patterned tiles to the floor were generally sound with the grout complete. **[Photograph 17]**

Photograph 17 shows the general condition of the floor tiles in the front sunroom.

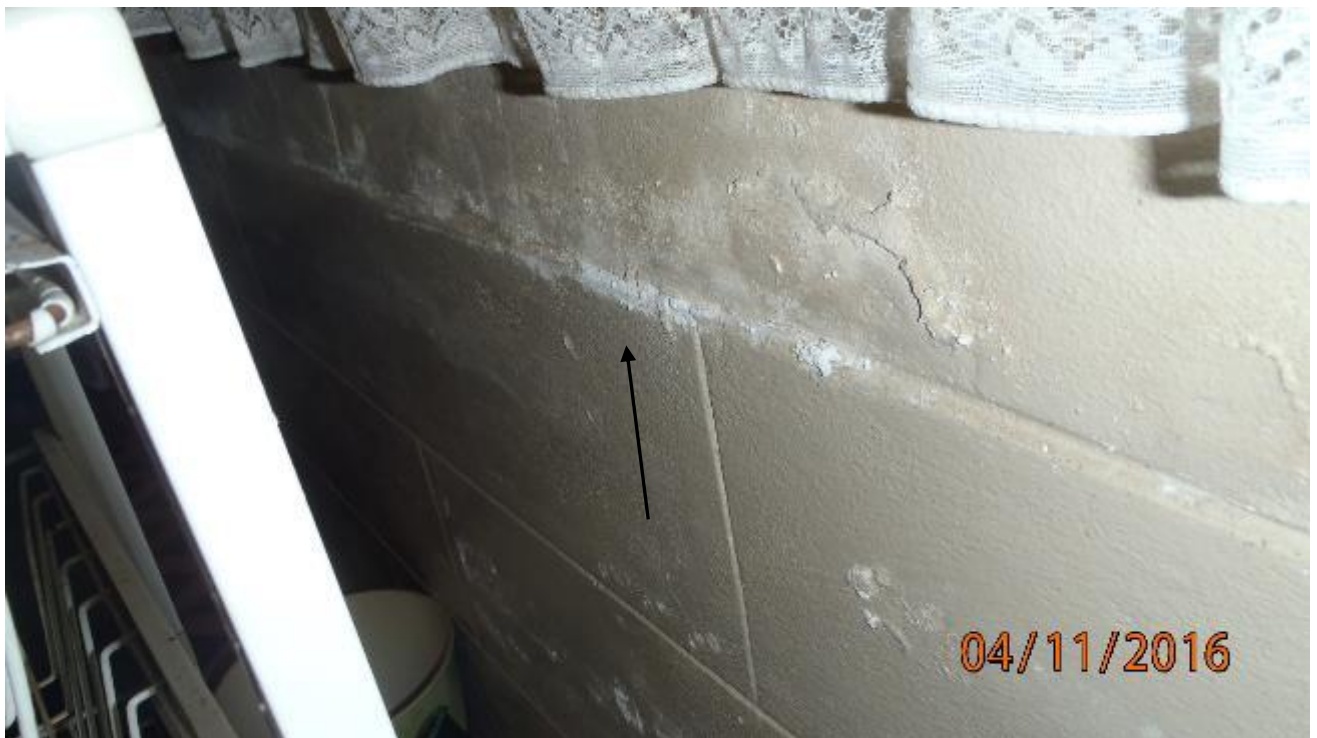
We noted flaking paint and areas of mineral deposits to the front south western external wall. This, in our experience, is consistent with rising damp. **[Photograph 18]**

Photograph 18 shows flaking paint and areas of mineral deposits to the front south western external wall.

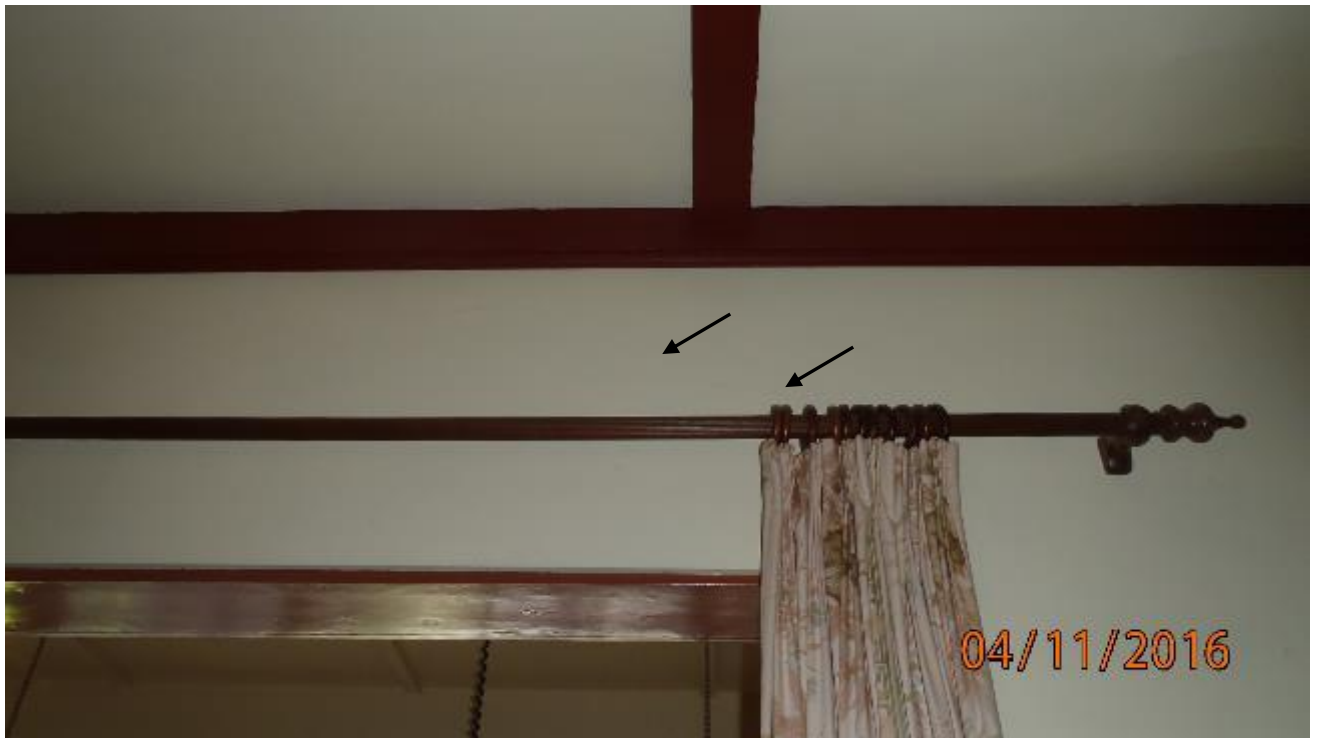
We noted hairline radial cracking [$<1.0\text{mm}$] to the wall above the door head to the front sunroom. **[Photograph 19]**

Photograph 19 shows radial cracking to the wall above the door head to the front sunroom.

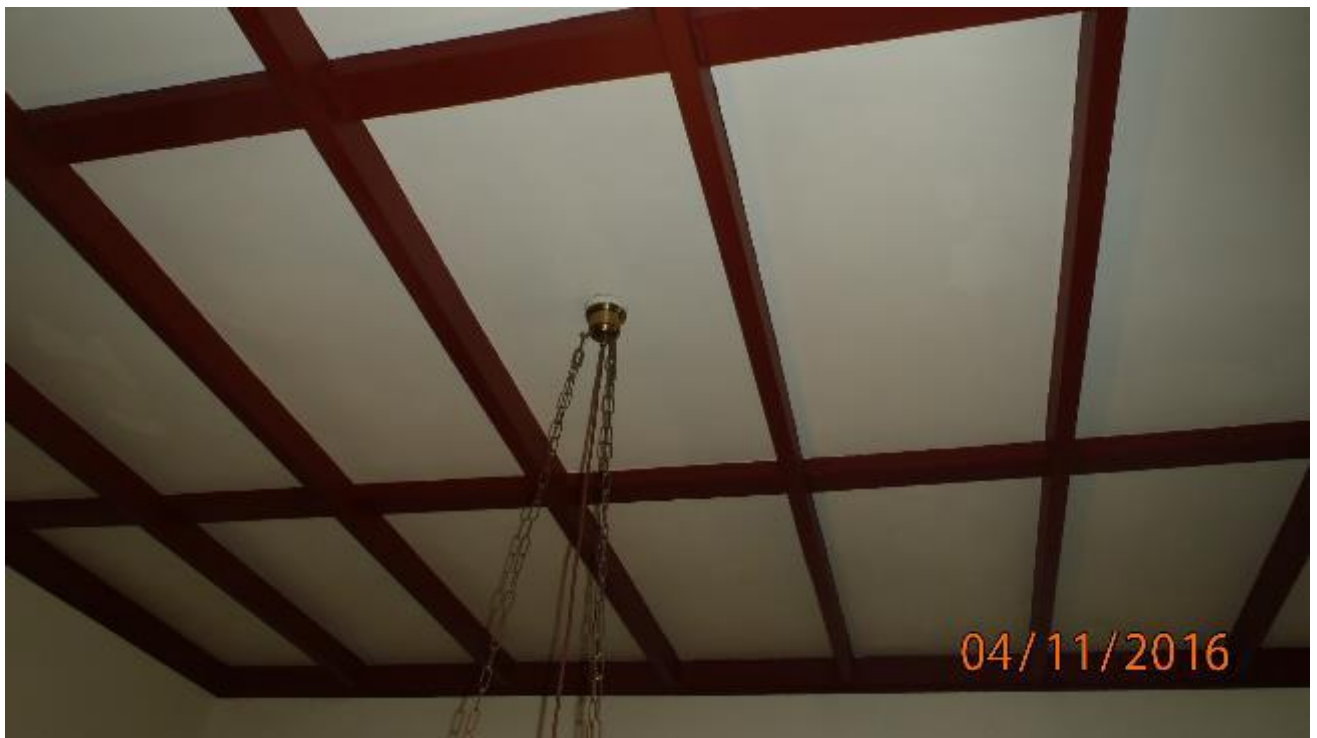
We noted that the ceiling has exposed joists. **[Photograph 20]**

Photograph 20 shows the general condition of the ceiling in the Front Bedroom.
