Dilapidation Assessment Report

Prepared for: Cape Cod Australia Pty. Limited
Job address: 19 Brook Street, Coogee.
Property Owner/s: Mrs. Margaret Bettison.
Report reference: **RANDWICK CITY COUNCIL**
Development Application No: not available
Date of assessment: 4th November 2016.

Re: Dilapidation Report

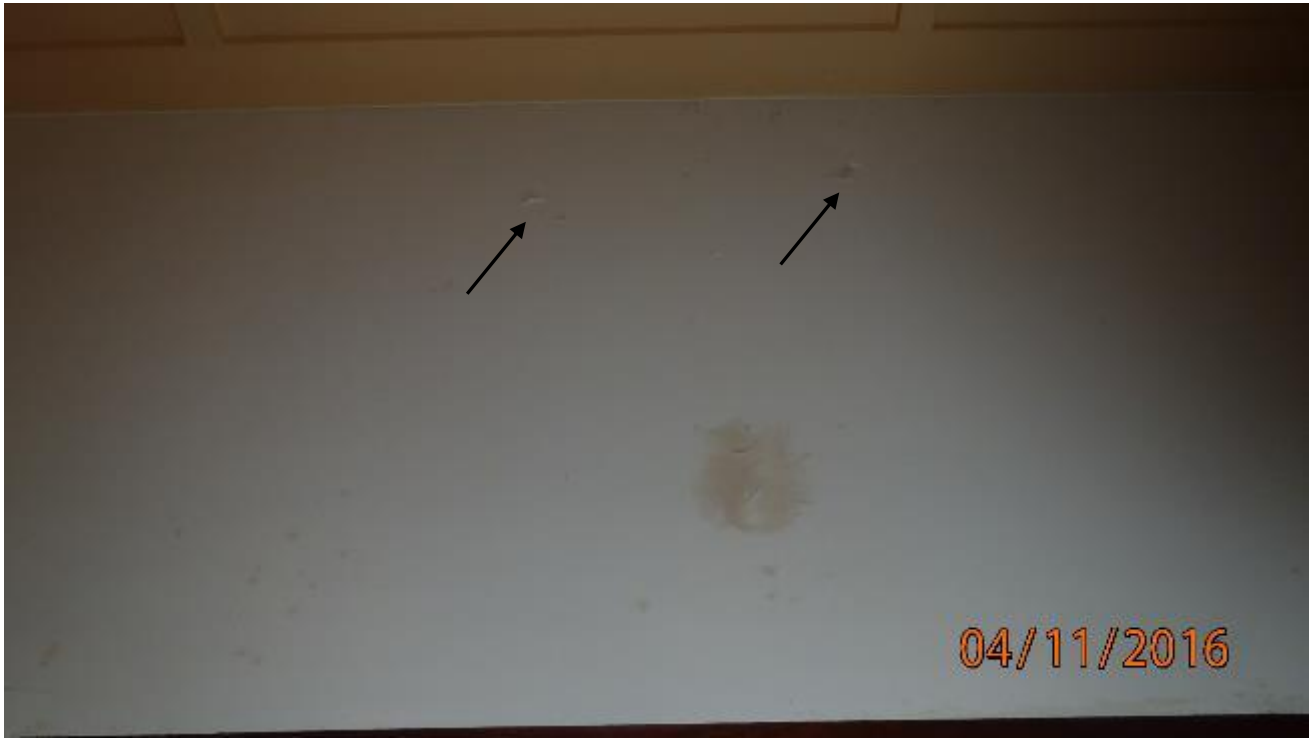
We noted flaking paint and evidence of a previous repair to the cement rendered wall adjacent to the Bedroom 1 door. **[Photograph 21]**

Photograph 21 shows flaking paint and evidence of a previous repair to the cement rendered wall adjacent to the Bedroom 1 door.

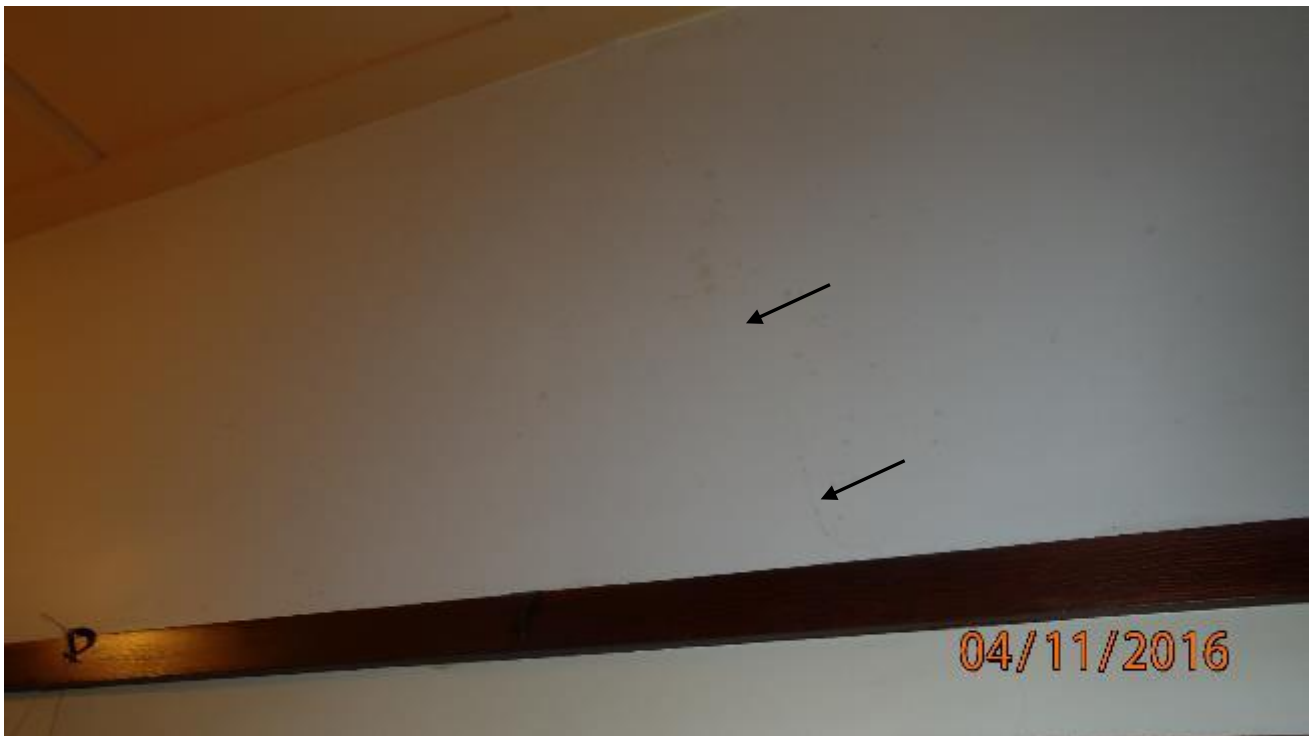
We noted hairline radial cracking [$<1.0\text{mm}$] and staining to the cement rendered wall above the Bedroom 1 door **[Photograph 22]**

Photograph 22 shows radial cracking and staining to the cement rendered wall above the Bedroom 1 door.

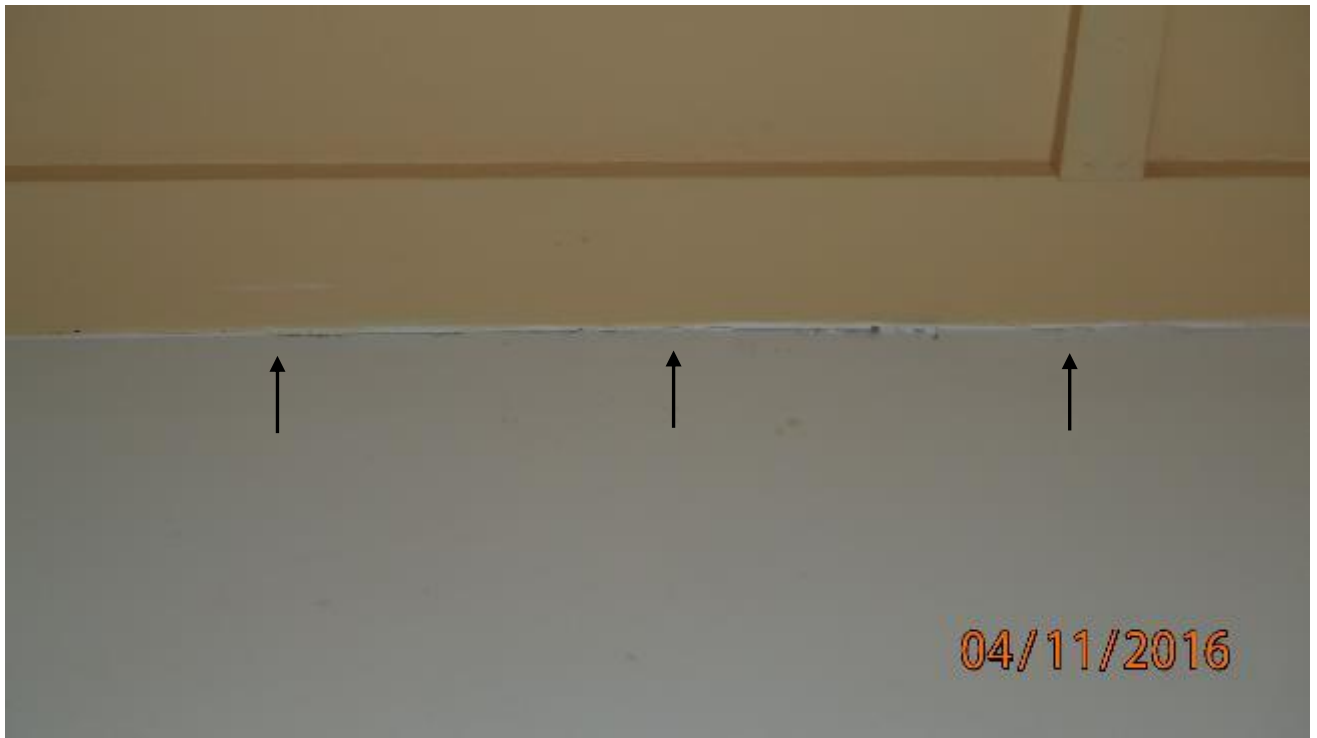
We noted separation cracking [$<1.0\text{mm}$] to the wall / ceiling junction timber moulding along the *common party / separation* wall with the adjoining property No. 17 Brook Street, Coogee. **[Photograph 23]**

Photograph 23 shows separation cracking to the wall / ceiling junction timber moulding along the common party / separation wall.

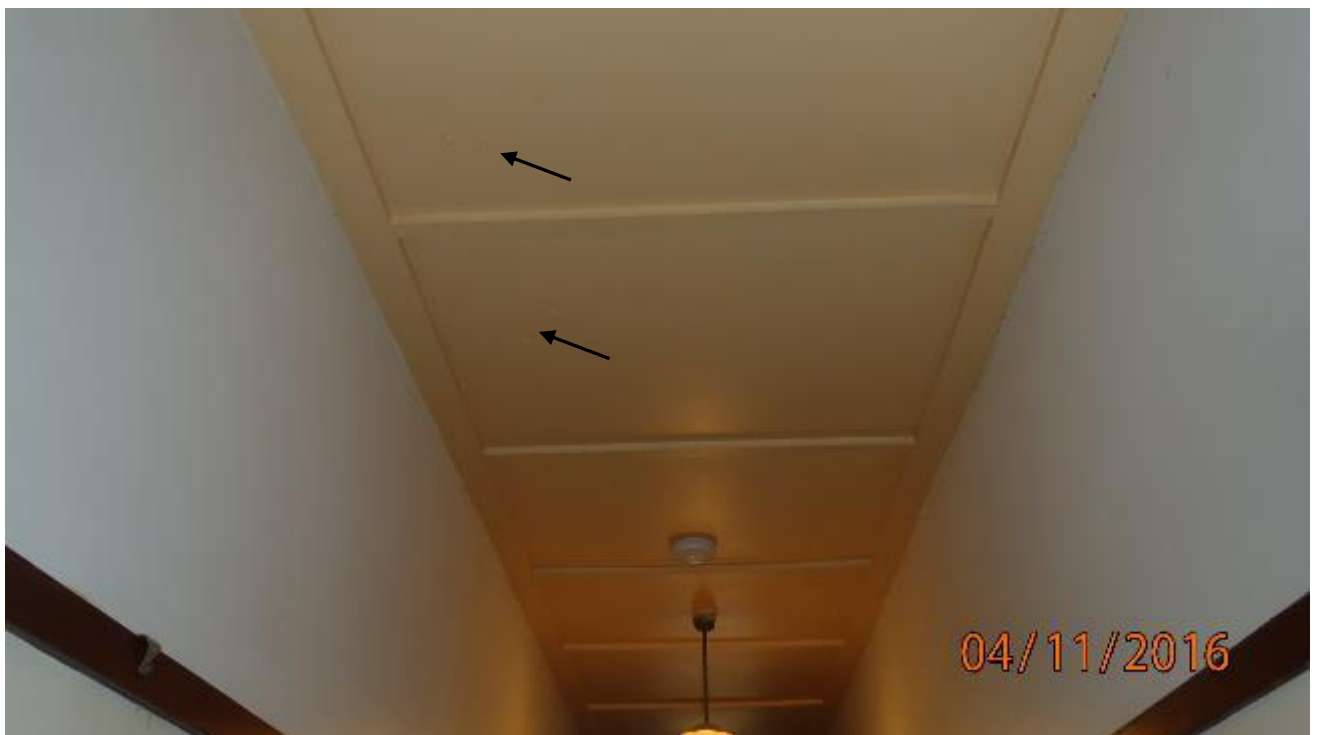
We noted flaking paint to the ceiling lining. **[Photograph 24]**

Photograph 24 shows flaking paint to the ceiling lining in the hallway.

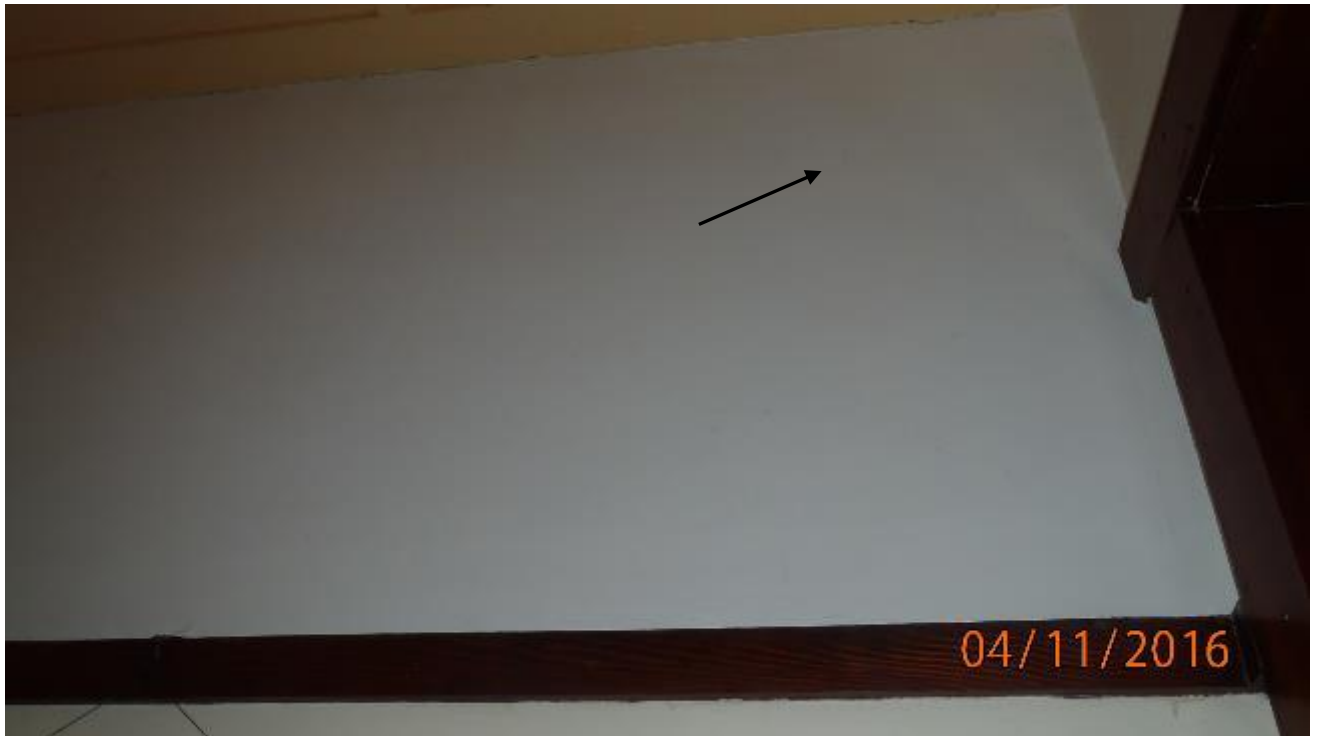
We noted flaking paint to the *common party / separation* wall with the adjoining property No. 17 Brook Street, Coogee adjacent to the hall middle doorway. **[Photograph 25]**

Photograph 25 shows flaking paint to the common party / separation wall with the adjoining property No. 17 Brook Street adjacent to the hall middle doorway.

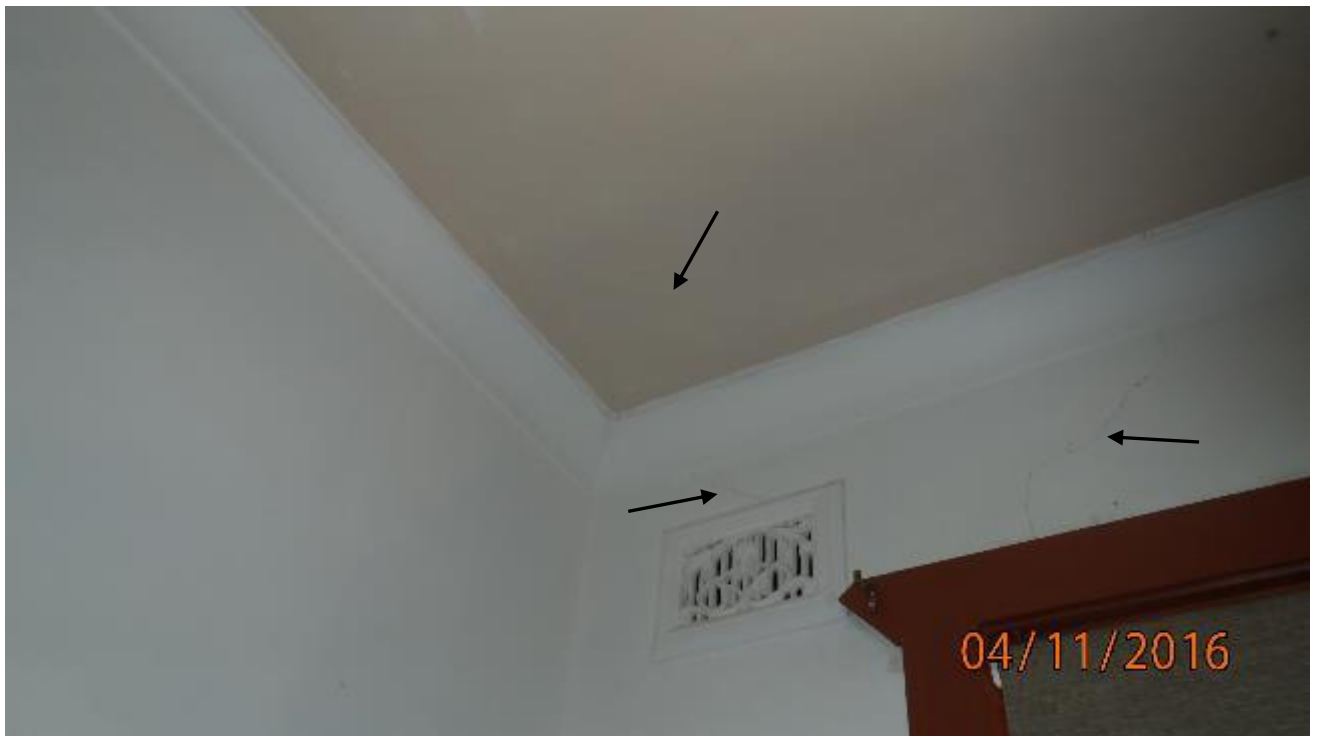
We noted hairline radial cracking [$<1.0\text{mm}$] to the plaster ceiling lining across the eastern corner. **[Photograph 26]**

We noted hairline radial cracking [$<1.0\text{mm}$] to the cement rendered wall around the wall vent and above the window on the external south eastern wall. **[Photograph 26]**

Photograph 26 shows radial cracking to the plaster ceiling lining across the eastern corner, radial cracking to the cement rendered wall around the wall vent and above the window on the external south eastern wall of Bedroom 2.

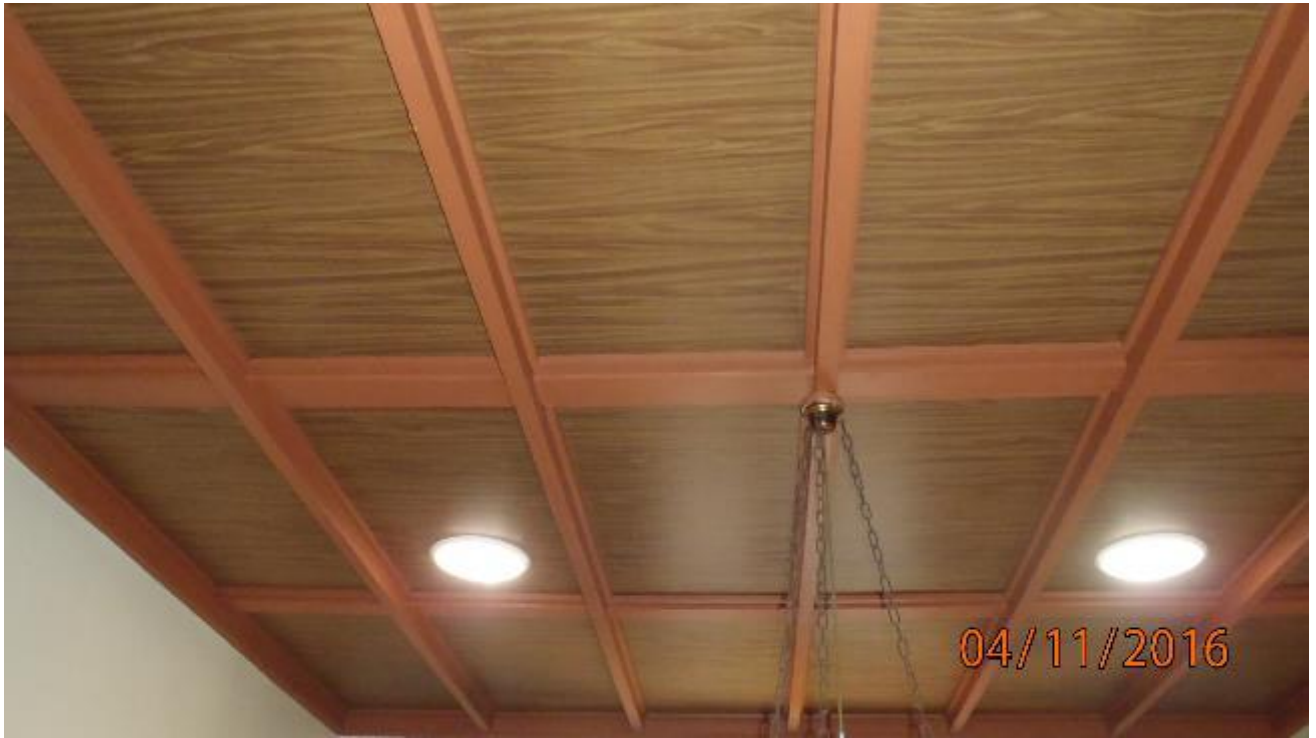
We noted that the ceiling was lined with timber look panelling. **[Photograph 27]**

Photograph 27 shows the general condition of the Lounge Room ceiling.

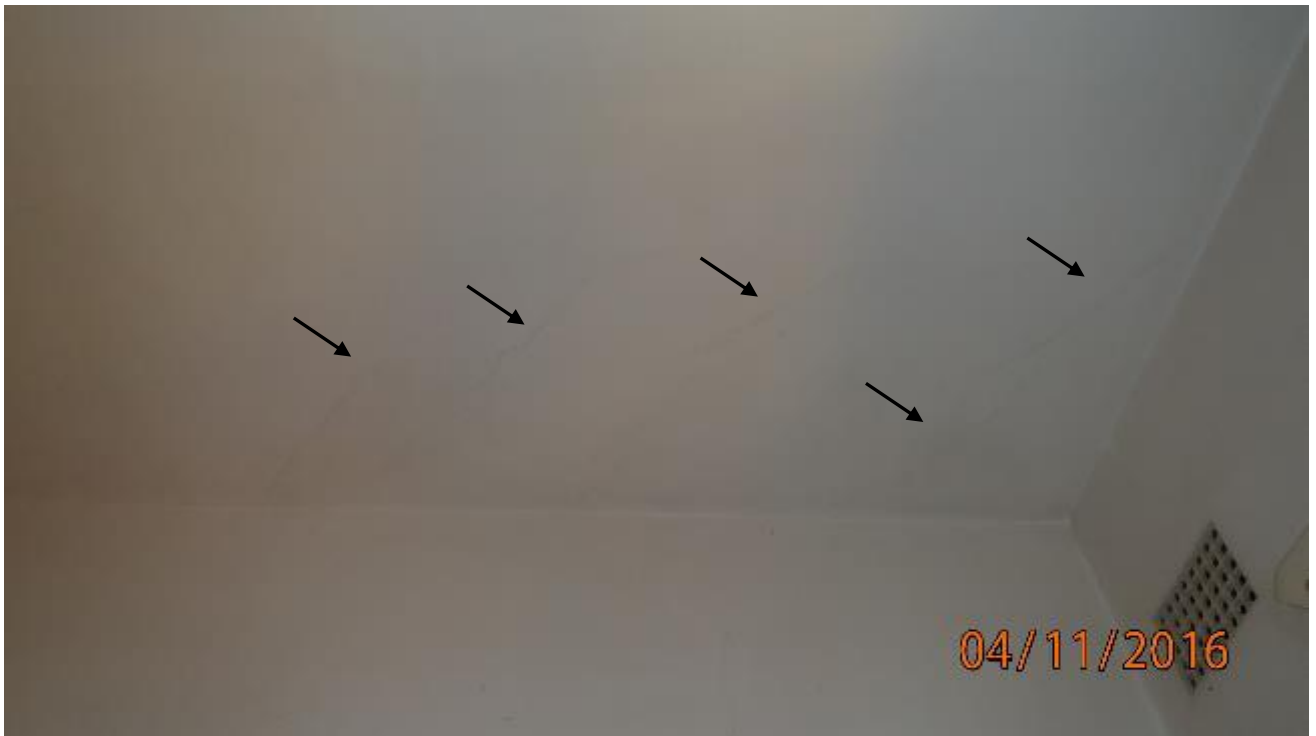
We noted hairline radial cracking [$<1.0\text{mm}$] to the plaster ceiling lining across the eastern corner. **[Photograph 28]**

Photograph 28 shows radial cracking to the plaster ceiling lining across the eastern corner of Bedroom 3.

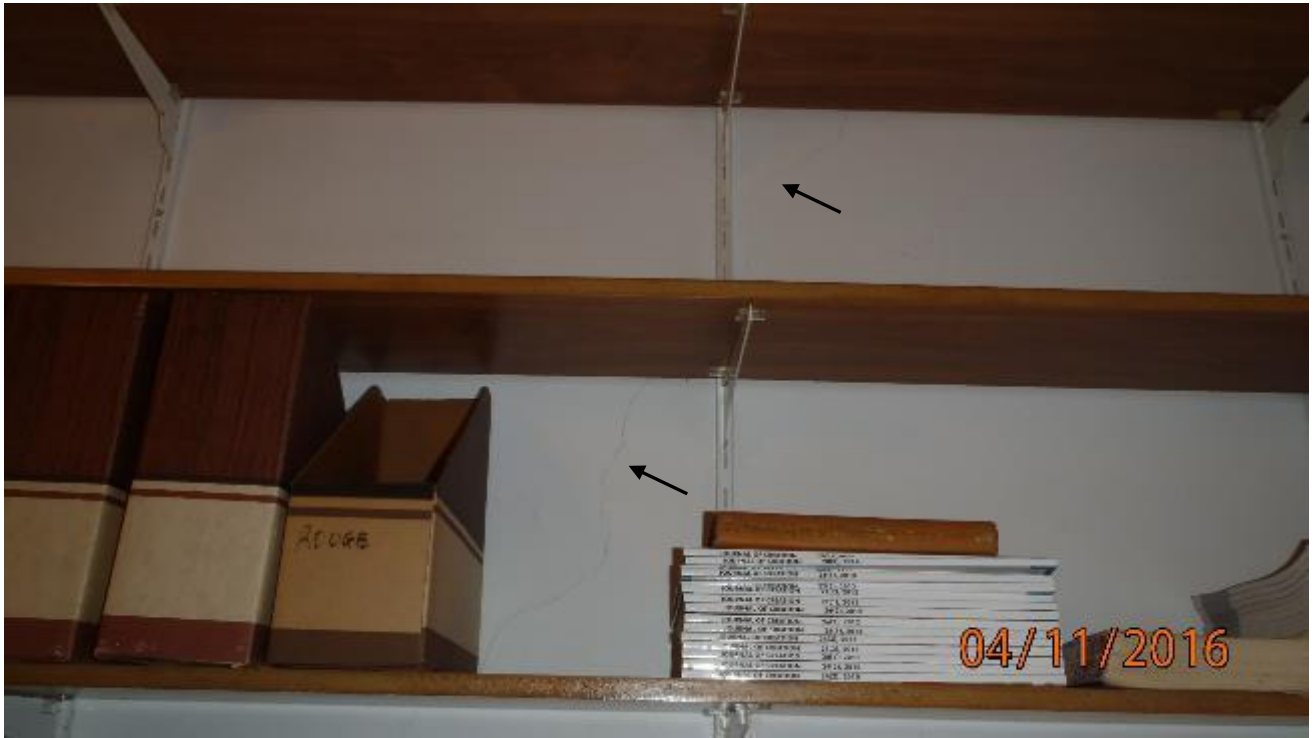
We noted radial cracking [$<1.0\text{mm}$] to the cement rendered north eastern wall behind the bookcase shelving. **[Photograph 29]**

Photograph 29 shows radial cracking to the cement rendered north eastern wall behind the bookcase shelving.

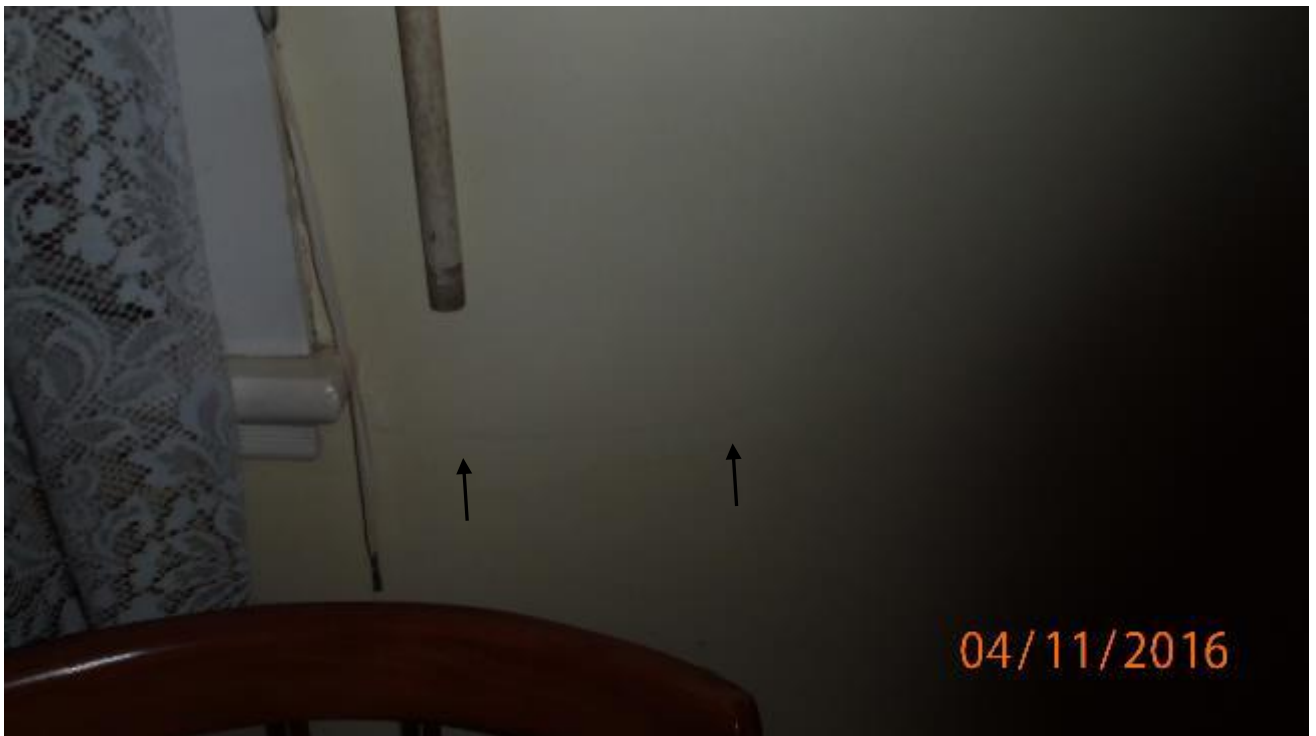
We noted radial cracking [$<1.0\text{mm}$] to the cement rendered north eastern wall adjacent to the window sill. **[Photograph 30]**

Photograph 30 shows radial cracking to the cement rendered north eastern wall adjacent to the window sill.

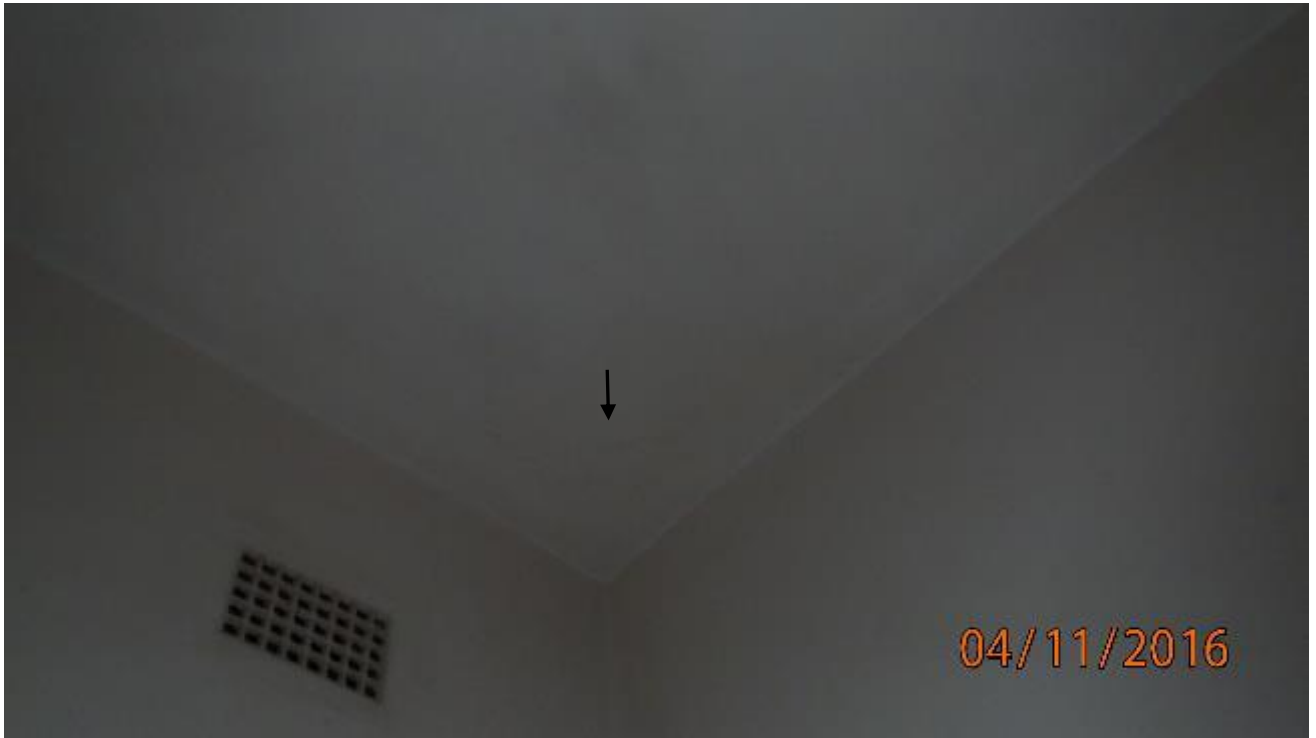
We noted hairline radial cracking [$<1.0\text{mm}$] to the plaster ceiling lining across the southern corner. **[Photograph 31]**

Photograph 31 shows radial cracking to the plaster ceiling lining across the southern corner of Bedroom 3.

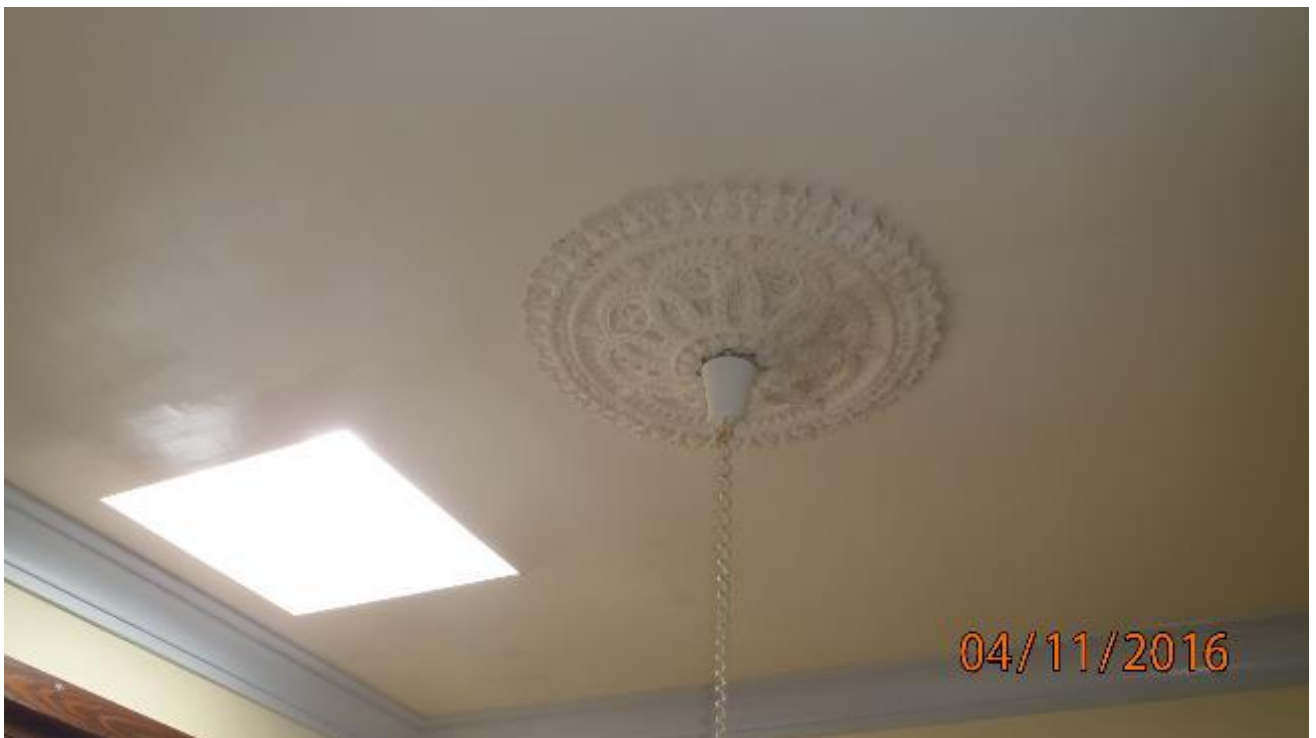
We noted a skylight built into the ceiling and a decorative plaster ceiling rose. **[Photograph 32]**

Photograph 32 shows the general condition of the ceiling in the Kitchen / Dining area.

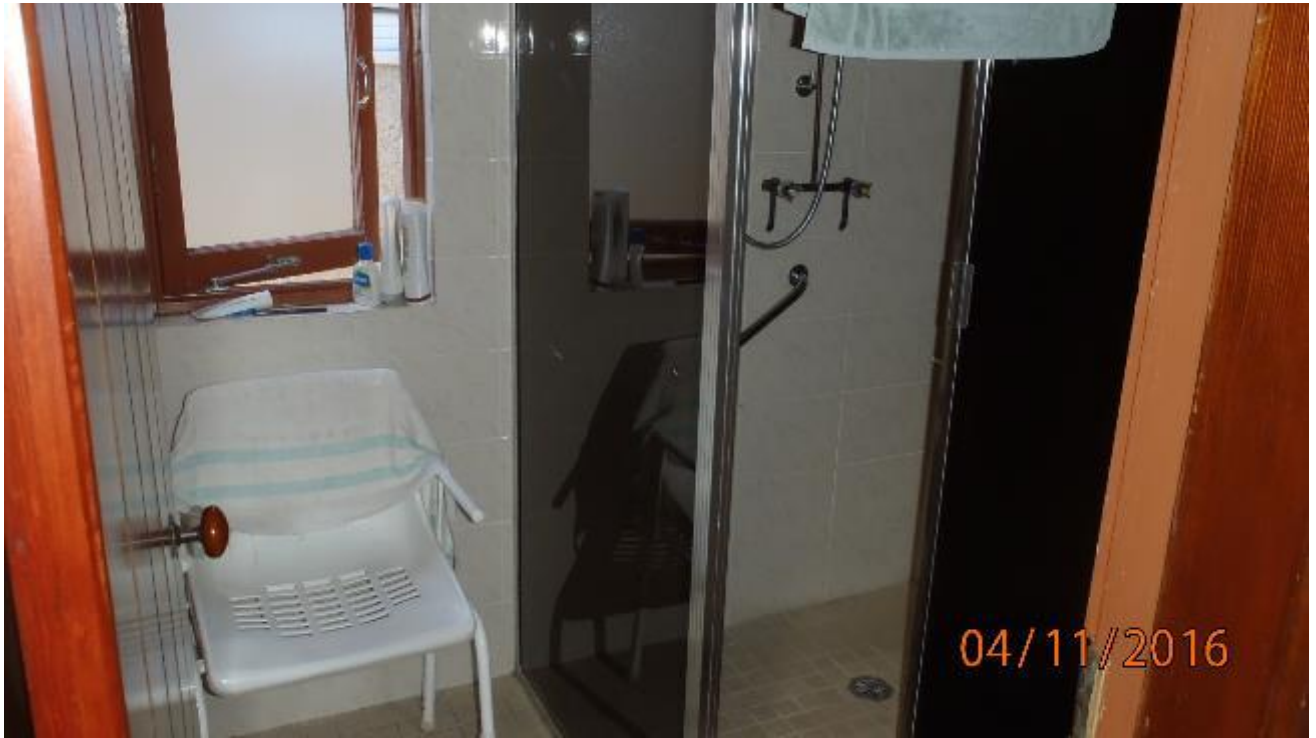
We noted that the grout to the wall and floor tiles is complete and that the wall and floor tiles when randomly "tap" tested appeared to be sound. We did not observe any recent cracking to the tile grout at the wall / wall, wall / floor junctions. **[Photograph 33]**

Photograph 33 shows the general condition and layout of the Bathroom.

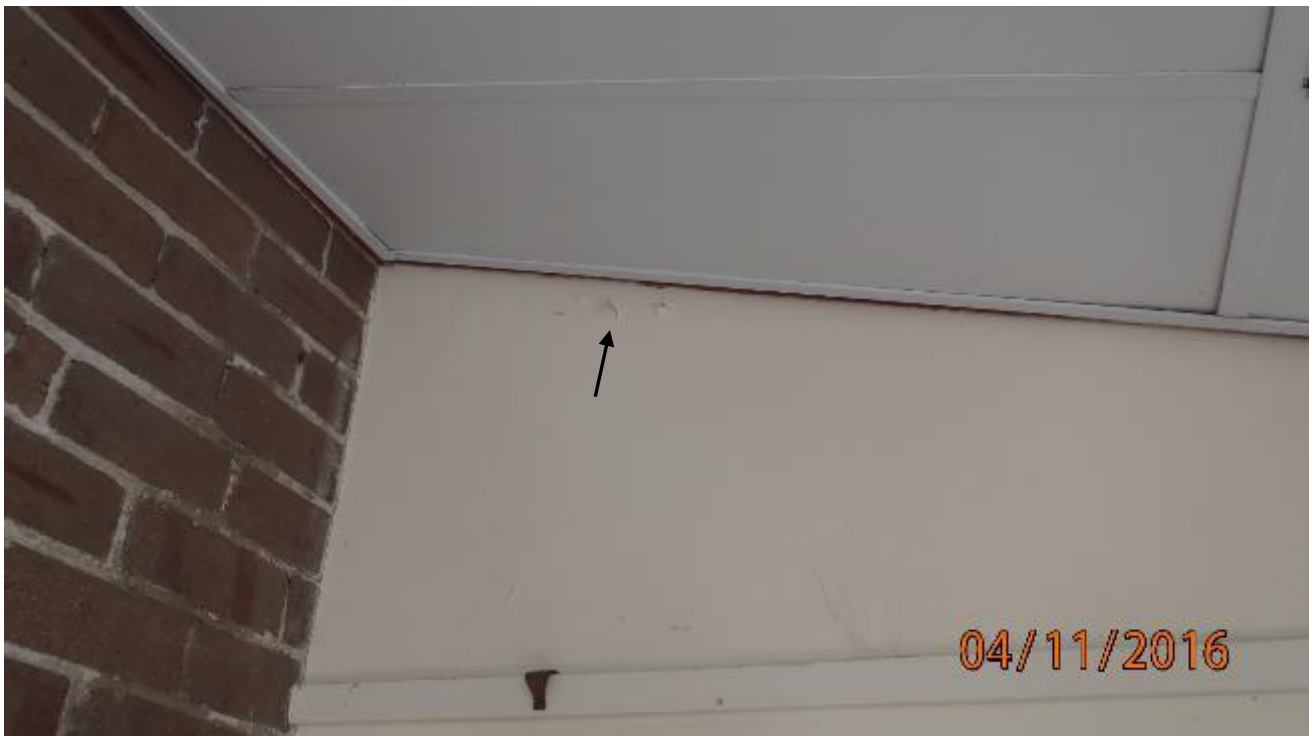
We noted that the ceiling is raked and further noted flaking paint to the wall along the *common party / separation* wall with the adjoining property No. 17 Brook Street, Coogee. **[Photograph 34]**

Photograph 34 shows the raked ceiling and flaking paint to the wall along the common party / separation wall with the adjoining property No. 17 Brook Street, Coogee.

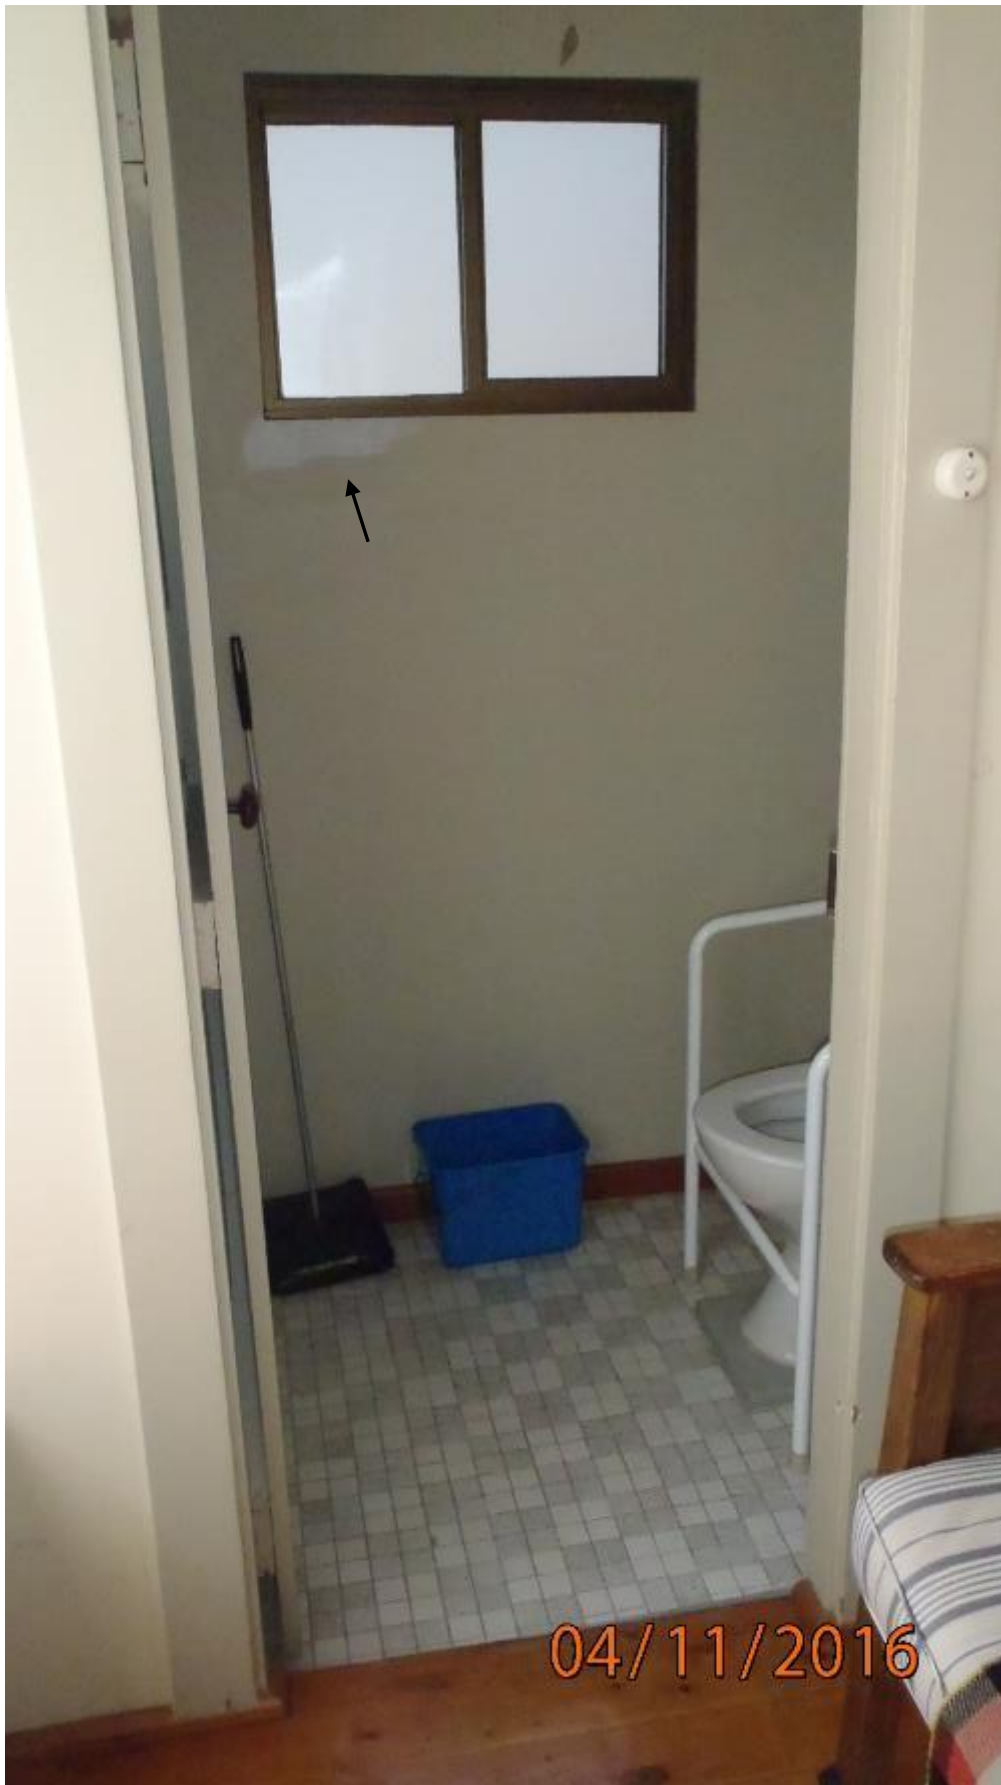
We noted evidence of a previous repair to the cement rendered wall below the window sill. **[Photograph 35]**

Photograph 35 shows the general condition and layout of the WC / toilet.

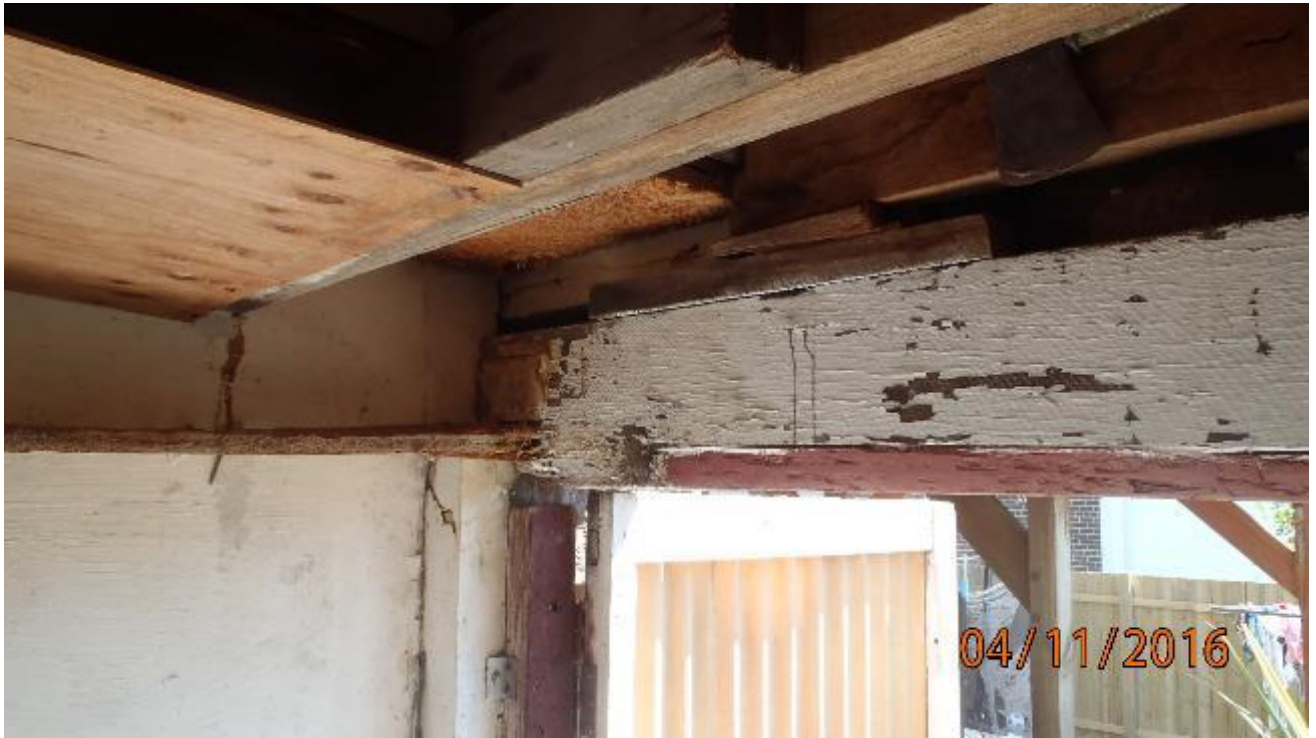
We noted flaking paint around the door **[Photograph 36]**

Photograph 36 shows flaking paint around the door in the Laundry.
