HAZARDOUS MATERIALS ASSESSMENT REPORT

Job details: Owner/s: Mr. N. & Mrs. K. Walker
Location: 25 Killarney Street, Mosman

Date of assessment: 23rd July 2014

Our reference: HM03160714

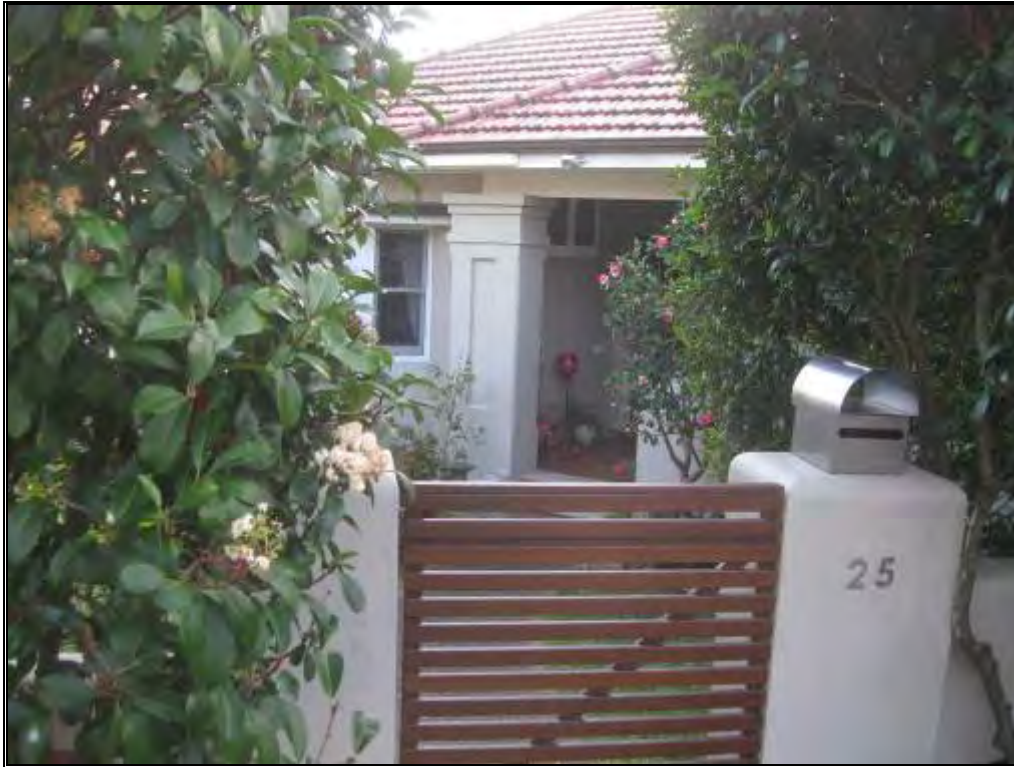
Front southern elevation of the residence
