HAZARDOUS MATERIALS ASSESSMENT REPORT

Client: Cape Cod Australia Pty. Limited

Job details: Owner: Mr C. Howells & Ms. E. Byron
Location: 49 Young Street, Cremorne.

Our reference: HM05150916

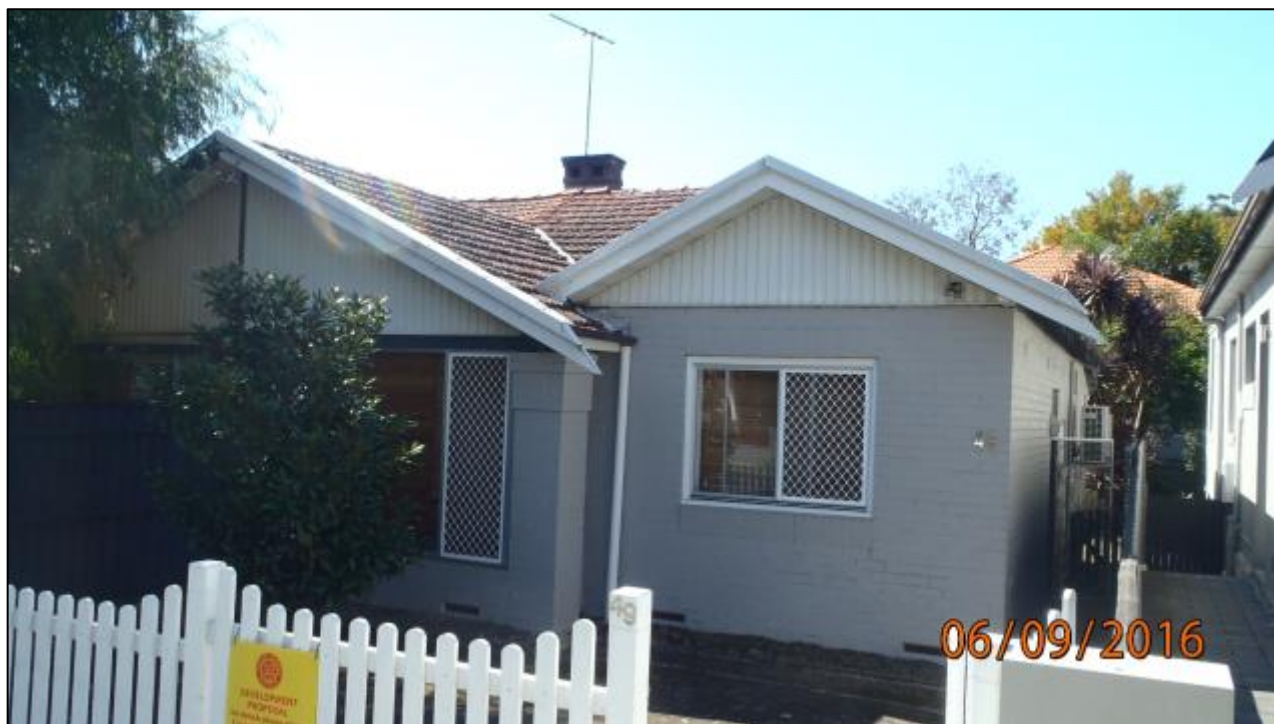
Front western elevation of the residence
