HAZARDOUS MATERIALS ASSESSMENT REPORT

Job details: Owner: Mr. M. Frost
Location: 83 Young Street, Cremorne NSW

Date of assessment: 21st July 2014

Our reference: HM03170714

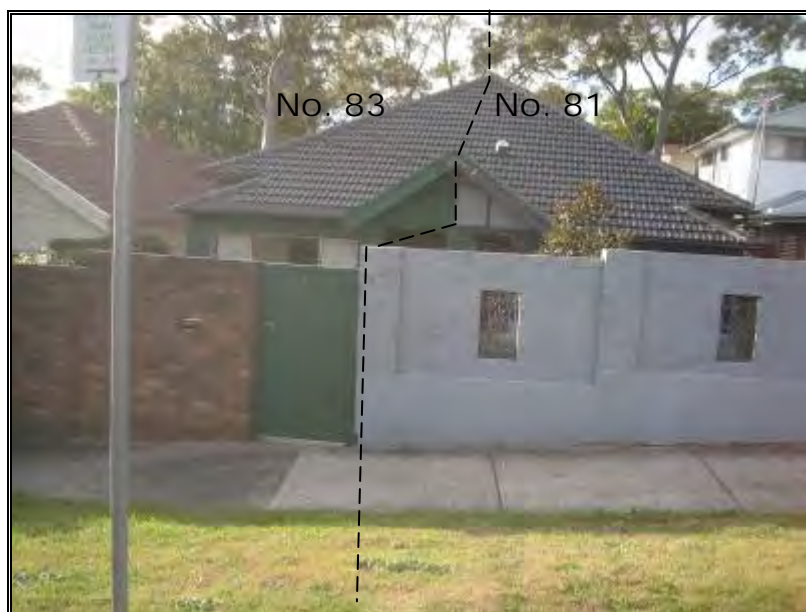
Front western elevation of the adjoining properties;
No. 81 and No. 83 Young Street, Cremorne
