HAZARDOUS MATERIALS ASSESSMENT REPORT

Client: Cape Cod Australia Pty. Limited

Job details: Owner: Mr. P. & Mrs. N. Rich.
Location: 29 Clyde Street, Croydon Park.

Our reference: HM05301116

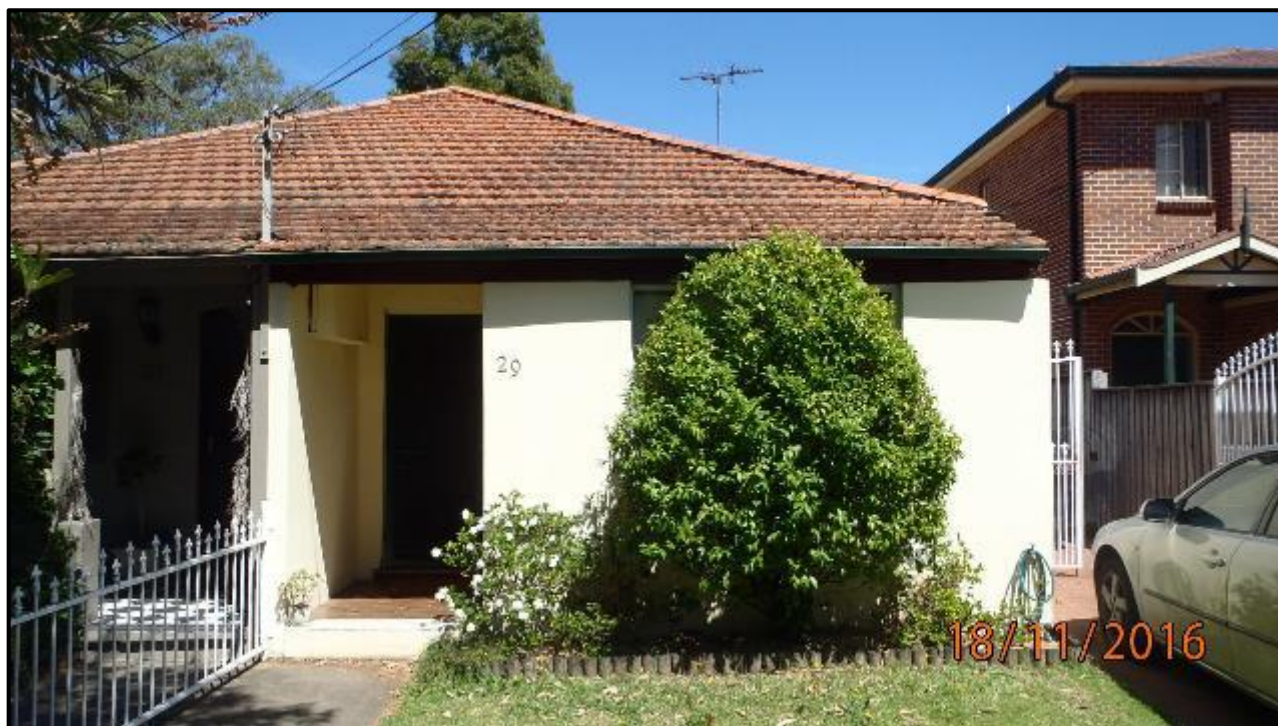
Front eastern elevation of the residence
