HAZARDOUS MATERIALS ASSESSMENT REPORT

Job details: Owner: Mr. D. Yeates & Ms. L. Halloran.
Location: 2 Walker Street, Canada Bay.

Date of assessment: 17th July 2017

Our reference: HM05930717

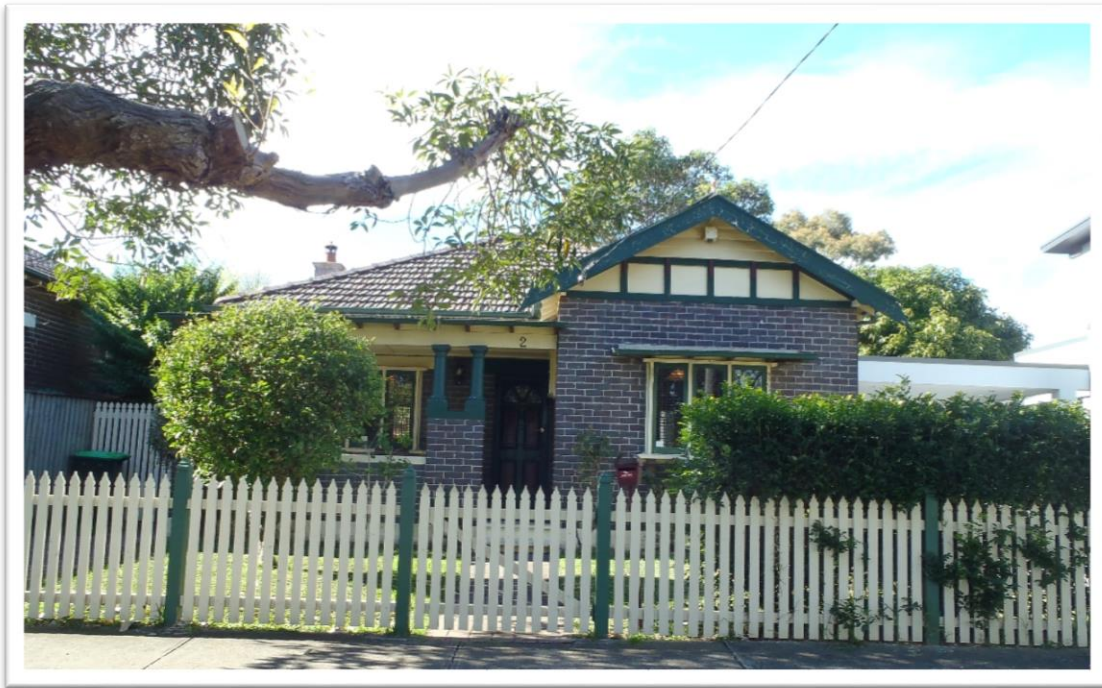
Front western elevation of the residence
