HAZARDOUS MATERIALS ASSESSMENT REPORT

Job details: Owner: Mr. J. & Mrs. J. Warburton
Location: 40 Rangers Avenue, Mosman.

Date of assessment: 11th November 2016

Our reference: HM05331116

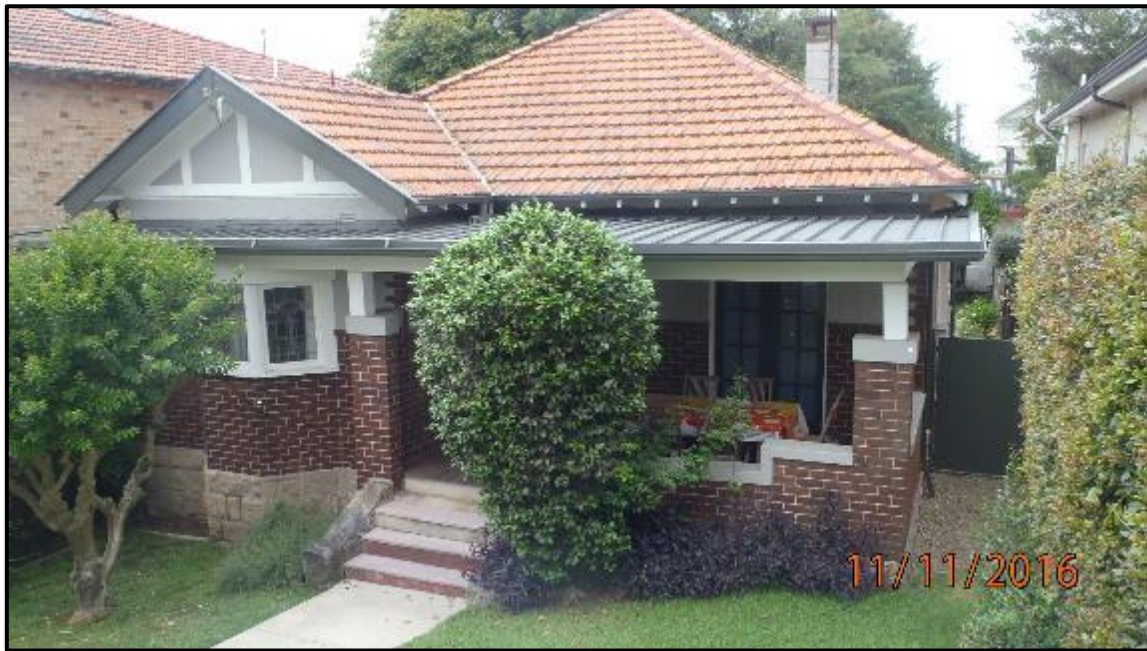
Front northern elevation of the residence
