## Dilapidation Assessment Report

Prepared for: **Cape Cod Australia Pty. Limited**

Job address: 34 Park Parade, BONDI NSW 2026.

Date of assessment: 19<sup>th</sup> May 2016

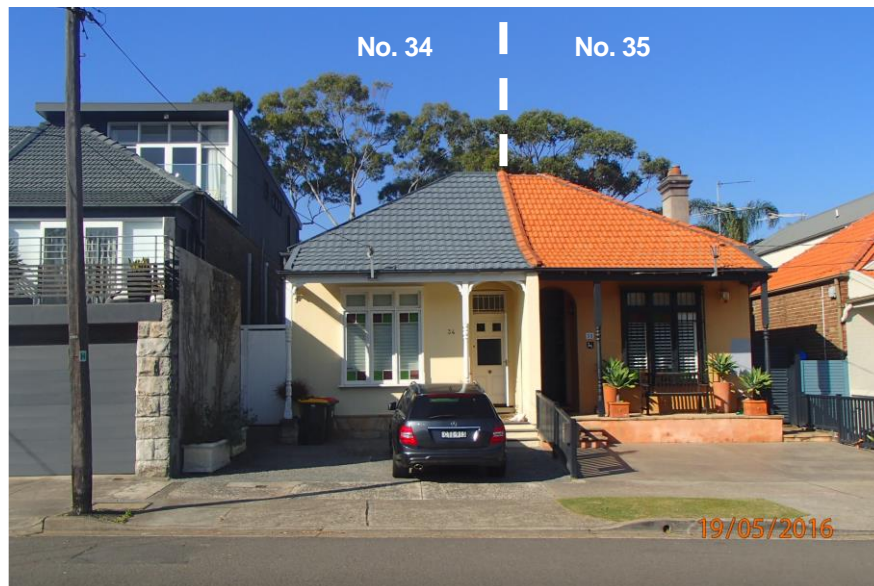
Shows the front western elevation of the adjoining properties:  
No.34 & No.35 Park Parade, BONDI.

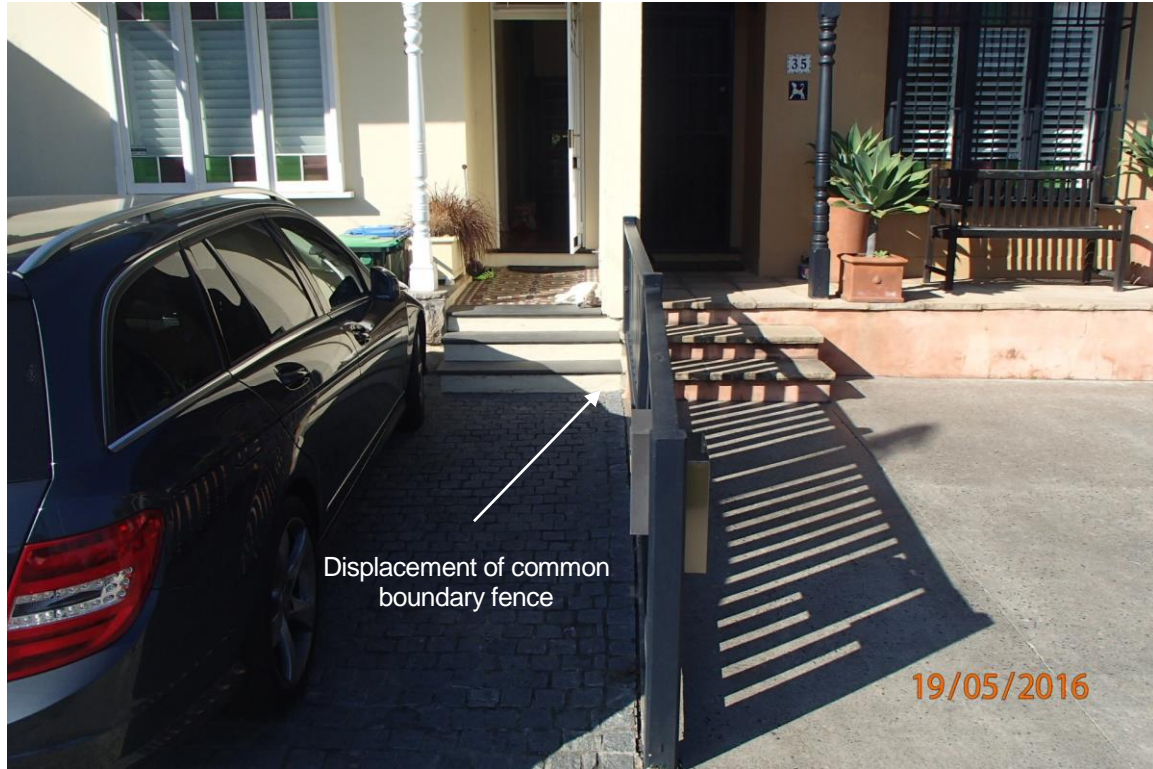
We noted that there is displacement of the front boundary fence. **[Photograph 1]**

**Photograph 1** shows the condition of the front boundary fence, Note: displacement.

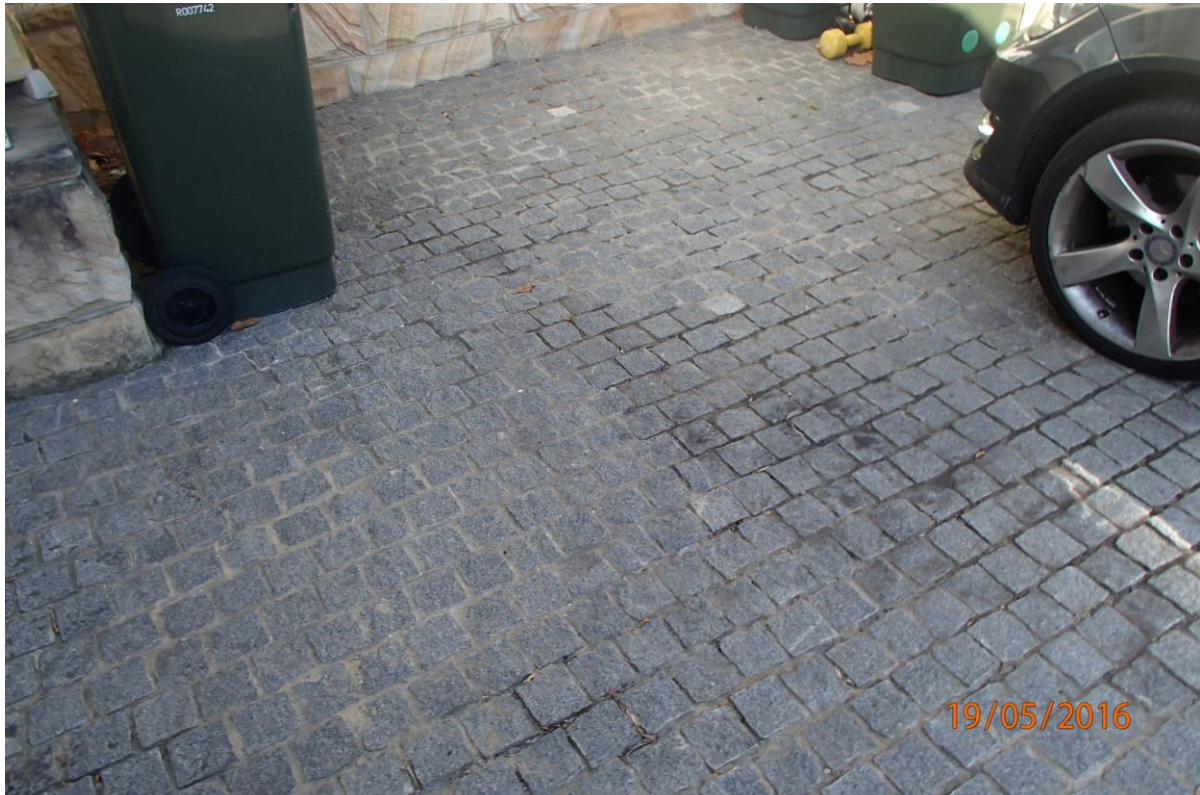
We noted that there is general movement driveway pavement. **[Photograph 2]**

**Photograph 2** shows displacement of the driveway pavement

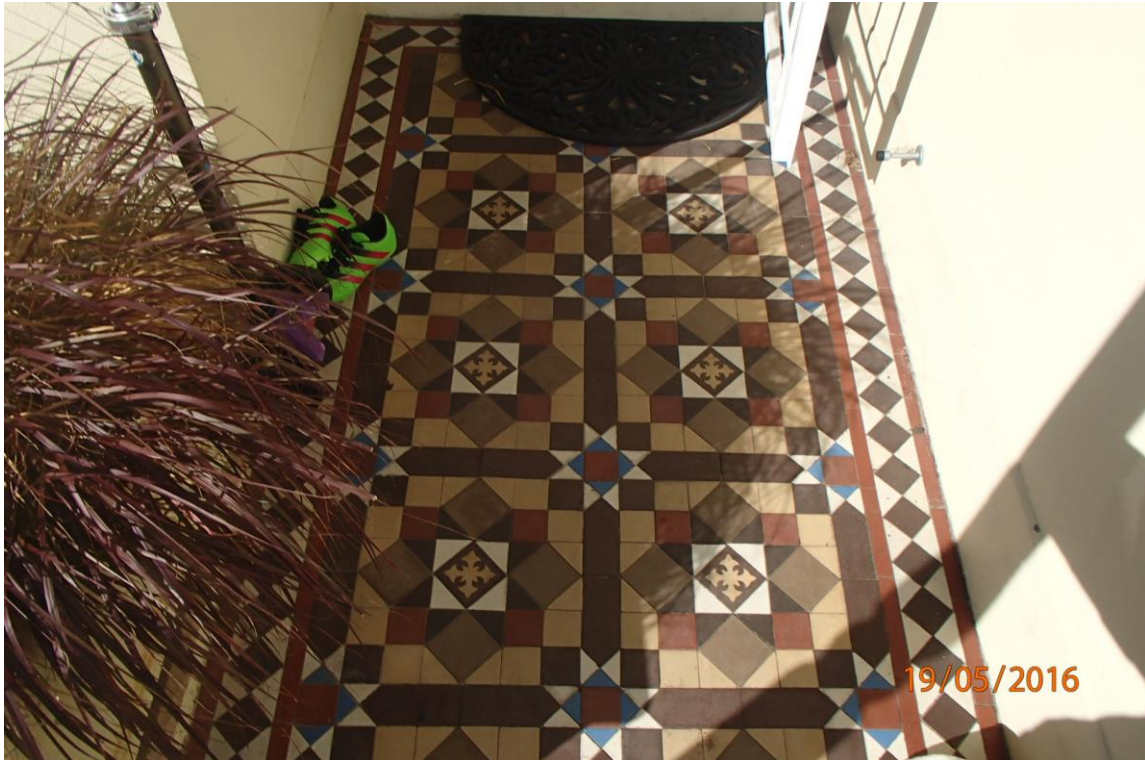
We noted that the tiles to the entry / verandah were generally in good condition. **[Photograph 3]**

**Photograph 3** shows the general condition of the entry tiles.

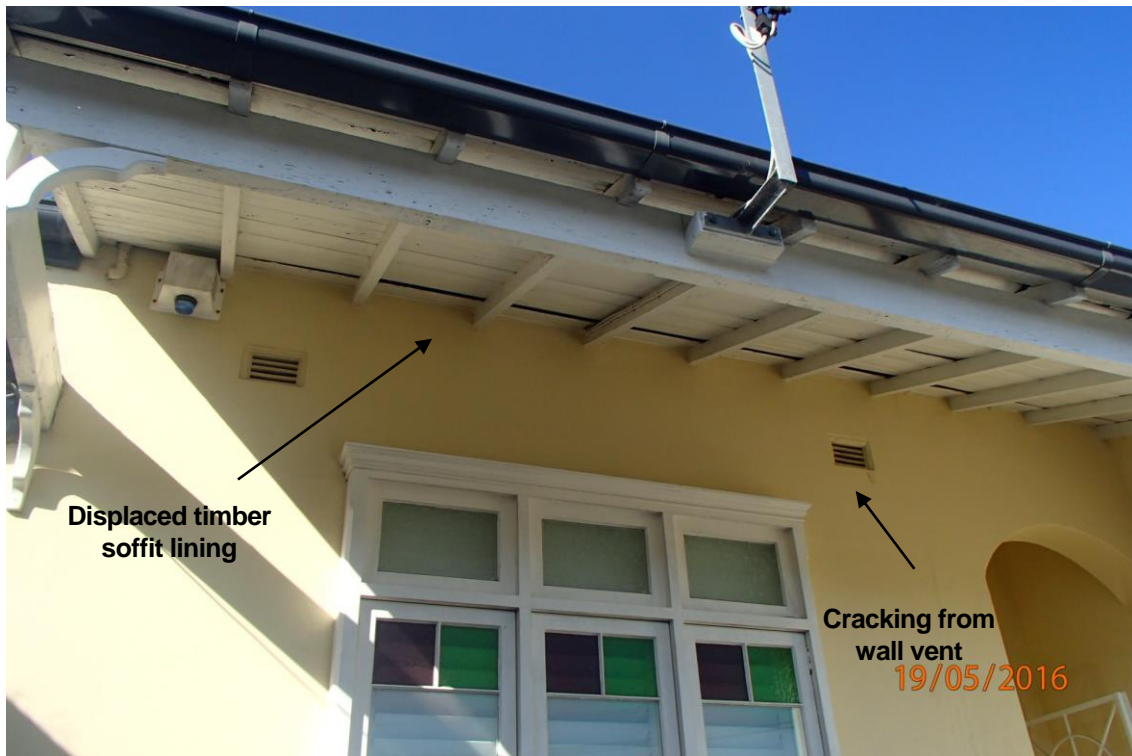
We noted displacement and general deterioration of the structure and surface coating timber fascia board and soffit lining to the front verandah **[Photograph 4 and 5]**

We noted that there is some settling of the brickwork and previous repairs to the bottom right hand side of the wall vent. **[Photograph 4]**

**Photograph 4** shows the general condition of the timber fascia board and soffit lining to the front verandah.

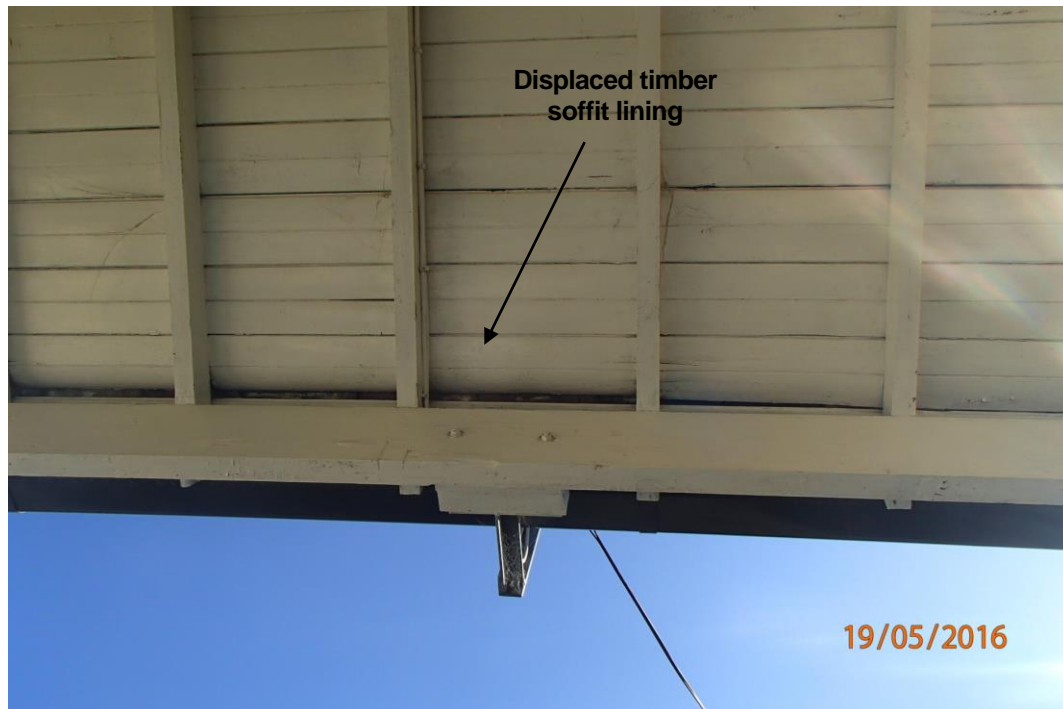
**Photograph 5** shows the general condition of the timber fascia board and soffit lining to the front verandah (Western edge)

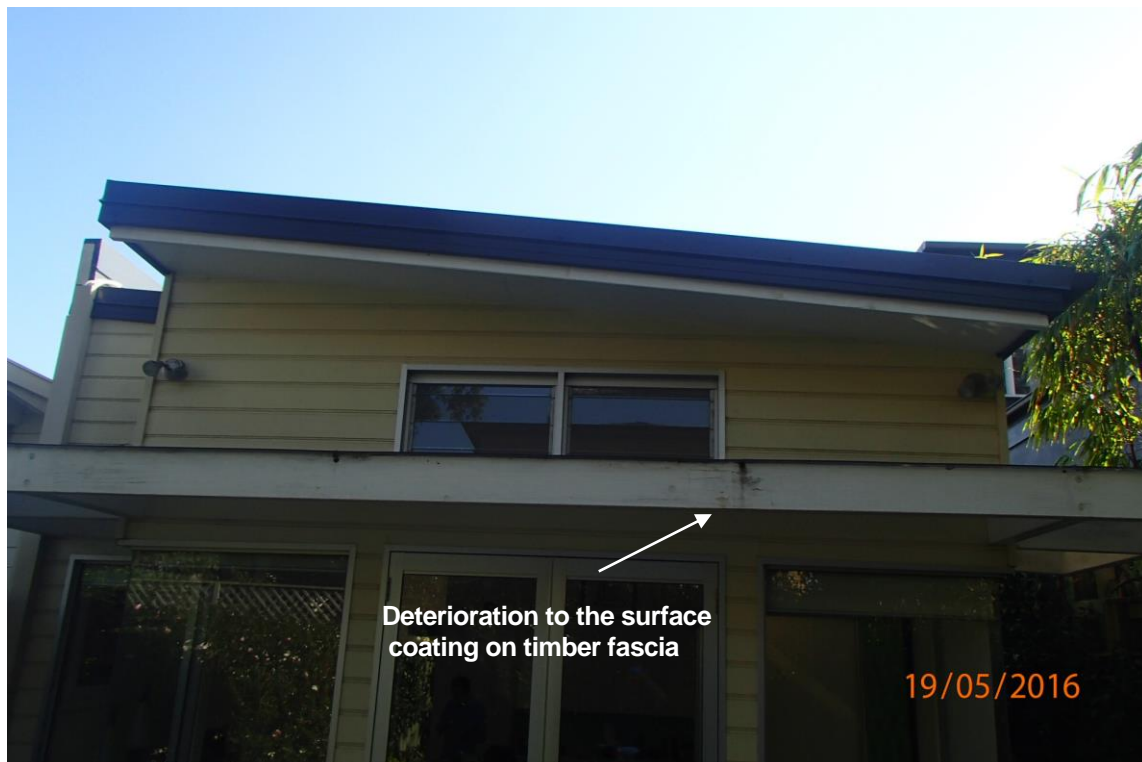
We noted ageing and general deterioration of the surface coating to the timber fascia board of the rear patio skillion roof **[Photograph 6]**

**Photograph 6** shows the condition of the surface coating of the timber fascia board weatherboard cladding (eastern elevation).

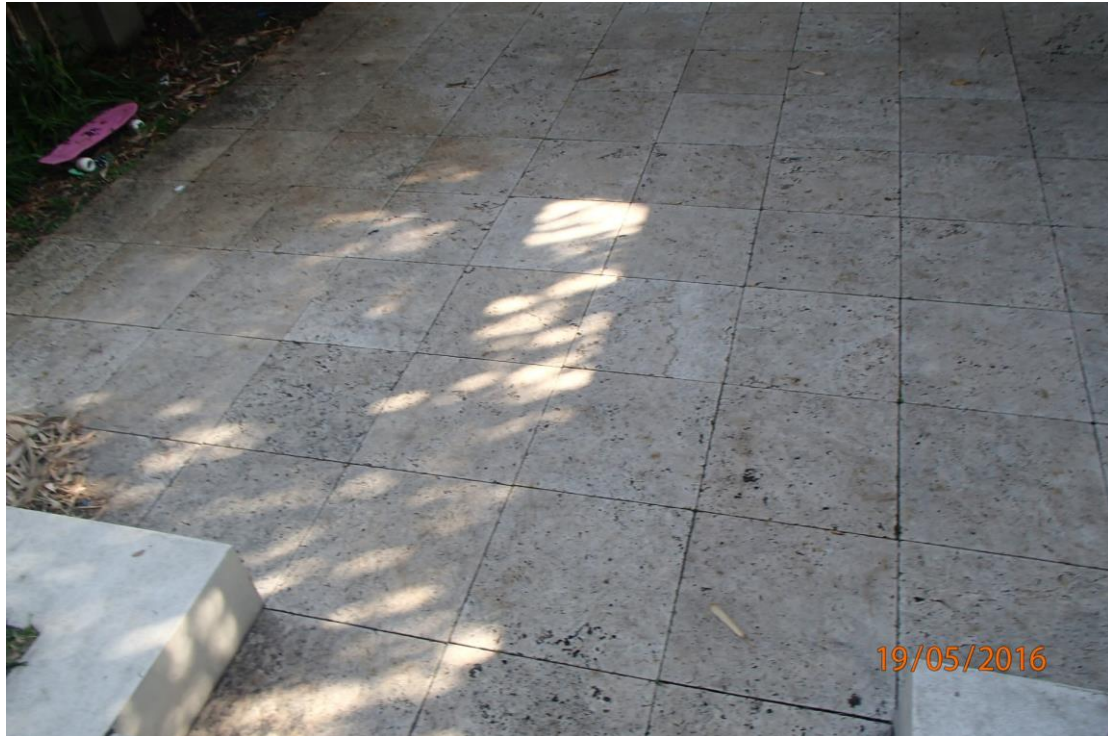
**Photograph 7** shows the general condition of the entry tiles.

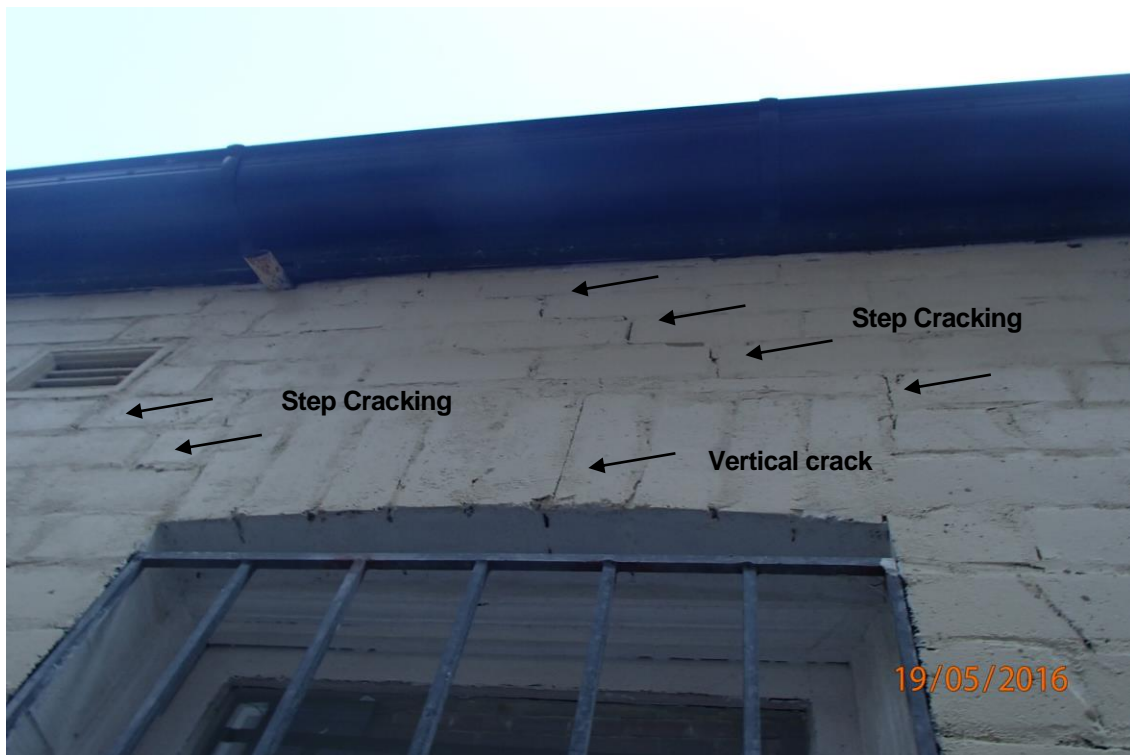
We noted that there is a stepped crack [1.0mm - <3.0mm] and evidence of previous repair to the brickwork extending from the right hand side of the Lounge room window head towards the gutter. **[Photograph 8]**

We noted that there is a stepped crack [1.0mm - <3.0mm] and evidence of previous repair to the brickwork extending from the left hand side of the Lounge room window head to the bottom right of the wall vent. **[Photograph 8]**

We also noted that there is a vertical crack to the Lounge room window head brickwork. **[Photograph 8]**

**Photograph 8** shows stepped cracking and previous repairs to the brickwork above the Lounge room window.

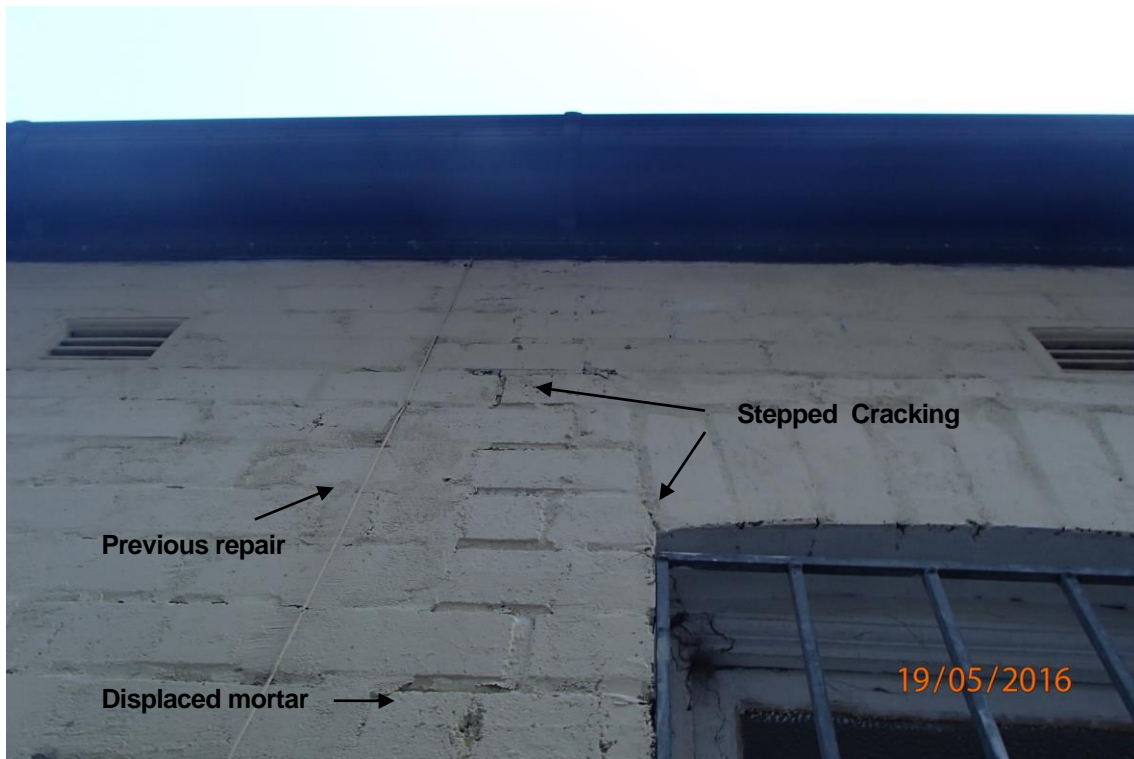
We noted that there is a stepped crack [1.0mm - <3.0mm] and evidence of previous repair to the brickwork extending from the left hand side of the Bathroom window head towards the gutter. **[Photograph 9]**

**Photograph 9** shows stepped cracking and previous repairs to the brickwork and displaced mortar to the top left hand of the Bathroom window.

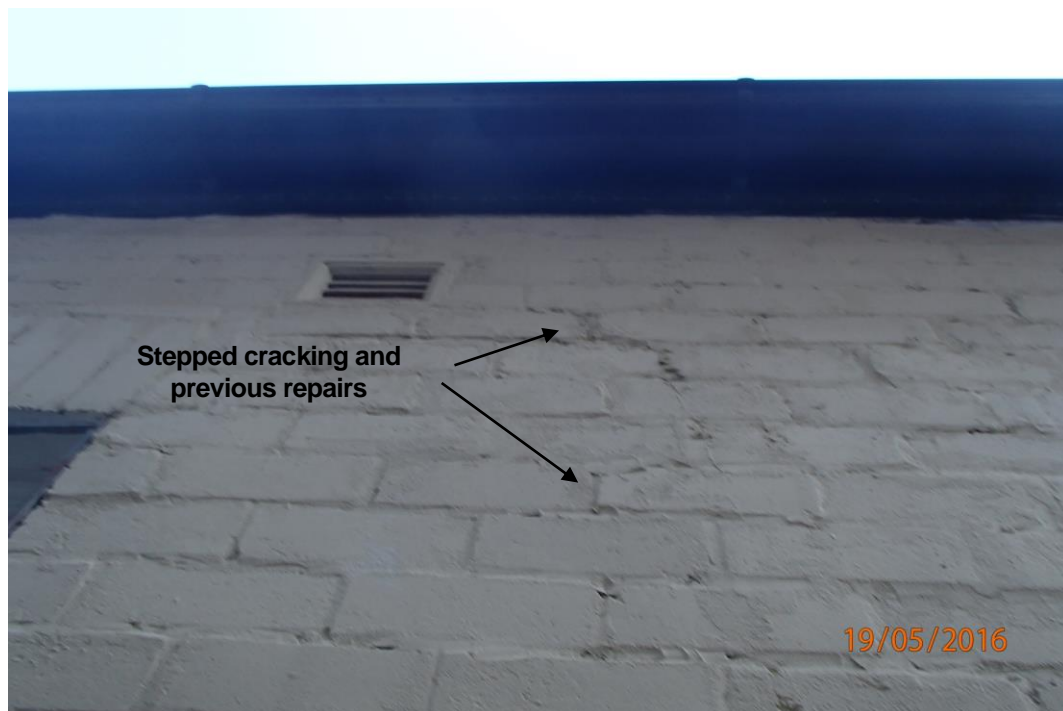
We noted that there is a stepped crack [1.0mm - <3.0mm] and evidence of previous repair to the brickwork extending from the bottom right hand side of the wall vent between the lounge room and the bathroom **[Photograph 10]**

**Photograph 10** shows stepped cracking and previous repairs to the brickwork on the bottom right hand side of the wall vent between the lounge room and the bathroom.

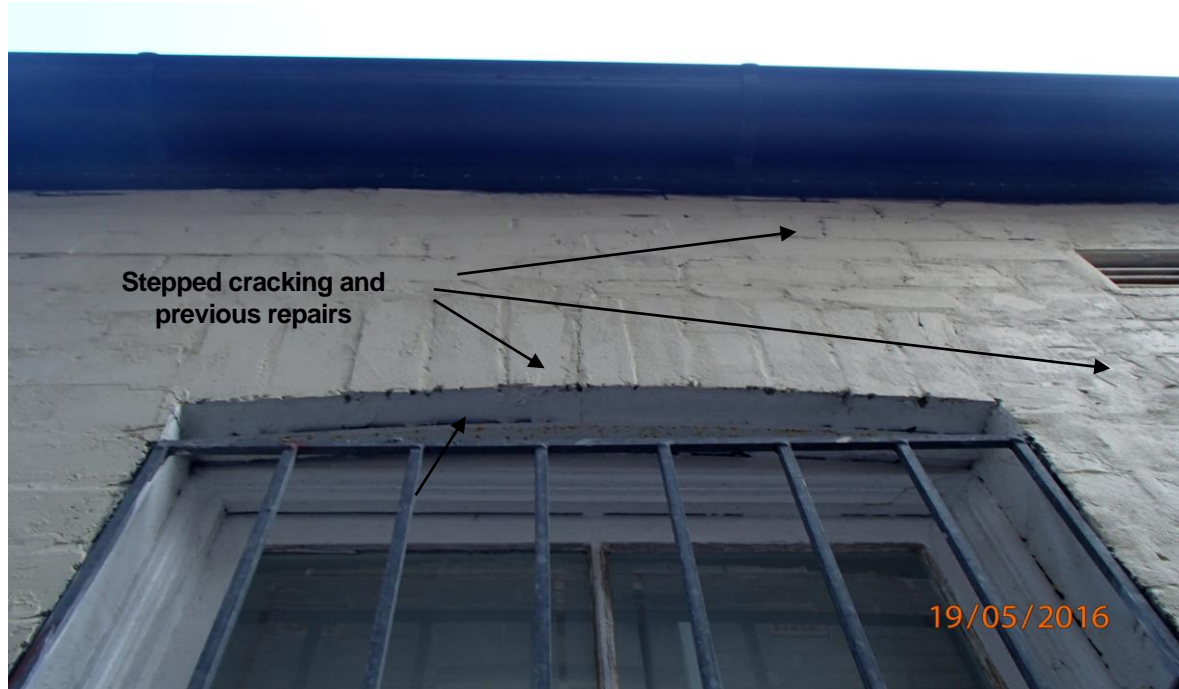
We noted that there is a stepped crack [1.0mm - <3.0mm] and evidence of previous repair to the brickwork extending from the centre of the Bedroom 2 window head towards the gutter. **[Photograph 11]**

We noted that there is a stepped crack [1.0mm - <3.0mm] and evidence of previous repair to the brickwork extending from the right hand side of the Bedroom 2 window head towards the bottom left of the wall vent. **[Photograph 11]**

**Photograph 11** shows a stepped crack and previous repairs to the brickwork to the brickwork extending from the centre of the Bedroom 2 window head towards the gutter and up towards the wall vent..

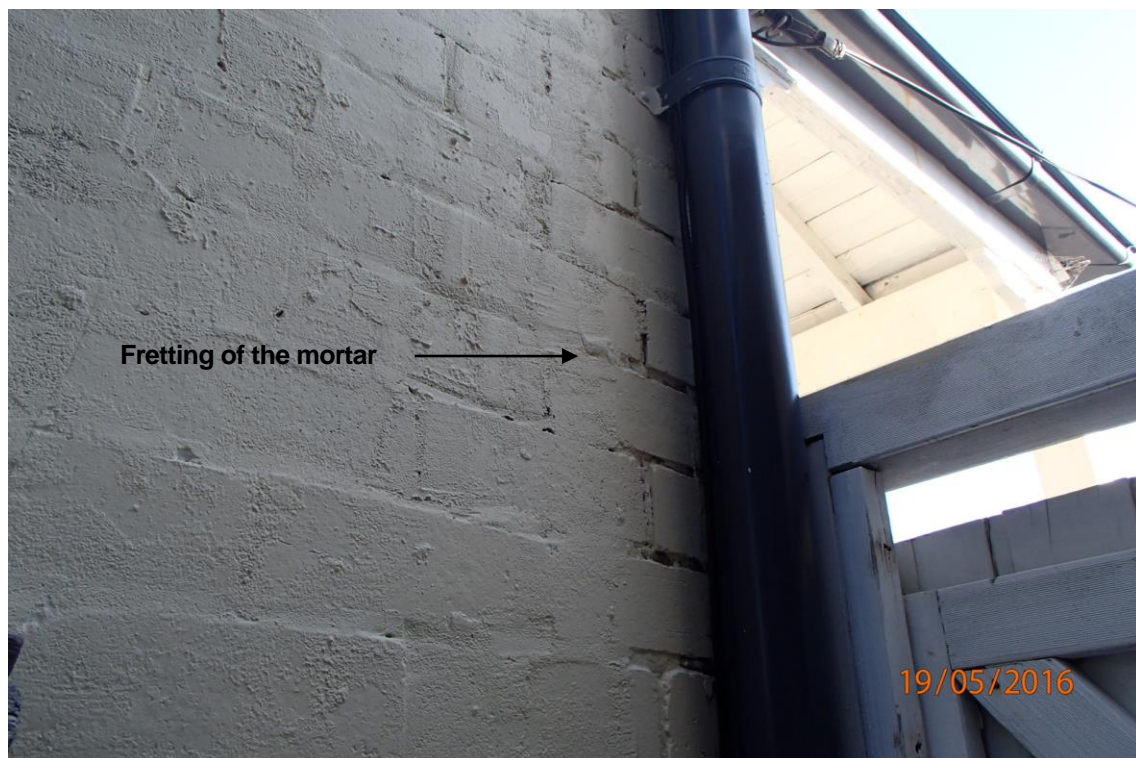
We noted that there is general deterioration [fretting] of the lime mortar to the brickwork on the front western corner of the premises abutting the downpipe. **[Photograph 12]**

**Photograph 12** shows general deterioration [fretting] of the lime mortar to the brickwork on the front western corner of the premises abutting the downpipe.

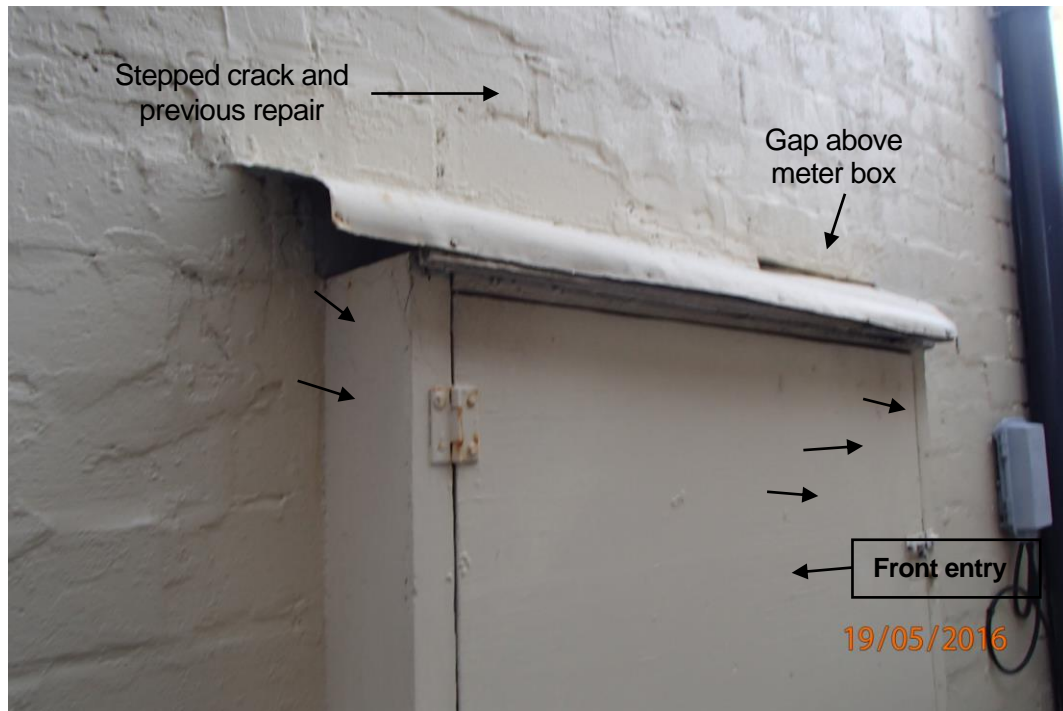
We noted that there is a stepped crack [1.0mm - <3.0mm] and evidence of previous repair to the brickwork extending from the centre of the electrical meter box towards the gutter. **[Photograph 13]**

We noted that there is a gap in the mortar above the flashing of the electrical meter box. **[Photograph 13]**

**Photograph 13** shows a gap in the mortar above the flashing of the electrical meter box and a previous step crack repair.

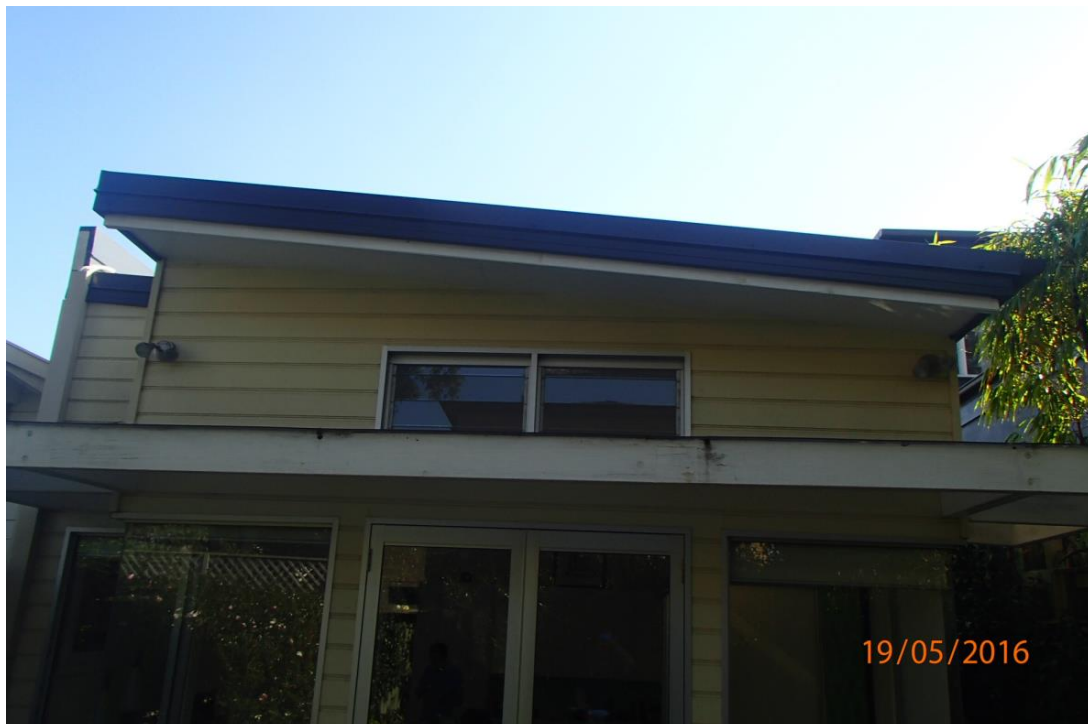
We did not observe any noticeable defects to the weatherboard lining to the rear of the premises. **[Photograph 14]**

**Photograph 14** shows the general condition of the rear eastern elevation.

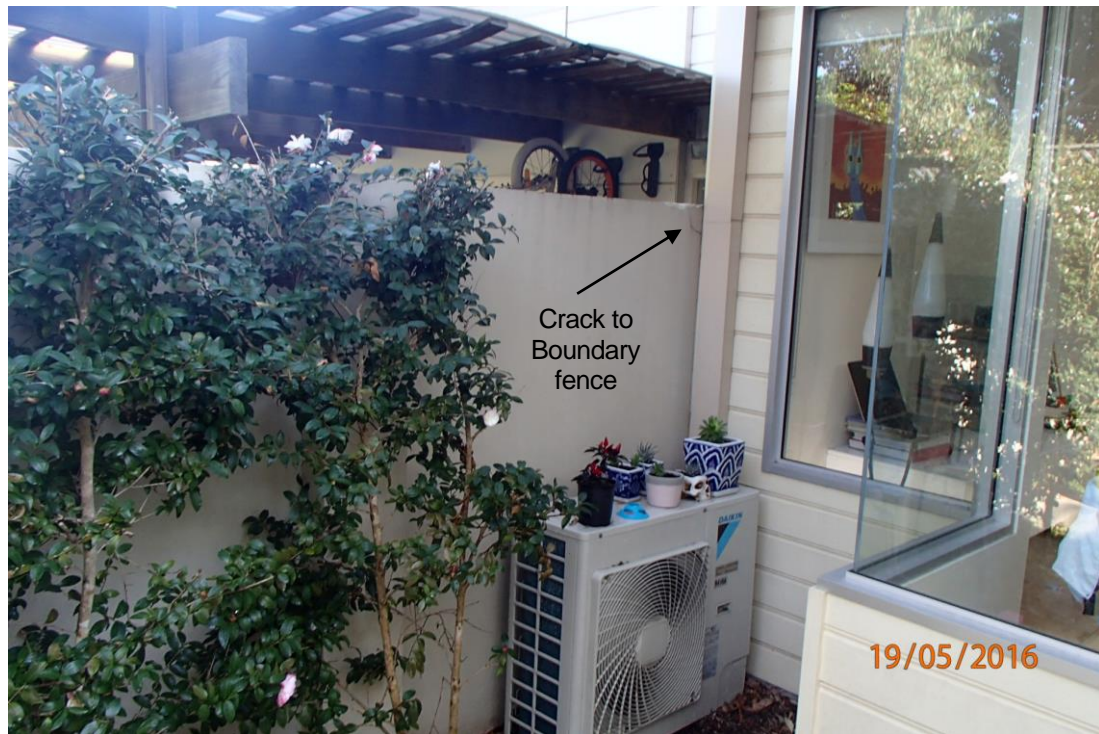
We noted that there is damage to the common boundary fence between No.34 and No.35. **[Photograph 15]**

**Photograph 15** shows damage to the common boundary fence between No.34 and No.35.

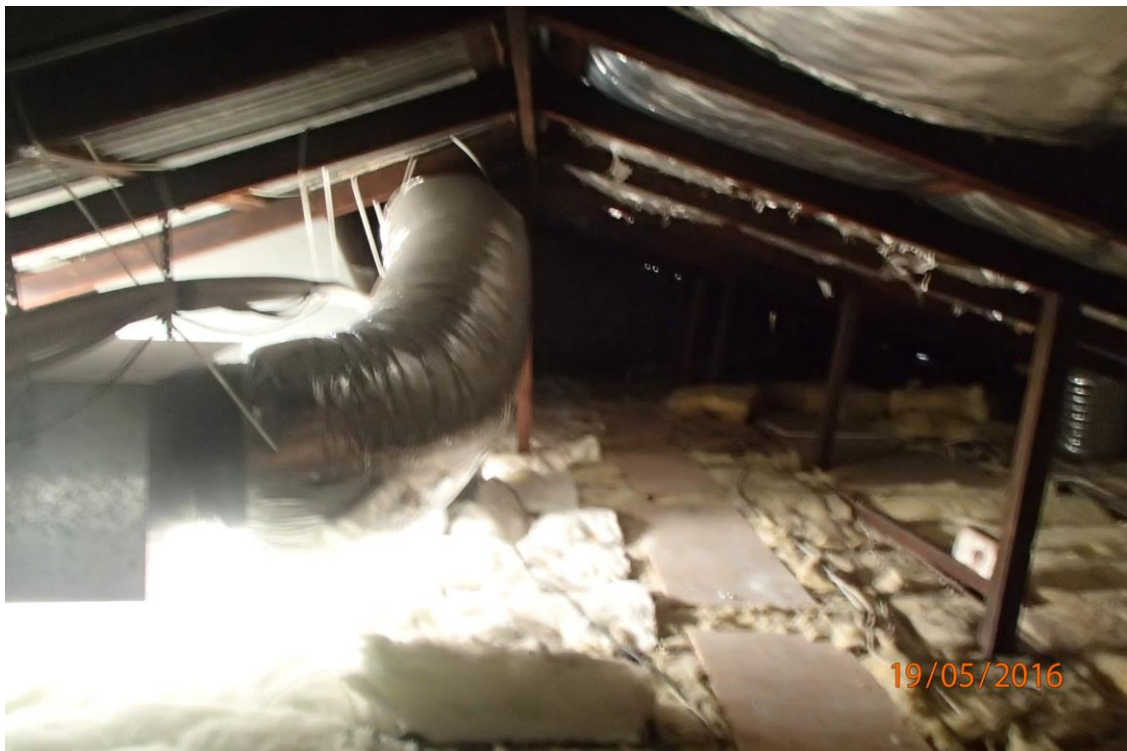
We observed that the *common* roof structure to the properties is of traditional cut and pitched timber construction. We noted that the clay brick *common party / separation* wall **does not** extend to the underside of the rafters and that the *common* ridge to the roof surfaces is located over the *common party / separation* wall. **[Photograph 16]**

We noted that there is a ducted air conditioning system installed in the roof space. **[Photograph 16]**

**Photograph 16** shows the common roof space between No.34 and No.35, noting the air conditioning system, no common party wall to the underside of the rafters and ceiling insulation.

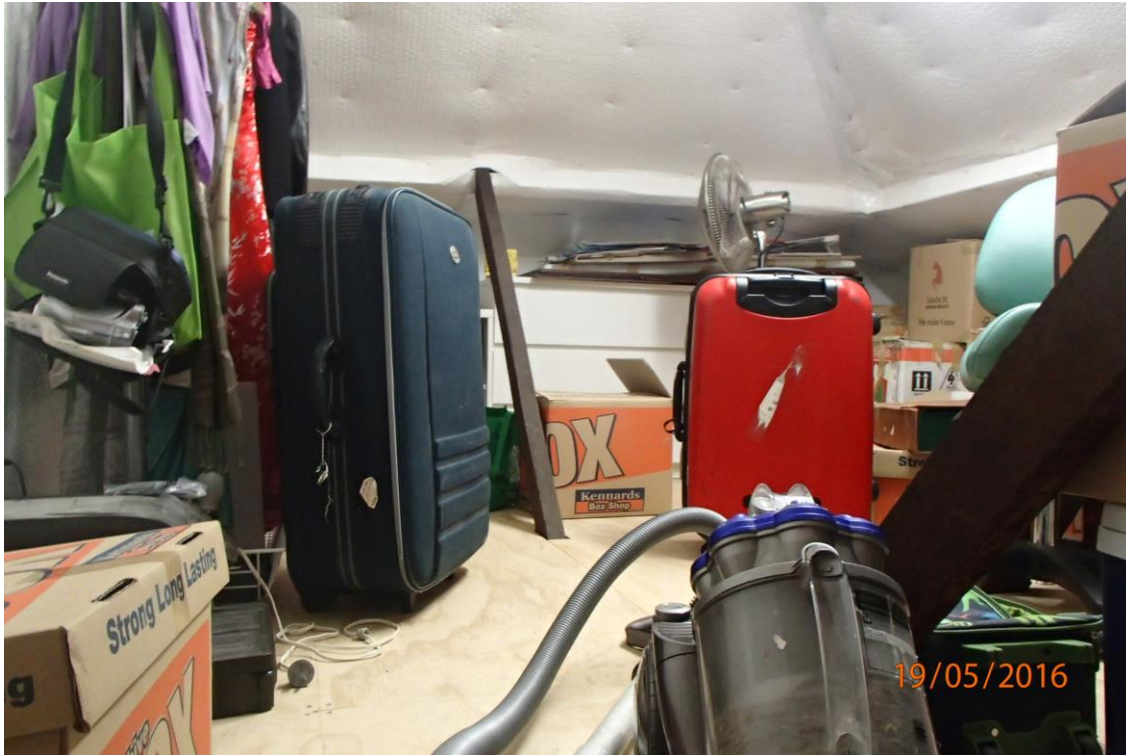
We noted that the roof space to the front western end (entered via the ceiling access point) is lined with a proprietary sound reduction material to provide an attic area. In this section of the roof space the rafters are concealed and there is sheet particleboard flooring concealing the timber ceiling joists. **[Photograph 17]**

**Photograph 17** shows the attic area within the roof space.

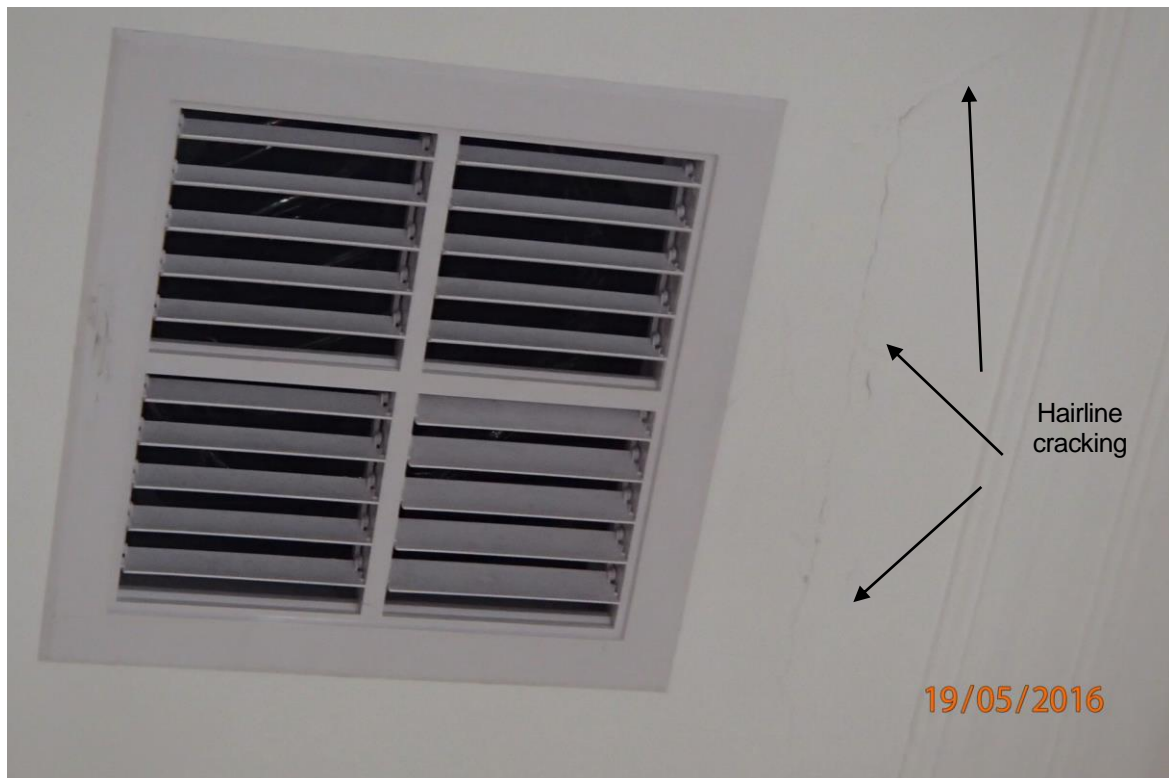
We noted a hairline crack [ $<1.0\text{mm}$ ] adjacent to the ducted air conditioning vent in the south western corner. [**Photograph 18**]

**Photograph 18** shows hairline crack adjacent to the ducted air conditioner vent

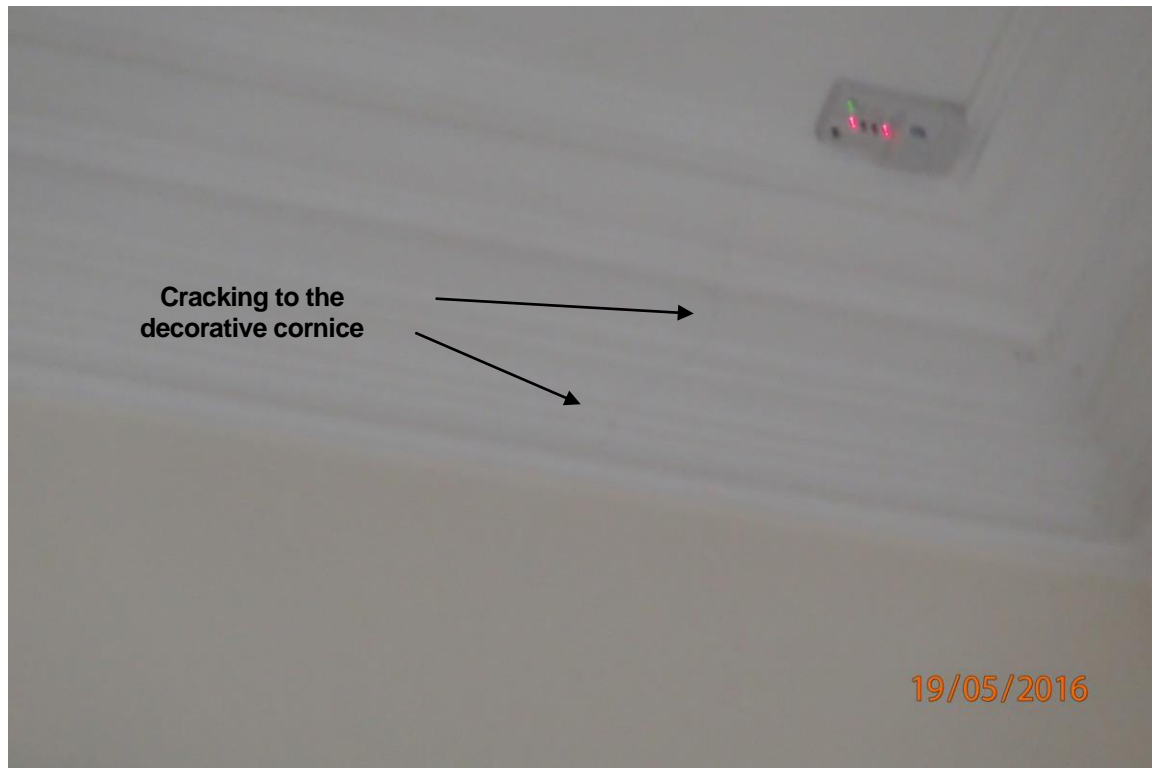
We noted a hairline crack [ $<1.0\text{mm}$ ] to the decorative cornice adjacent to the alarm controller. [**Photograph 19**]

**Photograph 19** shows radial cracks to the decorative cornice in Bedroom 1.

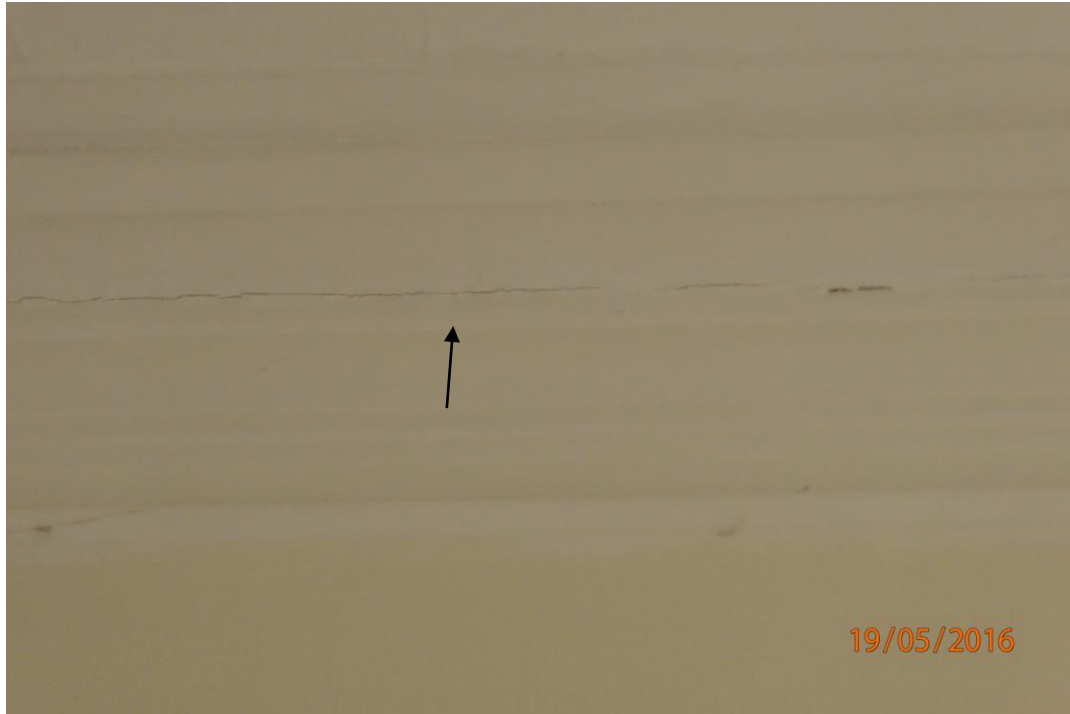
We noted a hairline separation crack [ $<1.0\text{mm}$ ] to the cornice in Bedroom 1. [**Photograph 21**]

**Photograph 21** shows separation crack to the cornice in Bedroom 1

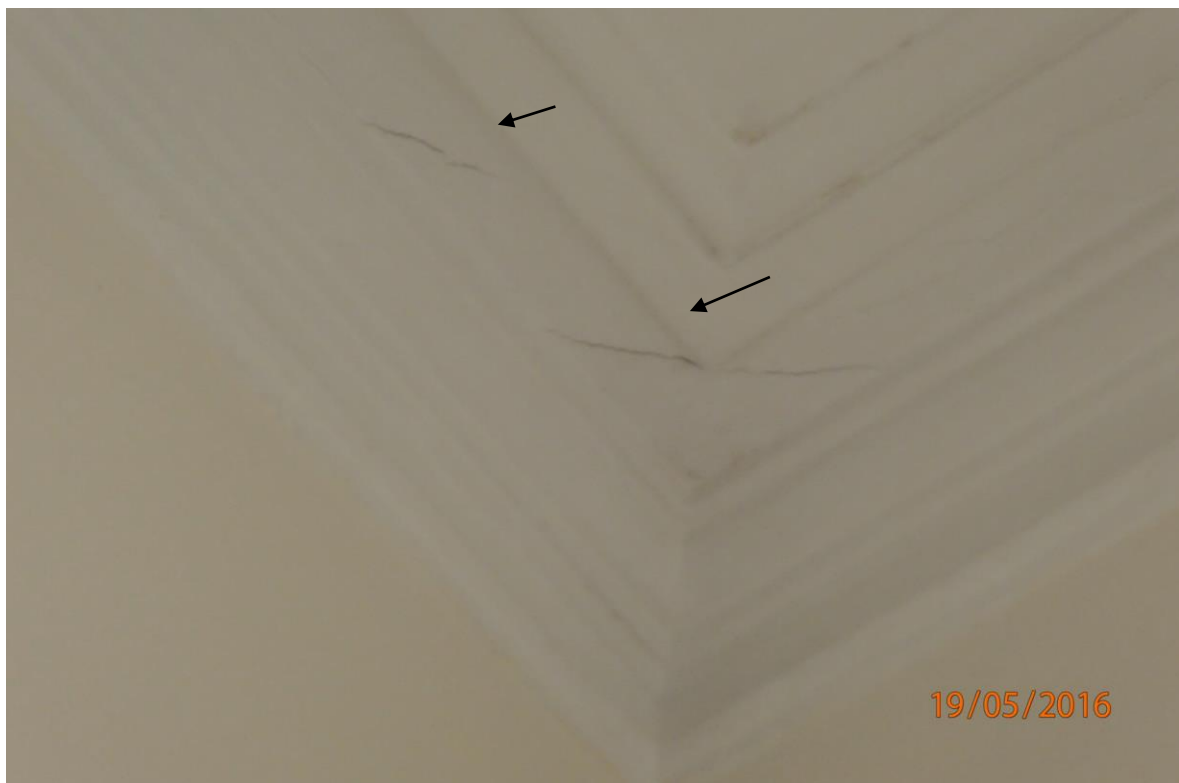
We noted hairline radial cracking [ $<1.0\text{mm}$ ] to the decorative cornice on the eastern side of Bedroom 1. [**Photograph 22**]

**Photograph 22** shows radial cracking to the decorative cornice on the eastern side of Bedroom 1.

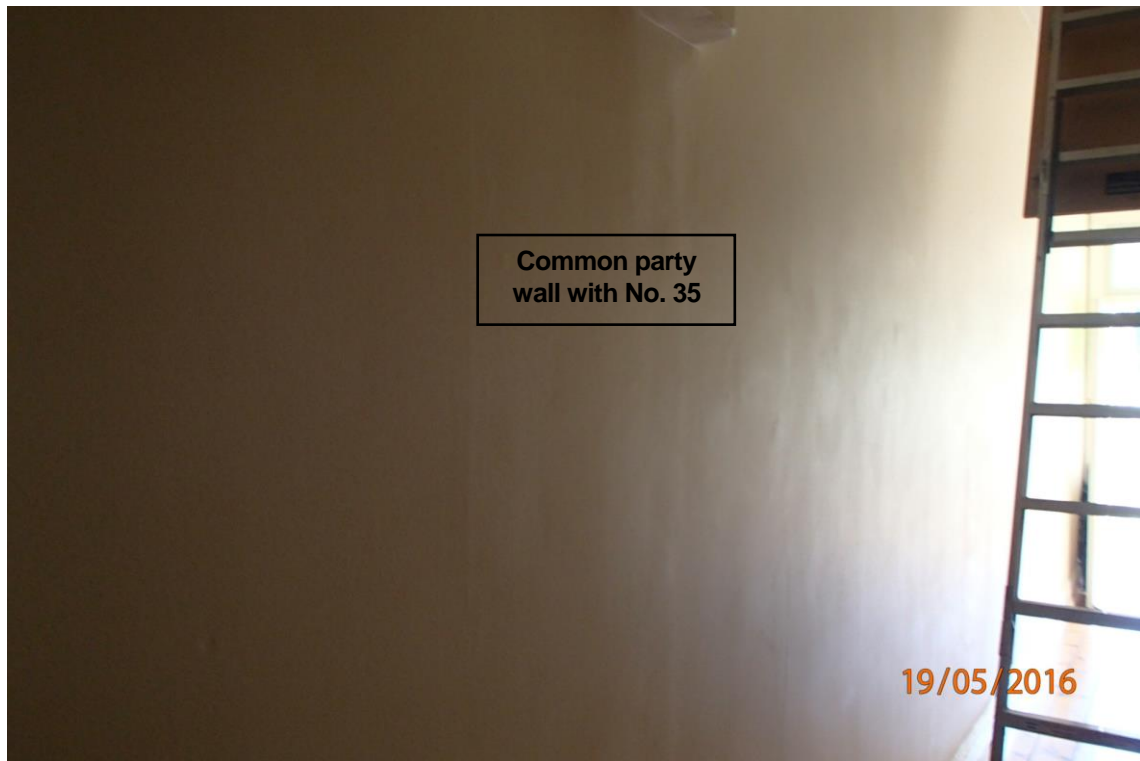
We did not observe any **recent** noticeable cracking to the surface coated cement rendered *common party / separation* wall. **[Photograph 23]**

**Photograph 23** shows the general condition of the *common party / separation* wall. **Note:** attic access
