## Dilapidation Assessment Report

Prepared for: **Cape Cod Australia Pty. Limited**

Job address: 34 Park Parade, BONDI NSW 2026.

Date of assessment: 19<sup>th</sup> May 2016

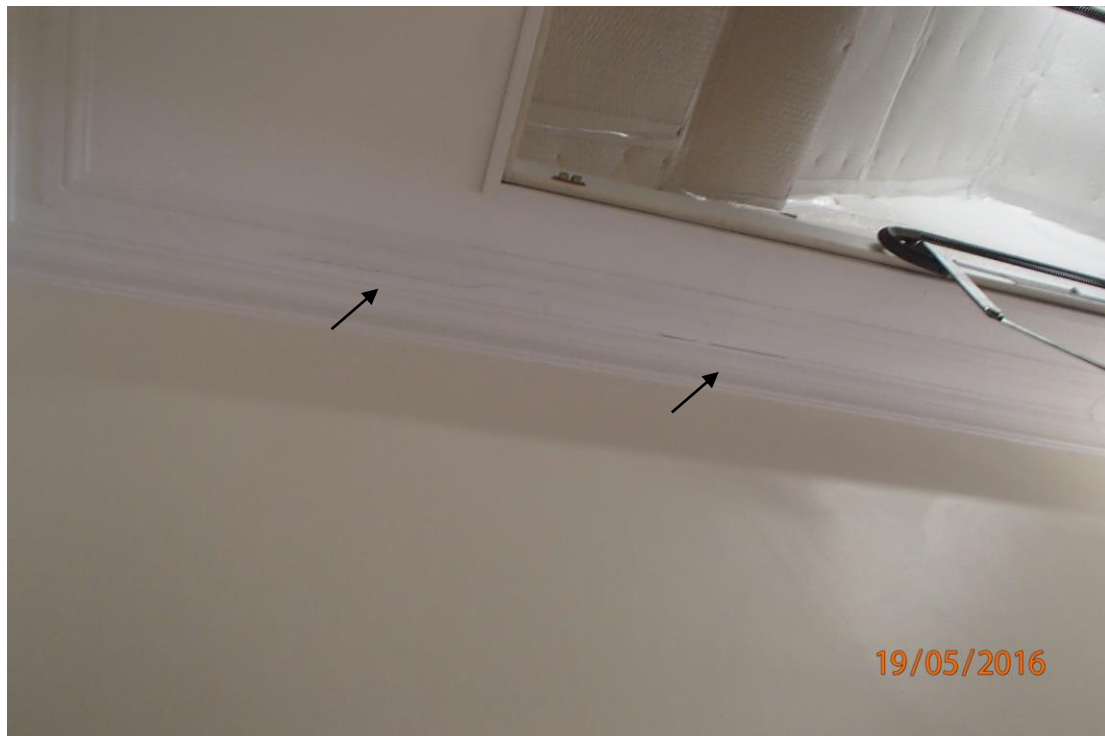
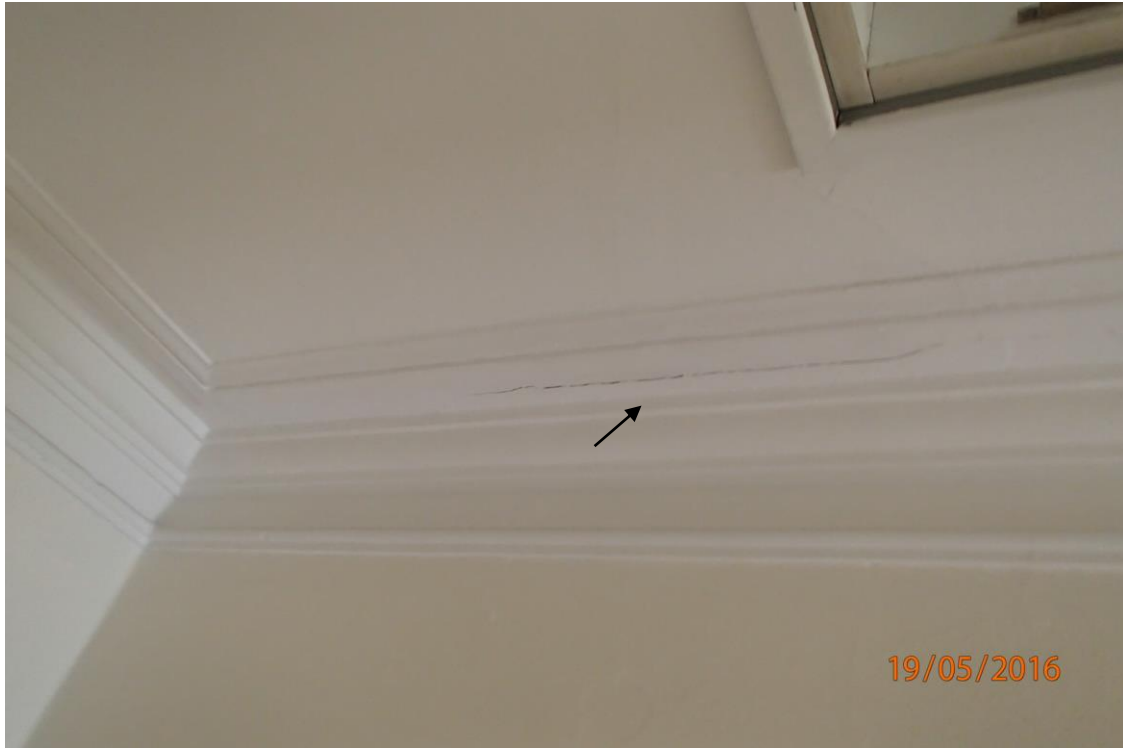
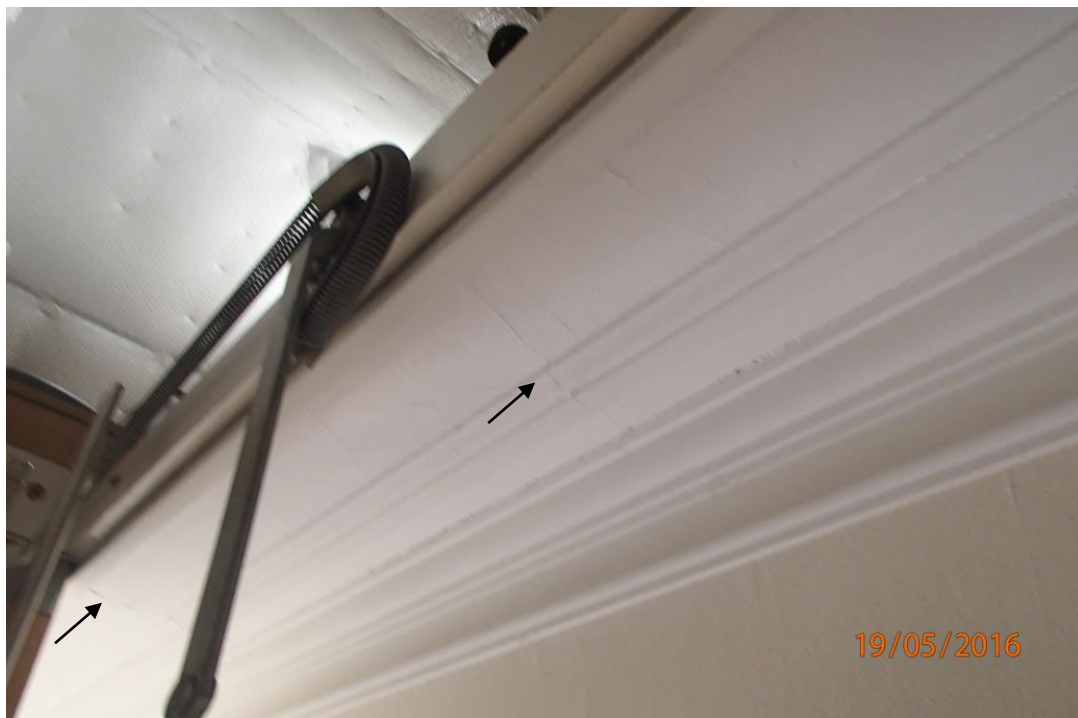
We noted some hairline cracking to the plaster cornice adjacent to the manhole / attic access **[Photographs 24, 25 and 26]**

**Photograph 24** shows hairline cracks to the cornice adjacent to the manhole / attic access in the entry / hallway.

**Photograph 25** shows hairline cracks to the cornice adjacent to the manhole / attic access in the entry / hallway.

**Photograph 26** shows hairline cracks to the cornice adjacent to the manhole / attic access in the entry / hallway.

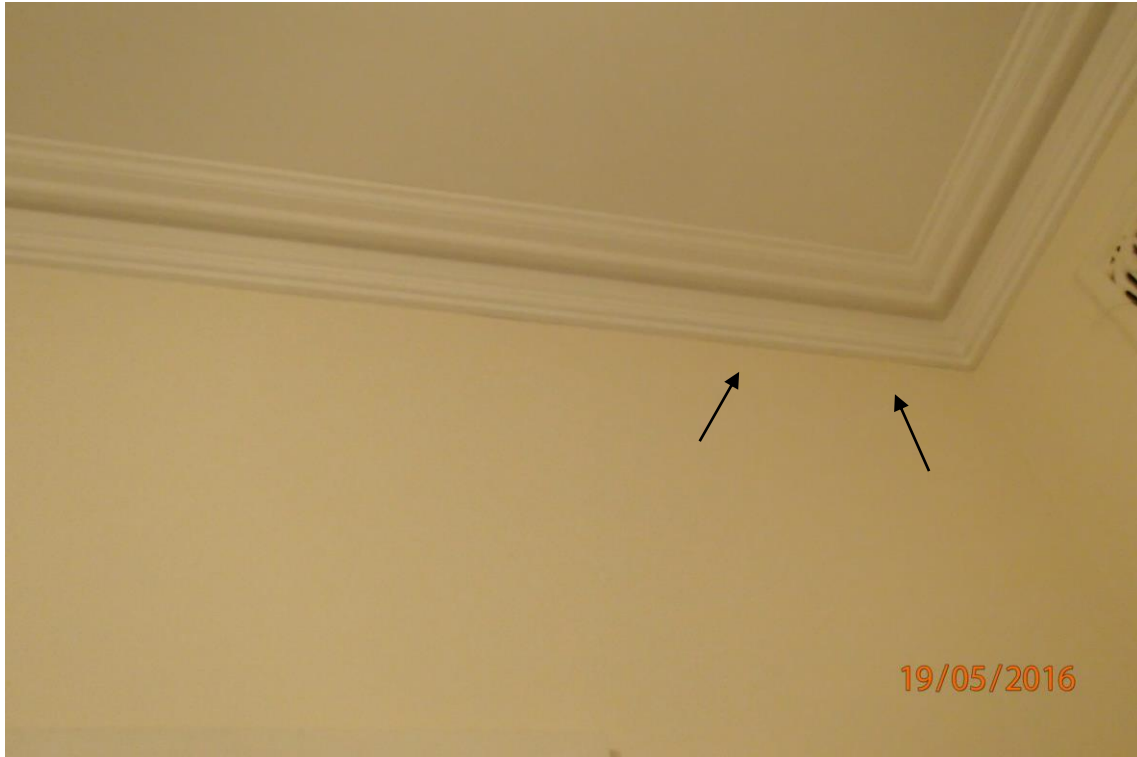
We noted a hairline separation crack [ $<1.0\text{mm}$ ] at the wall cornice junction to the western wall of Bedroom 2. [**Photograph 27**]

**Photograph 27** shows hairline crack at the wall cornice junction to the western wall of Bedroom 2

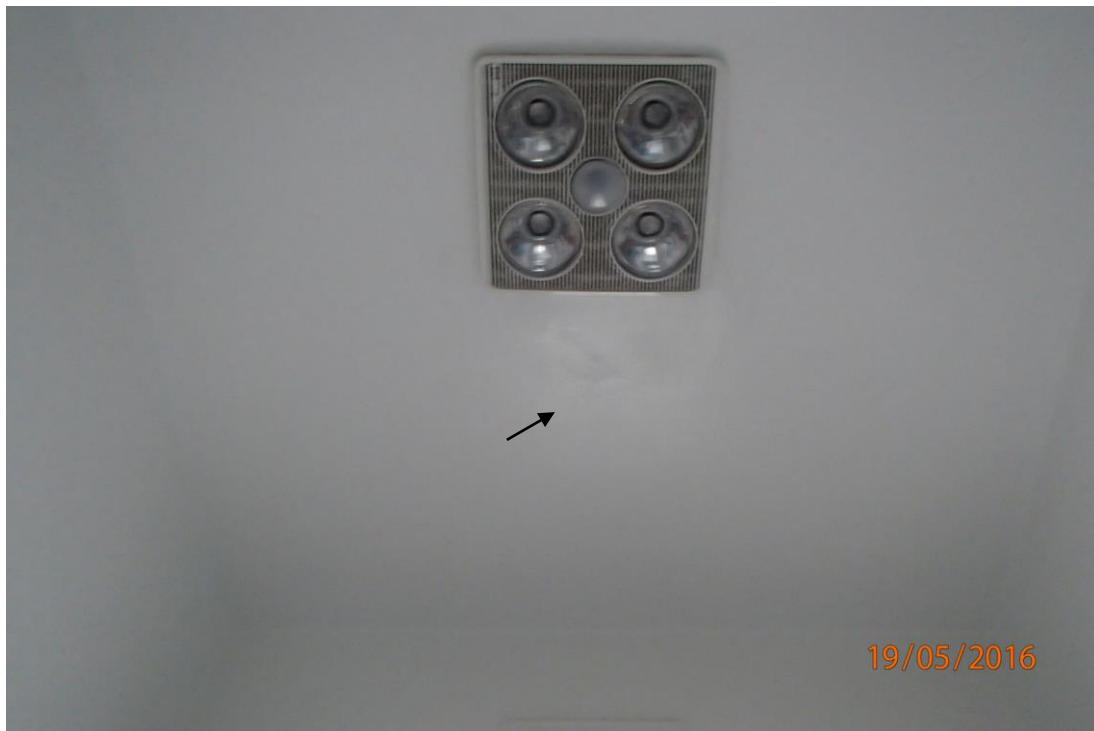
We noted a previous repair to the plaster ceiling adjacent to the combination fan/heater/light. [**Photograph 28**]

**Photograph 28** shows a previous repair to the ceiling adjacent to the combination fan/heater/light.

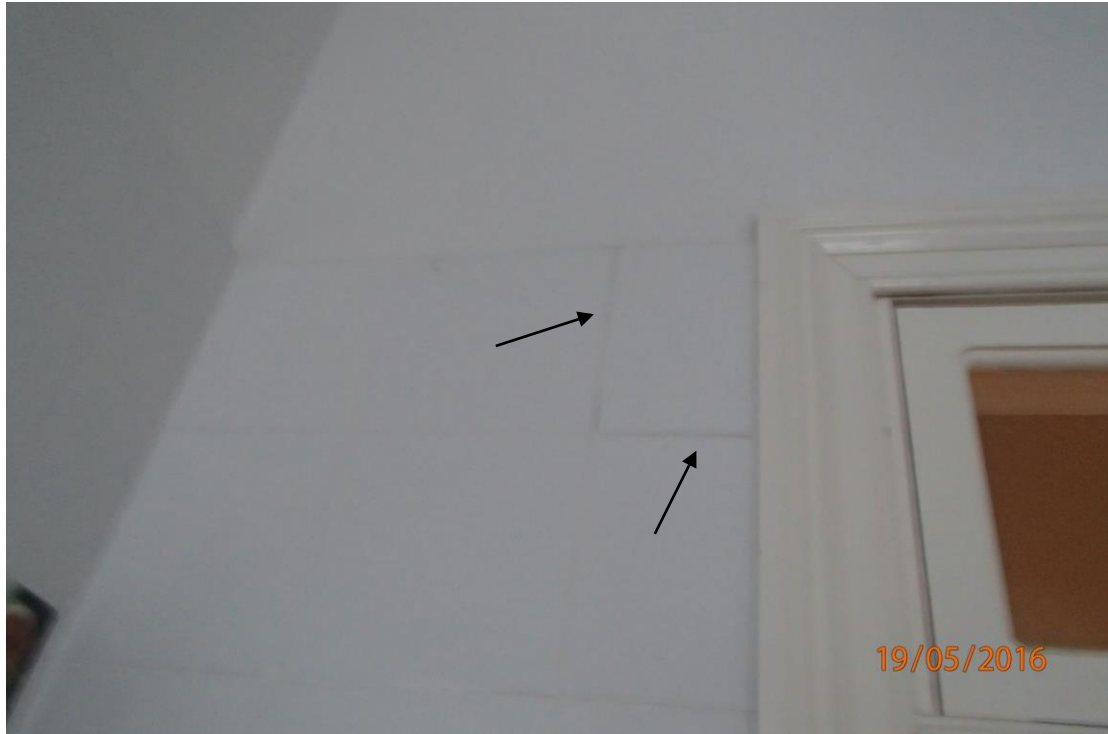
We did observe minor displacement of the tile grout in the Bathroom adjacent to the door jamb. [**Photograph 29**]

**Photograph 29** shows displacement of the tile grout in the Bathroom.

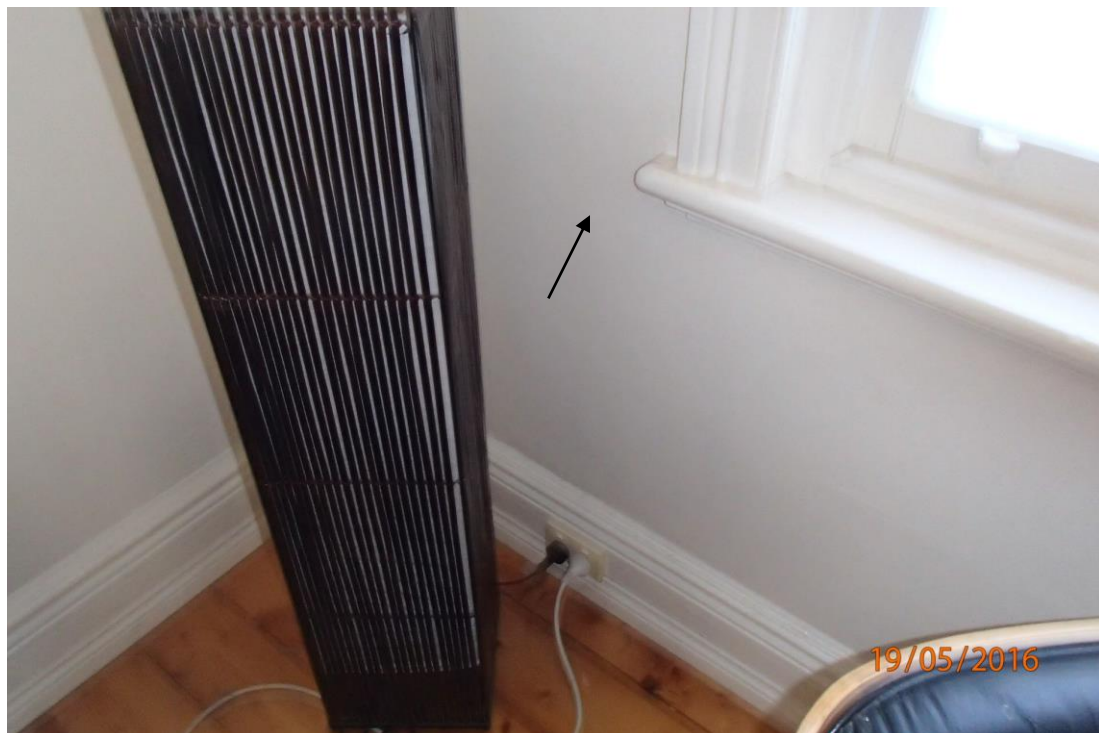
We noted a previous repair to the wall below left of the western window to the western end of the lounge room. [**Photograph 30**]

**Photograph 30** shows previous repair to the wall below left of the western window to the western end of the lounge room.

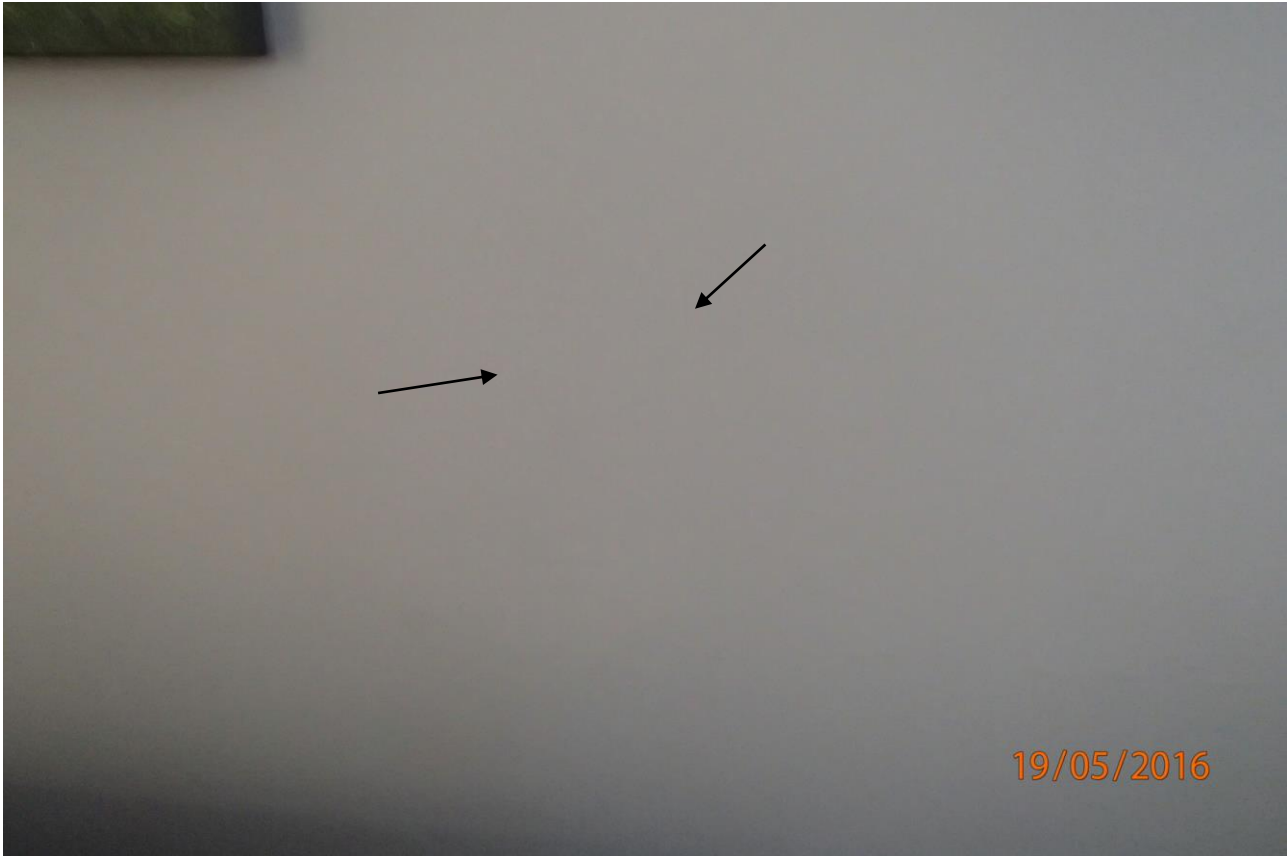
We noted a previous repair to the western wall of the lounge room. [**Photograph 31**]

**Photograph 31** shows a previous repair to the western wall of the lounge room.
