Dilapidation Assessment Report

Job address: 14d Dudley Street, Randwick NSW 2034

Report reference: Site assessment of the *common* south western and south eastern boundaries with the adjoining property: No. 14e Dudley Street, Randwick

Date of assessment: 27th April 2016

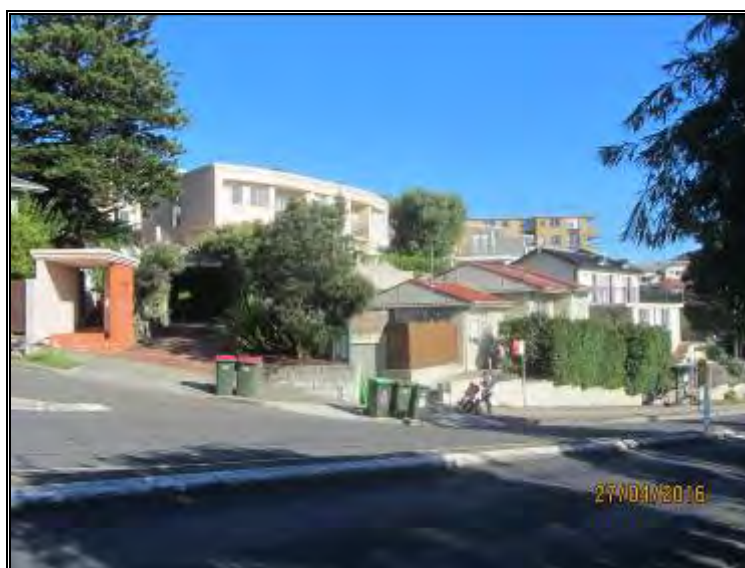
Shows the eastern elevation of this property as viewed from Dudley Street

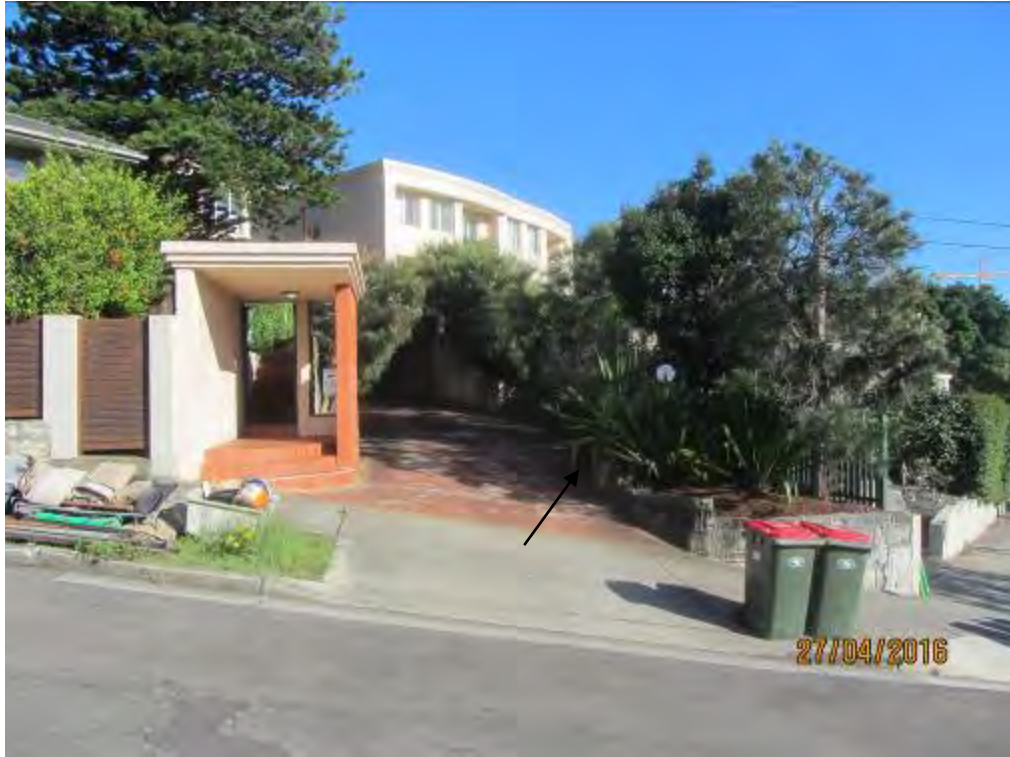
We observed that this *common* boundary is the south eastern boundary of your Client's property; No. 14d Dudley Street and measures in length a nominal 17.0m. **[Photograph 1]**

Photograph 1 shows the south eastern boundary between No. 14d and No. 14e Dudley Street, Randwick

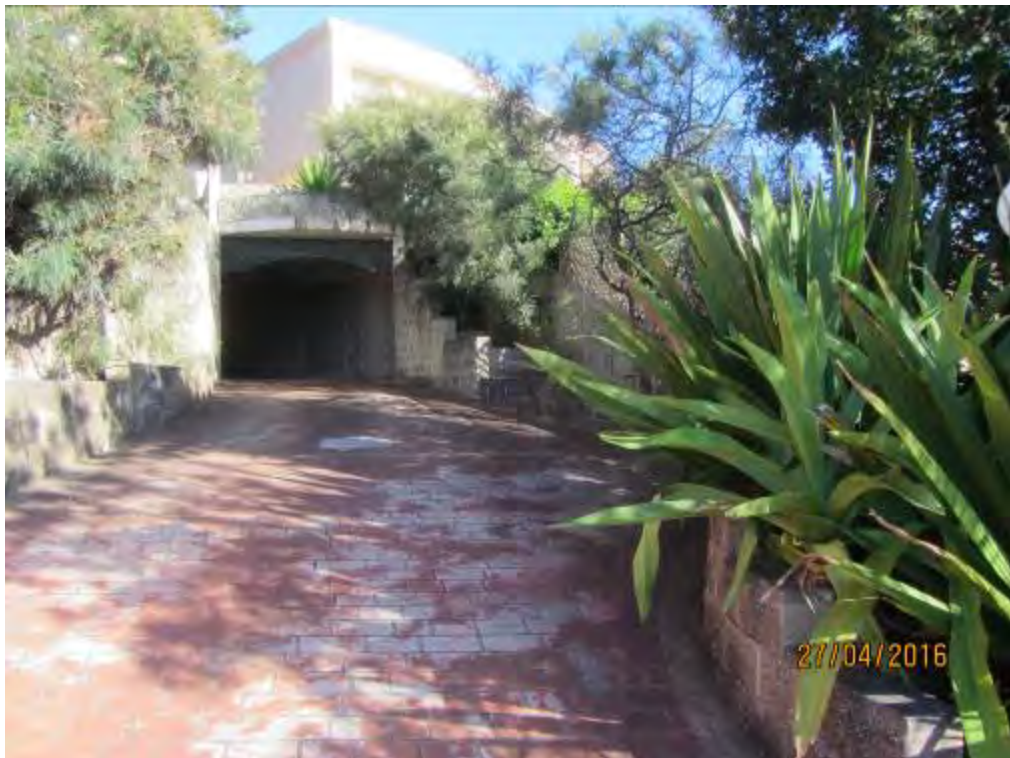
We noted that there is coloured stencil patterned concrete driveway that is located on the south eastern corner of this property, No. 14e Dudley Street that provided access to a Garage for the residential units. We noted that the Garage is excavated into the site a nominal 3.0m and is constructed of concrete blockwork with a concrete roof slab. **[Photograph 2]**

Photograph 2 shows the concrete driveway pavement and entry into the Garage

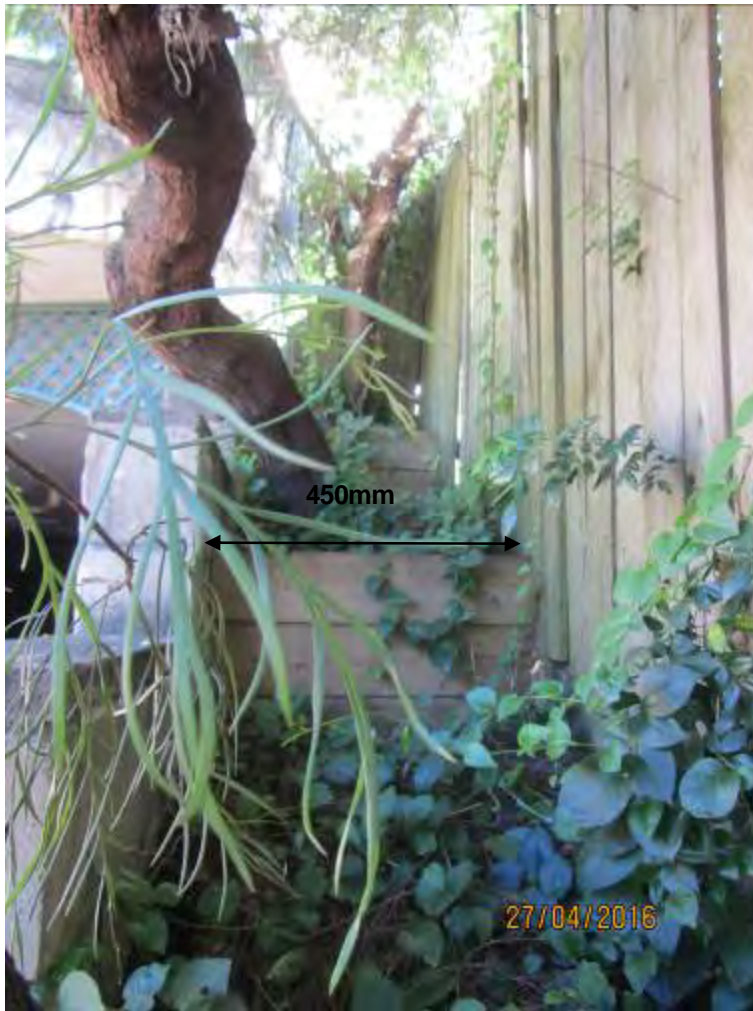
We noted that the concrete block retaining wall is a nominal 450mm from the *common* boundary with No. 14d Dudley Street [your client] and steps down following the slope of the site. **[Photograph 3]**

We noted that the slope of the ground between the retaining wall and the *common* boundary is retained by treated softwood sleepers that form steps to the slope. **[Photograph 3]**

We further noted that there are large shrubs growing between the retaining wall and the *common* boundary fence. **[Photograph 3]**

We noted that there is a nominal 1.8m high timber paling fence extending the full length of the *common* boundary. We noted that the fence is located a nominal 450mm from the concrete block retaining wall. **[Photograph 3]**

We also noted that there are a number of displaced palings to the fence and sagging of the rails. **[Photograph 3]**

Photograph 3 shows the slope of the ground between the retaining wall and the *common boundary* – Note: treated pine sleepers and large shrubs growing into the space

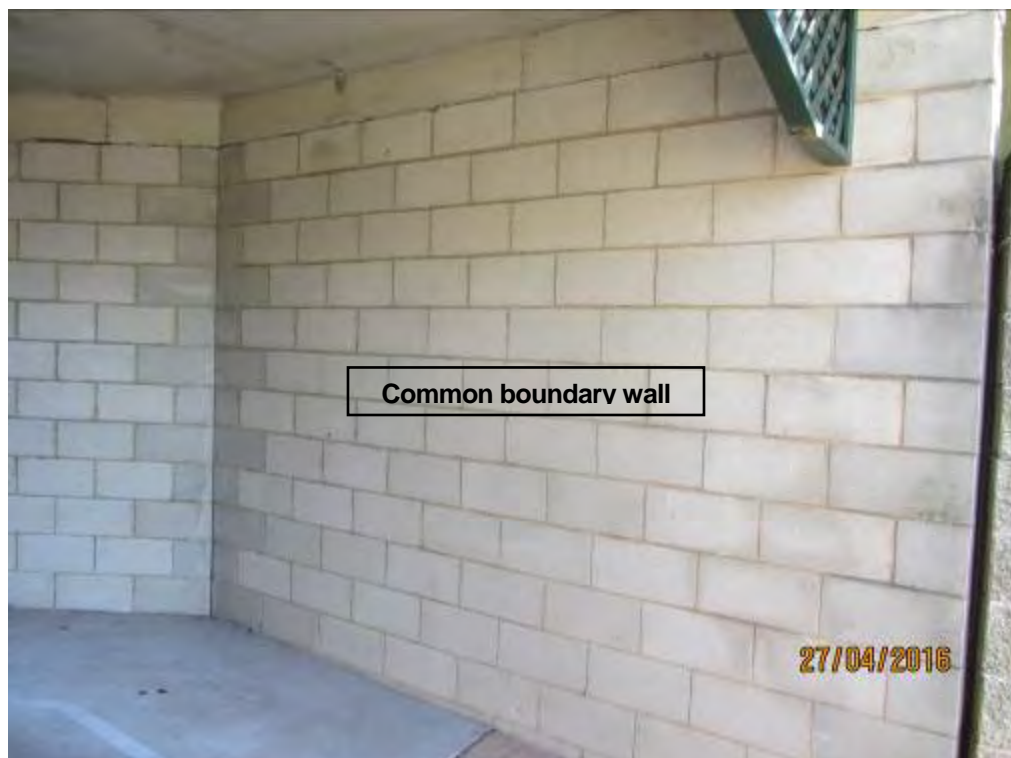
We did not observe and noticeable cracking the blockwork. **[Photographs 4 and 5]**

Photograph 4 shows the condition of the concrete block retaining wall in the Garage abutting the *common boundary* between the properties

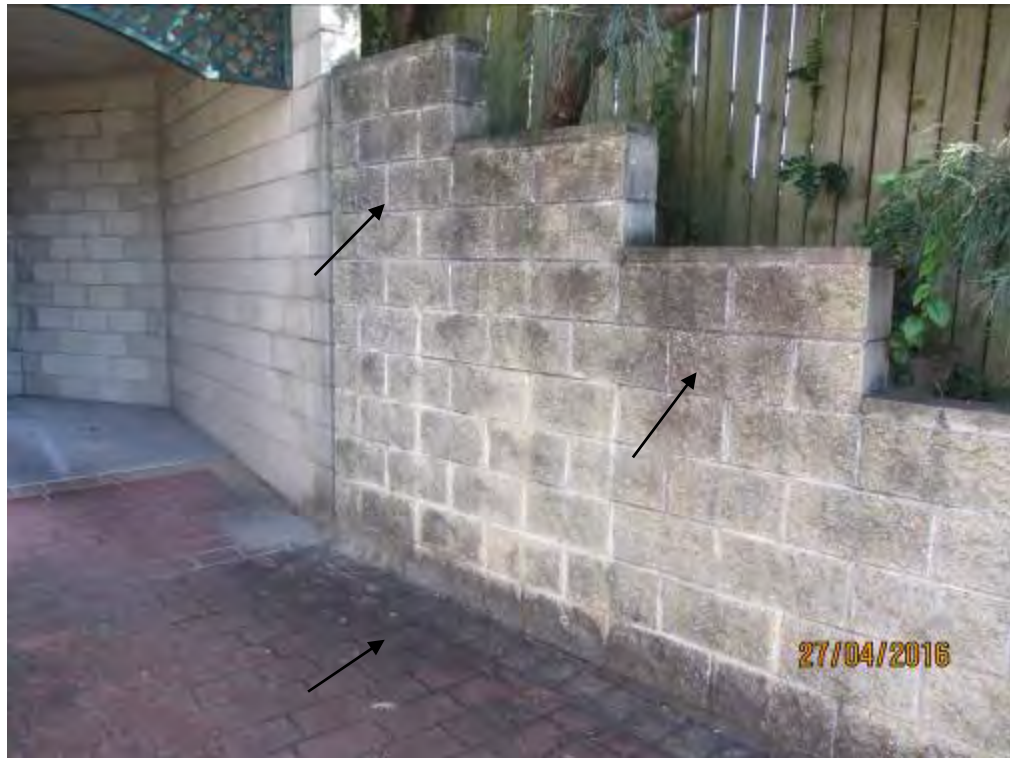
We noted discolouring of the blockwork due to weathering and surface water runoff. **[Photograph 5]**

Photograph 5 shows the condition of the concrete block retaining wall abutting the common southeast boundary between the properties – Note: staining to the face of the concrete blocks and to the driveway pavement

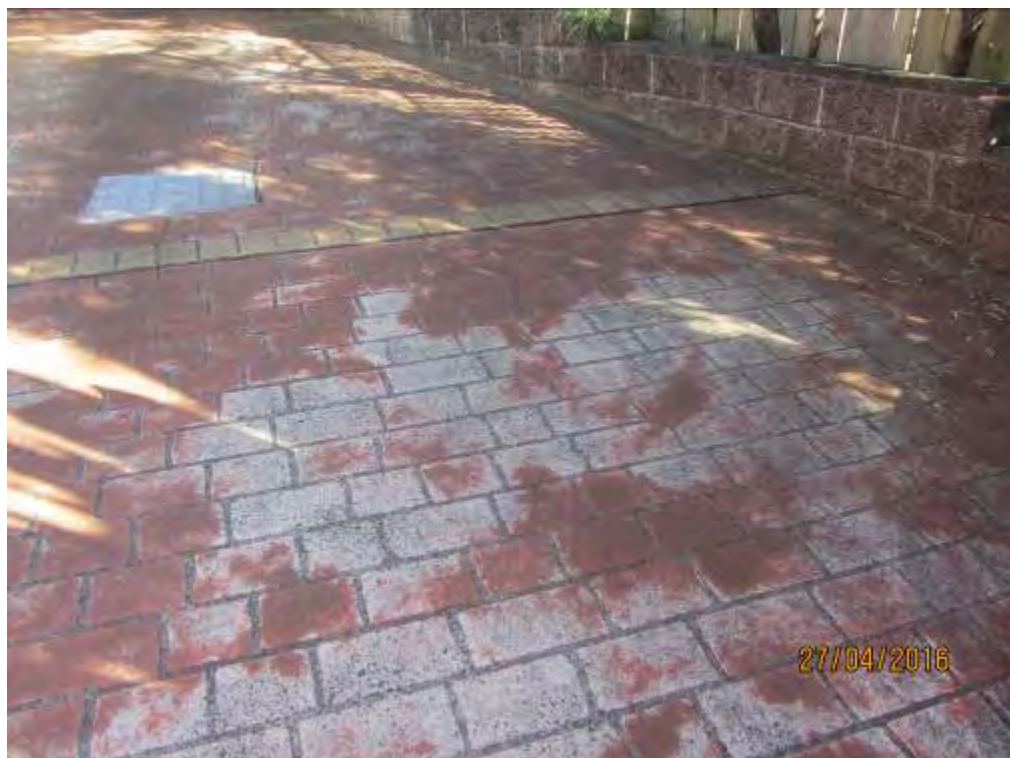
We noted that there is aging and general deterioration [wearing] of the surface coating to the stencil pattern concrete driveway. We also noted staining of the concrete pavement adjacent to the base of the retaining wall. **[Photograph 6]**

Photograph 6 shows the condition of the stencil patterned concrete driveway pavement

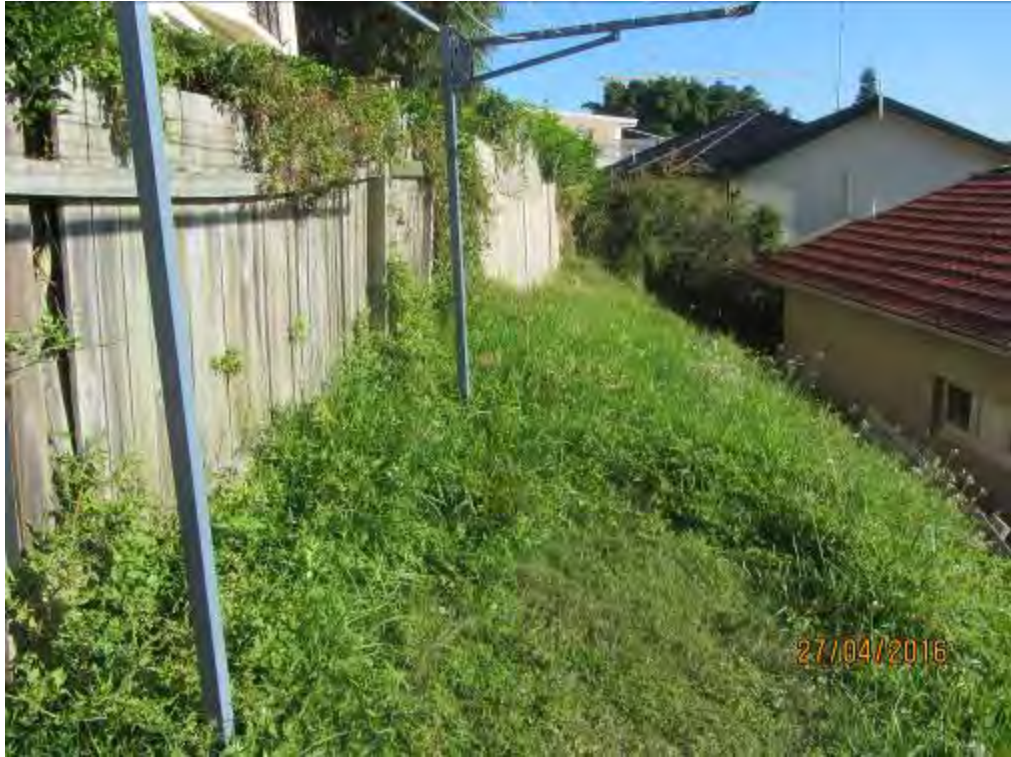
We observed that this *common* boundary is the rear boundary of your Client's property; No. 14d Dudley Street and measures in length a nominal 19.0m. **[Photograph 7]**

We noted that there is a nominal 1.8m high timber paling fence extending the full length of the *common* boundary. We noted that the fence is located a nominal 3.0m from the north eastern wall of this property, No14e Dudley Street. **[Photograph 7]**

Photograph 7 shows the condition of the palling fence to the *common south western boundary* viewed towards the northwest – Note: slope of the site away from the base of the fence

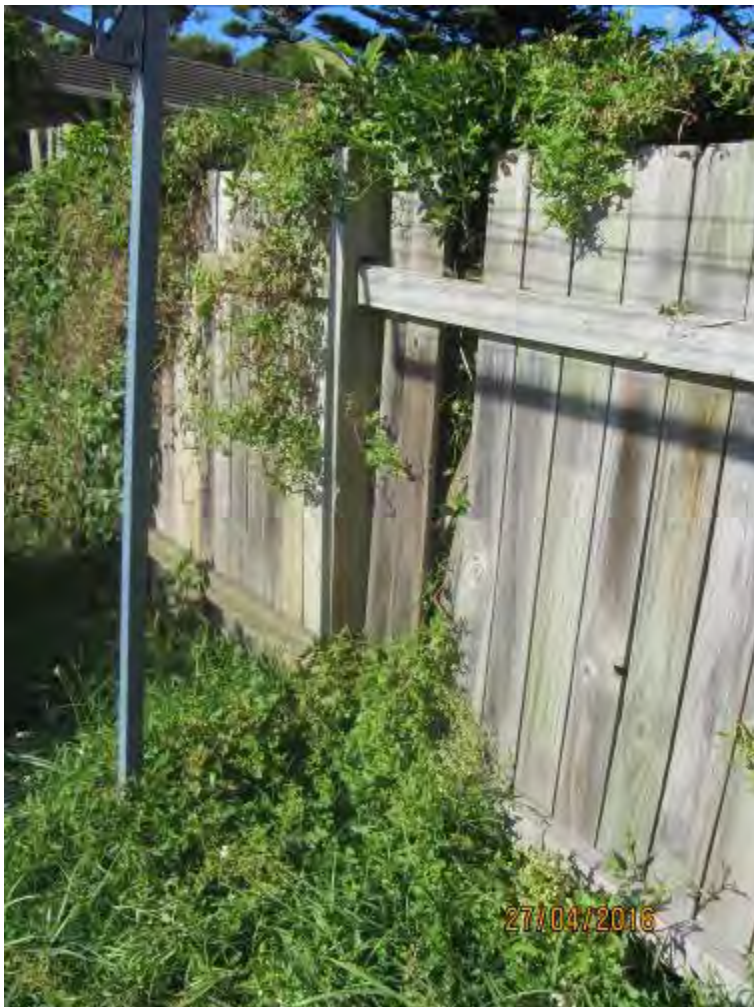
We also noted that there are a number of displaced palings to the south eastern end of the fence and sagging of the rails. **[Photograph 8]**

Photograph 8 shows the condition of the fencing to the south eastern end of the *common boundary fence*

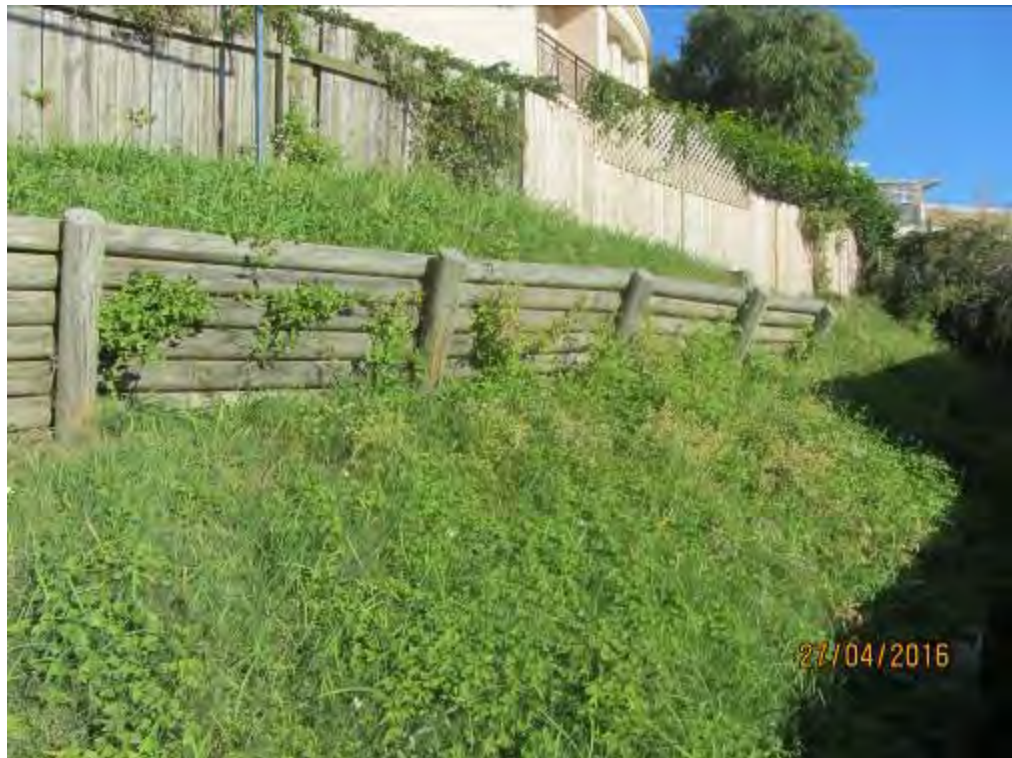
We further noted that the north western end or approximately 50% of the fence appears to be replaced. We also noted that there are two [2] panels of treated pine lattice that increases the height of the fence. **[Photograph 9]**

Photograph 9 shows the extent of the section of replaced palings to the north western end of the *common* boundary fence – Note: Lattice increasing the height of the fence

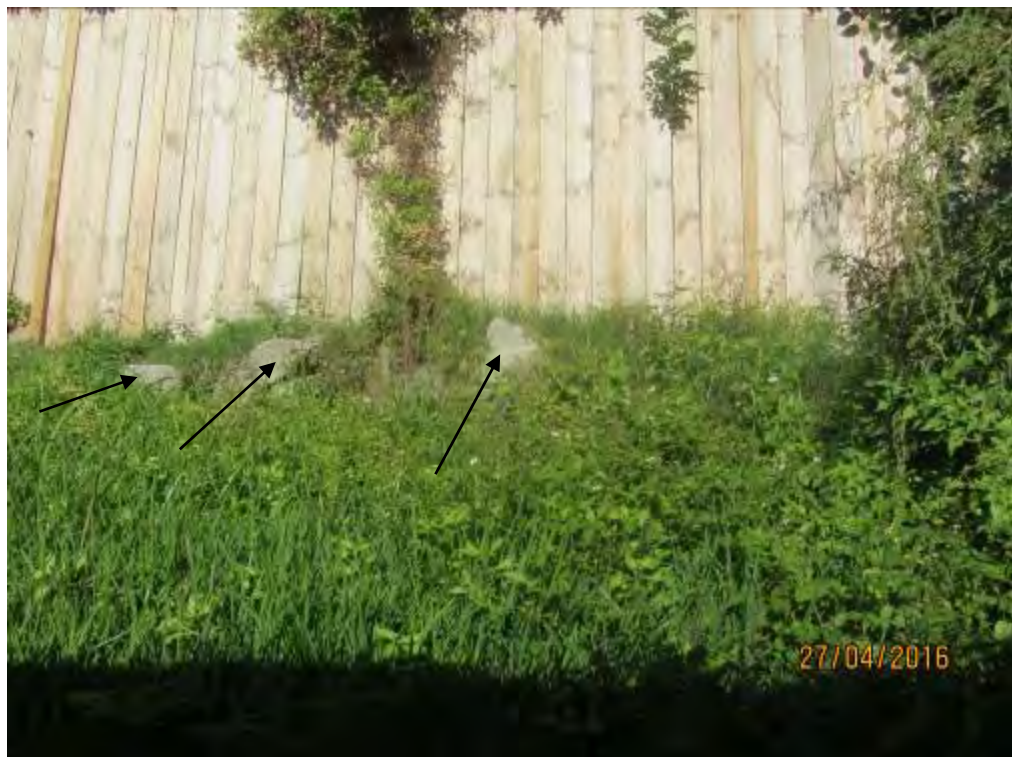
Notwithstanding this, we noted that there are random sized concrete pieces supporting the base of the paling fence towards the north western end of the boundary on your Clients side of the boundary. **[Photograph 10]**

Photograph 10 shows concrete pieces supporting the base of the garden bed towards the northwest end of the *common* boundary

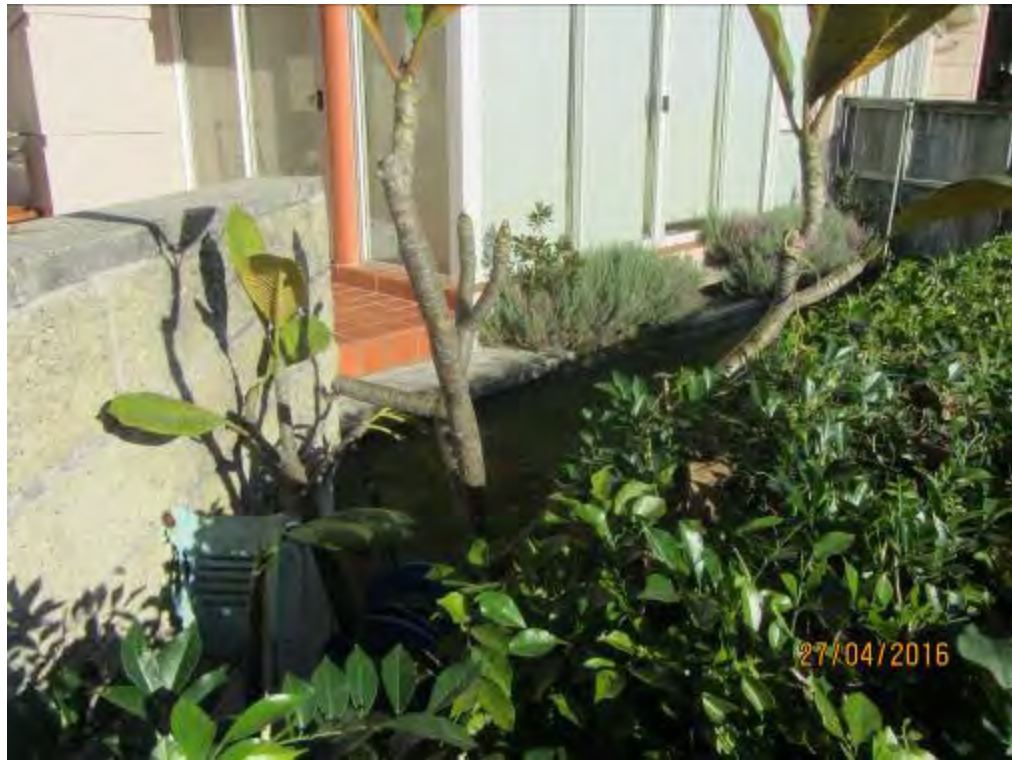
We noted that the area between the garden bed and the wall of the unit is a grassed lawn area. We further noted that the eastern corner of the property is a quarry tiled balcony area located over the concrete slab to the Garage. **[Photographs 11, 12 and 13]**

Photograph 11 shows the lawned area between the garden bed and wall of the south eastern unit

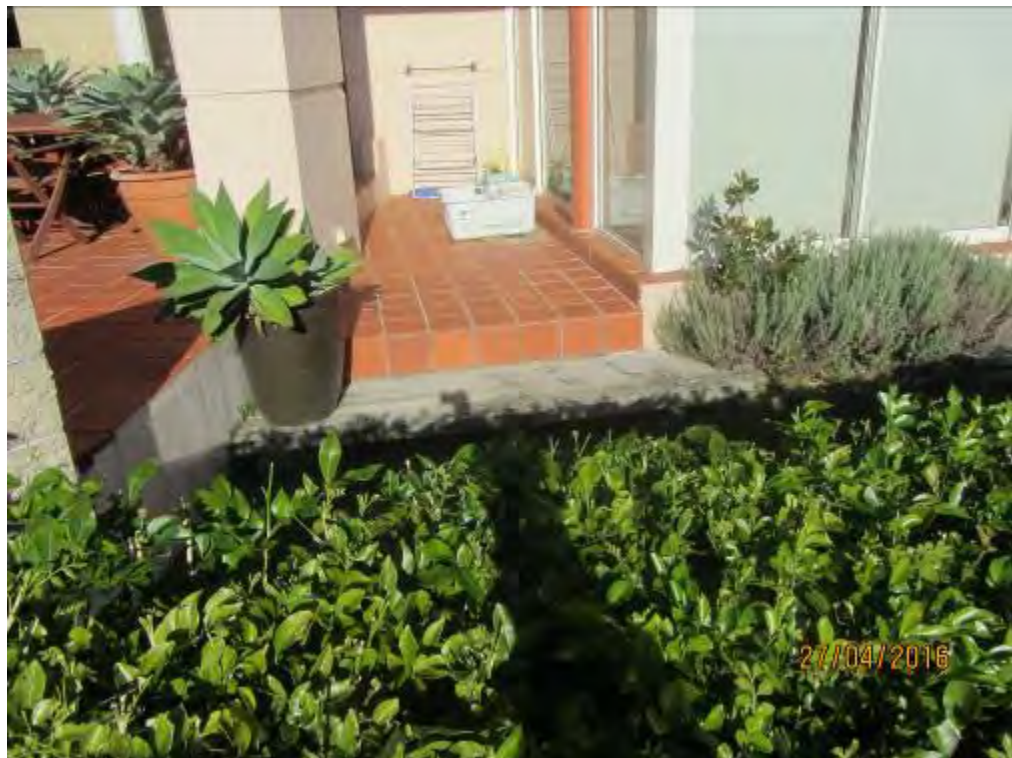
We did not observe any recent cracking to the quarry tiles. We noted that the grout to the tiles is generally complete and noted that there is a drainage point provided in the tiles. Due to concealment by the tiles we are unable to comment on the system of waterproofing or the condition of any waterproofing that may be under the tiles. **[Photographs 12, 13 and 14]**

Photograph 12 shows the lawned area and garden bed shrubbery abutting the *common* south western boundary

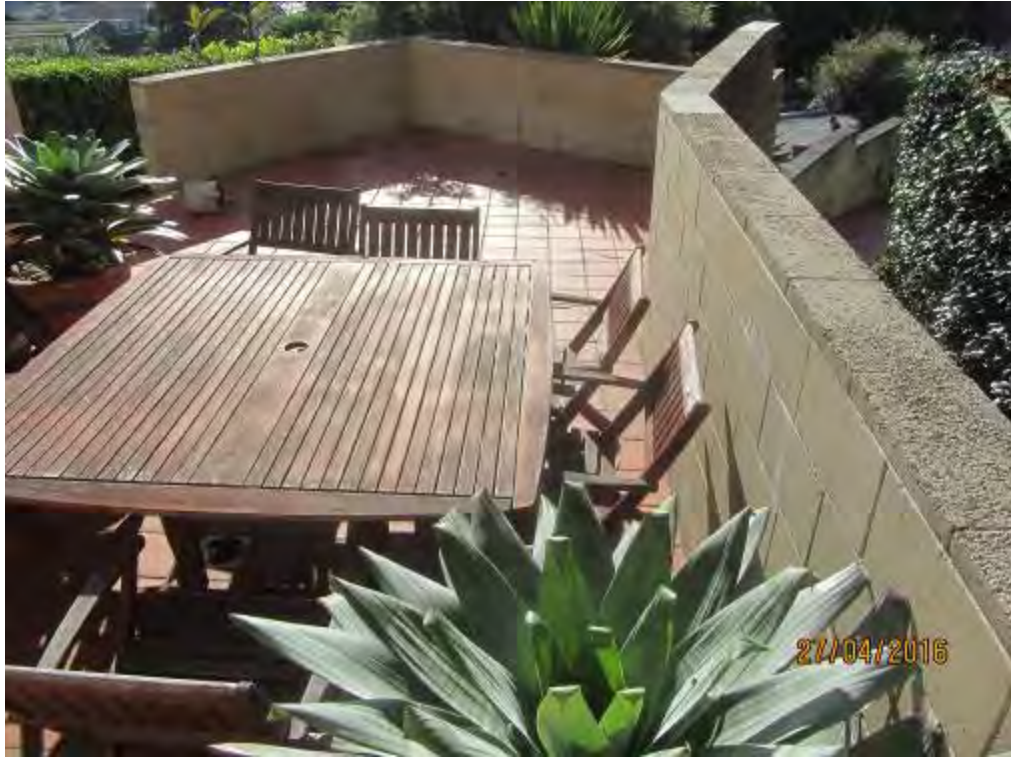
Photograph 13 shows the quarry tiled balcony deck over the Garage roof area

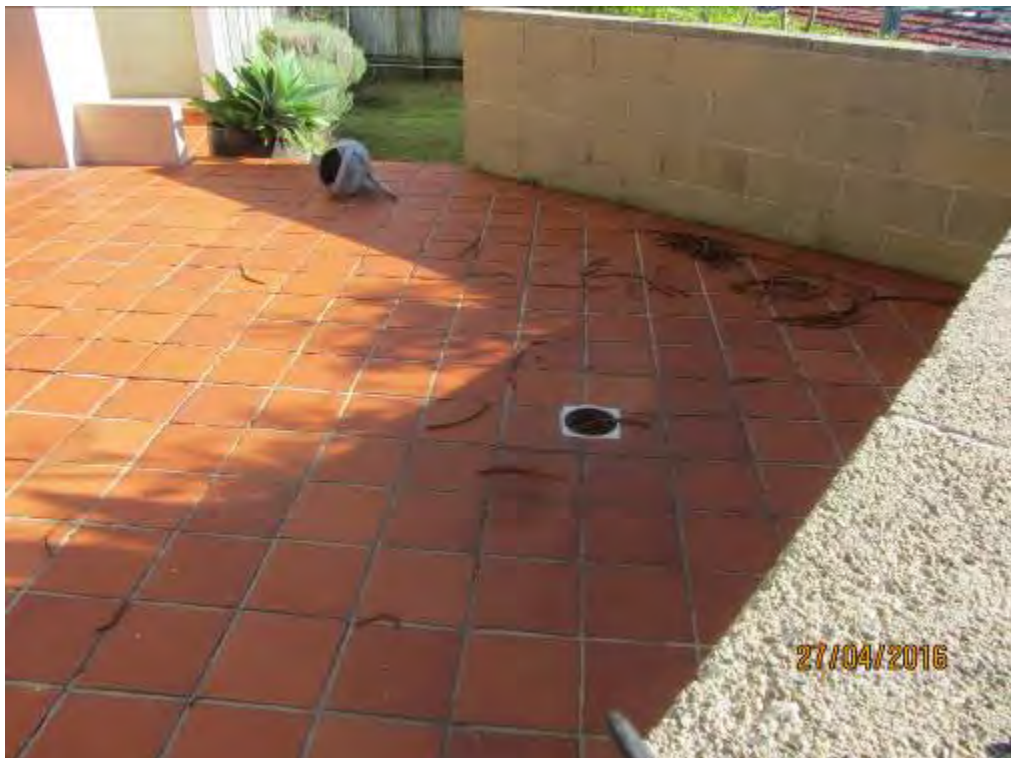
Photograph 14 shows the condition of the quarry tiles to the deck to the south eastern unit – Note: deck is the concrete slab roof to the Garage

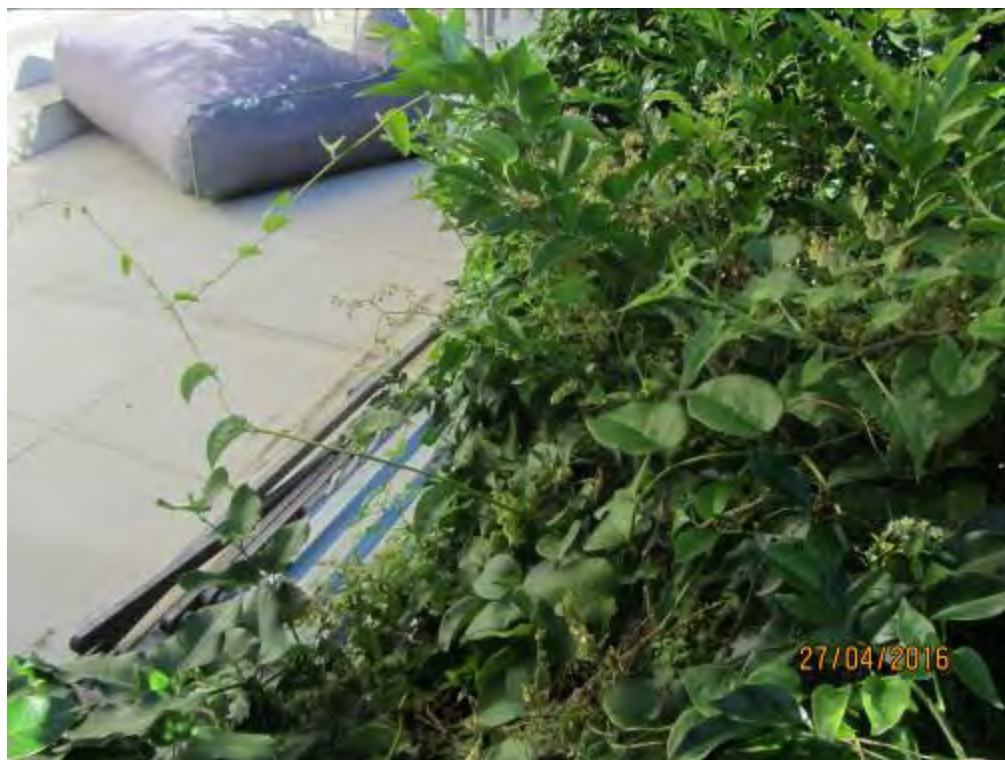
We noted that the area between the garden bed and the wall of the unit is tiled. We are unable to provide comment as to the depth or condition of the substrate to the tiles. We did not observe any recent cracking to the tiles and noted that the grout to the tiles is generally complete. **[Photograph 15]**

Photograph 15 shows the tiled area between the wall and the garden bed to the north western unit
