HAZARDOUS MATERIALS ASSESSMENT REPORT

Client: Cape Cod Australia Pty. Limited

Job details: Owner: Mr. C. Leeds
Location: 81 Young Street, Cremorne NSW

Our reference: HM03190714

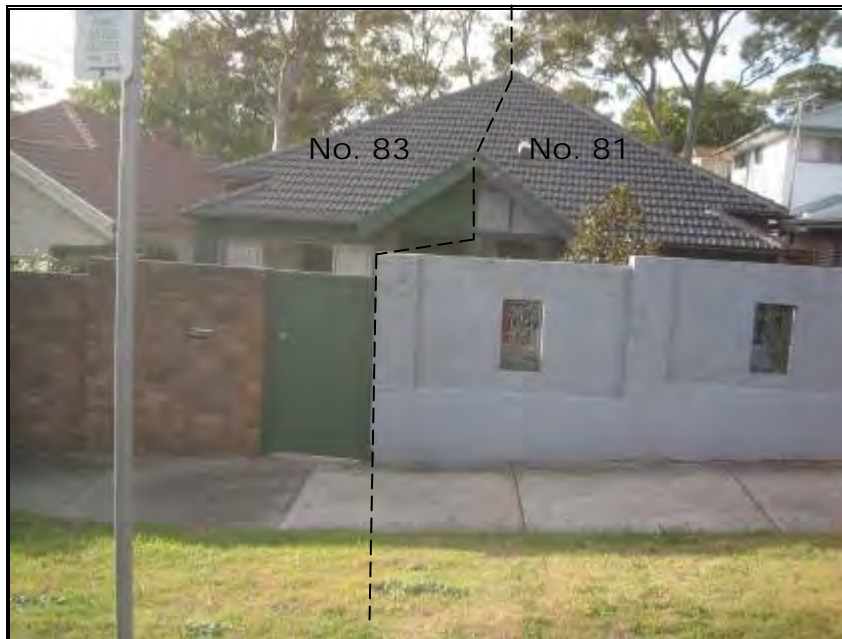
Front western elevation of the adjoining properties:
No. 81 and No. 83 Young Street, Cremorne
