HAZARDOUS MATERIALS ASSESSMENT REPORT

Job details: Owner/s: Mr. R. & Mrs. C. Ritchie
Location: 94 Condamine Street, Balgowlah

Our reference: HM02950414

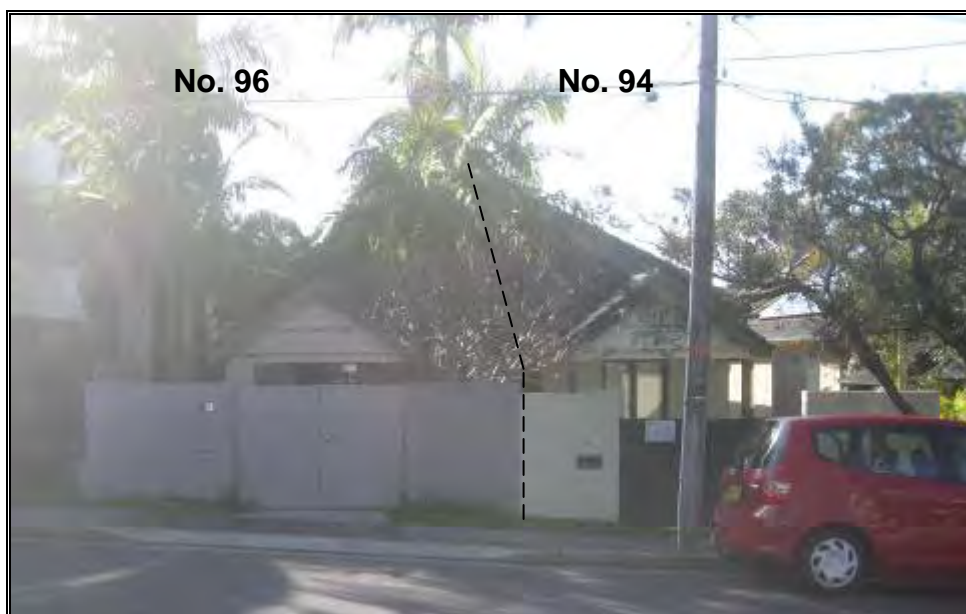
Front western elevation of the adjoining properties:
No.94 and No. 96 Condamine Street, Balgowlah
