## **HAZARDOUS MATERIALS ASSESSMENT REPORT**

**Job details:** Owner/s: Mr. K. Little & Ms. L. McCarron  
Location: 17 Talbot Street, Riverwood NSW

**Date of assessment:** 27<sup>th</sup> November 2014

**Our reference:** HM03551114

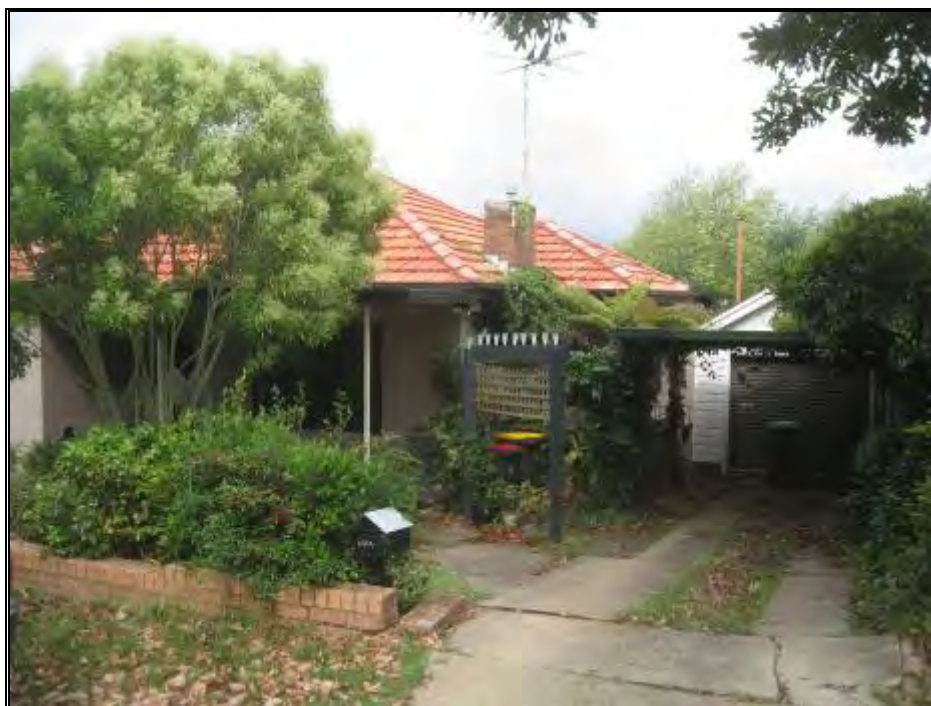
Front eastern elevation of the residence
