HAZARDOUS MATERIALS ASSESSMENT REPORT

Client: Cape Cod Australia Pty. Limited

Job details: Owner/s: Mr. R. Fleischer & Ms. L. Bristowe
Location: 76 Carrington Road, Randwick NSW

Our reference: HM04700316

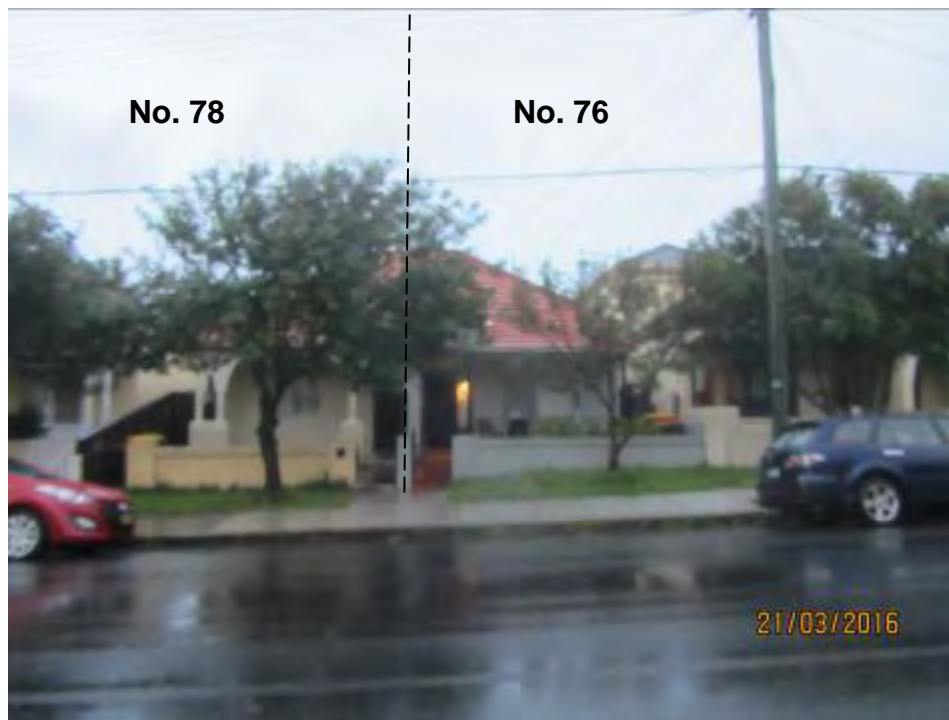
Front eastern elevation of the adjoining properties:
No. 76 & No. 78 Carrington Road, Randwick
