HAZARDOUS MATERIALS ASSESSMENT REPORT

Job details: Owner/s: Mr. S. & Mrs. T. Dowe
Location: 5 Bel-Hilton Parade, West Gosford

Date of assessment: 17th April 2015

Our reference: HM03880415

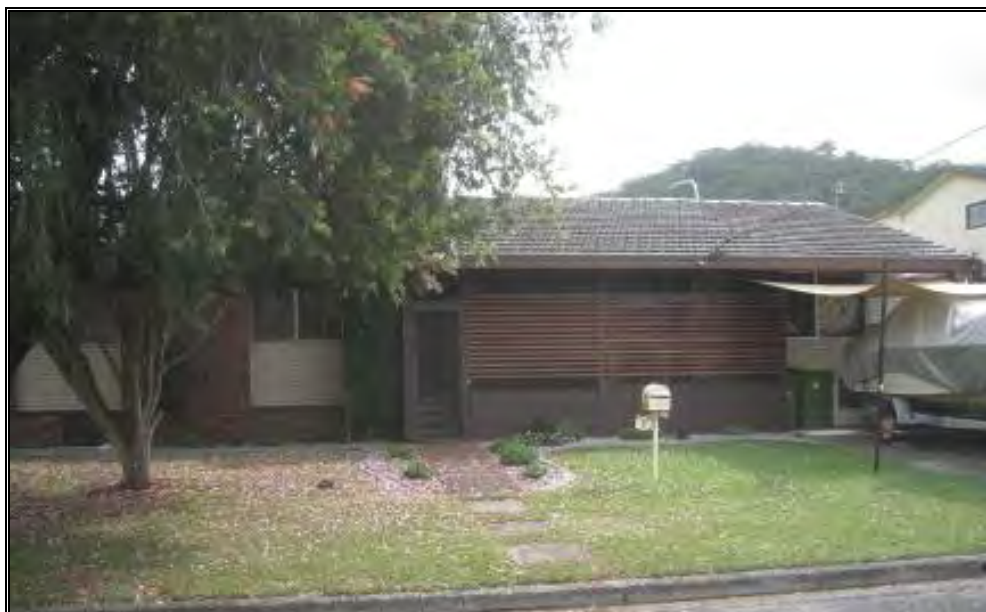
Front eastern elevation of the residence
