## Dilapidation Assessment Report

Prepared for: Cape Cod Australia Pty. Limited  
Job address: 26 Parraween Street, Cremorne.  
Property Owner/s: Mrs Rachel Cable.  
Report reference: **NORTH SYDNEY COUNCIL**  
Development Application No: not available  
Date of assessment: 13<sup>th</sup> August 2016

**Re: Dilapidation Report**

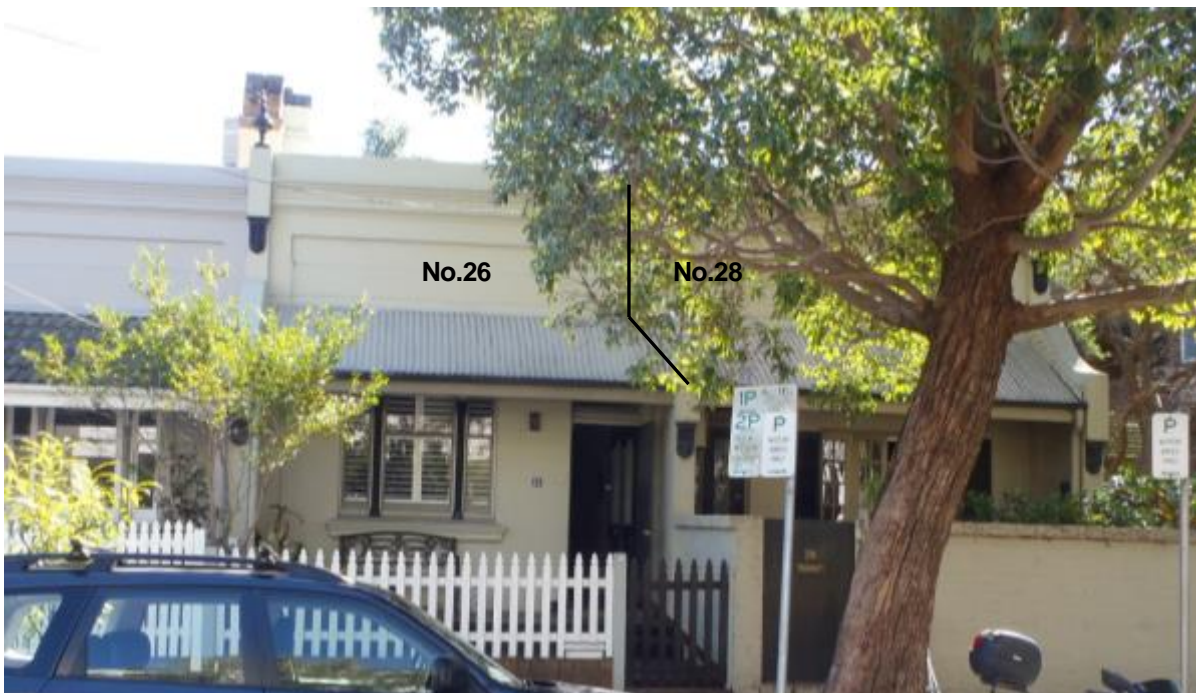
Shows the front south eastern elevation of the adjoining properties:  
No. 26 and No. 28 Parraween Street, Cremorne.

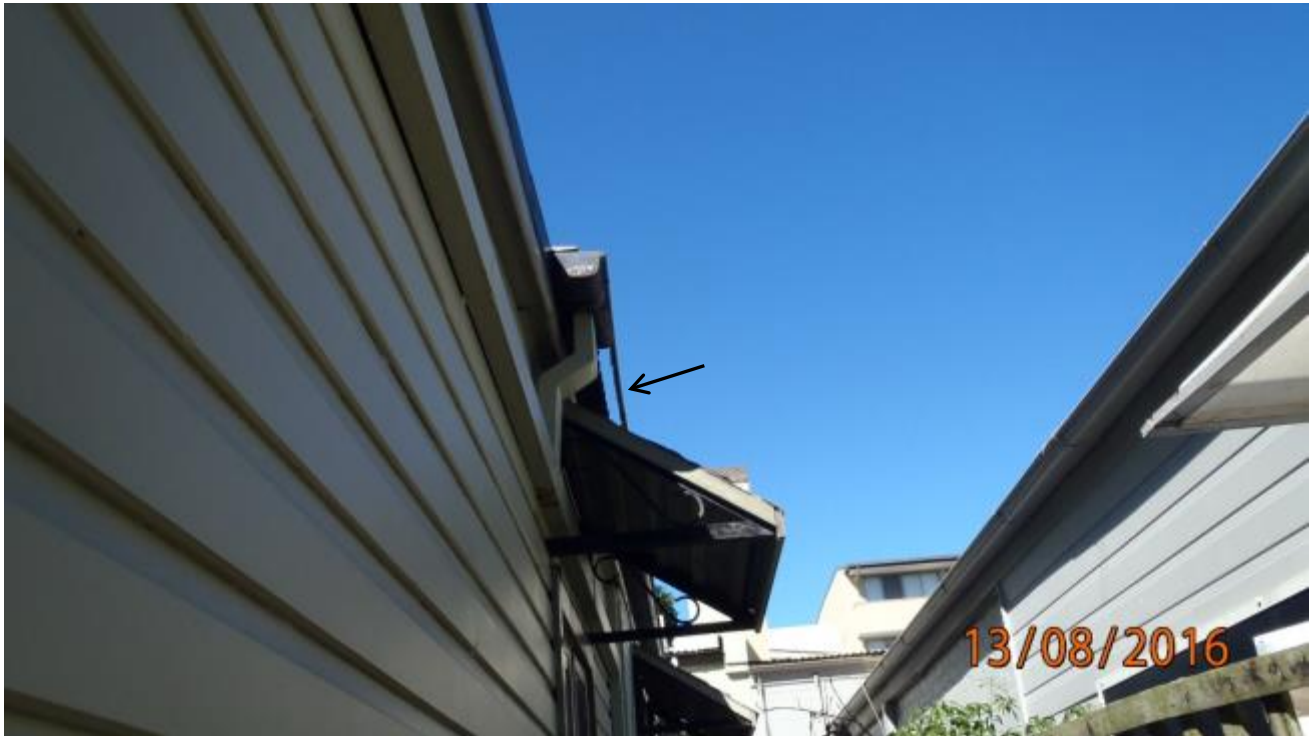
We noted that the pre-finished metal guttering and downpipes to the south western elevation were deteriorated and rusted **[Photographs 1 and 2]**

**Photograph 1** shows rusted out guttering to the south western elevation.

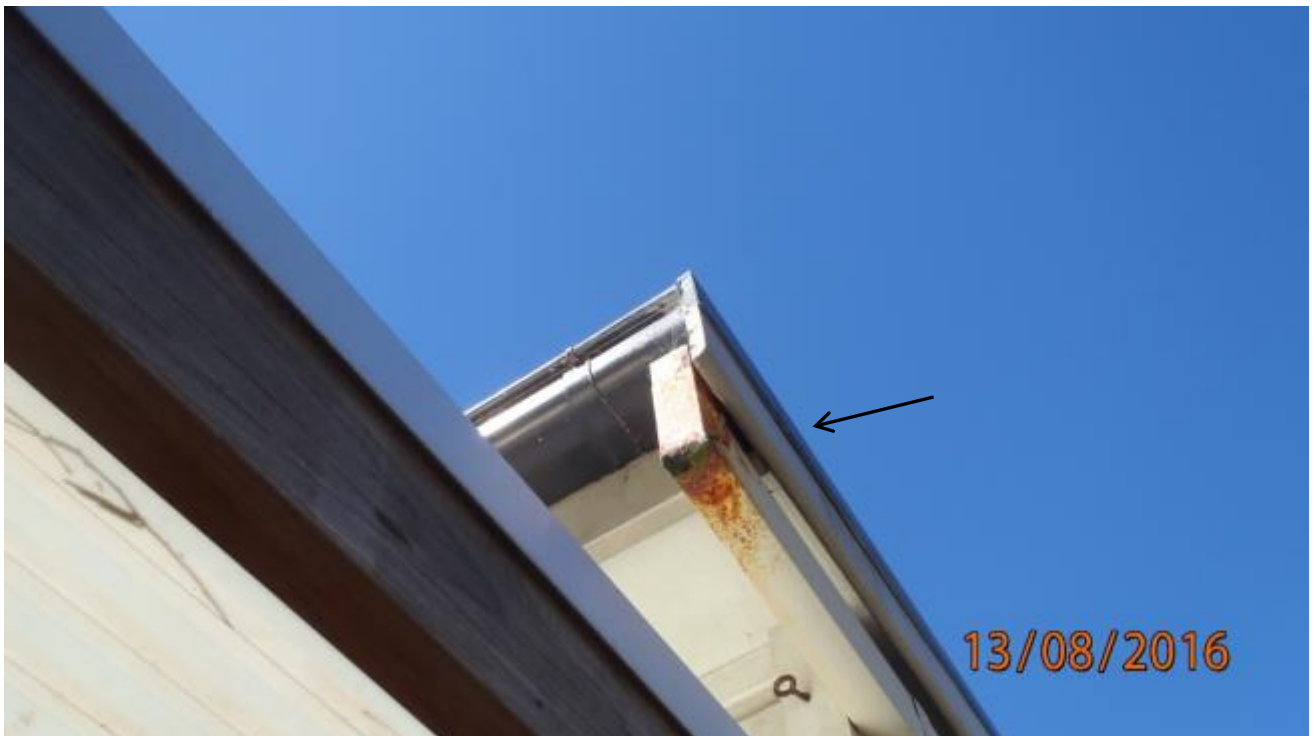
**Photograph 2** shows a rusted downpipe to the south western elevation.

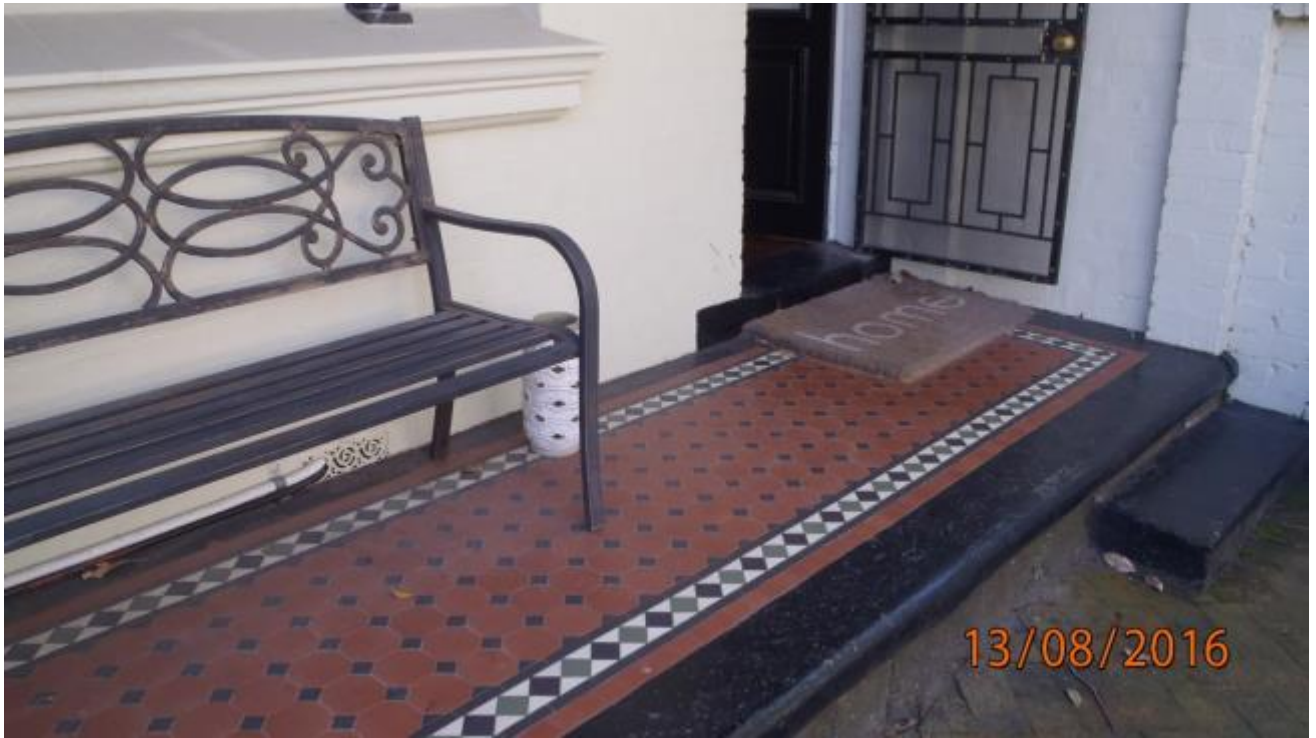
We noted that the front porch is a tiled suspended concrete slab construction **[Photograph 3]** and that the front courtyard is paved. **[Photograph 4]**

**Photograph 3** shows the general condition of the tiled front porch

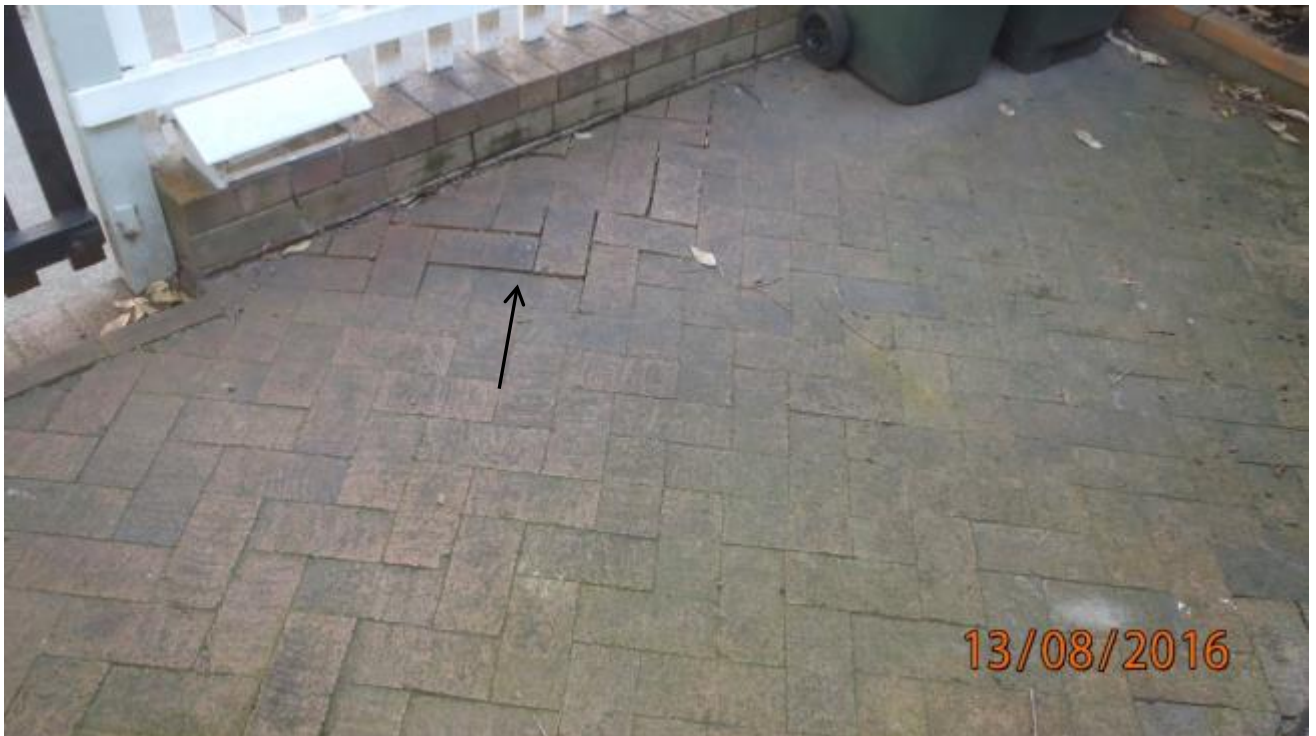
**Photograph 4** shows the general condition of the front courtyard paving. Note some displacement.

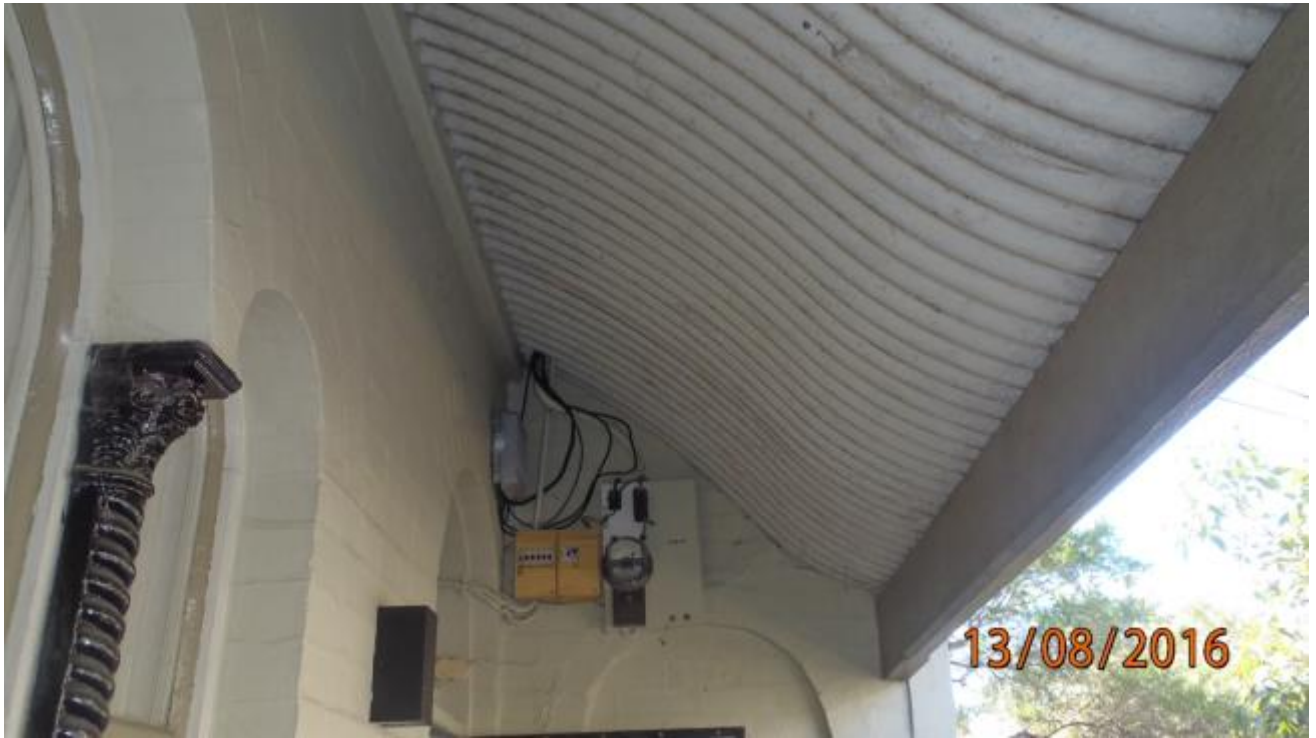
We noted that the front porch is covered with corrugated profile sheet metal roofing **[Photograph 5]**

**Photograph 5** shows the condition of the front porch roof section.

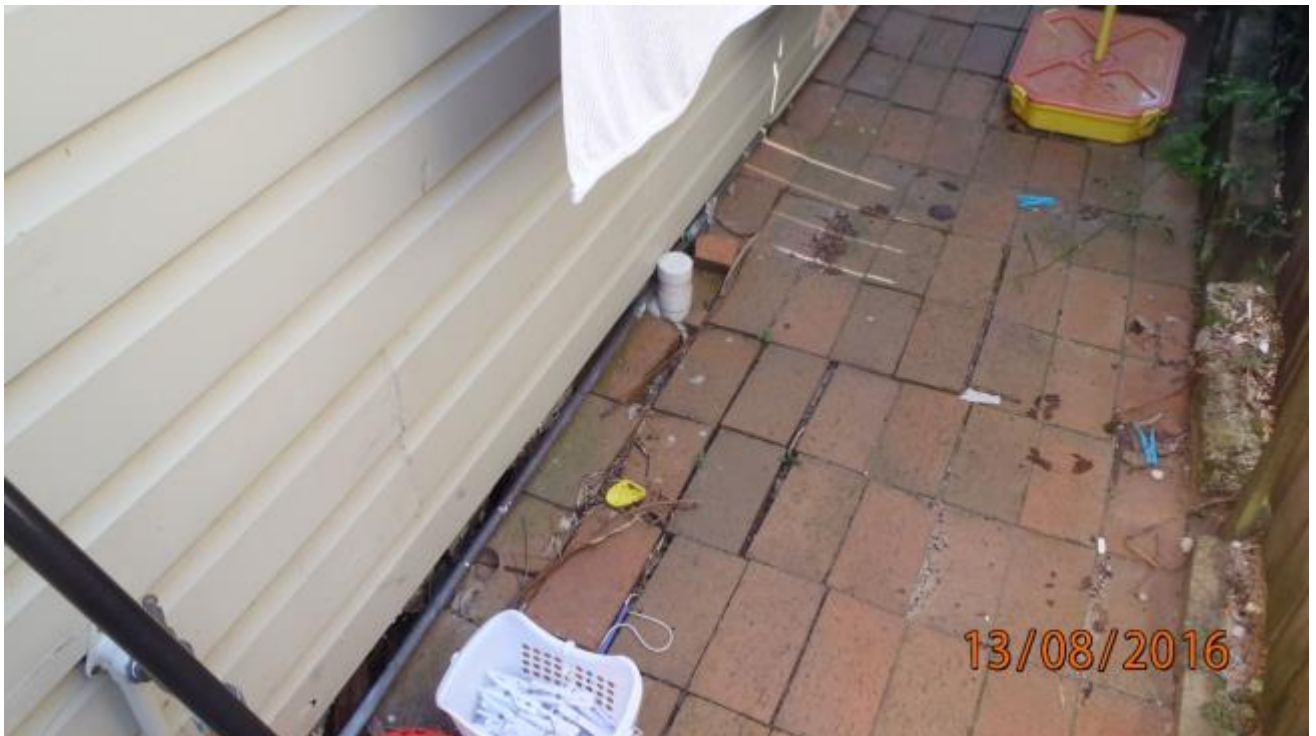
We noted displaced pavers to the path at the side elevation **[Photograph 6]**

**Photograph 6** shows displaced pavers to the side pathway.

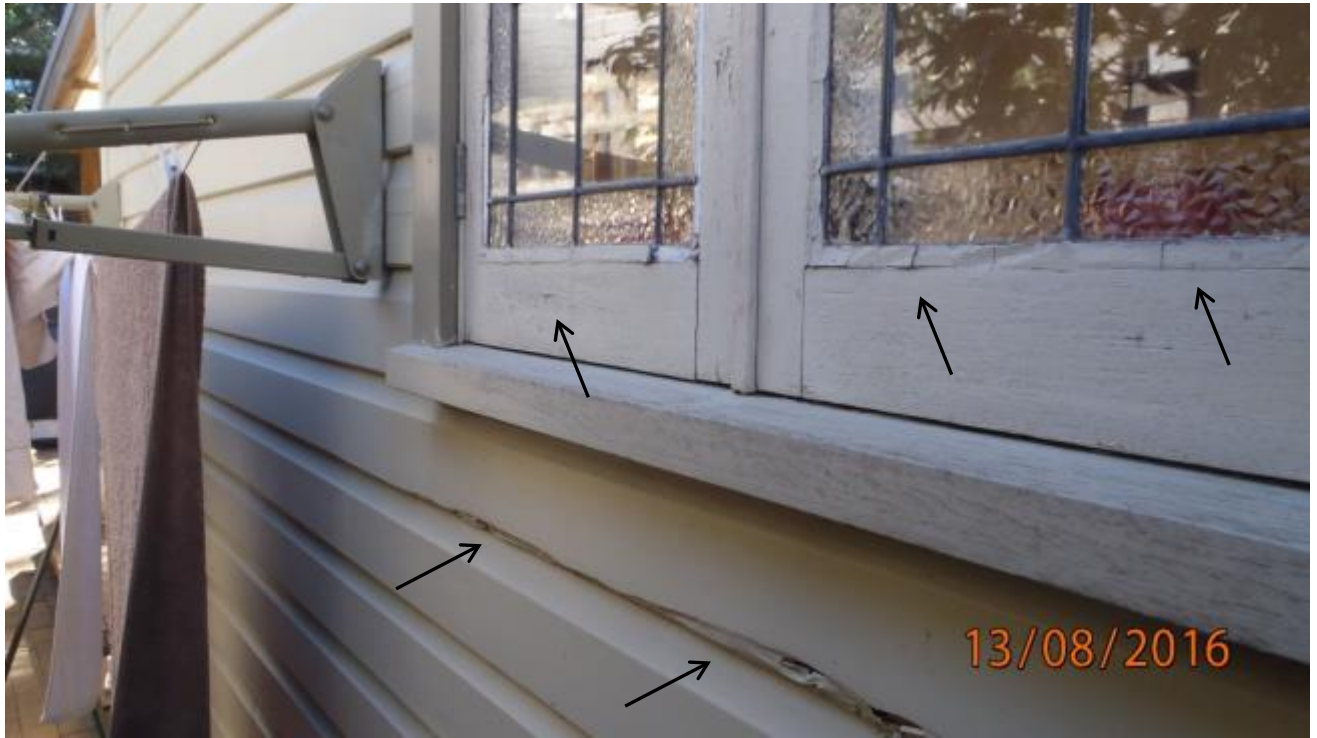
We noted damage to the timber weatherboard cladding under the kitchen window. We also noted deterioration to the surface coating to the window and window sill **[Photograph 7]**

**Photograph 7** shows damage to the timber weatherboards and general deterioration of the surface coating on the Kitchen window.

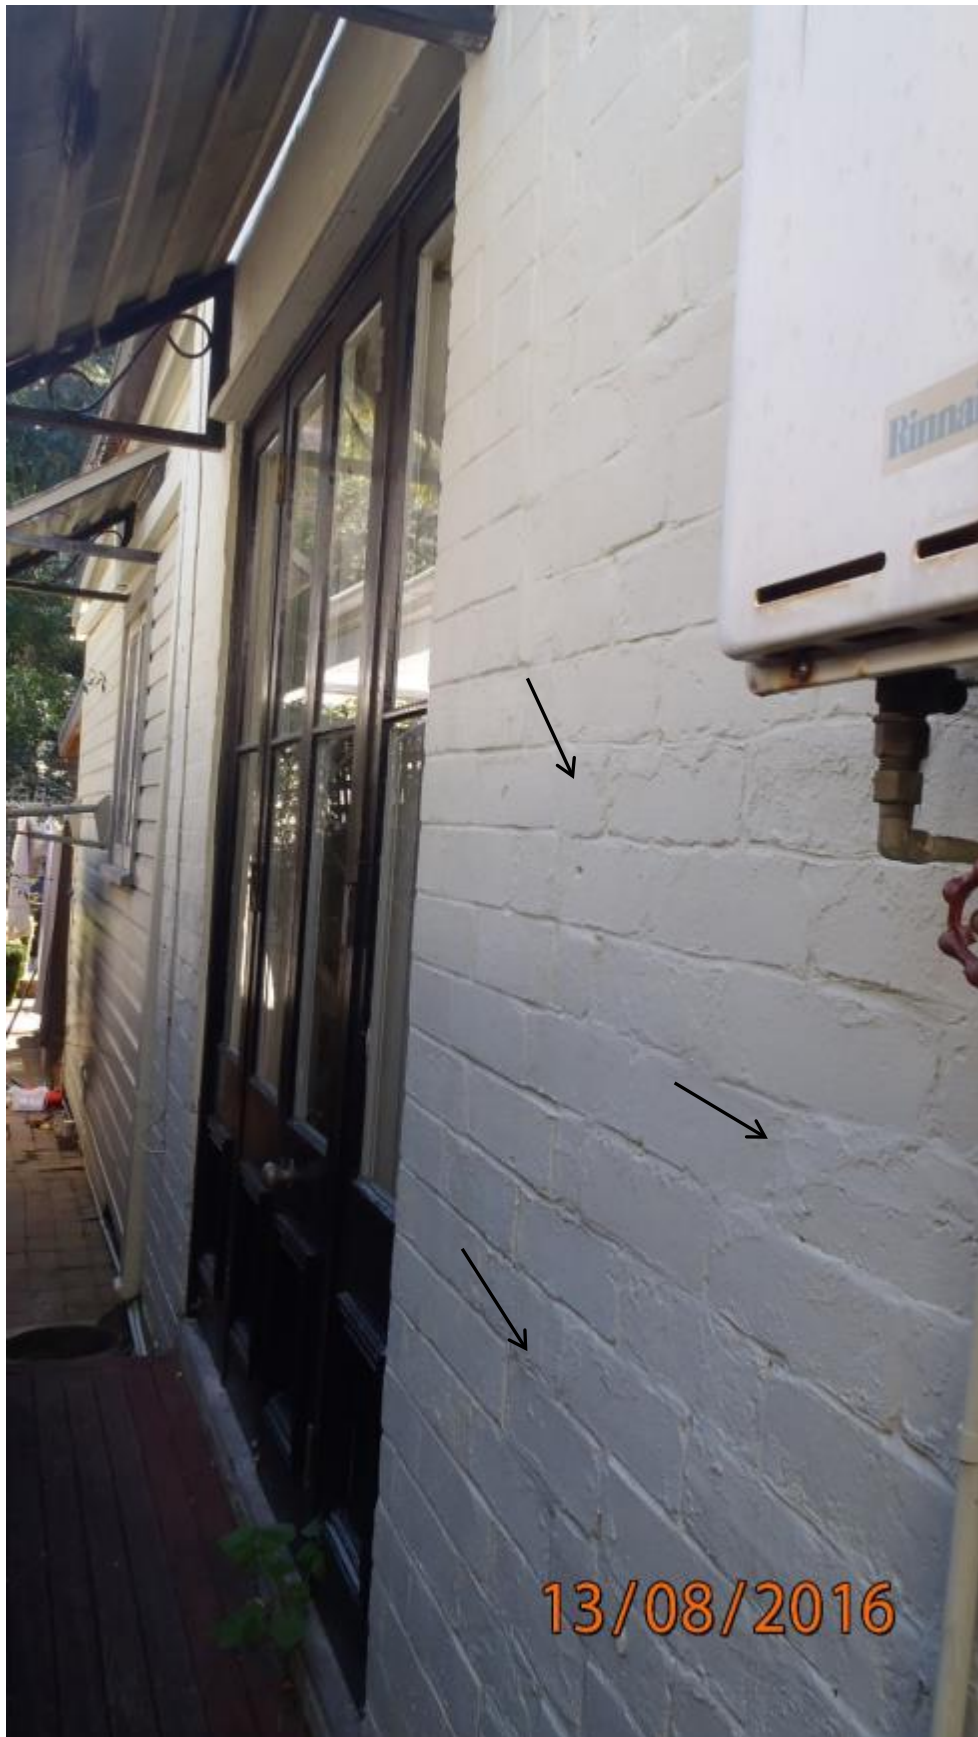
We noted a previous repair to the brickwork between the Lounge Room and the Bathroom. **[Photograph 8]**

**Photograph 8** shows evidence of a previous repair to the brickwork between the Lounge Room and the Bathroom.

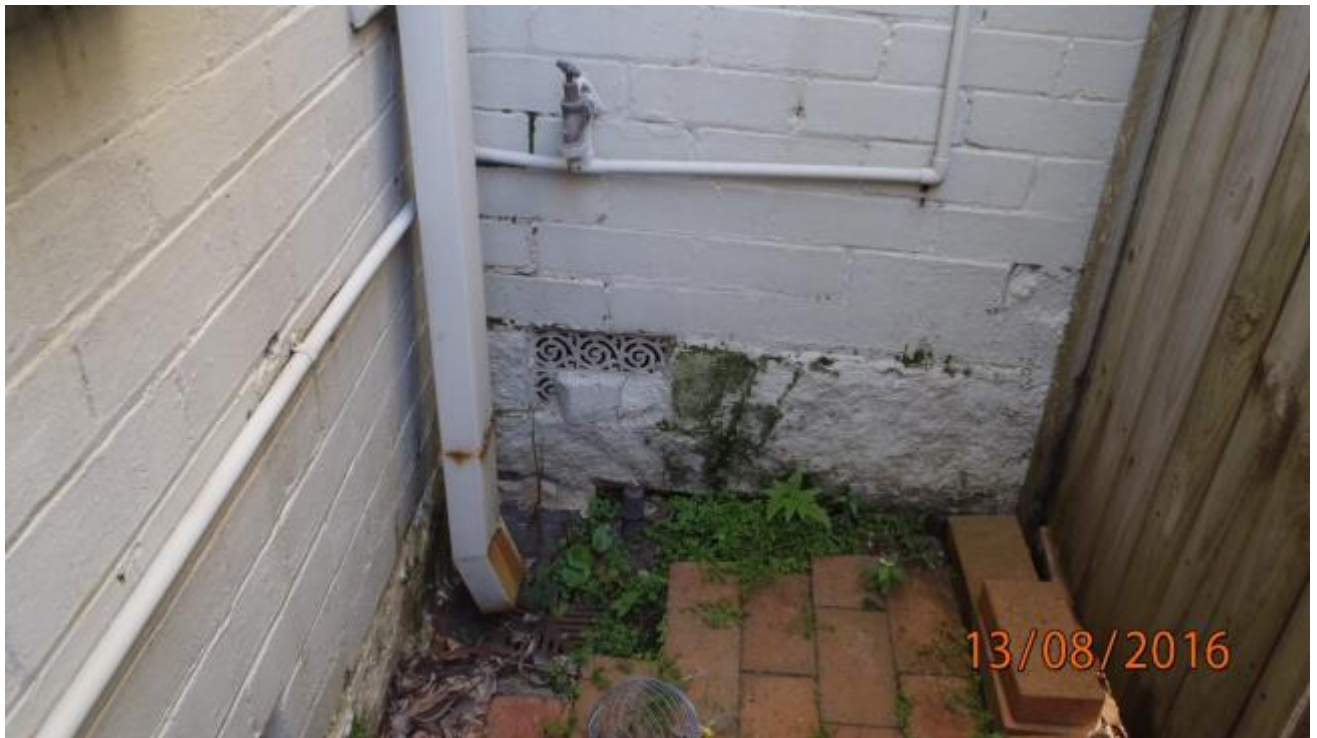
We noted a rusting downpipe and displaced pavers to the path outside the Bedroom 2 window.

We also noted lichen growth to the wall and fence outside the Bedroom 2 window **[Photograph 9]**

**Photograph 9** shows a rusted downpipe, displaced pavers and lichen/moss growth on the surface coated footings outside the Bedroom 2 window.

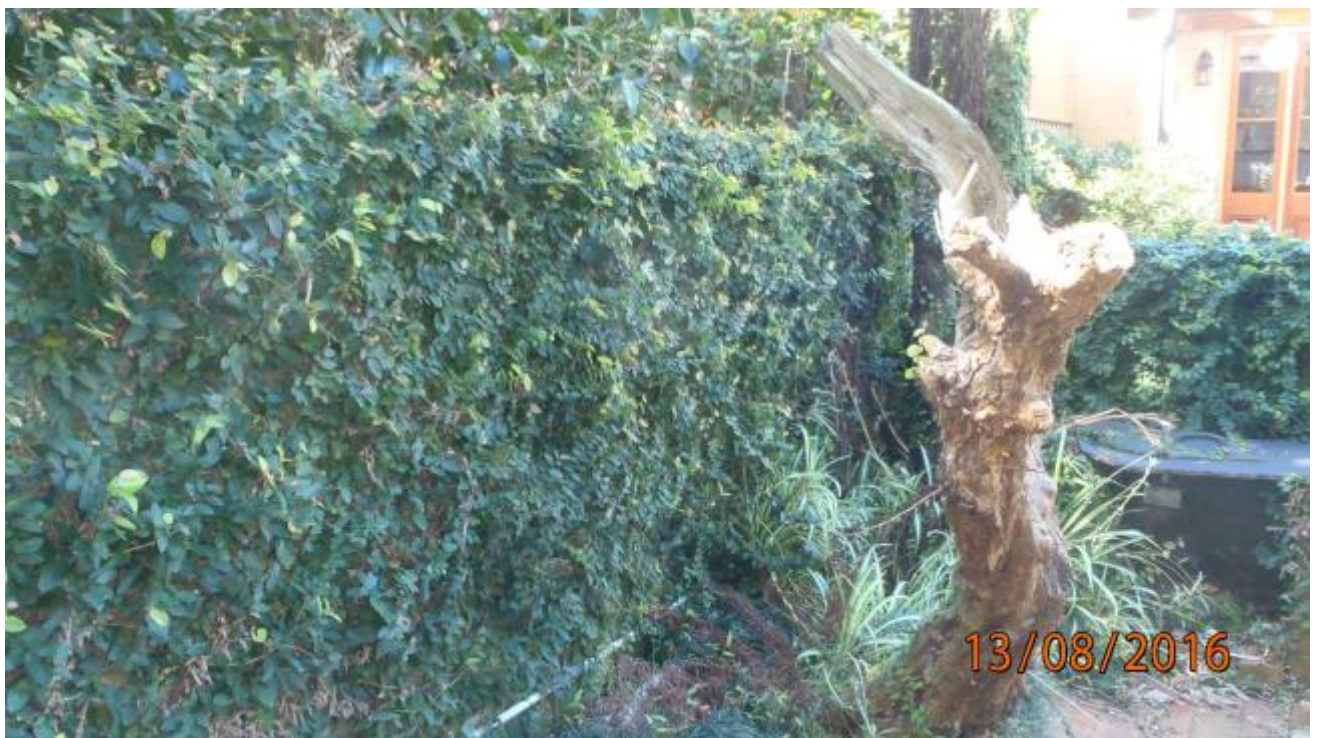
We noted that the common boundary fence between the adjoining property; No.28 Parraween Street, Cremorne has climbing plant growing along its entirety. **[Photograph 10]**

**Photograph 10** shows the rear common boundary fence between the adjoining property; No.28 Parraween Street, Cremorne.

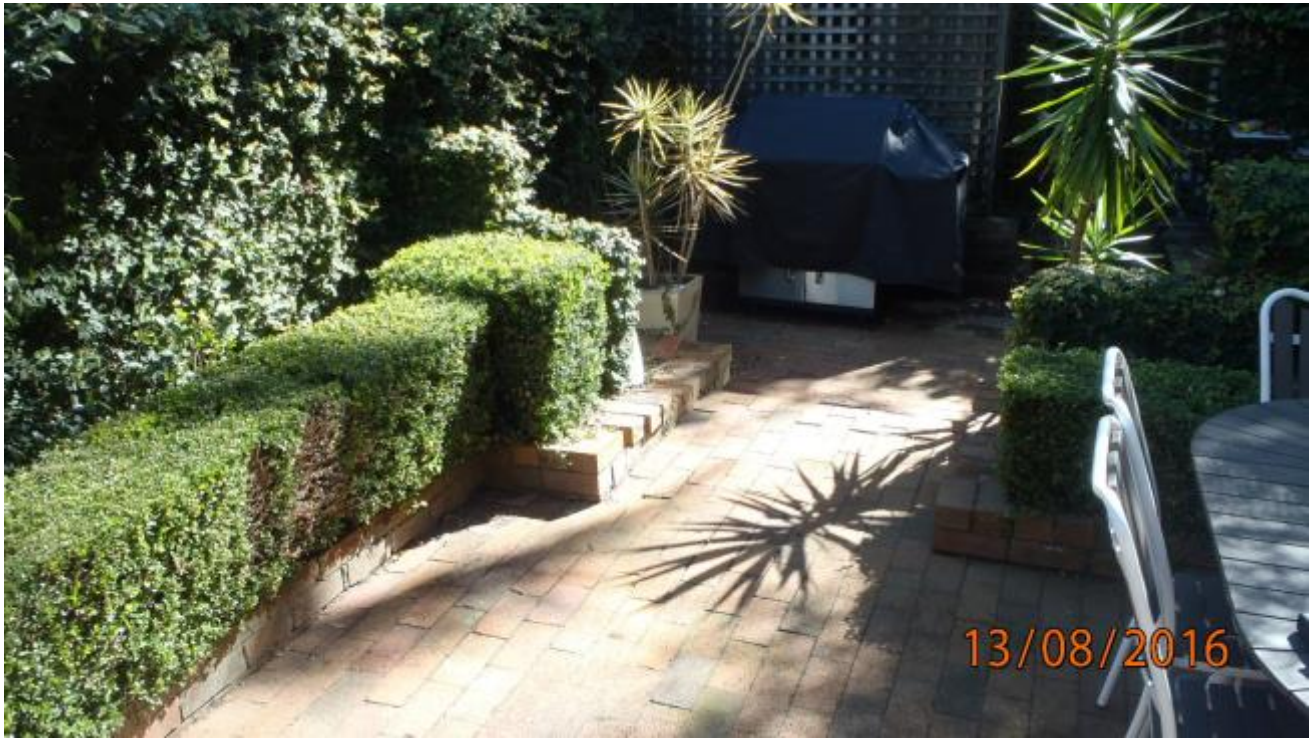
We noted that there was a paved outdoor area and barbeque area to the rear of the premises. **[Photograph 11]**

**Photograph 11** shows the general condition of the rear paved outdoor entertainment area.

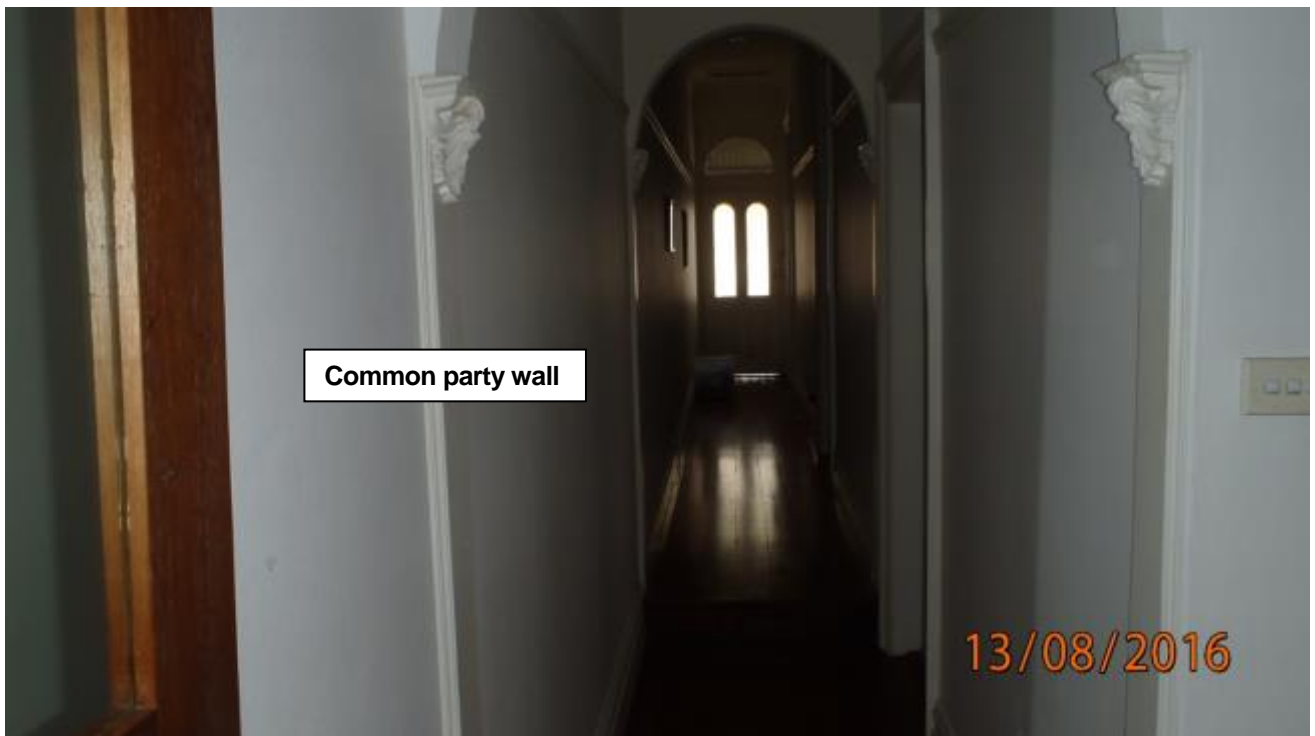
We noted that the north eastern wall of the Entry / Hallway is the *common party / separation wall* with the adjoining property; No.28 Parraween Street, Cremorne. **[Photograph 12]**

**Photograph 12** shows the general condition of the common party / separation wall.

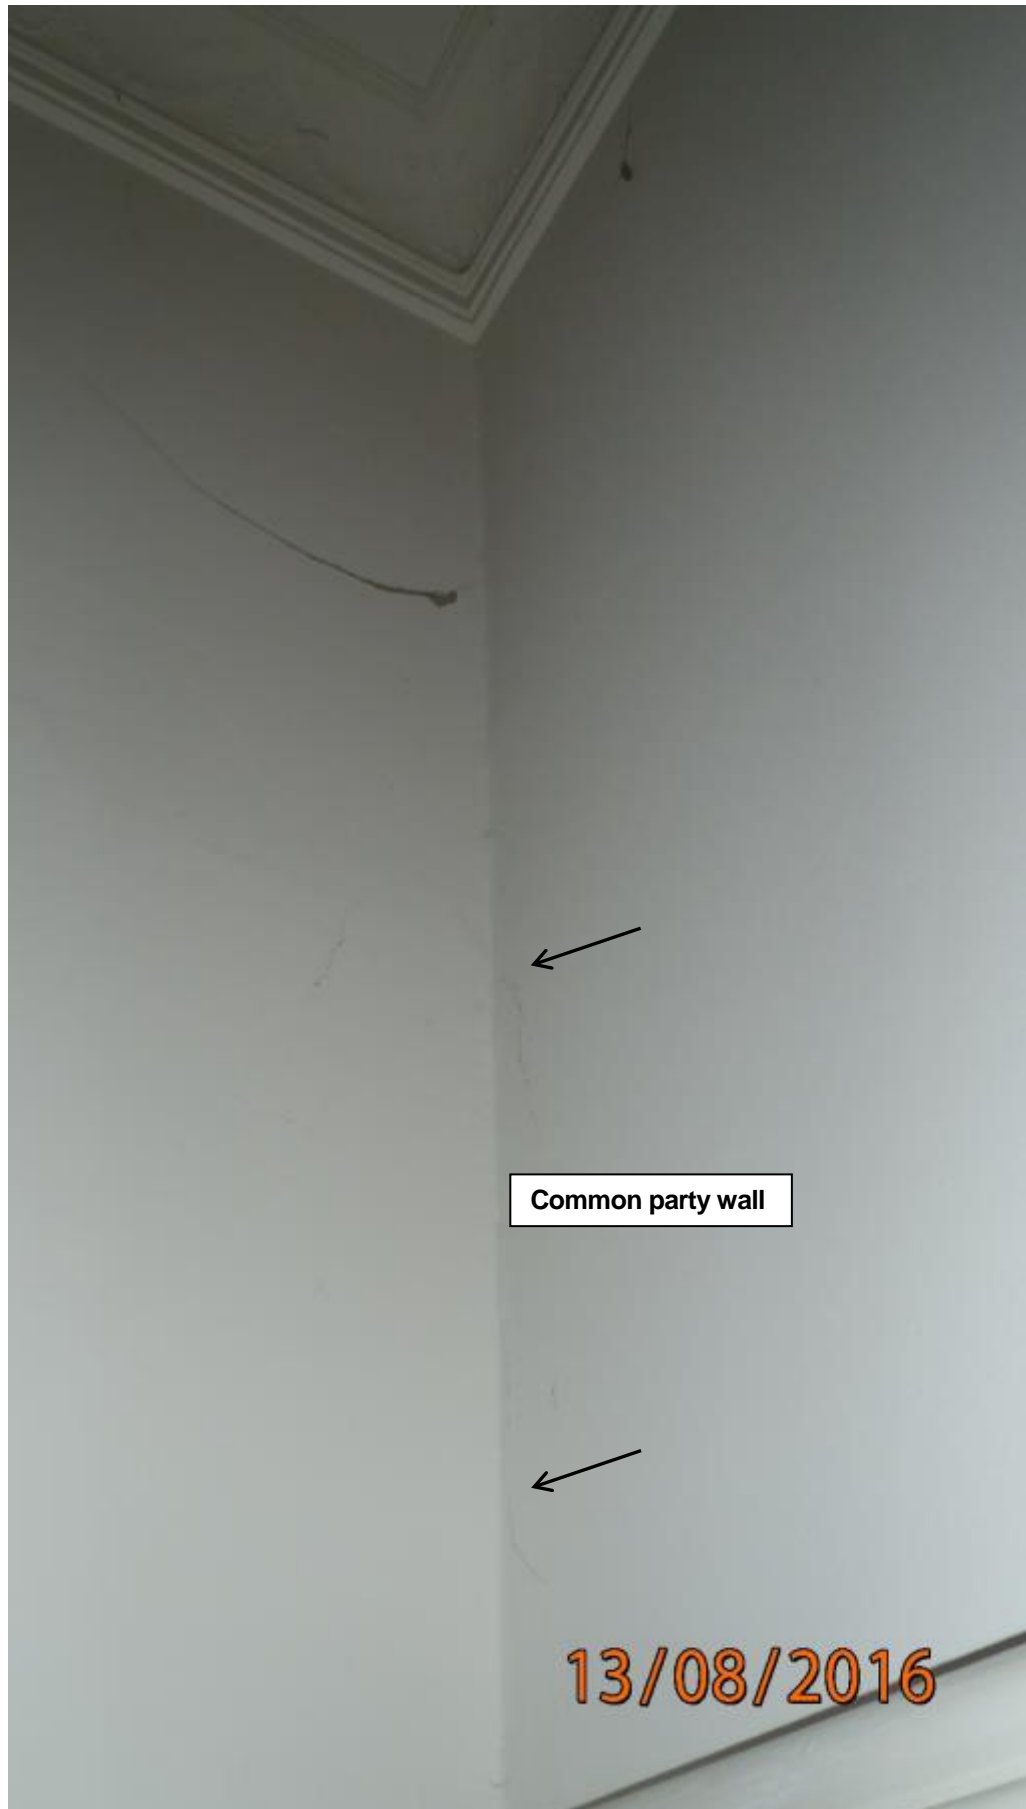
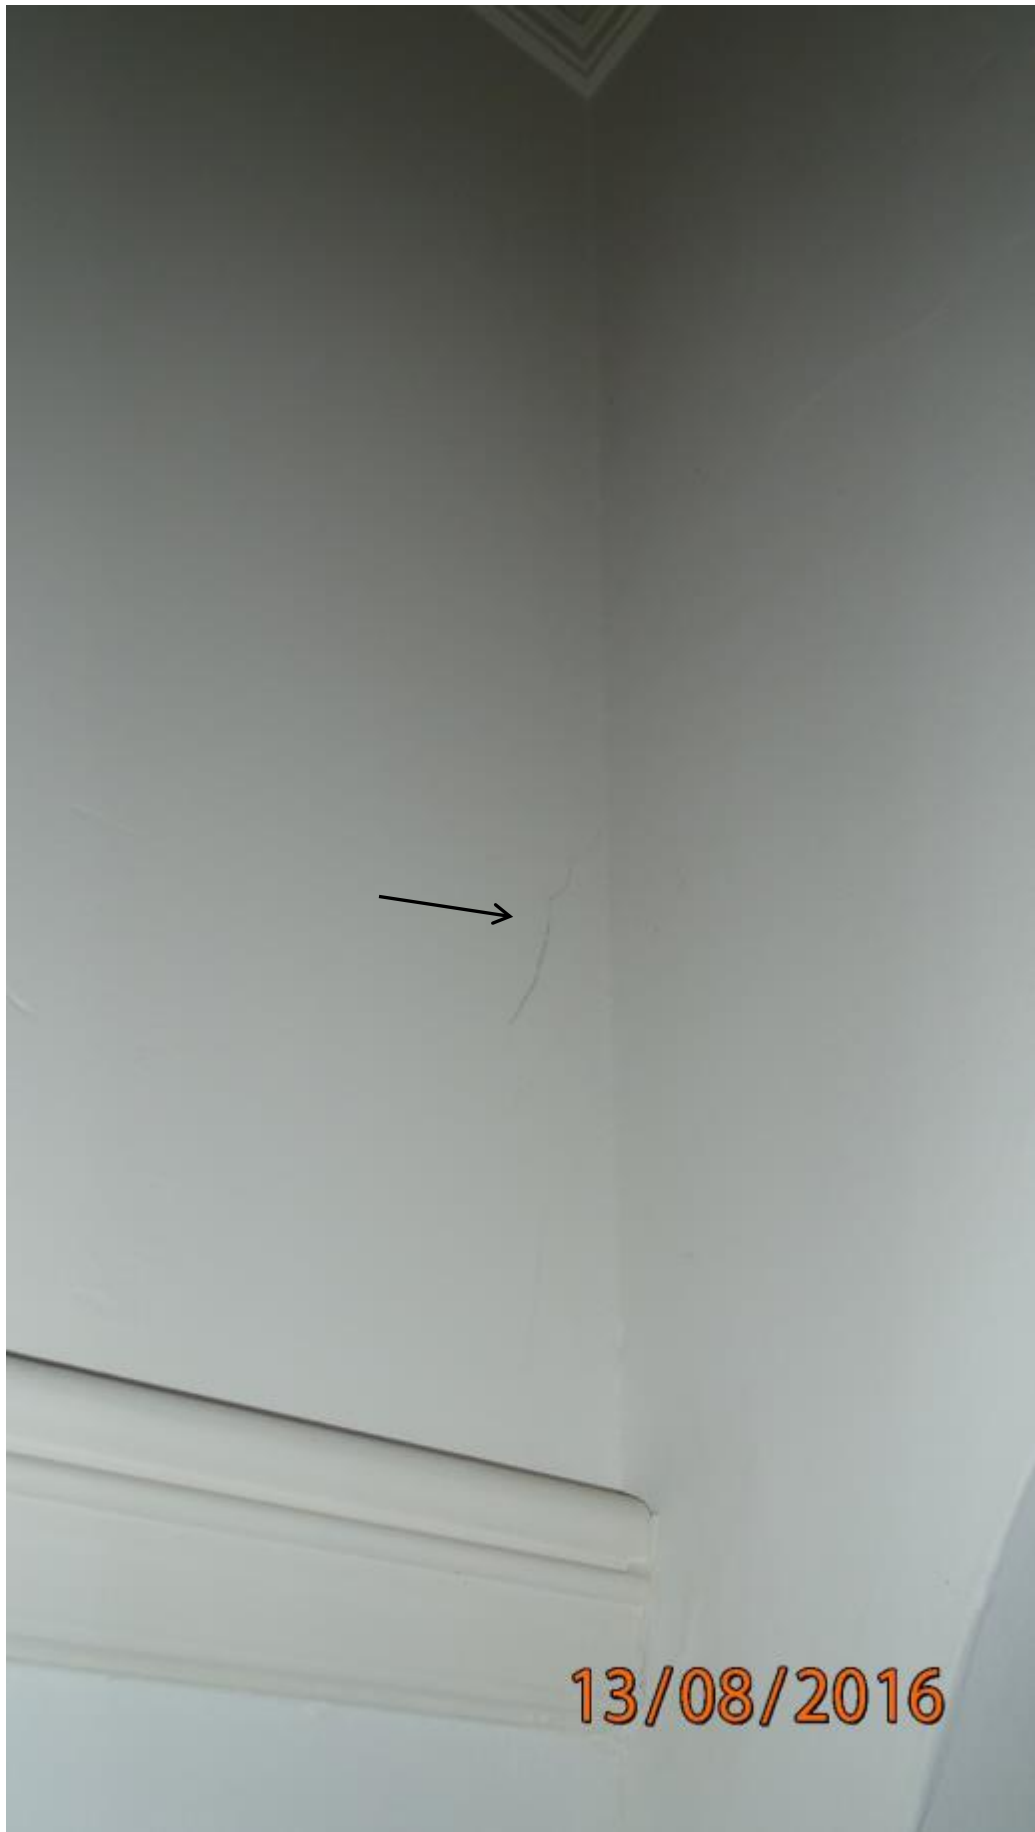
We noted vertical hairline cracking [ $<1.0\text{mm}$ ] to the wall / wall junction on both sides of the hallway arch **[Photographs 13 and 14]**

**Photograph 13** shows vertical cracking at the hallway arch.

**Photograph 14** shows vertical cracking at the hallway arch.

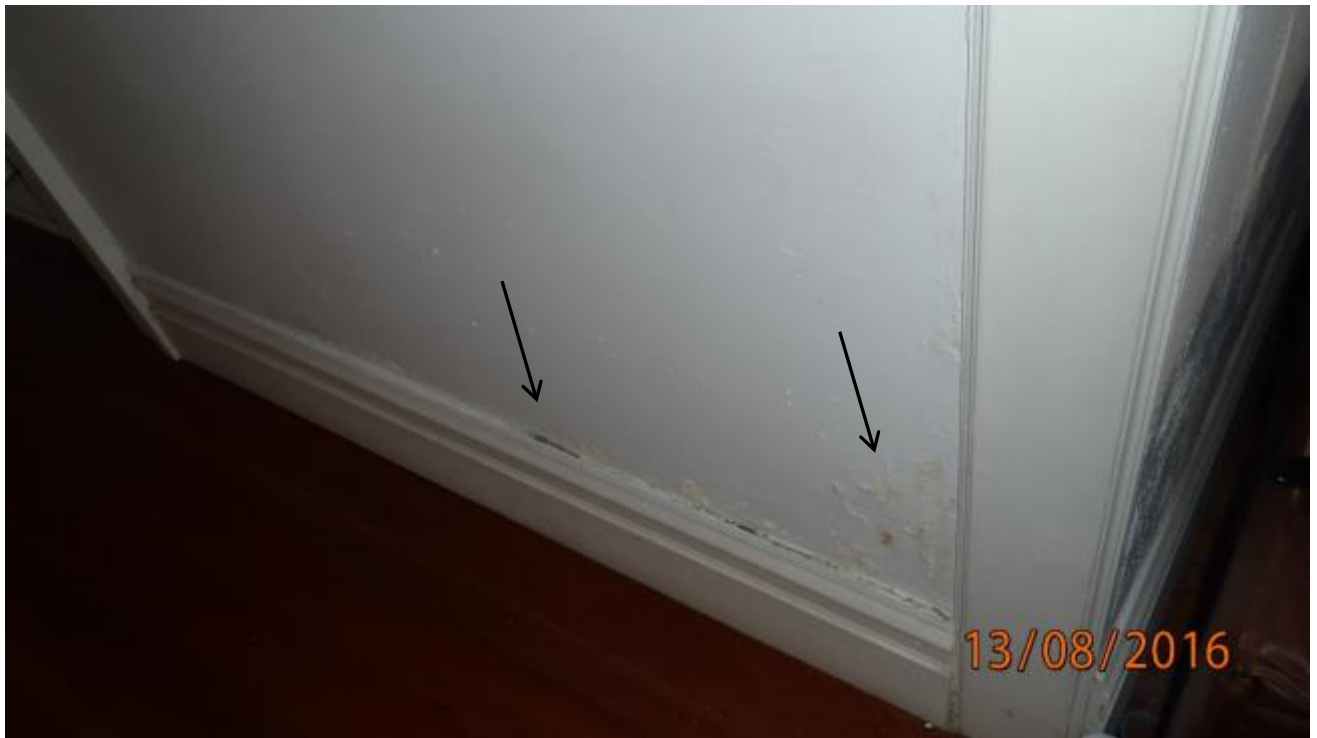
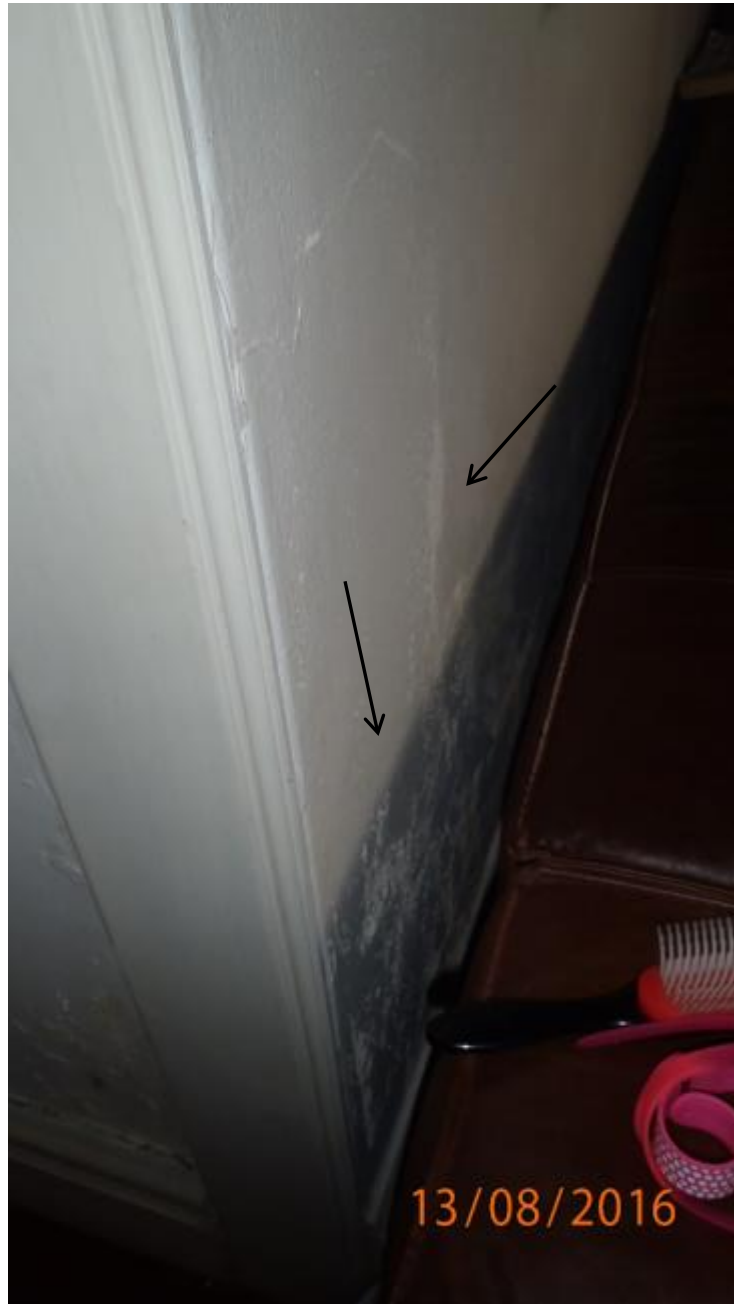
We noted areas of flaking / lifting paint to the internal wall common with the Bathroom. This, in our experience, is consistent with rising damp. **[Photographs 15 and 16]**

**Photograph 15** shows flaking / lifting paint to the internal wall common with the Bathroom. This, in our experience, is consistent with rising damp.

**Photograph 16** shows flaking / lifting paint to the internal wall common with the Bathroom. This, in our experience, is consistent with rising damp.

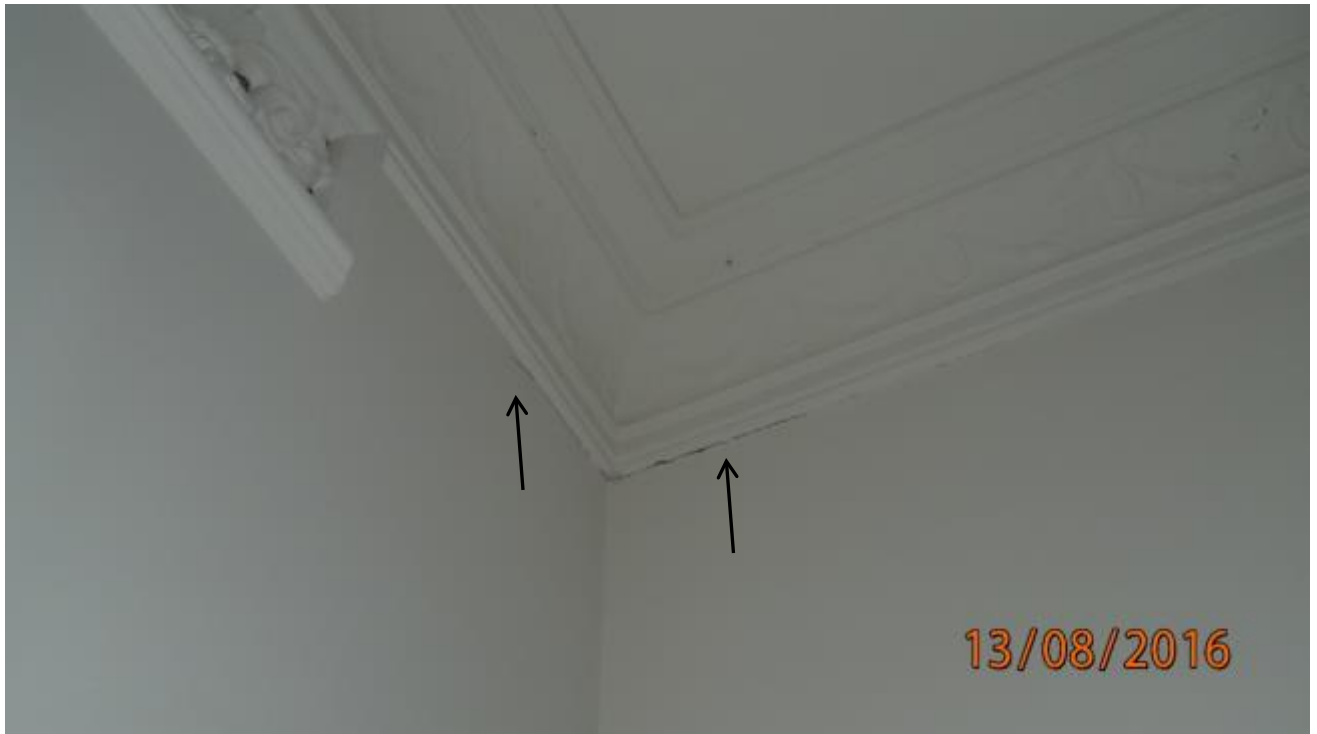
We noted separation cracking [ $<1.0\text{mm}$ ] at the cornice / wall junction in the northern corner. **[Photograph 17]**

**Photograph 17** shows separation cracking at the wall / cornice junction in the front Bedroom.

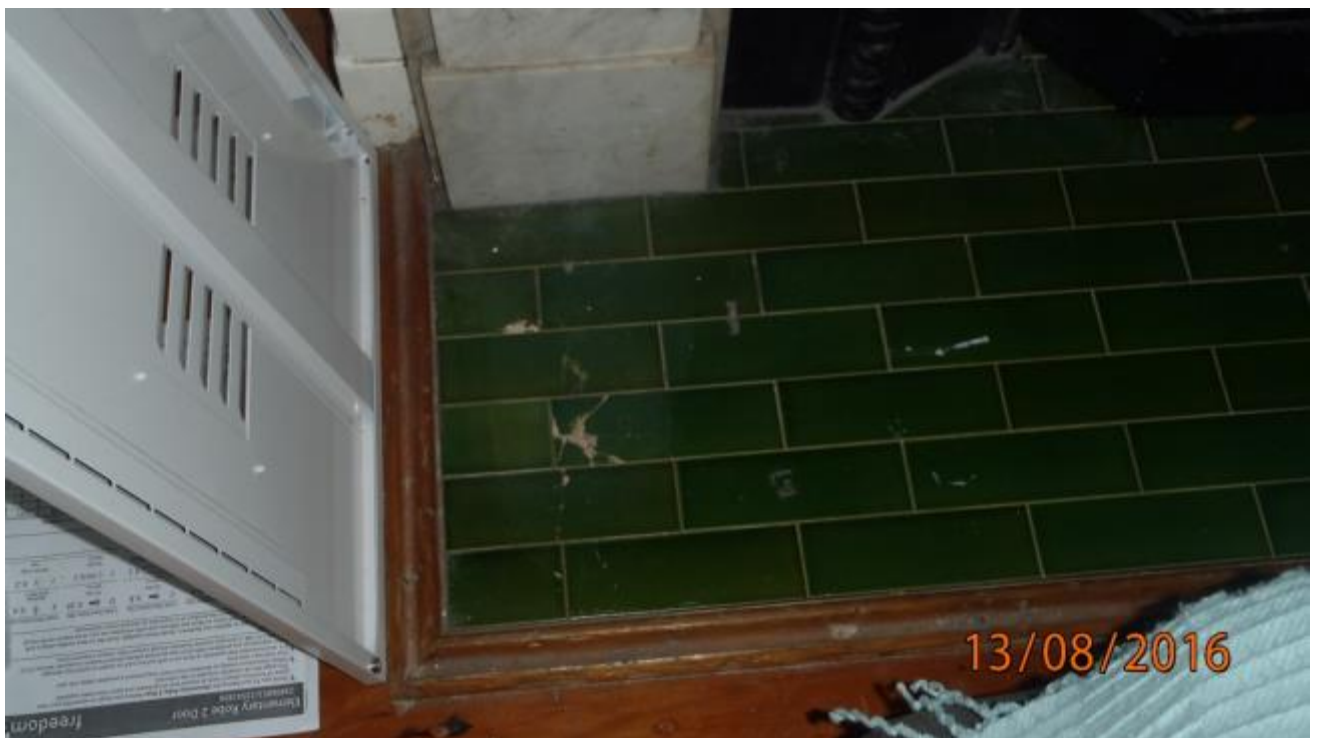
We noted chipped & cracked tiles to the fireplace hearth tiles. **[Photograph 18]**

**Photograph 18** shows chips and cracks to the hearth tiles of the fireplace in Bedroom 1.

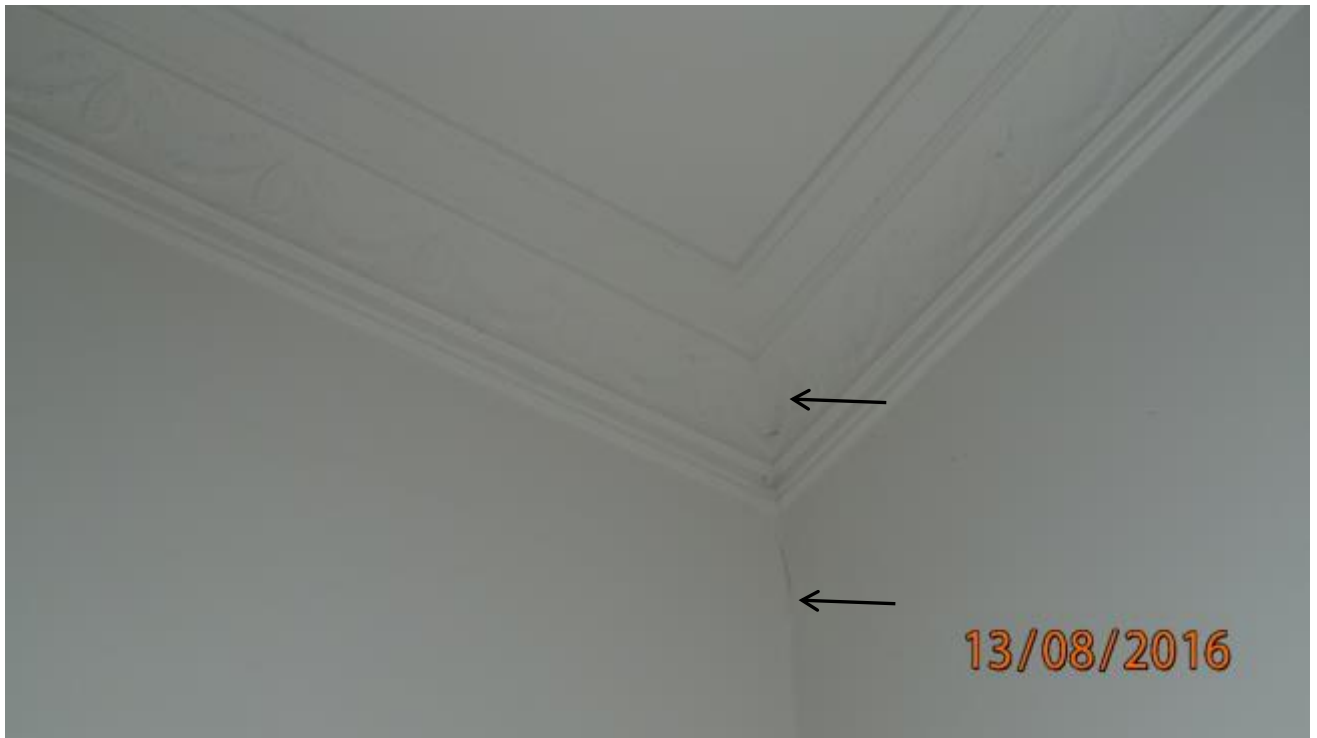
We noted vertical cracking [ $<1.0\text{mm}$ ] all the wall / wall junction extending through the wide decorative profiled plaster cornice in the northern corner. **[Photograph 19]**

**Photograph 19** shows a vertical crack at the wall / wall junction extending through the plaster cornice in Bedroom 2.
