## Dilapidation Assessment Report

Prepared for: Cape Cod Australia Pty. Limited  
Job address: 26 Parraween Street, Cremorne.  
Property Owner/s: Mrs Rachel Cable.  
Report reference: **NORTH SYDNEY COUNCIL**  
Development Application No: not available  
Date of assessment: 13<sup>th</sup> August 2016

**Re: Dilapidation Report**

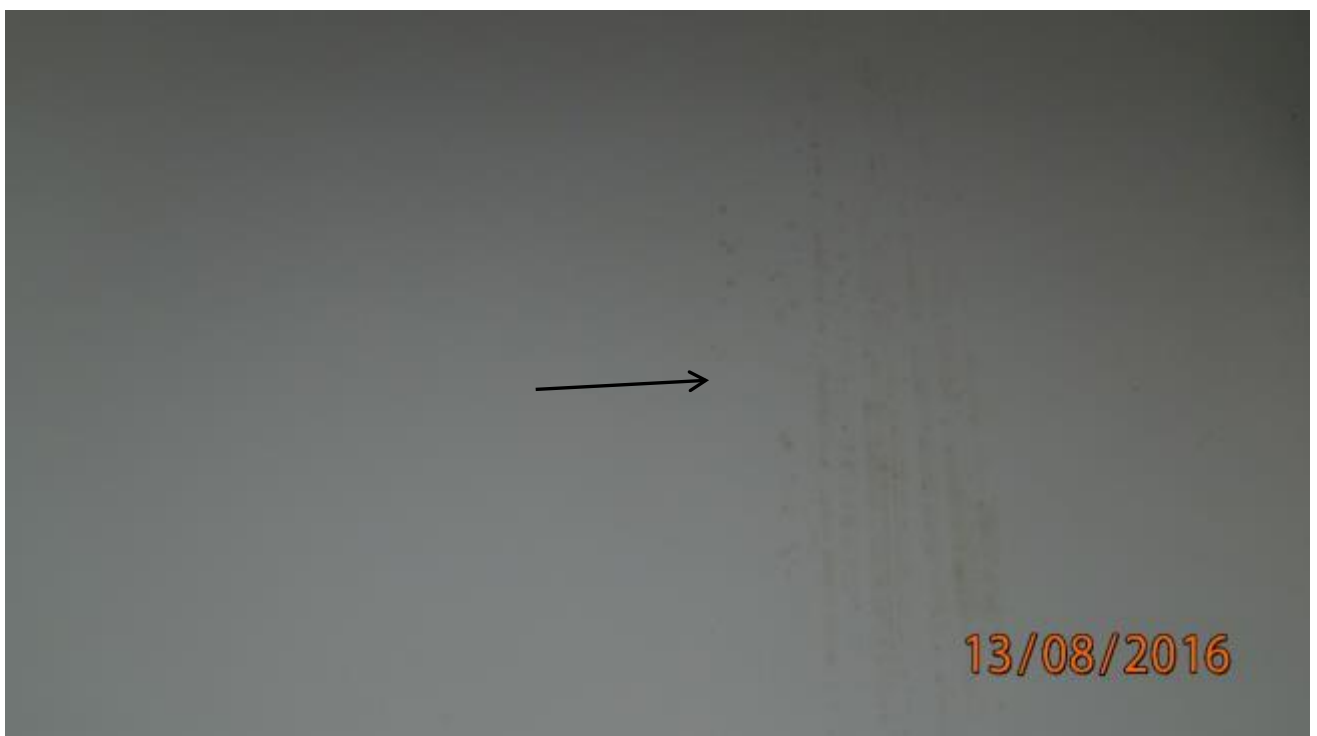
We noted staining to the painted cement rendered wall surface adjacent to the fireplace **[Photograph 20]**

**Photograph 20** shows staining to the cement rendered wall surface in Bedroom 2.

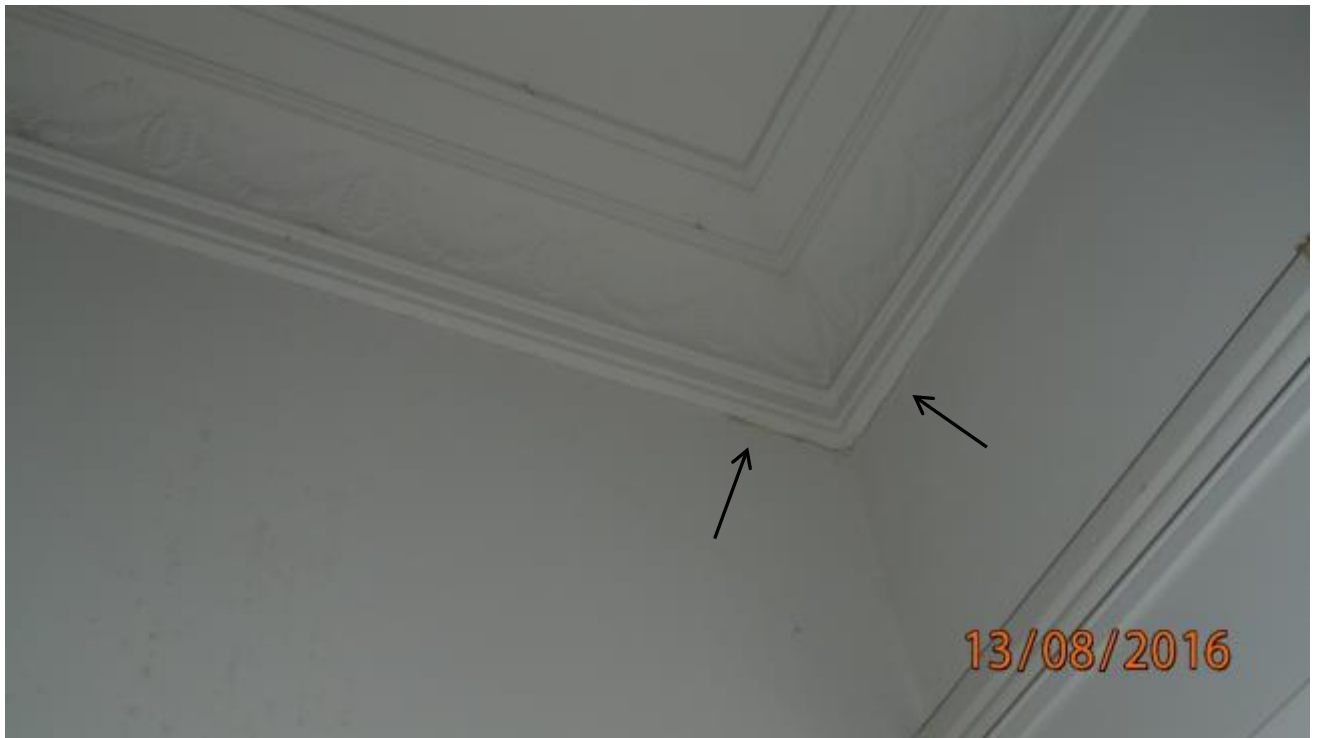
We noted separation cracking [ $<1.0\text{mm}$ ] at the cornice / wall junction in the western corner. **[Photograph 21]**

**Photograph 21** shows separation cracking at the cornice / wall junction in Bedroom 2.

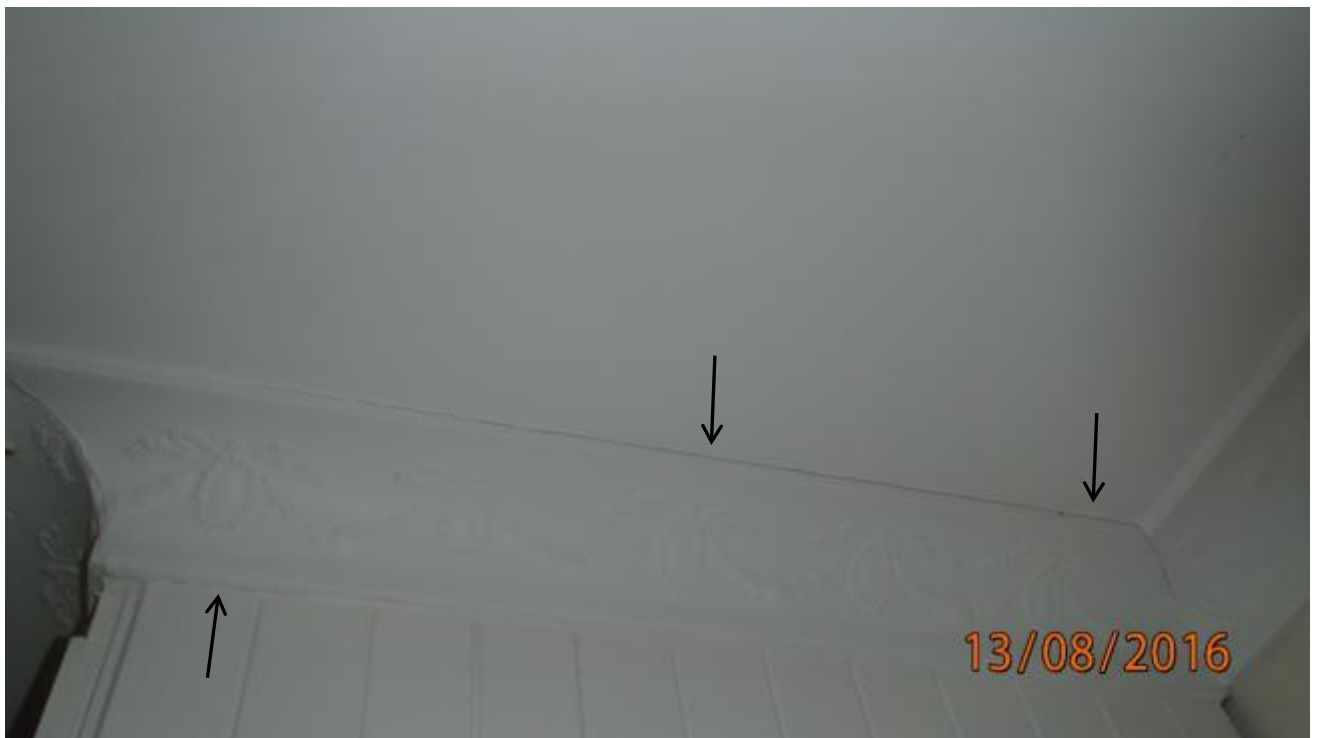
We noted separation cracking [ $<1.0\text{mm}$ ] at the cornice / wall and cornice / ceiling junction in the southern corner. **[Photograph 22]**

We also noted separation cracking [ $<1.0\text{mm}$ ] to the mitre joint of the wide decorative profiled plaster cornice in the southern corner. **[Photograph 22]**

**Photograph 22** shows separation cracking at the cornice / wall and cornice / ceiling junctions in the Bathroom.

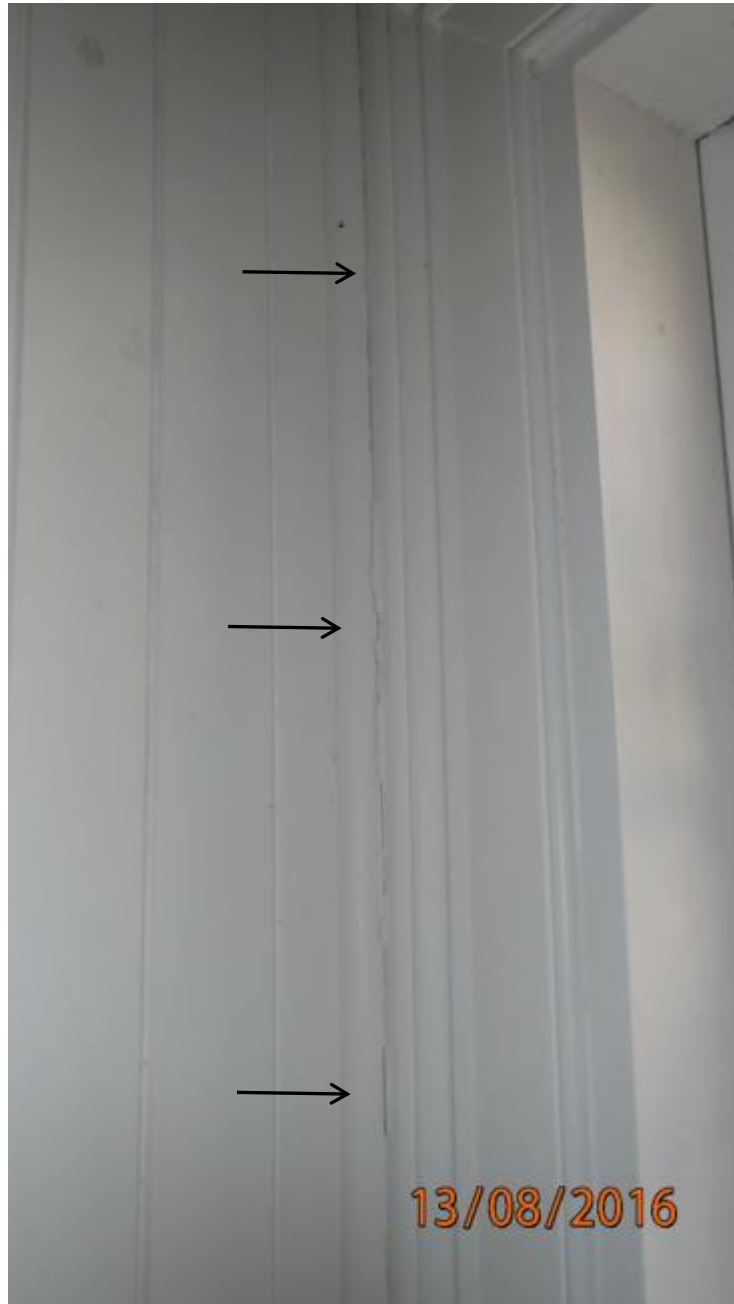
We noted separation cracking [ $<1.0\text{mm}$ ] at the wall / wall junction in the southern corner adjacent to the dryer cupboard. **[Photograph 23]**

**Photograph 23** shows separation cracking at the wall / wall junction adjacent to the dryer cupboard in the Bathroom

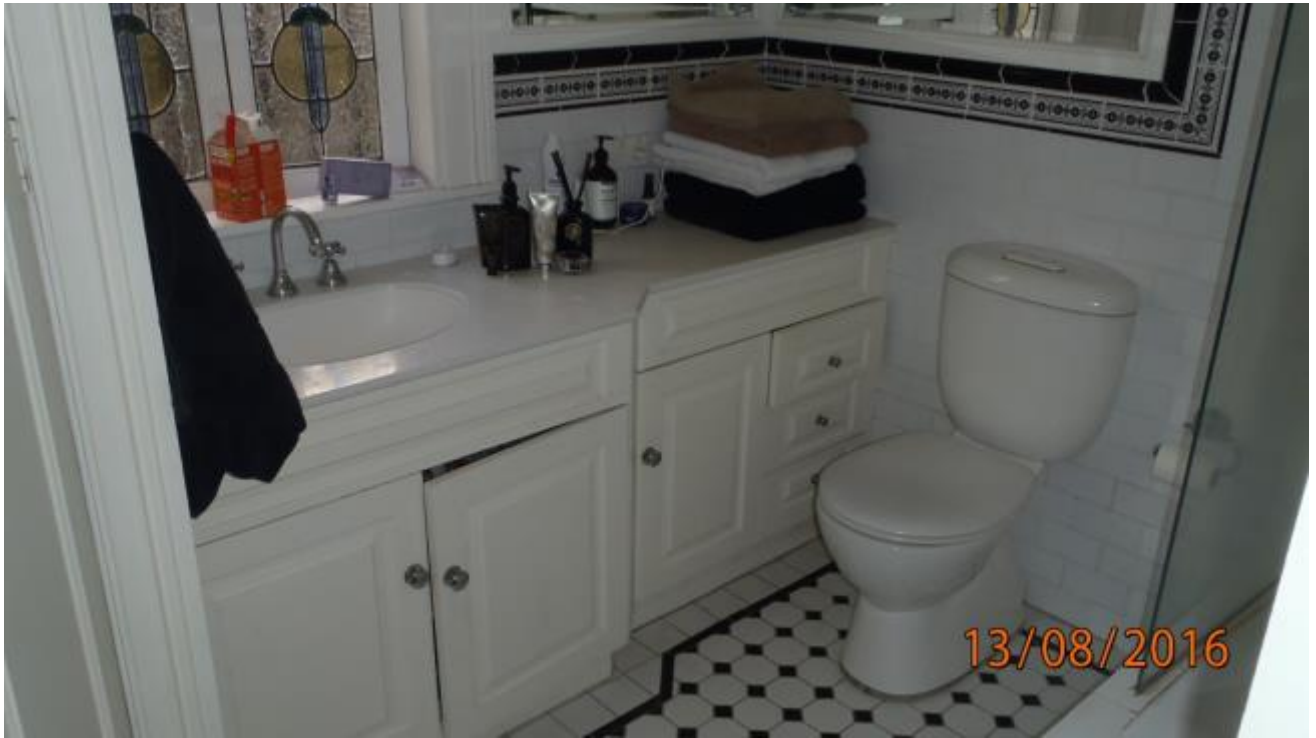
We noted that the grout to the wall and floor tiles is complete and that the wall and floor tiles when randomly “tap” tested appeared to be sound. We did not observe any recent cracking to the tile grout at the wall / wall, wall / floor junctions. **[Photograph 24]**

**Photograph 24** shows the general condition of the Bathroom.

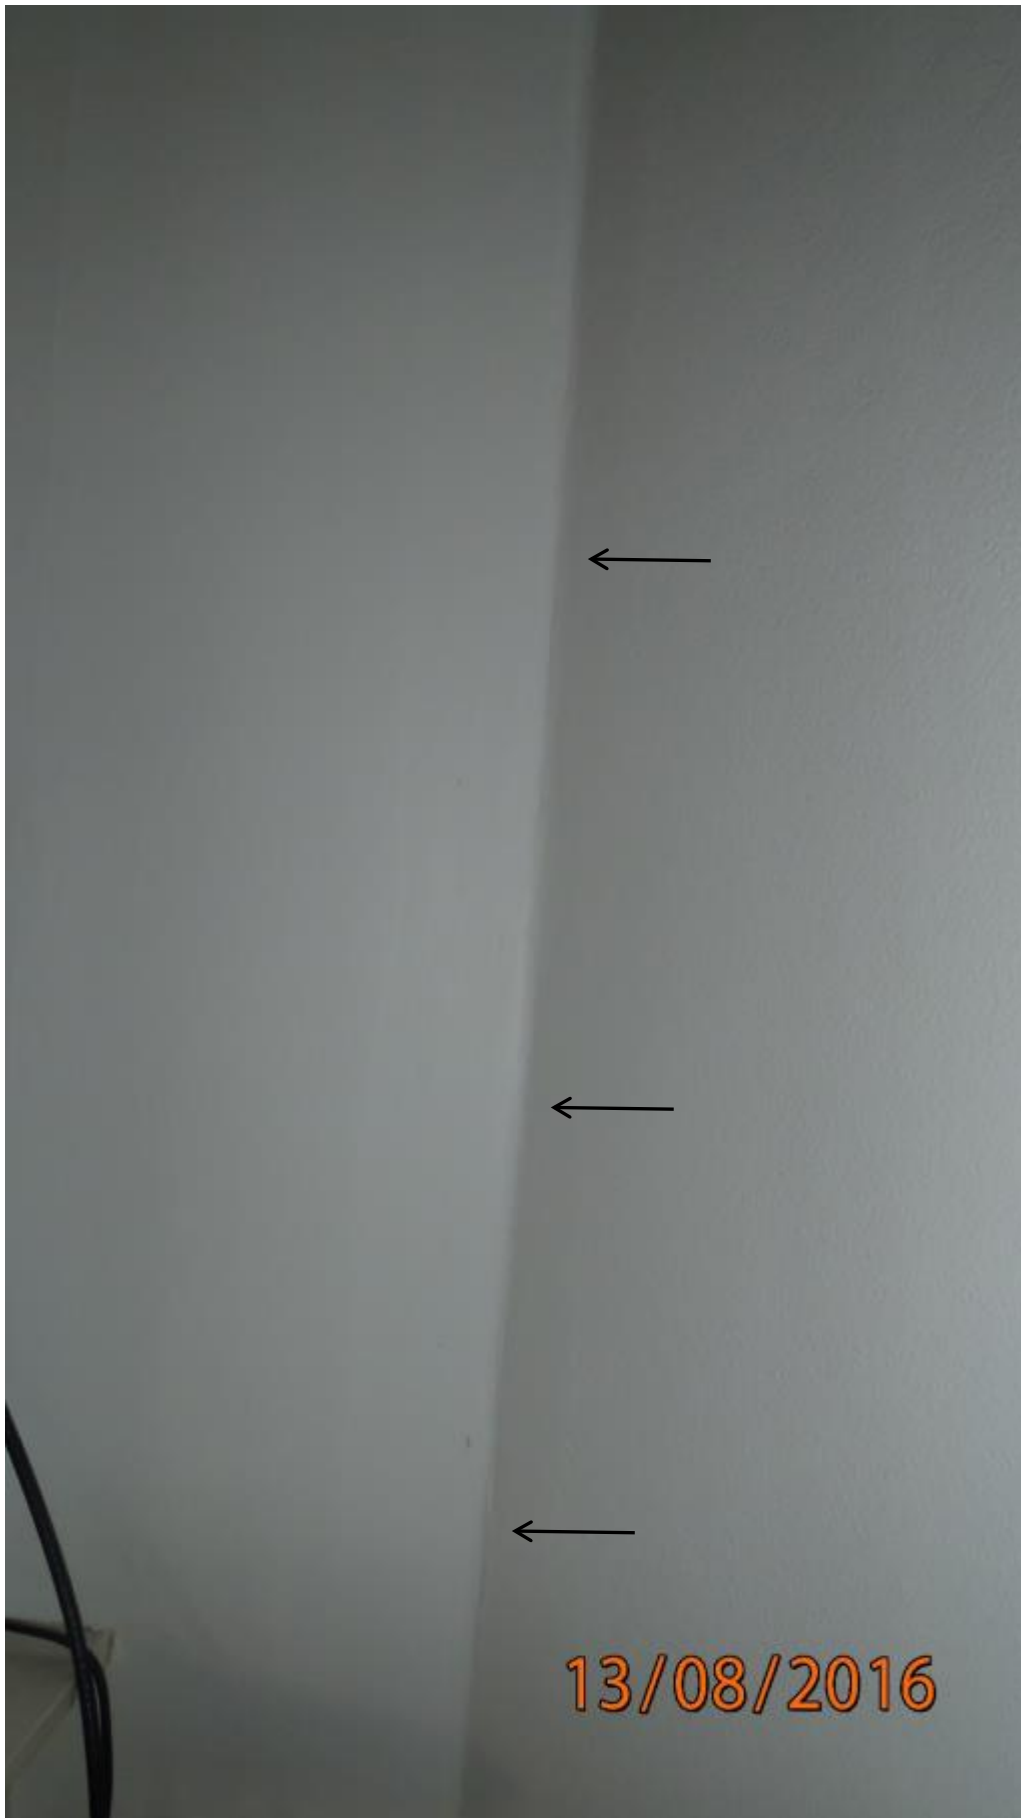
We noted hairline vertical cracking [ $<1.0\text{mm}$ ] at the wall / wall junction at the fireplace adjacent to the *common party / separation* wall with the adjoining property; No.28 Parraween Street, Cremorne **[Photograph 25]**

**Photograph 25** shows vertical cracking at the wall / wall junction adjacent to the *common party / separation* wall with the adjoining property; No.28 Parraween Street, Cremorne.

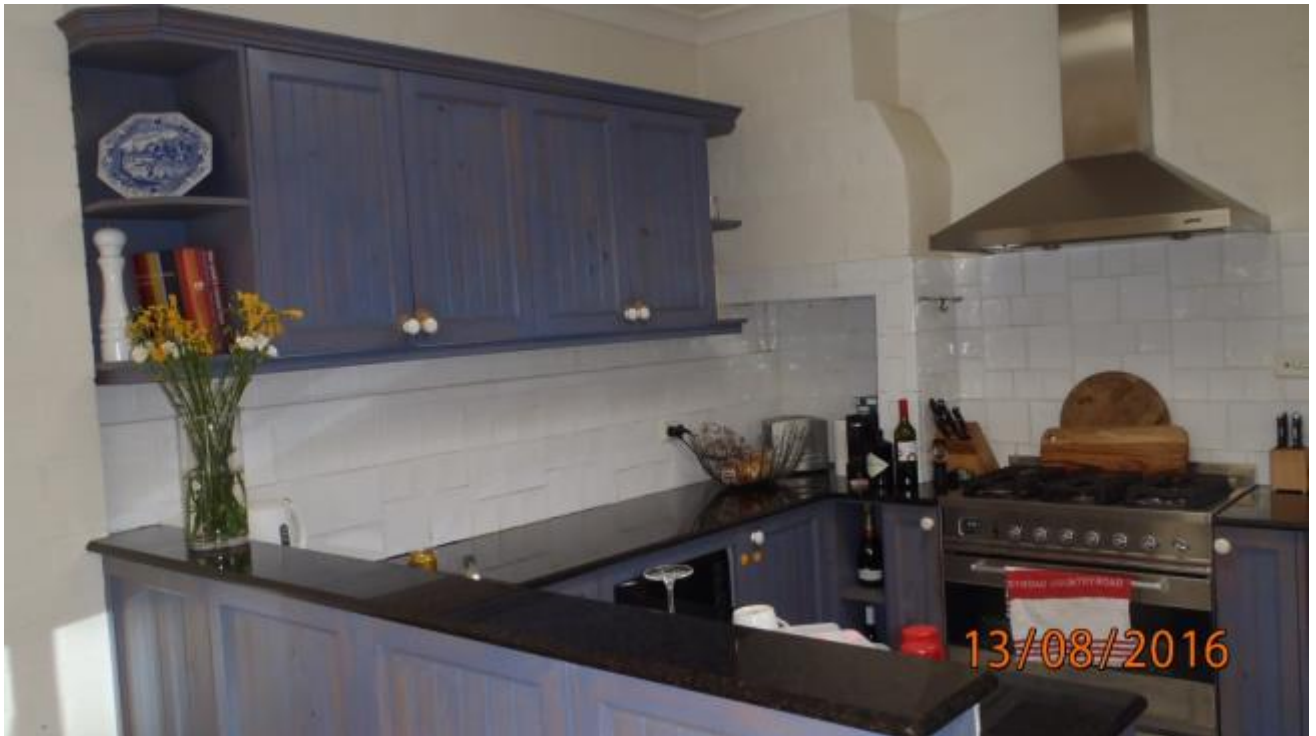
We noted that the grout to the wall and floor tiles is complete and that the wall and floor tiles when randomly "tap" tested appeared to be sound. We did not observe any recent cracking to the tile grout at the wall / wall, wall / floor junctions. [**Photograph 26**]

**Photograph 26** shows the general condition of the Kitchen.

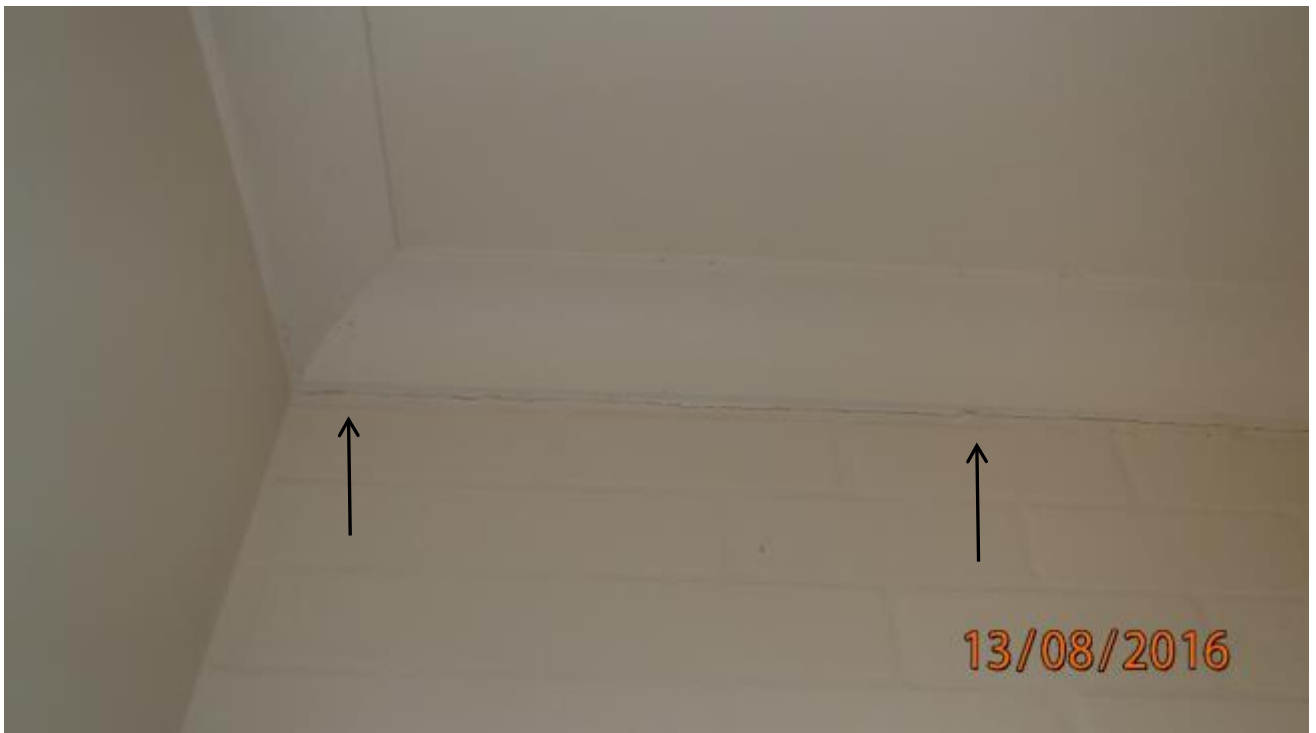
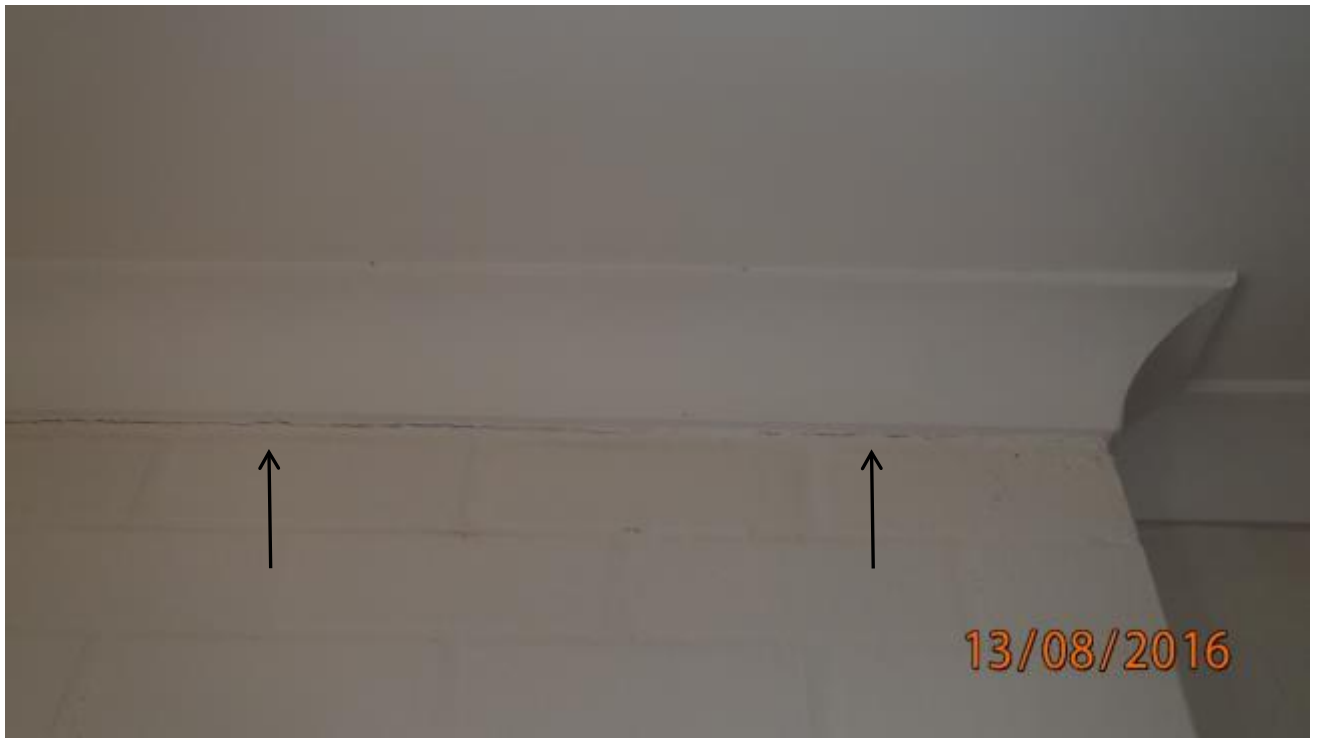
We noted separation cracking [ $<1.0\text{mm}$ ] at the cornice / wall junction on the north eastern wall (*common party / separation wall*) [**Photographs 27 and 28**]

**Photograph 27** shows separation cracking at the cornice / wall junction on the north eastern wall  
(common party / separation wall)

**Photograph 28** shows separation cracking at the cornice / wall junction on the north eastern wall (*common party / separation wall*).
