HAZARDOUS MATERIALS ASSESSMENT REPORT

Job details: Owner: Mr R. Speed & Ms. J. Howden.
Location: 9 Watson Avenue, North Wahroonga.

Plans for Job No: 7757/16

Our reference: HM05110816

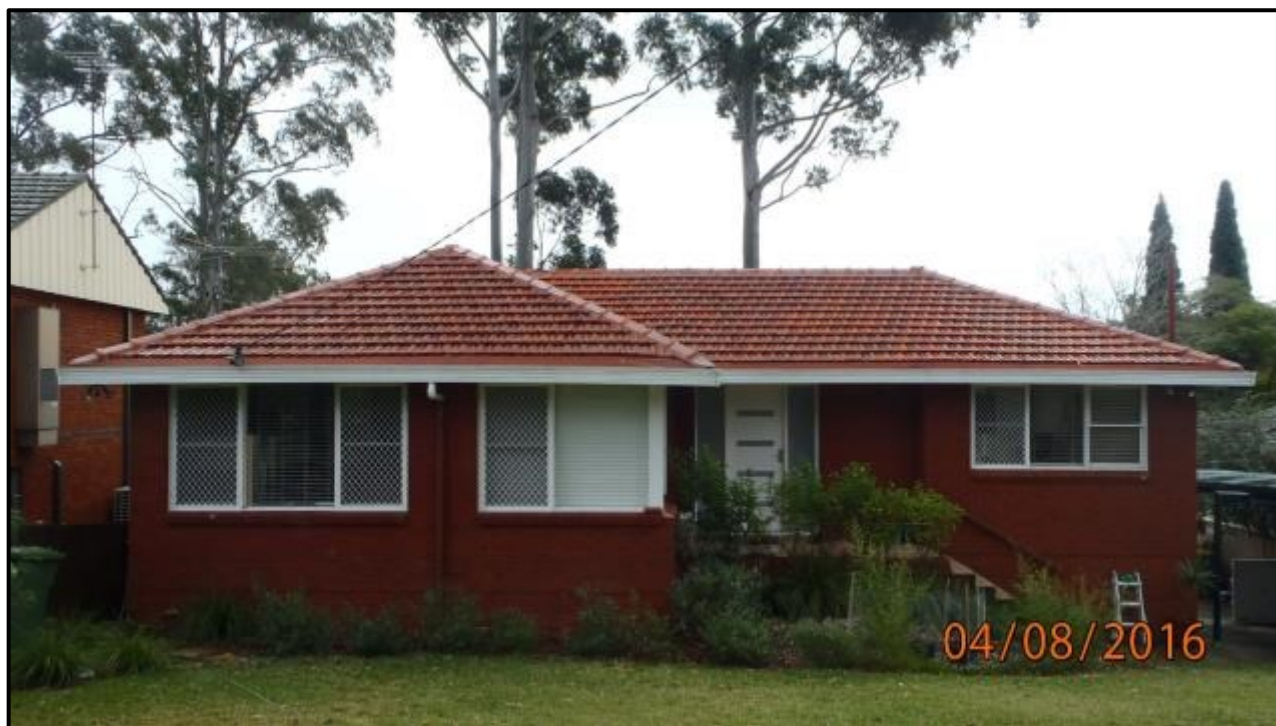
Front south eastern elevation of the residence
