## **HAZARDOUS MATERIALS ASSESSMENT REPORT**

**Job details:** Owner: Mr. S. Carson  
Location: 99 Ruthven Street, Bondi Junction

**Plans for Job No:** 7663/15

**Our reference:** HM04100715

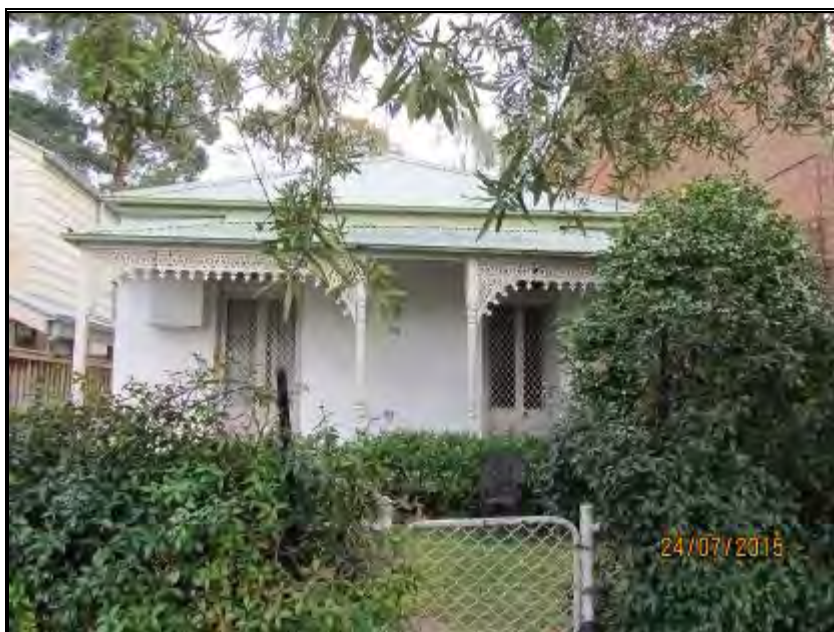
**Front eastern elevation of the residence**
