## **HAZARDOUS MATERIALS ASSESSMENT REPORT**

**Job details:** Owner: A. Gardiner.  
Location: 34A Edgecliffe Avenue, South Coogee

**Our reference:** HM06111017

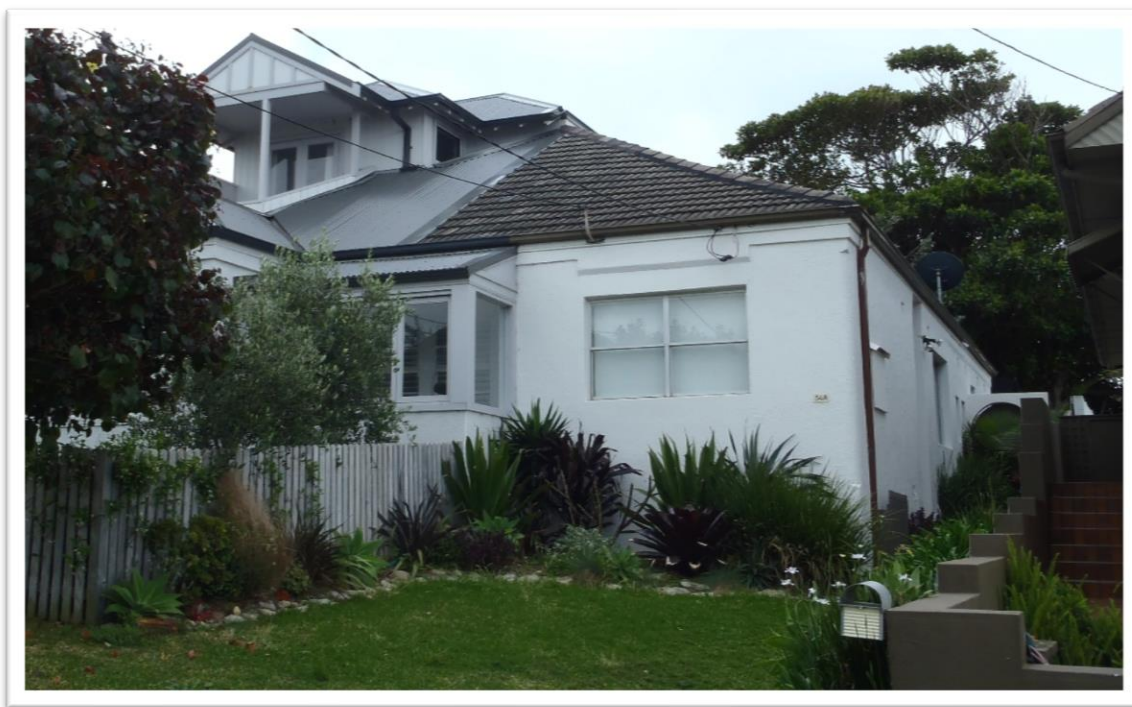
**Front southern elevation of the residence**
